DEPARTMENT OF THE ARMY  
UNITED STATES ARMY AVIATION TEST BOARD  
Fort Rucker, Alabama 36362

SUBJECT: Letter Report of Product Improvement Test of Mast,  
P/N 204-040-366-7, in the UH-1D Helicopter, USATECOM  
Project No. 4-5-0151-04

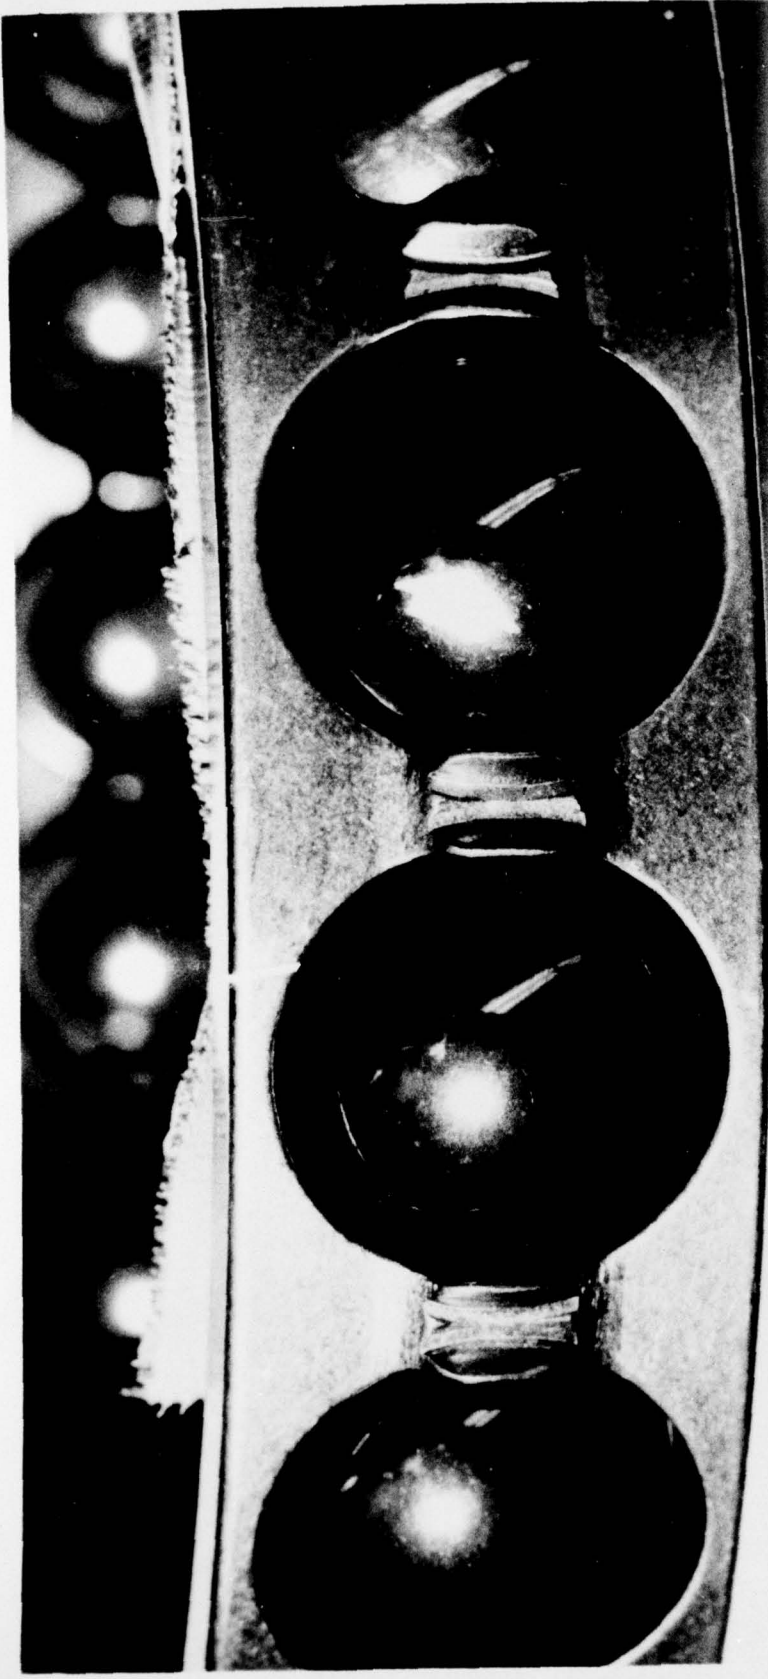
*Photograph 1*

(1) The first ball to the right of the "S/N 10" mark had a line running the entire circumference of the ball. A definite roughness existed at this line. Further visual inspection revealed that most of the balls had this line visible and detectable by touch to varying degrees (photograph 1, inclosure 1). The circumferential line of the balls appears to be a parting line formed during the impression-die-forging.

c. Reference the discrepancy reported in paragraph 4a(1) above. The manufacturer stated that they were unable to determine whether the balls were formed by impression-die-forging or skew rolling since the subcontractor considered this proprietary information. The detection of this line by feel was an abnormality which was not mentioned in the manufacturer's report.

b. The helicopter manufacturer be requested to perform a further study of the test bearing assembly, S/N 10, to determine whether the discrepancies not noted by the manufacturer's report (such as the feel-detectable circumferential lines and scratches or grooves on the balls) are characteristic of a design deficiency and that the cause of the discrepancies be determined.

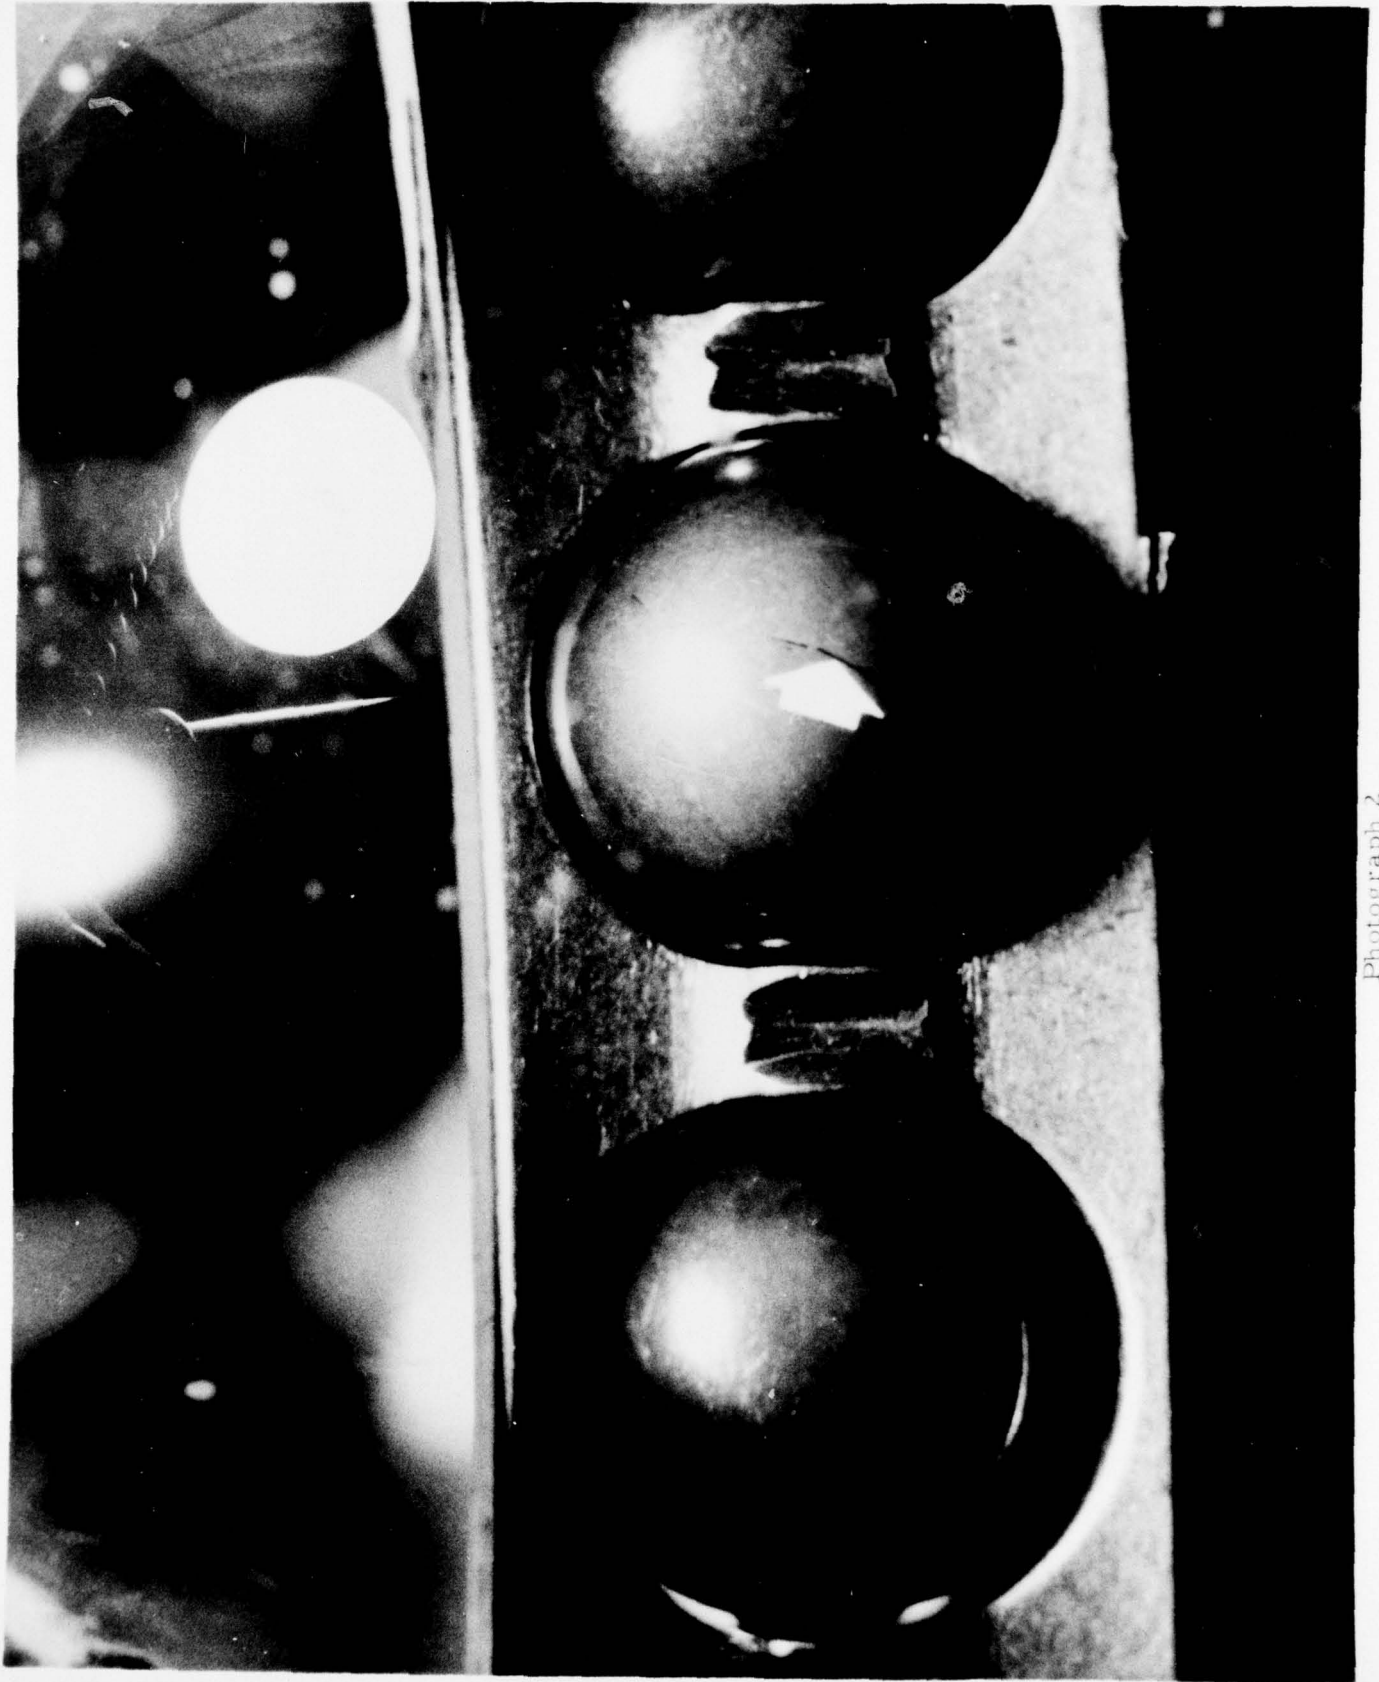
Photograph 2

(2) The second ball to the left of the "S/N 10" mark had a 3/16-inch long groove or scratch on it (photograph 2, inclosure 1). The groove or scratch could be seen and felt. In addition, grooves or scratches could be seen and felt on several of the other balls (photograph 3, inclosure 1). The grooves or scratches varied in length up to 3/16 inch. They appear to have been caused by metal particles or other foreign materials.

d. The discrepancies reported in paragraphs 4a(2) and 4a(4) above were not mentioned in the manufacturer's report.

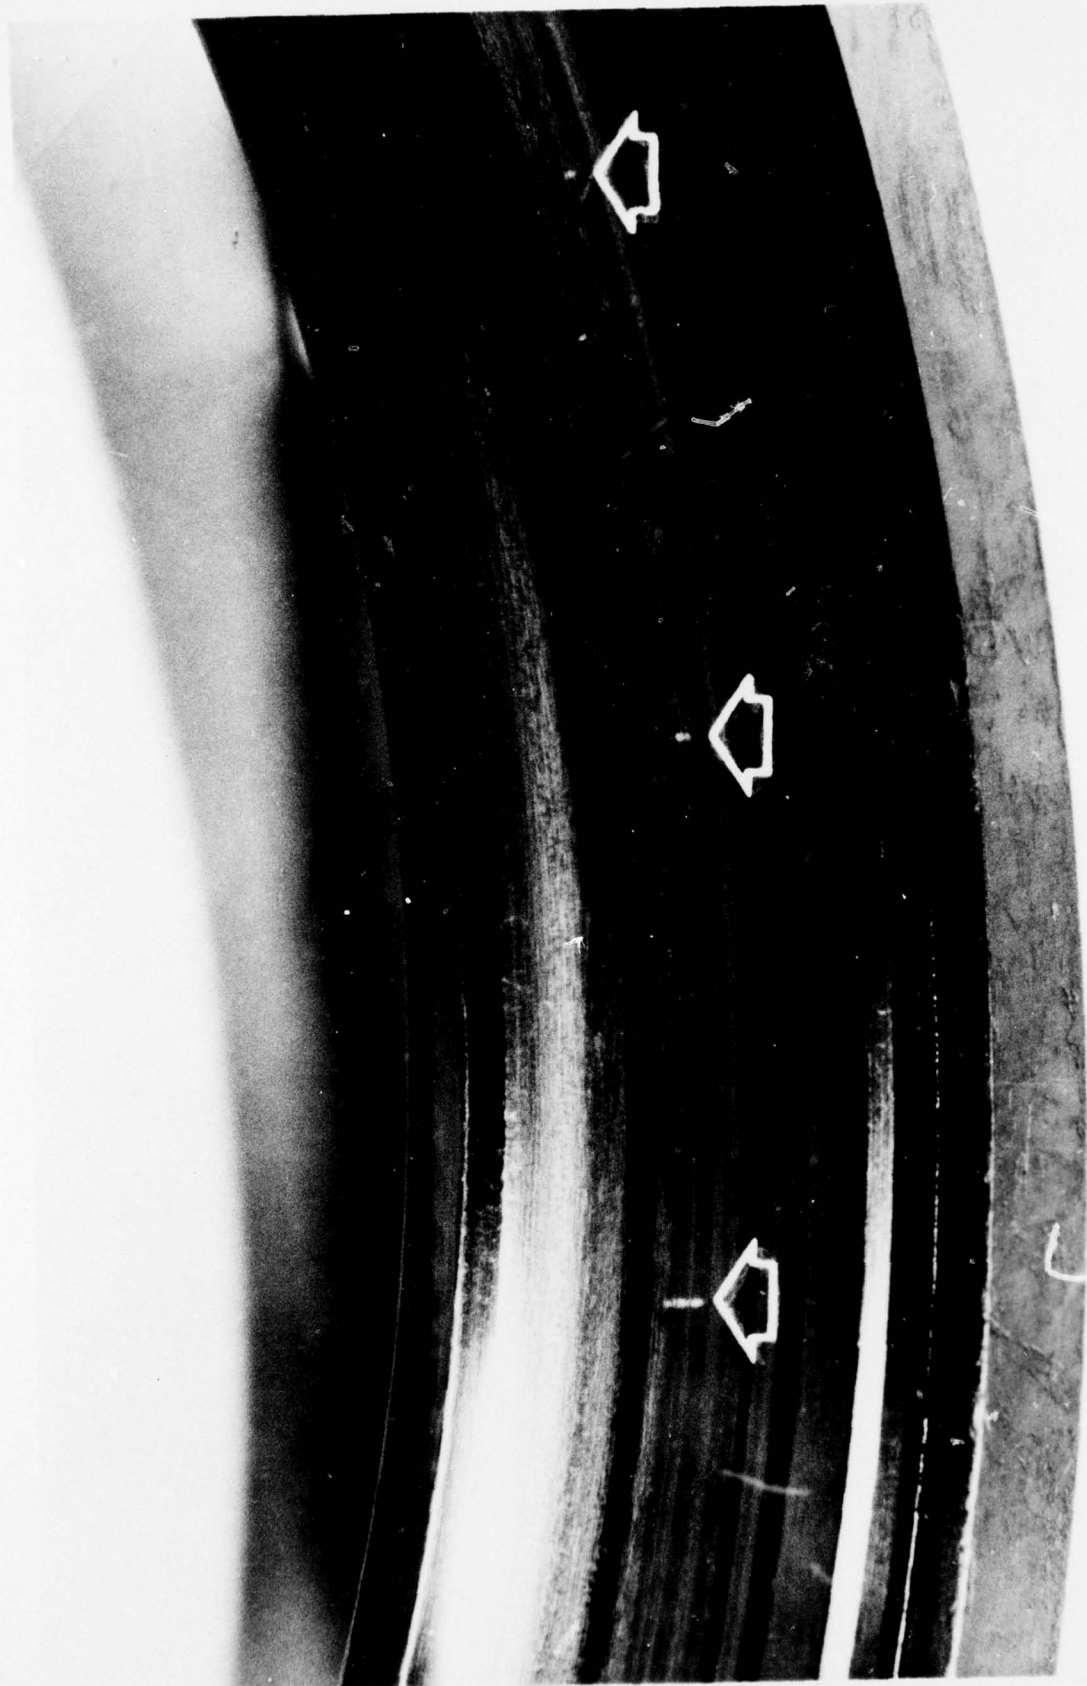
Photograph 4

(4) The outer race of the bearing had the following marks present (photograph 4, inclosure 1).

(a) A mark perpendicular to the circumference of the race and located 3/4-inch to the left of the "F" in the manufacturer's trademark. This mark was approximately 3/32-inch in length and was located in the center of the outer race.

(b) A mark perpendicular to the circumference of the race and directly under the "a" in the manufacturer's trademark. The mark was 1/32-inch long and was located in the center of the outer race.

(c) A mark perpendicular to the circumference of the race and 5/16-inch to the left of the "U" in "USA." The mark was 1/16-inch long and was located in the center of the outer race.
