AGATE

FULL-SCALE TEST AND DEMONSTRATION

REPORT NO: C-GEN-3451 - 1 (REV N/C)

Work Package Title: Full-Scale Test & Demonstration - WBS 3.4.5.1

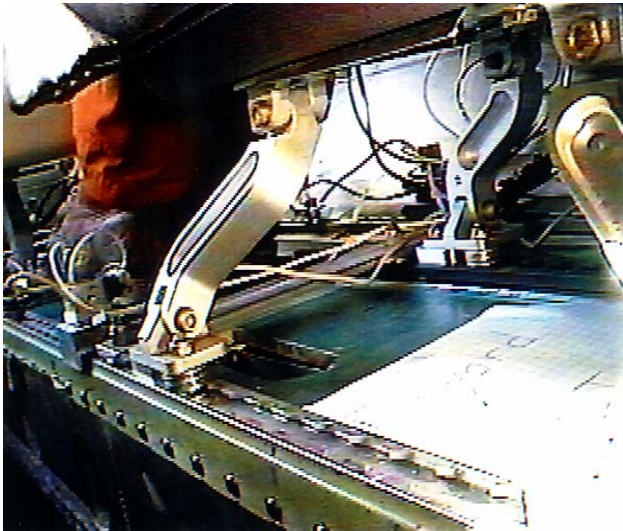
(a) Forward Seat Feet

An interesting observation in the crash pulse is the magnitude of the vertical acceleration at Station 3. The accelerometer was located at the forward outboard rail of Seat No. 5, and was placed on a cross-beam (Ref. Figure 3.1(a)). During primary impact, the beam deflected approximately 3.6 inches downwards, as calculated by integrating the vertical acceleration. The maximum acceleration recorded was 32 G's. Therefore, the deflection of the beam at Station 3 resulted in a significantly lower G level in comparison to Station 2 (115 G's) and 6 (124 G's), where the seat attachment is fairly rigid.

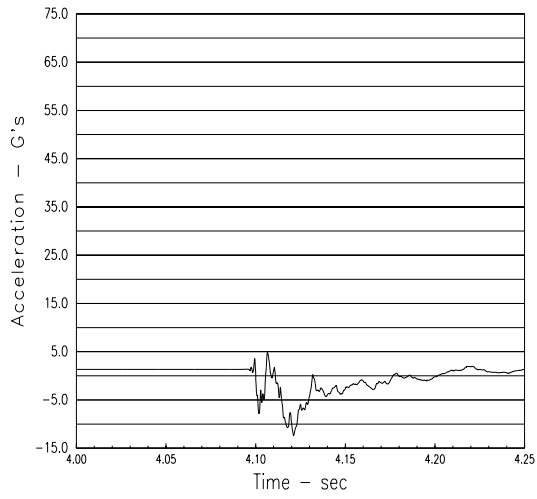
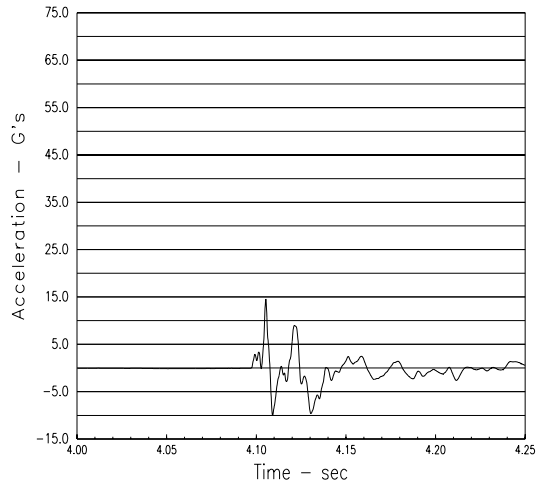
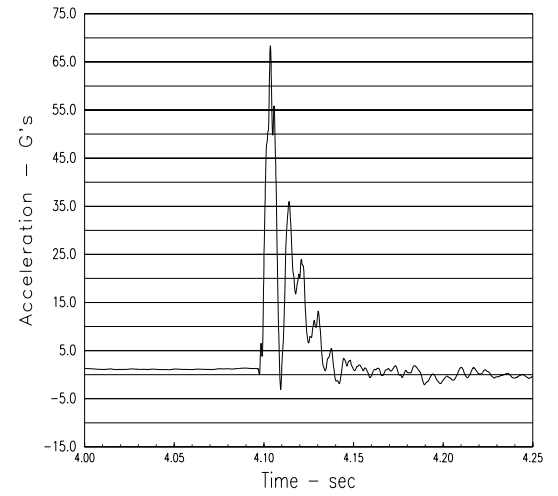
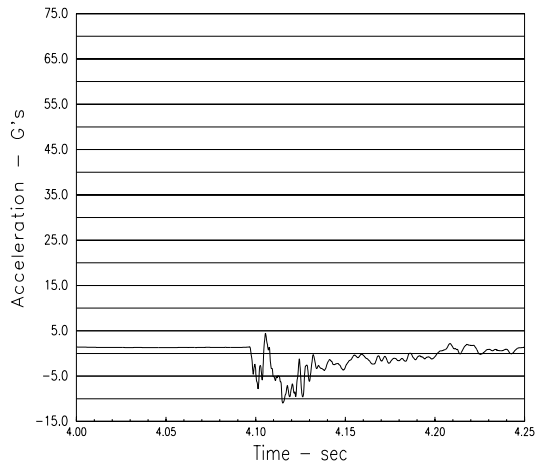
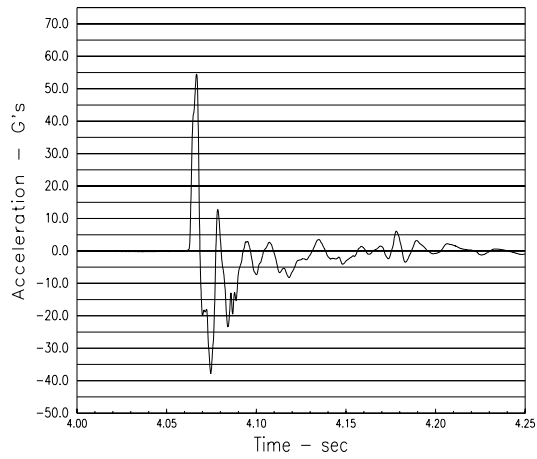
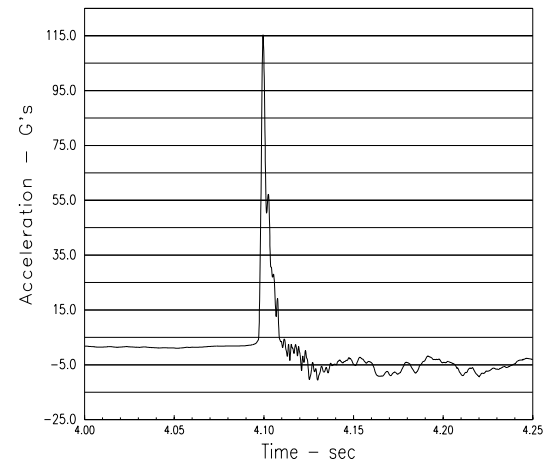
Figure 5.3(a) - Floor Acceleration

Time history plots of all floor accelerometer channels representing the primary impact are shown in Figure 5.3(a) and (b). A comparison of the acceleration data showed that the aircraft impacted the ground tail-end first, as indicated by the 6-3-2-1 accelerometer time sequence. The maximum X, Y and Z acceleration are -15g's, 70 g's

and 125 g's respectively. The average of the maximum accelerations for the X,Y and Z components are 12.6g's, 38.9g's and 84.5g's. The duration of each crash pulse did not exceed 50 ms.

The combined vertical/horizontal acceleration component of the FAR Part 23.562(b)(1) crash pulse is 19.0 g's. The crash pulse duration is 100 ms (rise time of 50 ms) and the minimum velocity change is 31 fps. For the Starship test, the average magnitude of the vertical acceleration is 84.5 g, which is considerably higher than the FAR requirements. However, the duration of the crash pulse 15 ms. By evaluating the most severe seat rail vertical crash pulse (Station6-Z), the velocity change by integration is 22.5 fps, which is lower than the FAR requirements.

In addition, the magnitude of acceleration at the point of impact and other locations along the fuselage varies significantly. For example, the Z-acceleration at Station 1, which is further away from the focal point of impact, is 45% lower than Station 2 and 6.

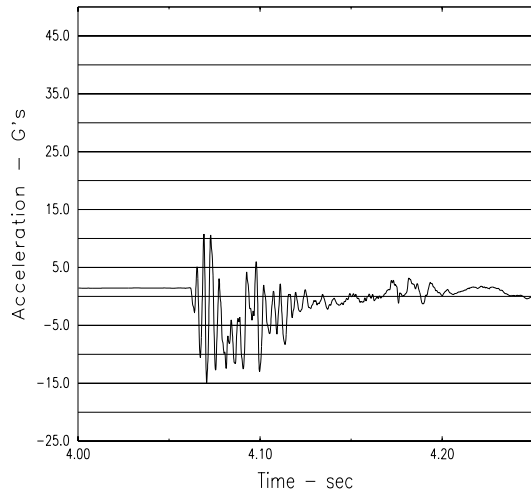
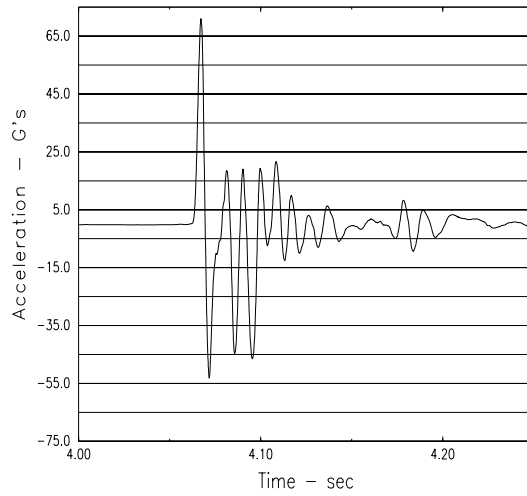
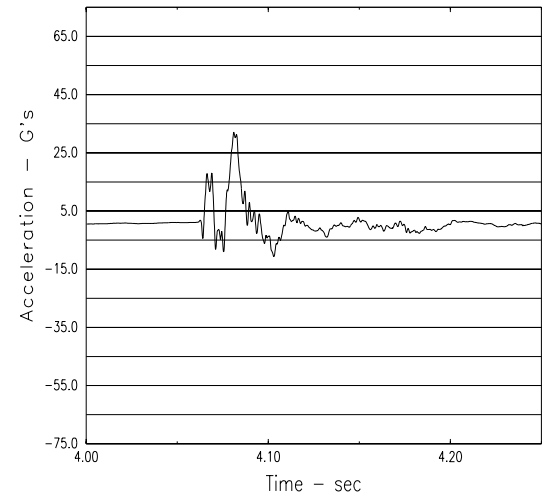
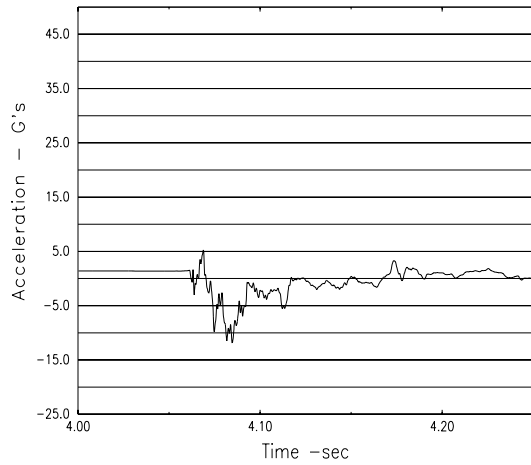
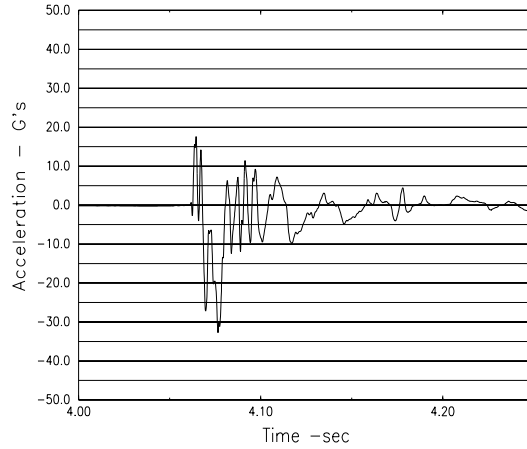
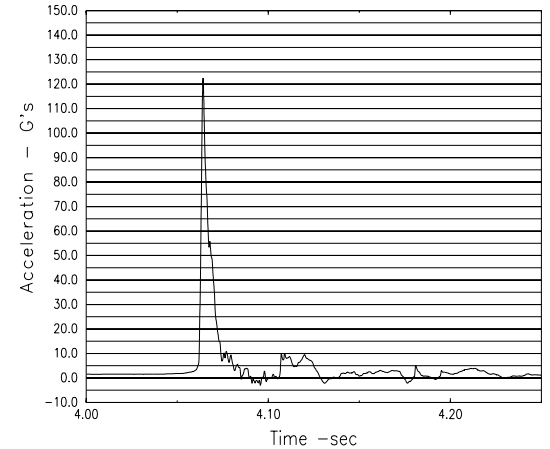
Figure 5.3(b) - Floor Acceleration

Similarly, the horizontal acceleration component for the FAR Part 23.562(b)(2) crash pulse is 25.6 g's (26 G's X cosine 10 degrees yaw), rise time of 50 ms and a minimum velocity change of 41.4 fps(42 fps X cosine 10 degrees yaw). For the Starship test, the maximum horizontal deceleration is approximately 12.6 g's measured at Station 3, and has a rise time of 33 ms. The calculated velocity

change is 7.9 fps. Again, the parameters are below the FAR test requirements.

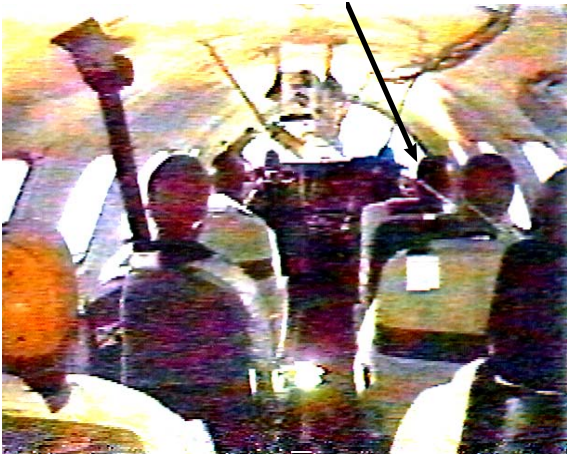
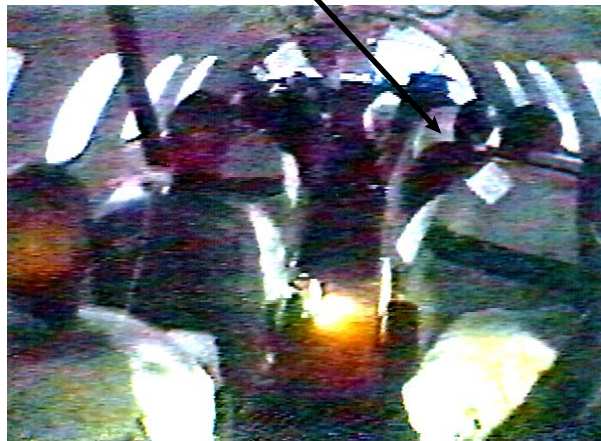
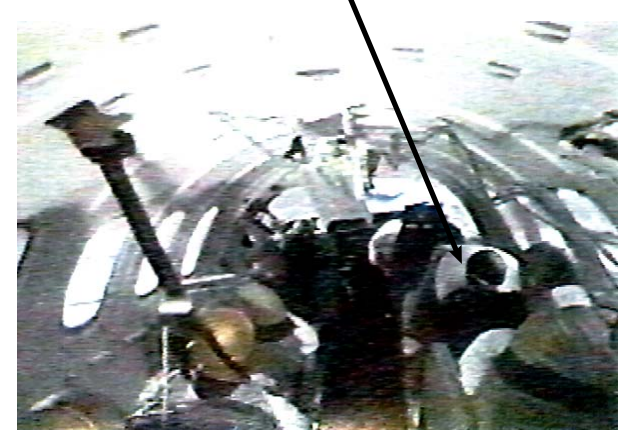
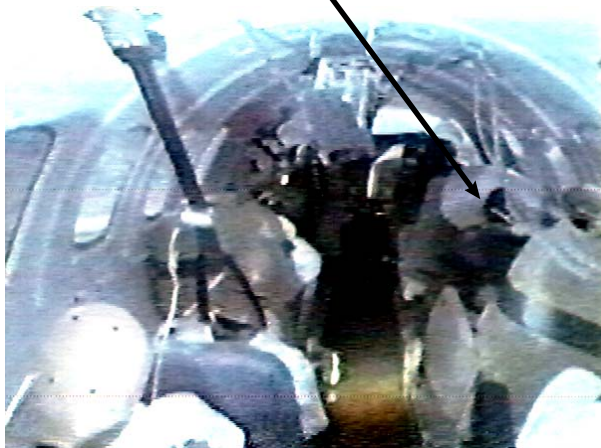
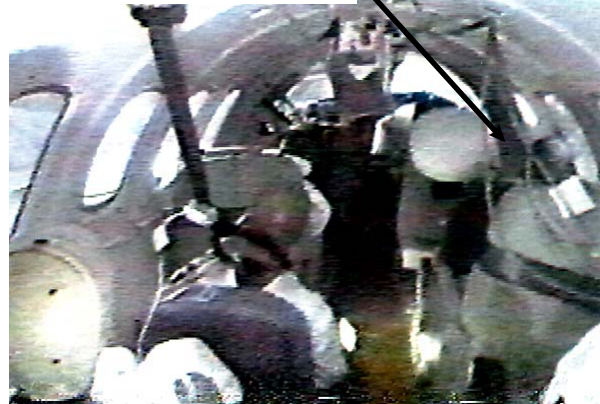
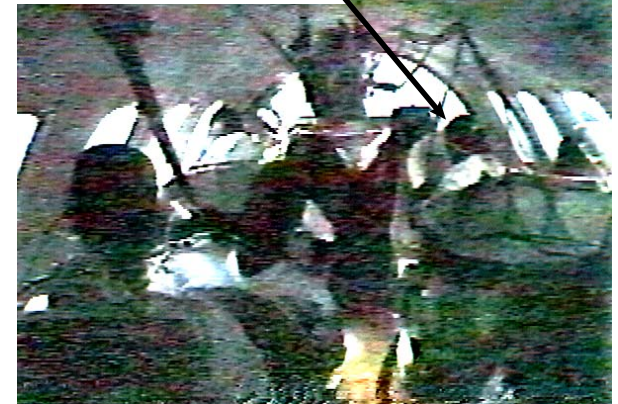
Figure 5.4 - Occupant Motion and Airbag Deployment Sequence

Figure 5.4 shows the sequence of events in the fuselage, captured from an internal high speed camera. It shows the airbag deploying at impact and remained inflated throughout the crash event. The occupant impacted the center of the airbag during primary impact and rebounded outboard momentarily. As the aircraft impacted the embankment, the occupant struck the airbag again.

As seen from this test, the placement of the airbag using headpath trajectory obtained from dynamic seat testing is reasonably accurate. Although data for HIC was not recorded, the airbag may be beneficial for reducing head injuries, such as facial lacerations.

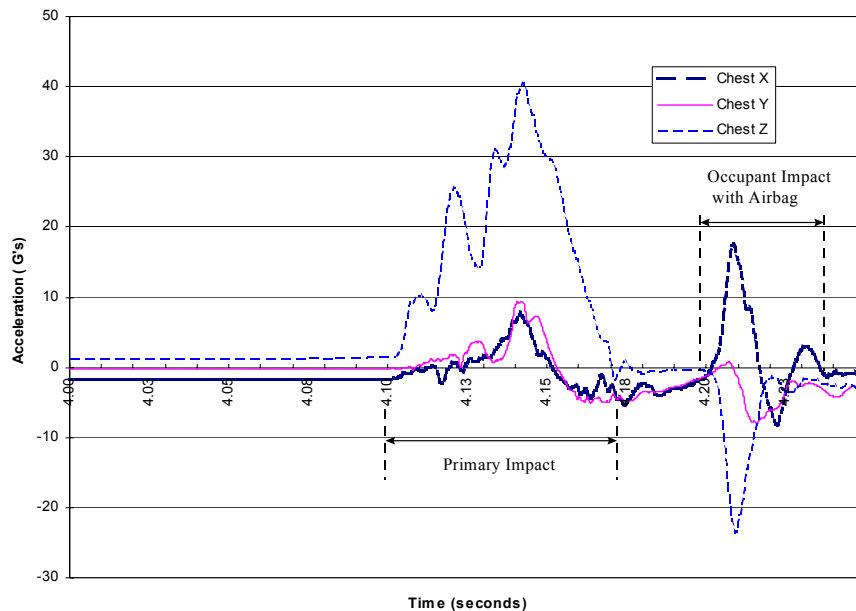
Figure 5.5 - Chest Acceleration: Occupant No. 5

A plot of the occupant chest acceleration is shown in Figure 5.5. The maximum vertical chest acceleration is approximately 40 g's, while the lateral and forward acceleration's are relatively low.
