MINISTRY OF SUPPLY
AERONAUTICAL RESEARCH COUNCIL
REPORTS AND MEMORANDA

Service Failures in Aircraft Structures Associated with Fatigue, Repeated or Dynamic Loads

*Reports and Memoranda No. 2688**
August, 1946

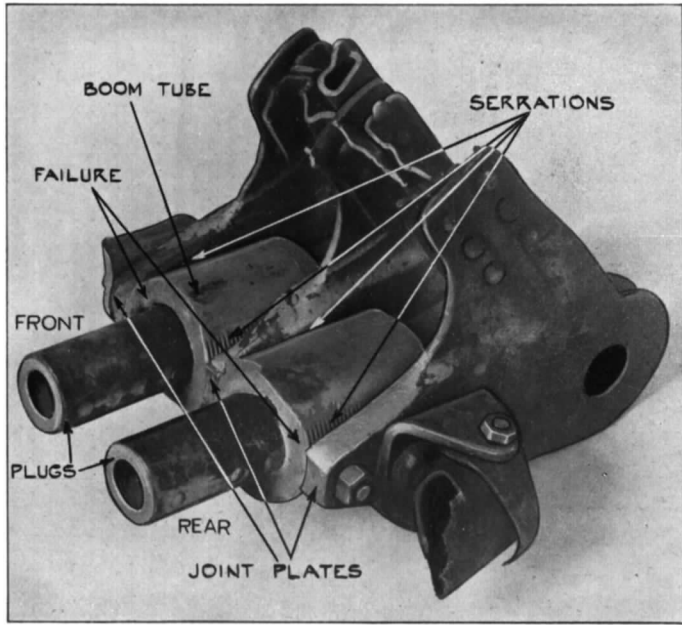
2. *Fatigue Type Failures.*—2.1 *A Spar Boom Failure.*—The spar booms, in which the failures described here occurred, are made up of a number of lengths of round section tube joined together by plates. Load is transferred from the tubes to the plates mainly through vertical serrations in both. Fig. 1 shows a typical joint in which the boom has failed and pulled off the plugs now seen protruding. A 'close up' of a fractured boom is shown in Fig. 2 from which it will be observed that there are two main areas of failure¹; the first extending from OO to LL and L, characterised like a fatigue fracture by its smoothness and orientation in the plane normal to the boom length, and the second the rest of the boom, which is more typically tensile in character. The first area, however, shows definite 'tide marks' which are absent from specimens subjected to the usual laboratory fatigue tests, but recent laboratory tests have produced tide marks. The stress cycle employed was 4.65 ± 0.7 tons/sq in. 500,000 times followed by 3.25 ± 1.75 ton/sq in. tension 50,000 times. Failure occurred after this had been repeated 22 times, *i.e.*, a total of 12 million cycles had been reached. In the usual type of fatigue test at 5 ± 0.5 ton/sq in. cracks were first noted after 2.5 million cycles and failure occurred after 5 million cycles. These stress figures refer to the mean stress in the boom adjacent to the joint and make no allowance for stress concentrations in the joint.

This figure of 320 flying hours is roughly the mean life of aircraft which failed in the manner described. A few aircraft failed after about 180 hours flying, but many others have flown considerably longer without boom failure occurring. Usually some cracking was detected at serrations during inspection and restrictions were put on the replacement of booms exhibiting marked cracking.

From the data available on laboratory life, flight life and measured boom stresses, it appears that service failures are probably due to either (i) the boom stress raises being more vicious, particularly in service aircraft which failed after comparatively few flying hours, or (ii) occasionally very high built-in stresses were present due to the method of tube manufacture or the technique of assembling the aircraft, plate and joint serrations, say, being forced together.

FIG. 1. A spar boom failure.

Considerable improvement in the laboratory life of booms was obtained by arranging that the change of section at the joint was more gradual. The boom material was also changed from one which obtained its strength by cold working, which produced cracks on occasions, to one which obtained its strength properties by heat treatment. These changes seem to have increased aircraft life considerably. The increasing use of concrete runways and the rigorous inspection instituted may also have had considerable influence. The precise nature of the loads causing the failures remains obscure and some tests on the usual type of sleeved joint have indicated that this, unless carefully designed, is not in laboratory test superior to the serrated joint.

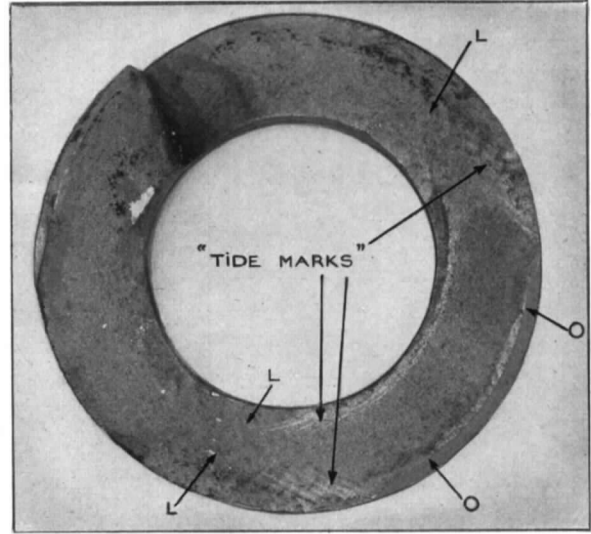
FIG. 2. Enlarged view of fractured boom.

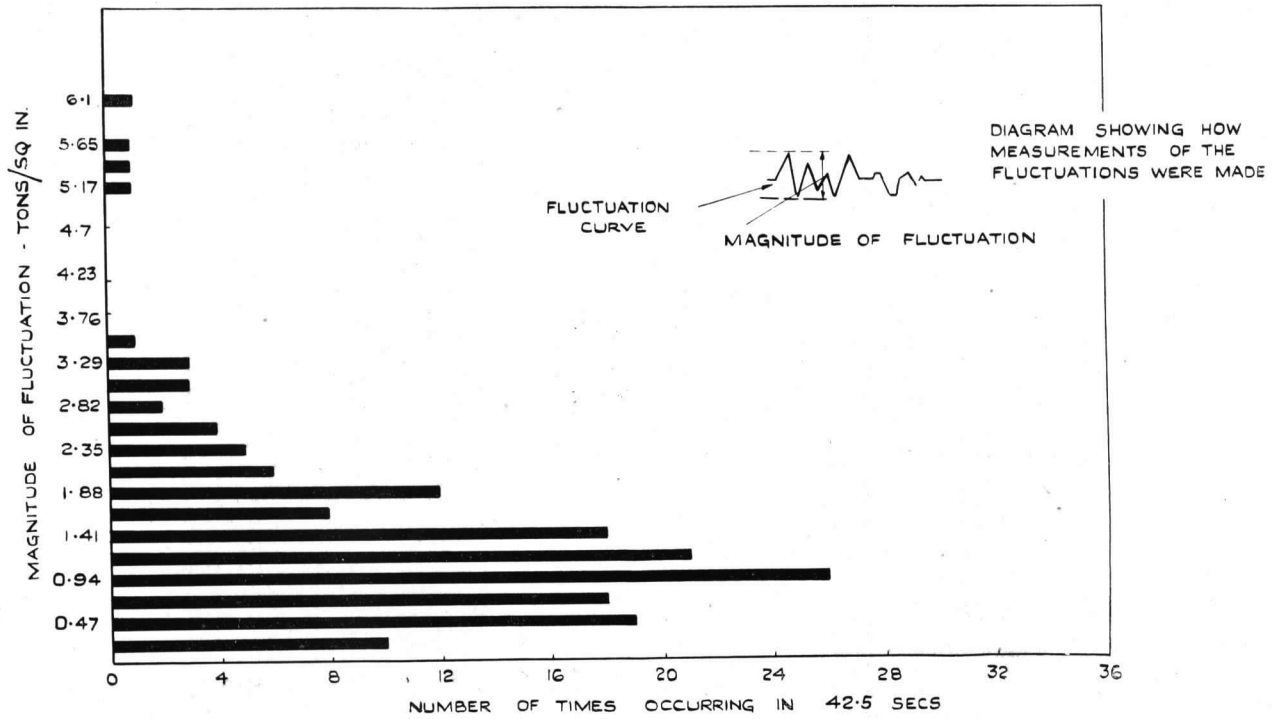
Flight and taxi-ing measurements² of boom stresses were made to ascertain the order of the working stresses. When the aircraft is at rest on the ground the boom stress is only about 1 ton/sq in., excluding any 'built in' stresses which may be present. The fluctuations which occurred in a severe taxi-ing run are shown in Fig. 2. In flight the mean steady stress is higher about 4 ton/sq in. and the predominant fluctuations in rough weather about ± 1 ton/sq in. at 2.7 c.p.s., *i.e.*, about 3 million cycles occur in 320 flying hours in *rough* weather.

FIG. 3. Fluctuation frequency diagram—taxi-ing at Upper Heyford.

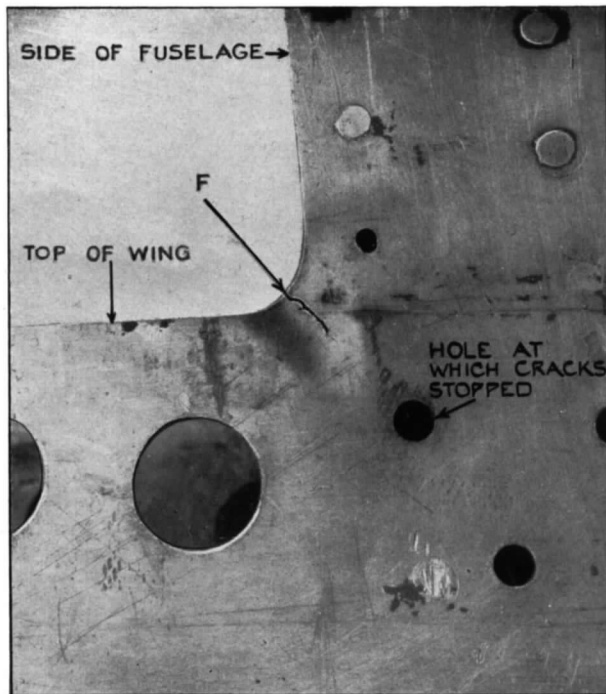
2.2 Web Cracks.—The centre section web of some wings rises above the spar booms and forms part of a fuselage bulkhead. Fig. 4 is a close-up of such a web. The boom root bolts pick up the large holes seen in the figure. The web frequently cracked, as at F, in the fillet which merges the web proper into the fuselage ring proper. This was probably due to stress concentration at the corner where the web changes in depth.

The stress concentrations leading to the web crack of Fig. 4 and the frame cracks in Fig. 11 might be classed as stress concentrations due to faulty outline design, whereas the others seem to be due to imperfections in detail design. The magnitude of stress concentration effects is usually difficult to estimate even when the loading is known. Data on load fluctuations is scanty and so too is information on the behaviour of materials under diverse load cycles. Stress lacquers and strain gauges may, however, give the designer information on the intensity of stress concentrations to supplement his experience on designing to avoid stress concentrations.

FIG. 4. Cracked web.

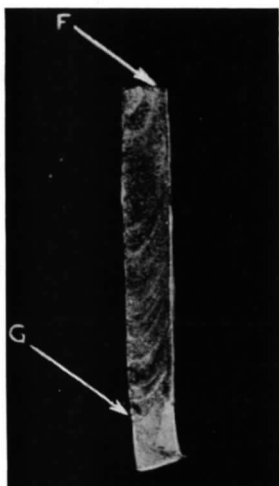
Buckling of the web has occurred at this corner as seen around the crack F. Such cracks had frequently the appearance of fatigue as in Fig. 5 between F and G but exhibited tide marks as in the spar boom failure in Fig. 2. This was not always the case as in Fig. 6 where only AB and CD are characteristic of fatigue. The intervening portion suggests that high magnitude loads have played a part in the failure. Cracks occurred when the corner F in Fig. 5 was sharp and also when it was well radiused. Fortunately the longest cracks examined ran into adjacent holes and did not continue through them. Thus although such webs, which are continuous in a shallow wing and deep fuselage, are clearly undesirable, no serious trouble occurred.

FIG. 5. Web fatigue crack.

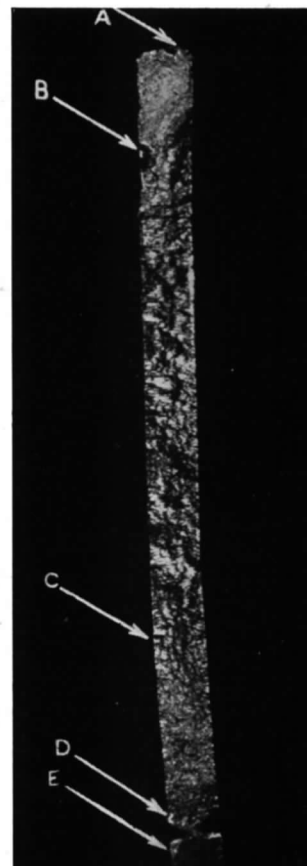
FIG. 6. Web crack.

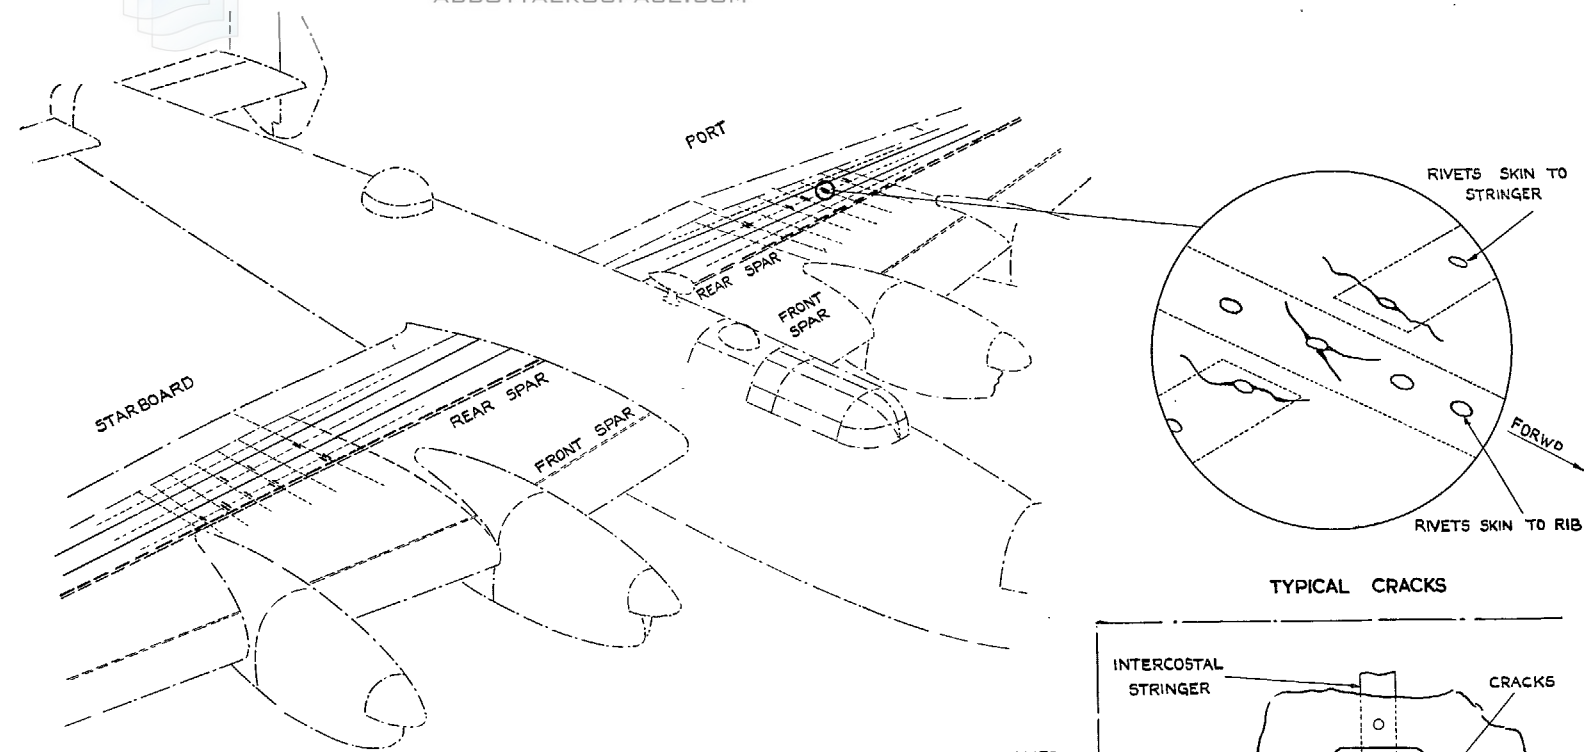
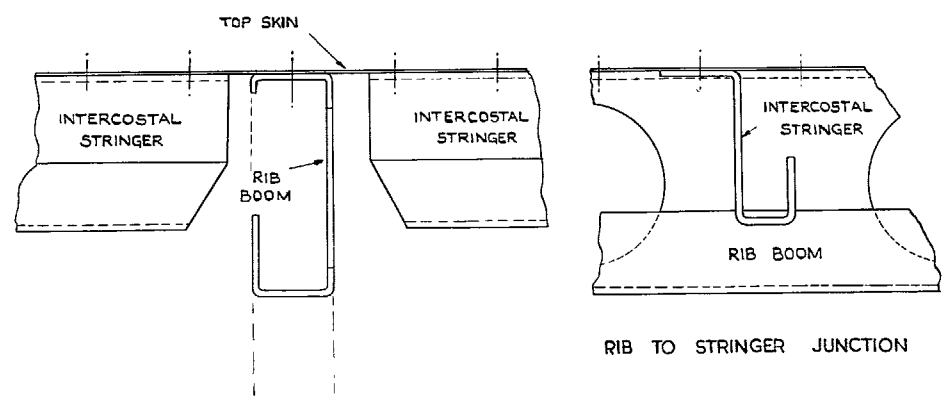
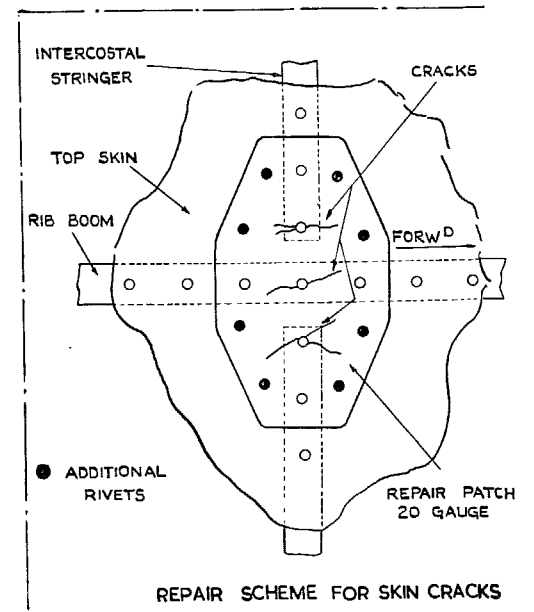
2.3 Cracks in Flat Plates.—These web plate cracks, when the radius is ample, may be considered as due in part to flat plates buckling in compression where not supported, here by the spar flange or the fuselage frame. Cracking was more common where stringers were interrupted at frames or ribs. Such cracking⁴ is shown diagrammatically in Fig. 7 and is probably due to severe engine vibration causing panel panting coupled with stress concentration due to the transfer of stringer end load by the flat plate skin.

LOCATION OF SKIN CRACKS ON MAINPLANES

FIG. 7. Wing skin cracks.

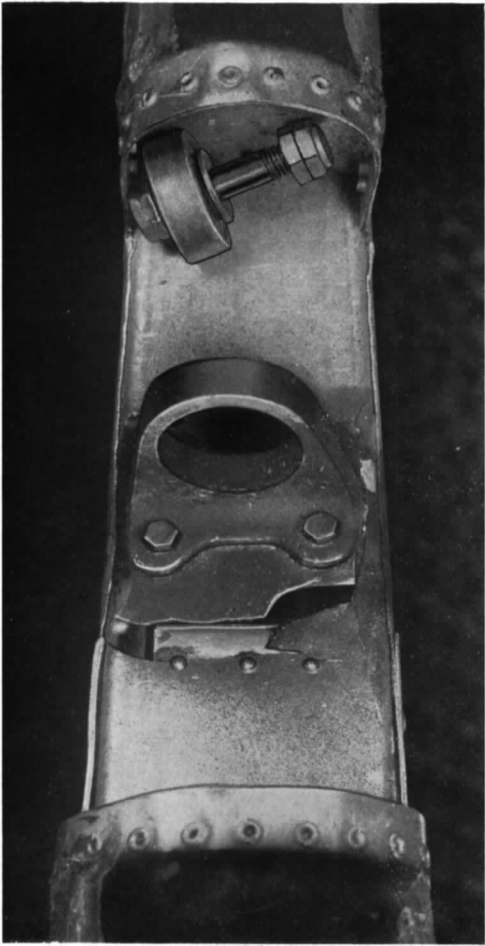
Cracking has also occurred where hinge bracket bending loads are transferred first into the web as in Fig. 8 with no adequate members to take the loads into the main structure. Shear and bending stress concentration probably play a part in this failure.

FIG. 8. Rudder hinge failure:

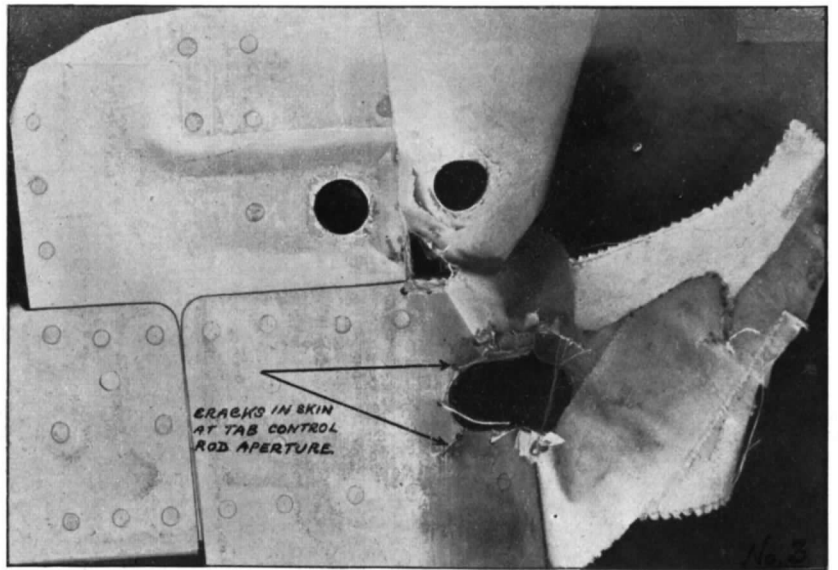
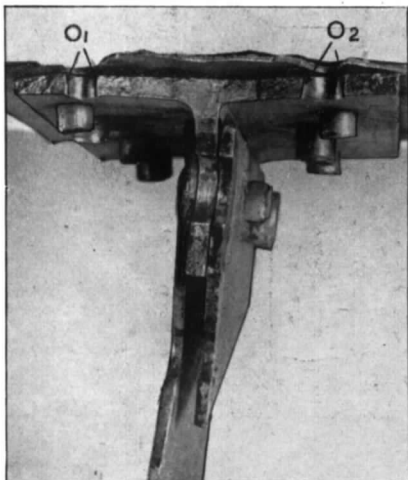
2.4 Rivet Failures or Failure Through Rivet Holes.—Such failures usually occur where, for example, the wing skin ends and the end load in the skin has to be fed into and transmitted by a continuous boom. Stress concentrations responsible for such failures have been the subject of much theoretical work⁶. In one case of such a tail plane failure, rivets fatigued and the tail plane boom crack extended down into the web. There is also evidence, in tail planes of this type, of such cracks starting from rivet holes in the web near the tail plane root. Similar failures have been reproduced in the laboratory by repeatedly loading this tail plane⁷. The appearance of the fracture surfaces was different, however, from those which occurred in practice and which are shown in Fig. 9⁸. The service failures were more of a fatigue character and calculations of the loads expected on this tail plane suggest that repeated loads of high intensity are probably not the explanation of the service failures. Severe estimates of the tail load are far below its static strength. In a flying accident in which a cracked tail plane was broken the load on the tail plane was in the direction such that the crack was on the compression side!

FIG. 9. Tailplane crack.

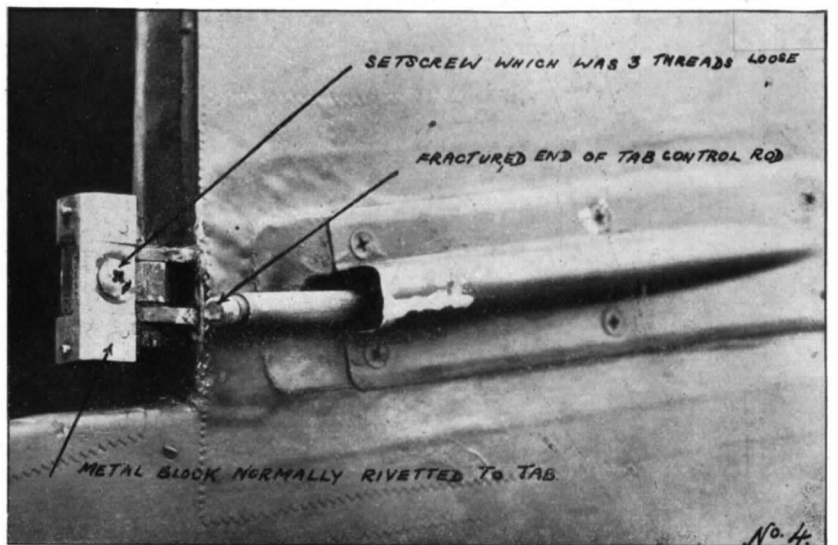
2.5 Rudder Failure Due to Excessive Tab Gear Backlash.—The rudder failure⁹ of Fig. 10 is an example of a fatigue type failure although it may also be due to repeated loads of greater intensity than those associated with fatigue. A tab operating rod failure through a screw thread and cracks in a cut-out in the rudder spar which run through holes provided for lacing the fabric are seen in the lower figure. The failure was probably associated with backlash in the tab and when this was restricted no further failure was reported.

FIG. 10. Rudder failure.

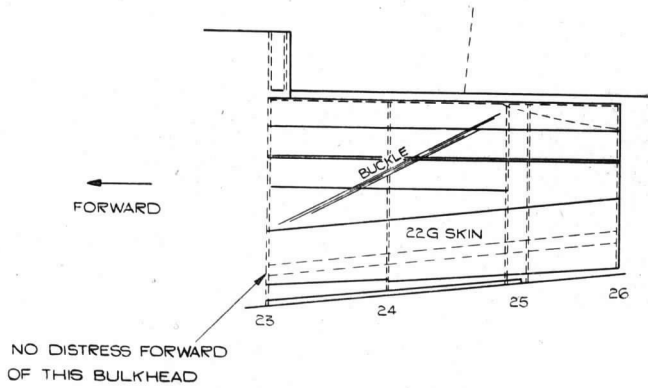
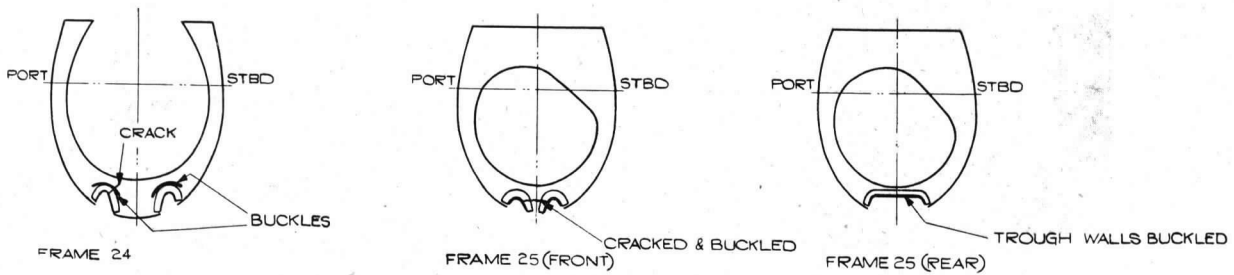
4. *A Suspected Repeated Loading Failure of a Fuselage.*—Fig. 11 is a diagram of the aft part of the fuselage concerned and shows the cross-sectional shape. The bottom of the fuselage between frames 23 and 25 has two troughs which converge towards frame 25 and between frames 25 and 26 become one trough. (These troughs are provided to house an arrester hook and its V-shaped attachment structure). Several service defects, which occurred in varying degrees of severity, are indicated in Fig. 11. Many fuselages had buckles in frame 25 between the troughs and had no other defect. The next stage of failure was buckling at both frames 25 and 24 with possibly cracks in frame 25 and rivets starting to pull. In more developed cases the trough walls aft of frame 25 had buckled, frames 25 and 24 had buckled and cracked, and a deep permanent buckle ran diagonally down the fuselage side. Fig. 12 is an internal view of the type of damage at frame 25, Fig. 13 that at frames 24 and 25 and Fig. 14 the external appearance of a fuselage.

FIG. 11. Aft fuselage defects.

A possible source of the loads causing failure was tail wheel shimmy caused by the shimmy dampers becoming inoperative. Action was taken to remedy this fault and also to strengthen the fuselage. Reports of trouble then ceased. If is, therefore, not known whether shimmy

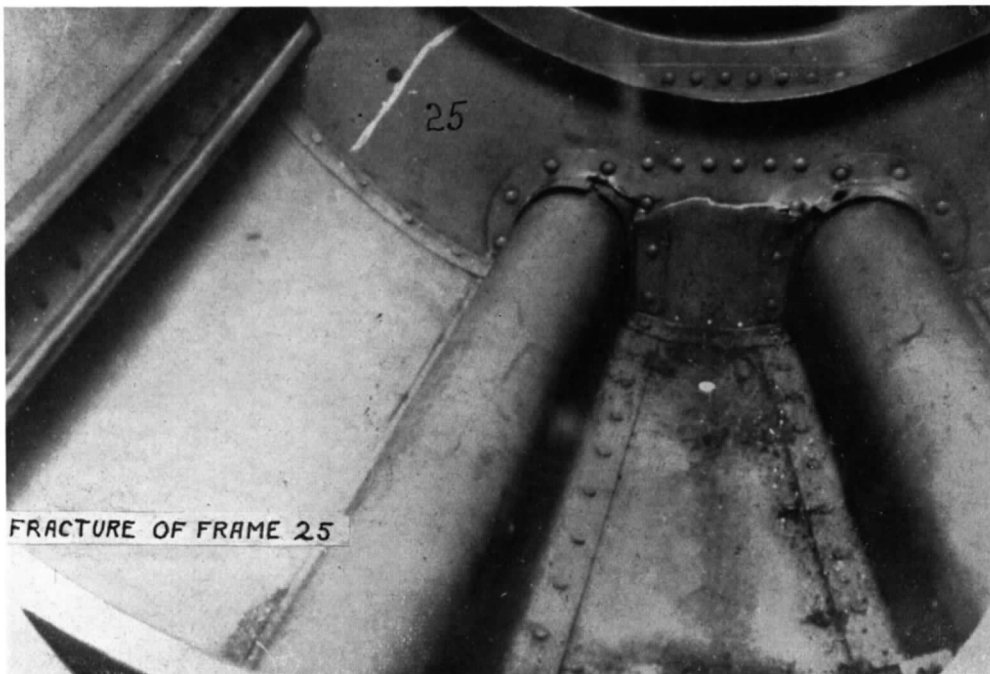
FIG. 12. View showing damage at frame 25.

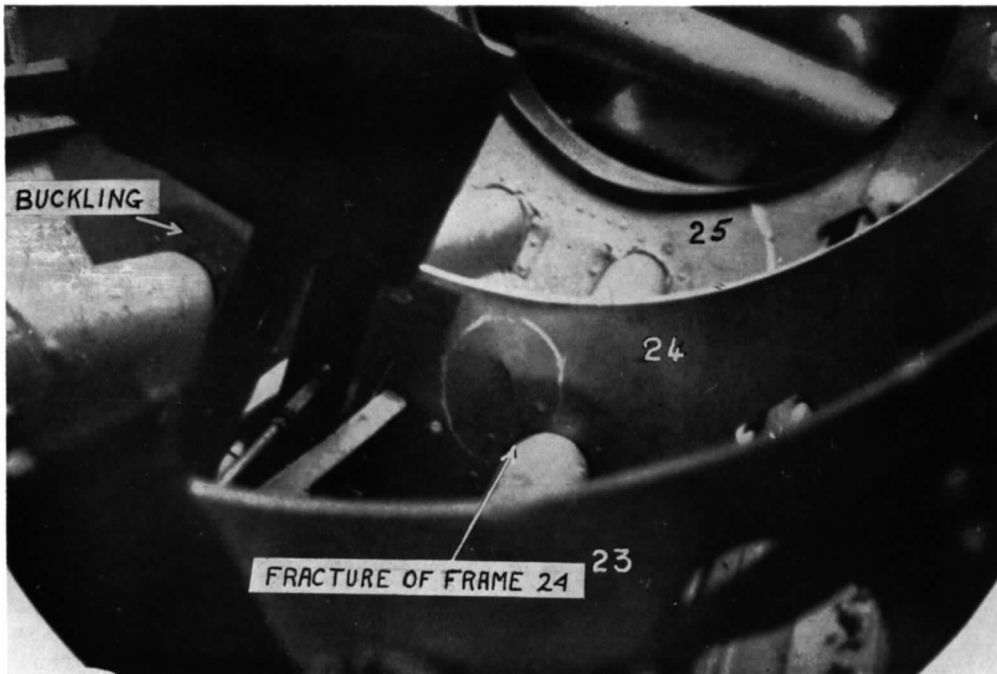
FIG. 13. View showing damage at frames 24 and 25.

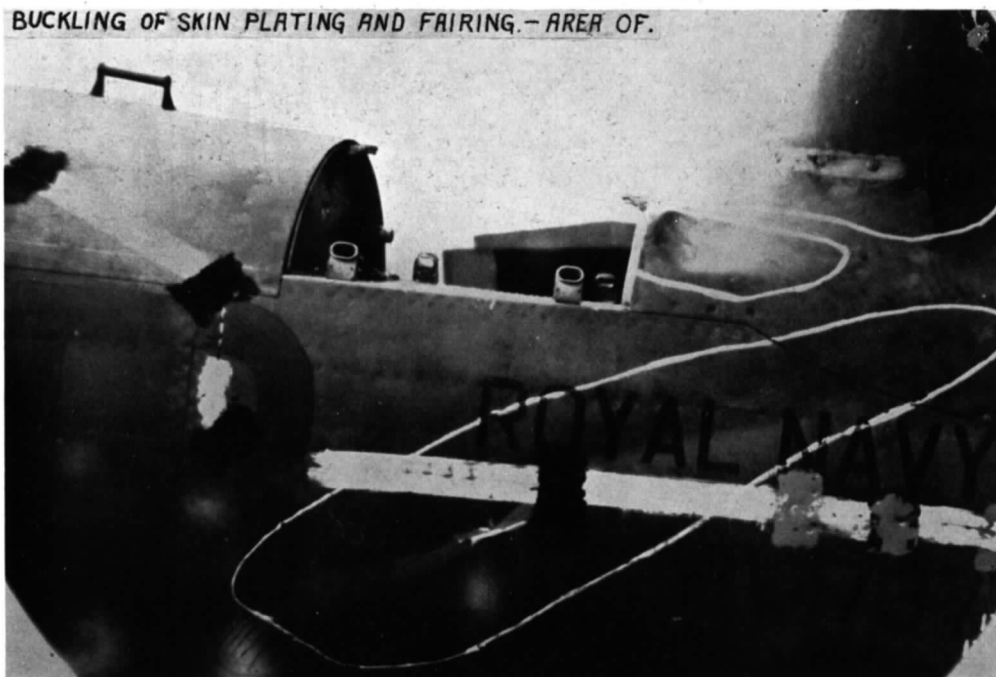
FIG. 14. External buckle on fuselage.

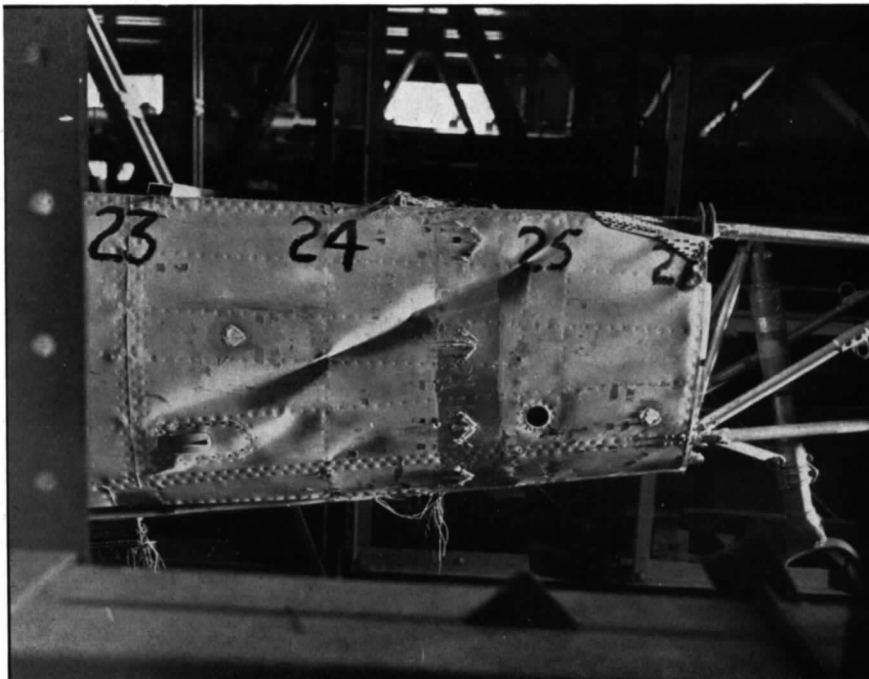
In a static test¹² done on the fuselage the external buckling shown in Fig. 14 was reproduced as indicated in Fig. 15 but only after frame 25 had been artificially cut to resemble the service damage shown in Fig. 12. The fuselage had also been previously heavily loaded, the magnitude of the loads exceeding those which were later necessary to cause the heavy fuselage buckles shown in Fig. 15. This heavy loading in the previous test had failed to produce failure at frame 25 as in Fig. 12 although some slight buckling occurred at this frame. In fact the tail wheel unit structure which was used to apply shear and torsion loads to the fuselage failed; a condition which was not common to those service incidents which exhibited only slight defects. With frame 25 artificially damaged the tail unit was strong enough to break the fuselage; but whether this was primarily due to cutting this frame or to previous heavy loading is not established. It is apparent, however, that in service something was happening which differed from what occurred in the first static laboratory test, and resulted in the buckling and cracking of successive fuselage frames. While it is possible that another fuselage may have behaved differently from the test fuselage (insofar as, for example, the frames were initially buckled, or the applying of torsion loads through the fin and tail plane attachments produced a different distribution of loads at frame 25) it seems more probable that under repeated and reversed loading actions a different result from that obtained in the static test would have occurred. Evidence of this is found in the progressive nature of the fractures and defects suggested by the various degrees of damage sustained as already described, in the rubbing together of the fractured faces of frame 25 and in the buckling on both port and starboard edges of the crack that were revealed on close examination.

FIG. 15. - Fuselage failure in test.
