R. & M. No. 2789  
(11,412)  
A.R.C. Technical Report

# Investigations on Stalling Behaviour, Rudder Oscillations, Take-off Swing and Flow Round Nacelles on the Tudor I Aircraft

D. J. LYONS, B.Sc. (ENG.)

*December, 1947*

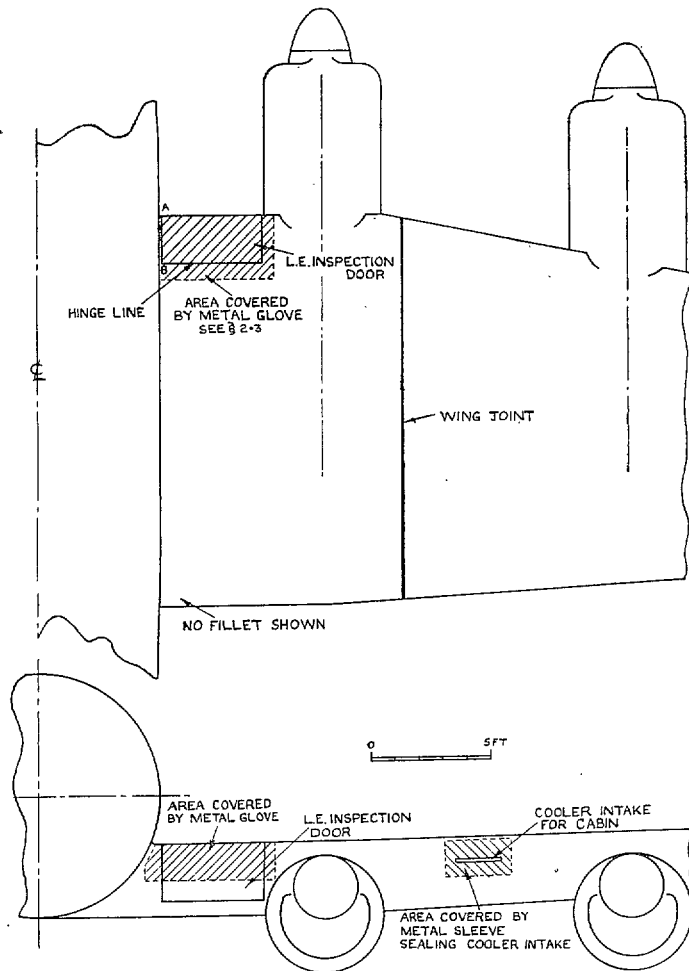
- (a) wing joint sealed with fabric strip doped to the aircraft skin (*see* Fig. 5),
- (b) cooler intake for cabin, open, closed and faired over with a metal sleeve (*see* Fig. 5),
- (c) wing root fillet edges sealed (*i.e.*, junctions between fillet and wing and body surface sealed with fabric strip doped to the aircraft skin),
- (d) extension of the inner nacelles.

FIG. 5. Sketch of inner wing.

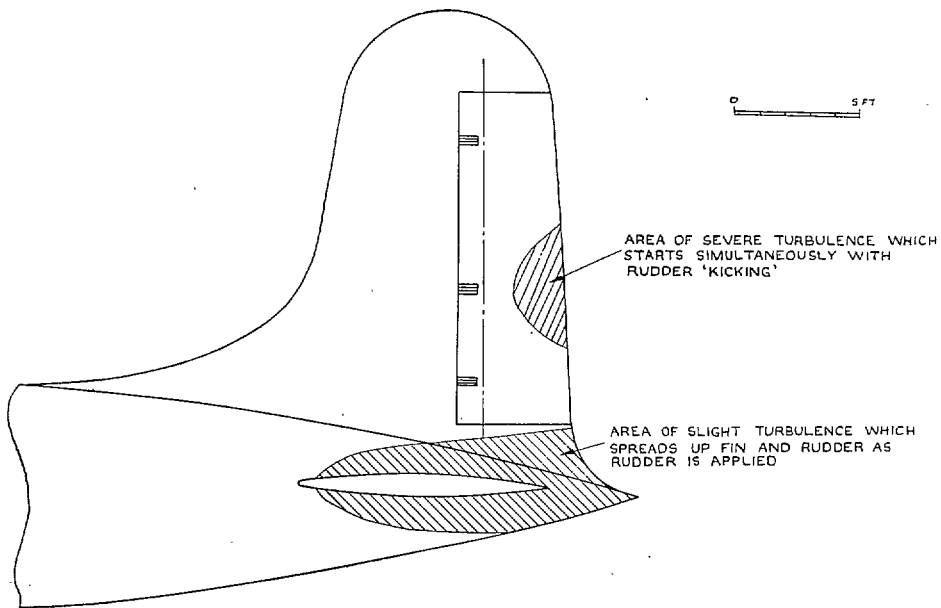
- (f) in every case, however, as rudder kicking commenced, a bad stall of the flow was observed in the centre of the rudder on the suction side (*see* Fig. 6), and it was concluded that this stall must be the cause of the kicking. The stall appeared to be similar to the usual control stall at large angles but it was, of course, occurring at an exceedingly low rudder angle.

FIG. 6. Sketch illustrating flow breakaway in the rudder region.

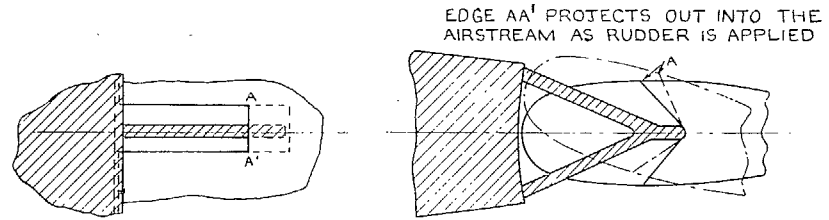
(a) ORIGINAL UNMODIFIED HINGE CUTOUT

3.3. *Tests of Hinge Cutout Modifications.*—Close examination of the hinge cutouts on the full-scale aircraft (G.AGST), showed that, besides the existence of the large area through which air could flow, a sharp edge at the rear of the cutout projected out into the airstream as rudder was applied (see Fig. 7a). A preliminary modification was made at the R.A.E. by filling in the cutout by a fairing attached to the fin and by fitting suitably curved plates to this fairing to cover the projection on the rudder when rudder was applied (see Fig. 7b). Flight tests with all three cutouts modified in this way, showed that the kicking had been eliminated up to  $\pm 16$  deg rudder angle. The aircraft was then returned to Messrs. A. V. Roe for a production hinge cutout fairing to be incorporated; the production modification is the local formation of a concentric nose at the hinge cutout, so that the fairing block attached to the fin can be extended right up to the concentric nose, and only a very small leak is left (see Fig. 7c). In this condition there was only minute kicking up to  $\pm 18\frac{1}{2}$  deg of rudder angle. The rudder pedal forces were then adjusted by means of the gearing of the geared tab, until full rudder could be obtained at low flight speeds with reasonable foot loads. It was clear, therefore, that bad flow initiated by the hinge cutouts was solely responsible for the rudder kicking at low rudder angles on the *Tudor*, and that the wind tunnel tests had rightly predicted this. Previous wind-tunnel tests<sup>5</sup> had shown the bad effect of hinge cutouts on the hinge moment characteristics of controls.

FIG. 7. Hinge cutout modifications on the rudder.

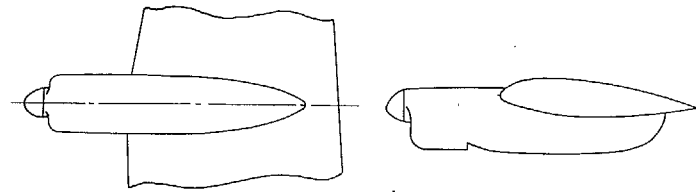
(a) ORIGINAL TYPE (17-7-46)

5. *Nacelle Design.*—5.1. *Flow Tests on Original Inner Nacelle.*—The original inner nacelle shape is shown in Fig. 8a. It was not the first type flown on the *Tudor*, but a compromise arrived at after the *Lancaster* type nacelles had given vibration troubles during early development tests at the firm. Shortening the nacelle to finish at the flap hinge had eliminated a periodic shake felt on the whole aircraft.

Because of the loss in performance from that estimated, attention was drawn by the R.A.E. to the probability that the flow round the rather bluff ends of the inner nacelles was bad. Flow observations in flight by means of 'deep-tufting' showed clearly that a complete breakaway of flow was occurring behind the nacelle over the whole speed range, slight improvement only being noticed as the stall was approached. It was also noted that the flow could be cleared up completely by lowering the flaps through a small angle (10 to 15 per cent of maximum travel), and that as the flow breakaway was stopped by this means a good deal of the continuous vibration felt on the aircraft ceased at the same time. The poor inner nacelle shape was, therefore, producing both drag and vibration. Clearly lengthening of the inner nacelle rear fairing was required, and both because of the previous trouble experienced by the firm, and of evidence produced by wind tunnel tests that the optimum nacelle design was not obtained by the nacelles finishing at the trailing edge (R. & M. 2406<sup>7</sup>), it was considered that the nacelle should extend some 18 in. to 2 ft behind the trailing edge. As an interim step, however, the *Lancaster* type nacelle was refitted.

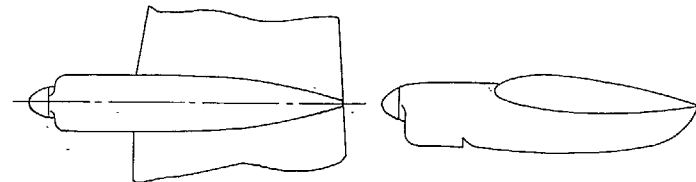
(b) 'LANCASTER' TYPE

Deep-tufting tests showed that while the breakaway in flow behind the nacelle had been reduced to about  $\frac{1}{3}$  of that previously noted, there was still sufficient breakaway to cause concern about the drag resulting from it. Also the vibration experienced on the aircraft as a whole had changed character. Instead of the continuous vibration noted with the 'original' inner

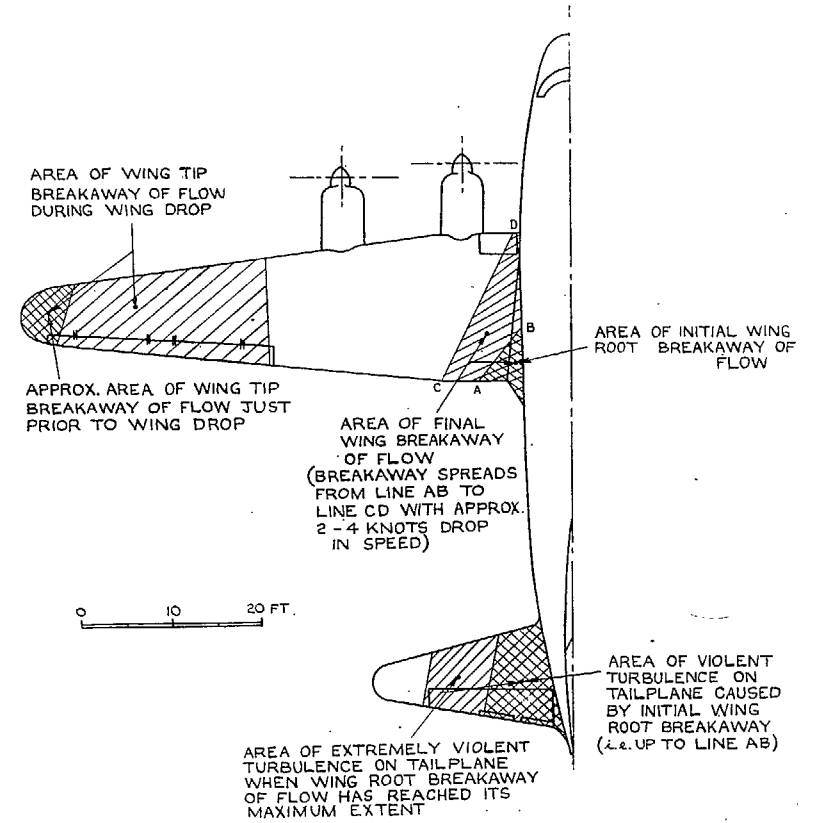
(ii) A diagram of the breakaway of flow observed in flight is shown in Fig. 2. As the pattern of breakaway was almost identical in all cases (*i.e.*, flaps up and down, engines on and throttled), only a general picture is given without any absolute speeds. The measured flight speeds at buffeting and the stall are given in Test 7, Table 1. With engines throttled back the flow picture was roughly symmetrical about the centre line; with engines on the flow was asymmetrical, in that the speeds at which the phenomena happened on each side were different (the starboard wing root breakaway commencing before that on the port wing), though the breakaway picture was similar.

- (a) the first sign of bad flow as the flight speed was lowered, was a small breakaway in the wing root fillet. At the same time an area of fairly violent turbulence appeared on top and bottom inboard portions of the tailplane and elevators (*see* Fig. 2). Simultaneously appreciable buffeting was felt on the stick and on the whole aeroplane.

(b) As the speed was lowered a further 2 to 4 knots A.S.I., the breakaway in the wing root fillet spread rapidly forward up to the line CD in Fig. 2. At the same time the turbulence on the tailplane spread out, until at least  $\frac{2}{3}$  of the tailplane span was involved, and became extremely violent. This spread of the turbulence was accompanied by extremely violent aircraft buffeting, vicious oscillation of the whole tail end of the fuselage, and increasing nose-down pitch. The aircraft tended to porpoise violently and it was extremely difficult to hold the nose of the aircraft up, though the stick force was not excessive if back elevator trim was used.

FIG. 2. Sketch illustrating flow breakaway on wing and tailplane of aircraft at the stall (engine on or glide, flaps up or down) as shown by 'deep-tufting.' (Small wing root fillets.)

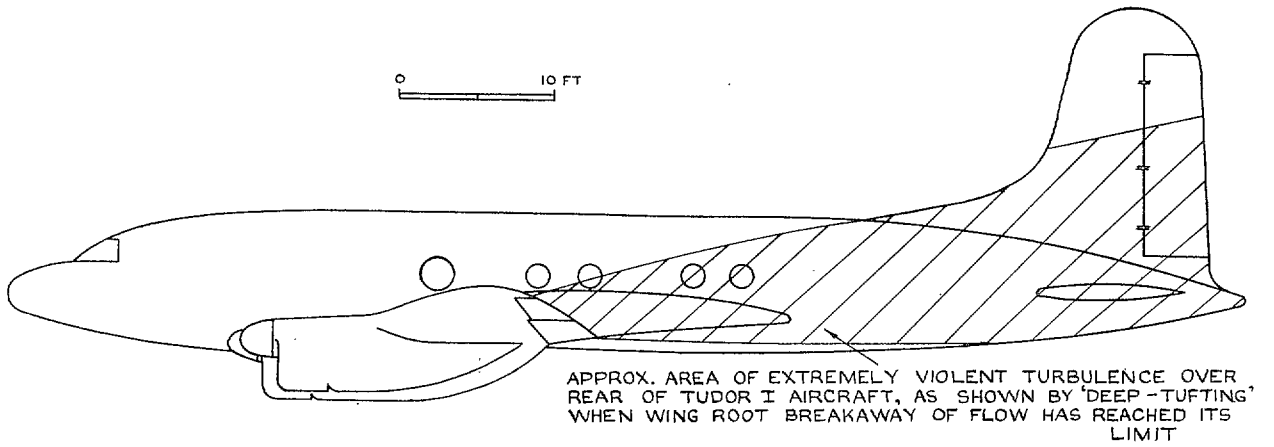
(d) As the wing root breakaway spread forwards to the line CD, it was noted that there was considerable spread of the wake upwards, as well as outwards over the tailplane. Fig. 3 shows the area of extreme turbulence of flow as observed by the tufts in side view. The whole of the body flow from the wing back was involved, and the turbulence extended for about  $\frac{1}{2}$  to  $\frac{2}{3}$  up the fin and rudder.

FIG. 3. Sketch illustrating flow breakaway over fin and rudder at the wing root stall.

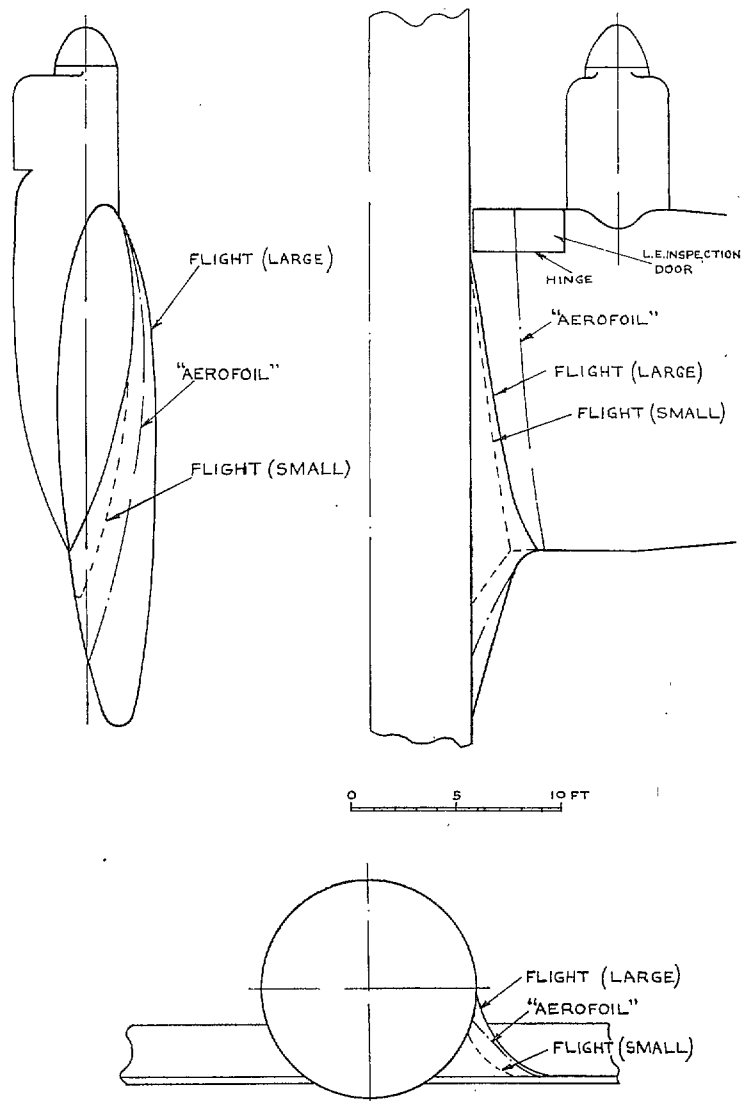
(iii) From the observations described in (ii) it was clear that the  $C_{Lmax}$  values on the *Tudor I* were normal (Ref. 2) though on the low side, and that the severe buffeting, which in practice limited the apparent stall to a very low  $C_{Lmax}$ , was caused by a deep and violent wing root breakaway, occurring at a very low  $C_L$ , the resultant violent wake passing over the tail end of the aircraft. It was fairly evident, therefore, that prevention of the premature wing root breakaway would obviate the early buffeting. There was some possibility that the fairly sharp insweep of the body in both plan and side view just forward of the tailplane position, may have worsened the effect of the wake hitting the tailplane, by causing a further breakaway to occur at the change in body shape; but this would be, clearly, a secondary effect and it was considered that the best dividend would be paid by obviating the wing root breakaway at its source. The first and obvious method of doing this was to improve the wing root filleting. At this time Messrs. A. V. Roe Ltd. had designed a new and larger fillet and were fitting it to *Tudor G.AGST*. Accordingly this aircraft was sent to the R.A.E. for test with the new fillet and the next section describes the results of tests made on this aircraft with this fillet. The drawing of this large fillet is shown in Fig. 4.

FIG. 4. Sketches of wing root fillets flown on the aircraft.
