ATSB TRANSPORT SAFETY BULLETIN
Aviation Level 5 Investigations AB-2010-061
Final

Level 5 Factual Investigations: July 2010 to September 2010

AB-2010-061

**Level 5 factual investigations:
1 July 2010 to 30 September 2010**

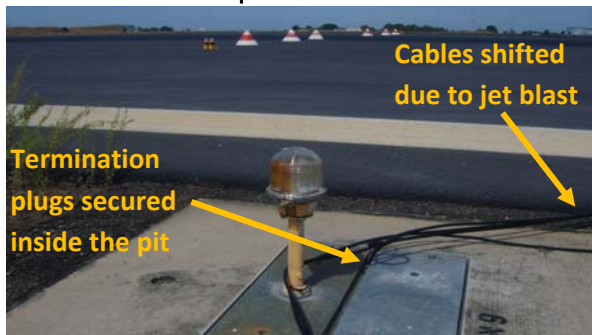
Figure 1: Runway 11 displaced threshold and northern pit

To modify the lighting system on runway 11/29, temporary cables were placed behind the displaced threshold from a lighting pit on the northern side to a lighting pit on the southern side of the runway. The lighting pit on the northern side was a newer style and the termination plugs connecting the cables were placed inside the pit and the cover screwed down to secure it (Figure 1).

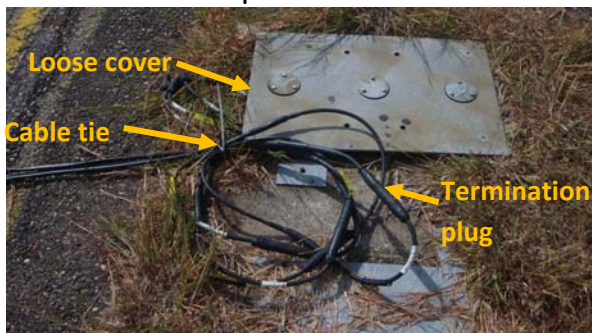
Figure 2: Runway 11 displaced threshold and southern pit

The duty technician arrived at the aerodrome at 1910, and found that the cables used to enable the displaced threshold for runway 11 had pulled apart, most likely due to jet blast. The cables were reconnected, the lighting circuit breaker reset, and the runway lighting system re-energised. At 1923, the runway edge lighting was restored. The Orion landed soon after, with the other holding aircraft landing a short time later.

On the southern side of the runway, the pit was an older style and had a cover that could not be secured. During the lighting modification, the termination plugs were placed inside the pit and the cover loosely fitted over the top. The lighting technicians reported that because the cover for the pit could not be secured, jet blast had pulled the cables out of the pit and separated the plugs, resulting in the lighting failure.

After the incident, the cables were looped and cable tied so that they could not be separated from undue tension (Figure 2).

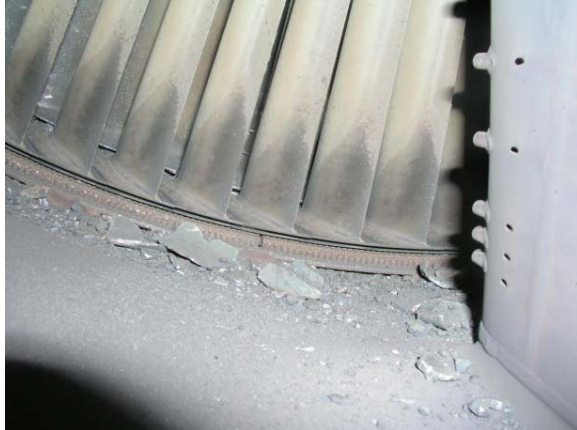
Figure 1: Debris in engine tailpipe

A post landing inspection by maintenance personnel found metal debris and evidence of a fire in the tailpipe of the right engine.

During the inspection, the HPC stages 6 to 11 vane airfoil surfaces were found to be broken and/or missing. Impact damage to some stage 5 vane trailing edges was also noted. A build up of molten blade and/or vane material had been deposited on all vane and rotor path surfaces from the stage 5 vane trailing edges downstream, which was consistent with an internal titanium fire.

The right engine of VH-VQO was identified within the service bulletin, V2500-ENG-72-0528, as possibly being affected by the HPC stage 6 stator vane manufacturing defect. The examination of the engine indicated that the partial power loss event initiated from material failures in the same location as the suspect stage 6 stator vanes. Due to the extensive damage, it was not possible to precisely determine the reason for the event; however, the engine manufacturer considered a vane failure was likely. Corroborating this was that some previous stage 6 vane failures had lead to titanium fires, similar to the one which occurred in VH-VQO after the power loss.

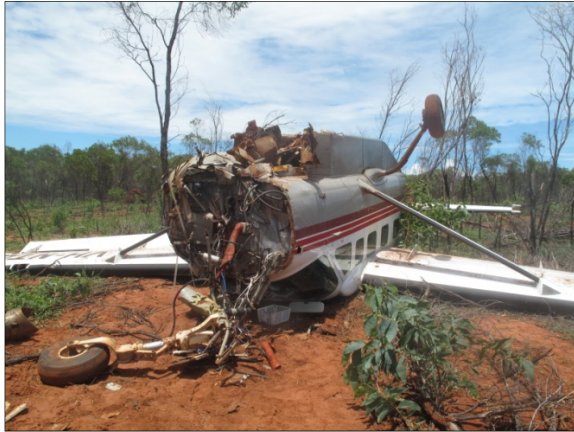
Figure 1: Accident site

The pilot, who was the only occupant sustained minor injuries. Examination of the aircraft by a third party and inspection of the photographs taken of the accident site, revealed that the engine, left main gear and nose gear had separated from the airframe during the accident sequence. There was a significant amount of oil present on the underside of the aircraft, indicating that the oil had leaked from the engine during operation. The engine was removed from the accident site as an assembly by a third party. The propeller was removed and the engine was shipped to an engine overhaul facility where a disassembly and examination was conducted under the supervision of the ATSB.

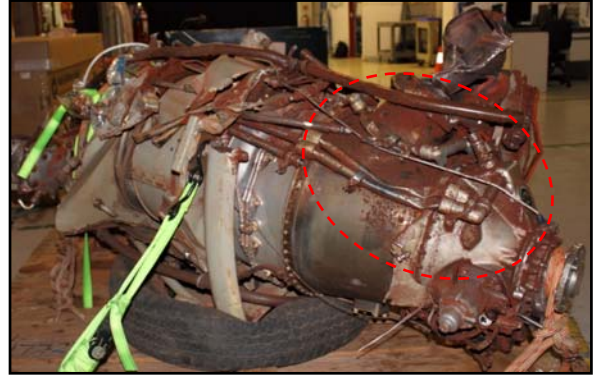
Figure 2: Engine assembly

External examination of the engine showed that red dust from the accident site had attached itself to the areas of the engine that had been contaminated with engine oil. It was apparent that there was a high concentration of oil on the outer surface of the reduction gear box between the 4 and 7 o'clock positions, the mid and rear sections of the engine were relatively oil free in comparison. Figure 2 shows the engine assembly as received at the engine overhaul facility, attached to a pallet with the bottom of the engine facing upwards; the highlighted area indicates a high concentration of oil contamination.

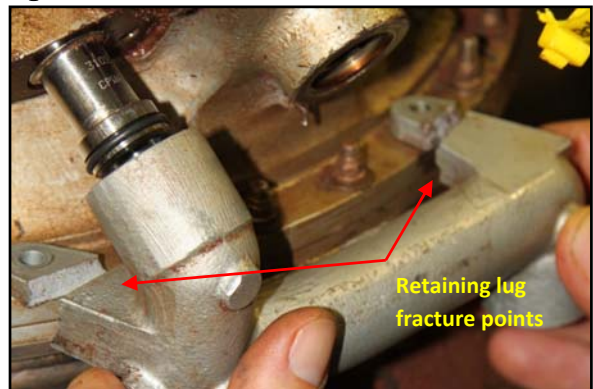
Figure 3: Oil transfer tube

The engine examination revealed accident damage to several components and oil lines. All of the engine's external oil seals were inspected with no pre-accident defects identified. The engine was disassembled at the hot section and accessory gear box, so an internal examination could be conducted. No pre-accident defects were noted during the internal examination. The accessory gear box chip detector, reduction gear box chip detector and the engine's main oil filter were inspected, with no foreign particles or debris noted in the oil system. Approximately 1 quart (0.92 L) of oil was drained from the engine, which had a normal operating capacity of 14 quarts (13.25 L). A sub section of oil pressure tube, that transferred oil from the oil pressure pump to the reduction gear box, was found to have fractured at both attachment lugs (Figure 3).

In order to establish the manner in which the oil tube attachment lugs had fractured and whether or not the failure contributed to the oil pressure issues, the tube was sent to the ATSB engineering facilities for a detailed metallurgical examination.

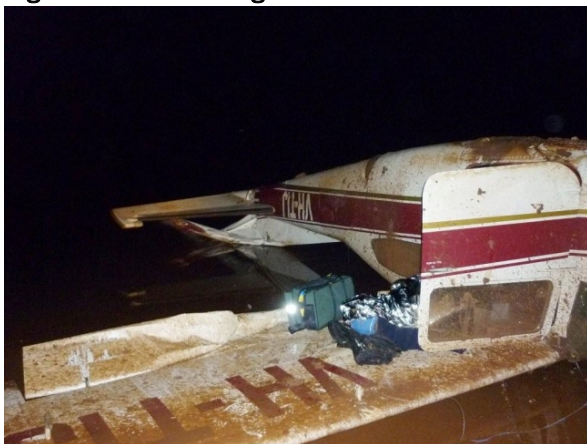
Figure 1: VH-TJ resting inverted on salt lake

His next recollection was waking up and realising the aircraft had collided with terrain. The aircraft sustained serious damage (Figure 1).

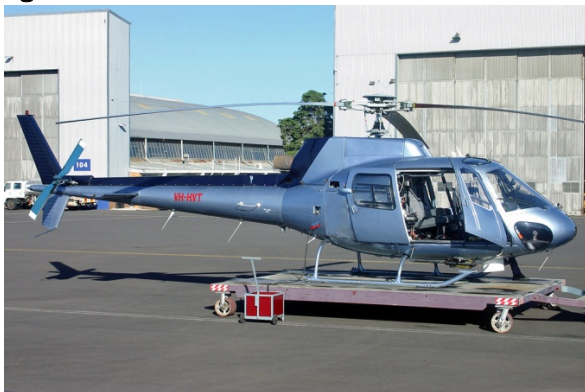
Figure 2: VH-HVT

At about 1110 Eastern Standard Time⁸⁴, the pilot stated that he commenced a right turn with the intention of returning via the same route. The pilot reported that during the turn, the helicopter was travelling between 10 and 15 kts and descending slightly to maintain the height above the canopy. About two thirds of the way through the turn, the pilot observed a tree branch protruding about 1 m above the average height of the surrounding canopy and about 2 m away from the front of the helicopter. The pilot recollected trying to climb the helicopter, but the branch impacted the front lower right side about 2 seconds later. The branch contacted and broke the helicopter's chin bubble and slid down the right hand the side of the helicopter (Figure 2).
