ATSB TRANSPORT SAFETY BULLETIN
Aviation Level 5 Investigations
AB-2010-103
Final

Level 5 Factual Investigations: 1 October 2010 to 31 December 2010

**Level 5 factual investigations:
1 October 2010 to 31 December 2010**

Report No.	Publication date	ISBN	Reference Number
AB-2010-103	January 2011	978-1-74251-132-0	Jan11/ATSB05

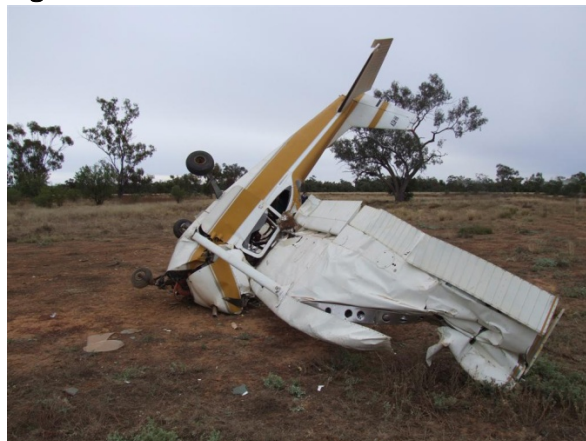
Figure 1: Cessna 172 VH-RZV

A police officer who attended the scene observed that a large tree in the vicinity of the accident site had several freshly broken branches about 10 m above the ground. Severed branches and part of the aircraft's right wing tip were found between the tree and the aircraft.

The damage to RZV was consistent with the right wing colliding with a tree branch followed by the aircraft impacting the ground inverted, with a steep nose-down attitude (Figure 1).

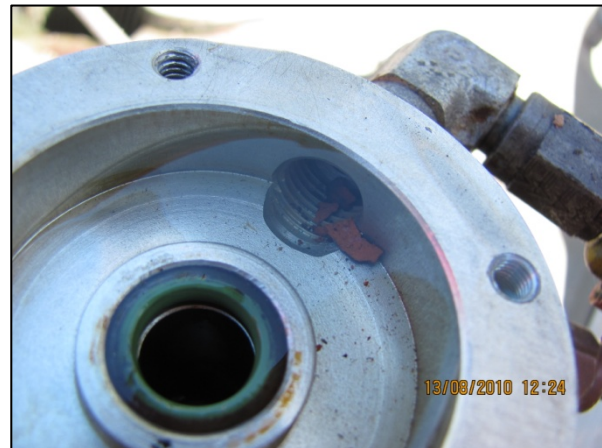
Figure 2: Fuel manifold valve with debris

An inspection of the fuel system found a small amount of orange coloured debris in the fuel manifold valve, before the fuel filter screen (Figure 2).

The Australian Transport Safety Bureau (ATSB) obtained a sample of the debris for identification and found that the debris appeared to be an agglomeration of fine particulate matter. The composition of the debris was primarily iron and oxygen with traces of cadmium, manganese and zinc. The investigation could not determine the exact origin of the debris.

It was unlikely that the small quantity of debris found in the fuel system lead to the total power loss of the engine.

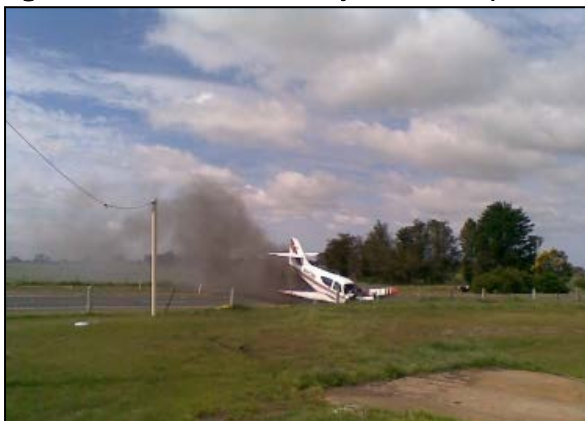
Figure 1: VH-CSH immediately after the impact

With assistance, the pilot and passenger exited the aircraft through the windscreen. The pilot sustained serious injuries, including a fractured ankle, while the passenger sustained minor injuries. After the occupants egressed, the aircraft caught alight, resulting in serious damage².

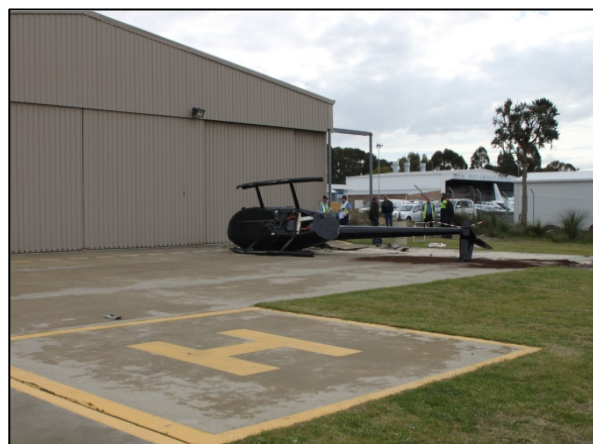
Figure 1: VH-ZVF at the accident site

A Jandakot tower controller reported that at 0714 they observed the helicopter rise above the hangar, tilt towards it and then descend out of their view. About a second later, they heard a loud bang. The helicopter sustained serious damage in the impact (Figure 1). The pilot sustained minor injuries while the passenger was uninjured.

The helicopter came to rest on its right side and fuel leaked from the fuel vent lines, about 70 litres was recovered by emergency services. As a result of the main rotor blades impacting the apron, fragments of blade were deposited over a large area. The furthest of these fragments was found 352 m from the accident site within an area of parked aircraft. Main rotor blade fragments also penetrated the hangar doors adjacent to the accident site.

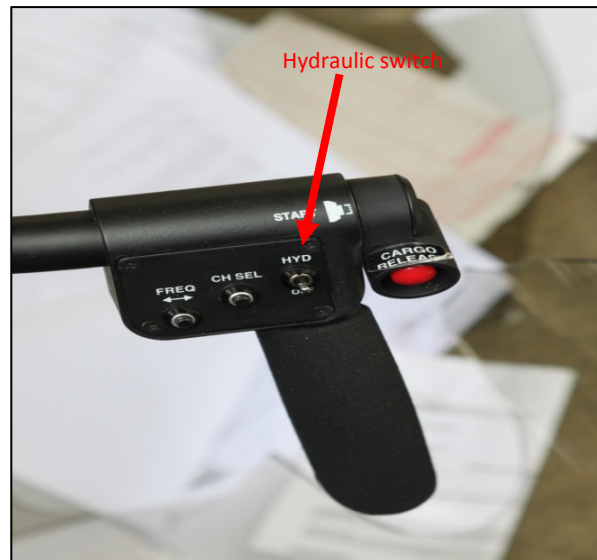
Figure 2: VH-ZVF Cyclic mounted hydraulic switch

The pilot had been taught a supplementary method of checking the hydraulic system that, in addition to the preceding check, involved the momentary deactivation of the hydraulic circuit breaker. Once the circuit breaker was re-set, the cyclic hydraulic switch must be returned to ON. It was after this supplementary procedure that the pilot believes he may have inadvertently forgot to switch the hydraulics switch back to ON.
