Aviation Short Investigation Bulletin

Issue 27

ATSB Transport Safety Report
Aviation Short Investigations
AB-2014-024
Final – 19 March 2014

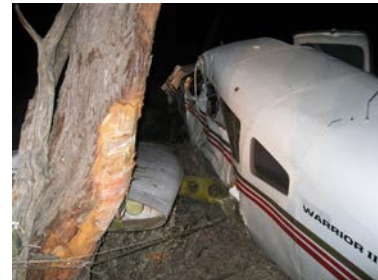
Damage to VH-CCQ

The aircraft was substantially damaged (Figure 1), the pilot sustained serious injuries and the passenger sustained minor injuries.

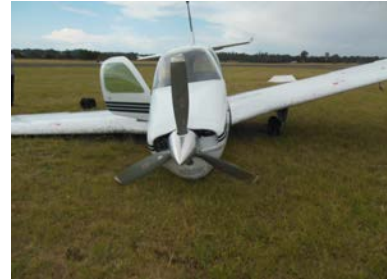
VH-YEN damage

With the left main gear almost extended, the aircraft began to veer to the right. The instructor noted that there were buildings in the path of the aircraft and elected to reject the take-off. When the aircraft had slowed to about 30-40 kt, the nose dug into the grass alongside the runway.

The instructor and student were not injured, but the aircraft sustained substantial damage.

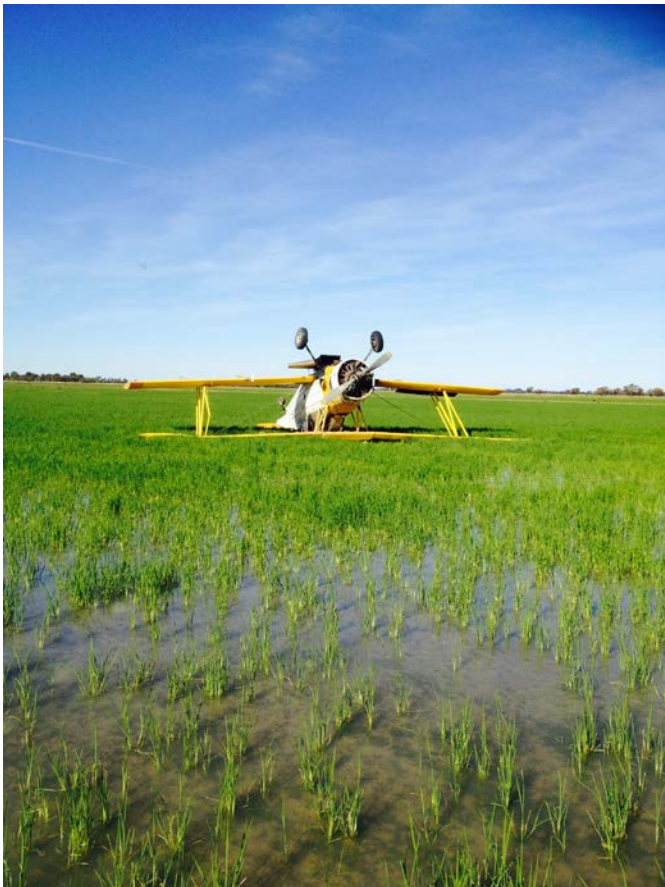
Figure 1: Damage to VH-CCF

When at about 20-30 ft AGL, with a nose high attitude, the pilot felt the aircraft's wings shaking, indicating an imminent stall.¹ The pilot increased engine power in an attempt to avert the stall, but the aircraft continued to descend. Shortly after, the wheels touched down in a rice paddy in about 20 cm of water and the aircraft flipped over (Figure 1). The aircraft was substantially damaged. The pilot was uninjured.

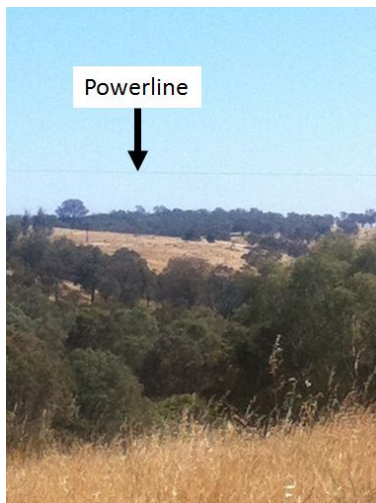
Figure 1: Unknown powerline

The pilot then commenced spraying the gully, which required looking out of the helicopter window and door towards the ground. He then sighted power lines (Figure 1) just as the helicopter main rotor disc struck the wires. The pilot immediately conducted a precautionary landing. The helicopter sustained substantial damage to the main rotor blades (Figure 2). The pilot was uninjured. The strike also resulted in insulators being detached from the 22,000 volt power lines.
