Australian Government
Australian Transport Safety Bureau

Aviation Short Investigations Bulletin

Issue 30

ATSB Transport Safety Report
Aviation Short Investigations
AB-2014-064
Final – 26 May 2014

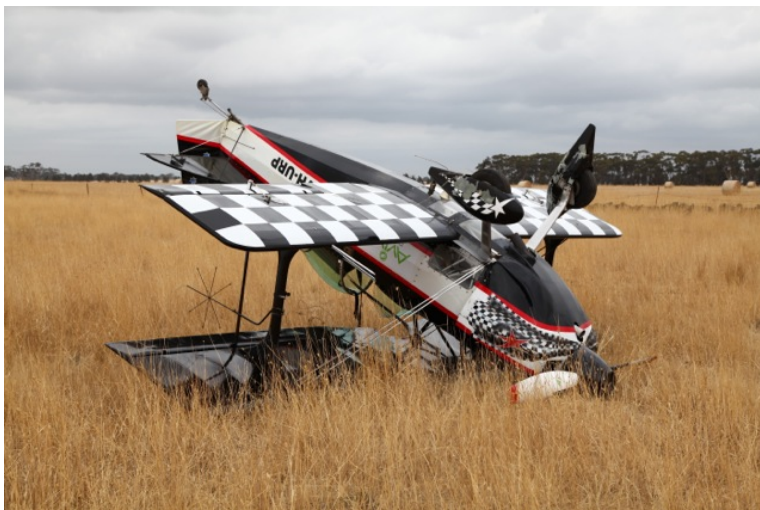
Figure 1: Damage to VH-URP

During the landing roll, the aircraft collided with a rock and nosed over, coming to rest inverted. The aircraft was substantially damaged (Figure 1).

The pilot reported that the 'flop tube' may have become stuck. It supplies the engine with fuel from the top of the tank when the aircraft is inverted. This may have been resolved by rolling the aircraft inverted. However, this was not a safe option at low altitude, with a partial or complete engine failure.

The damage to the aircraft was assessed as being greater than the replacement cost therefore no post-accident engineering inspection was conducted to determine the cause of the engine failure.

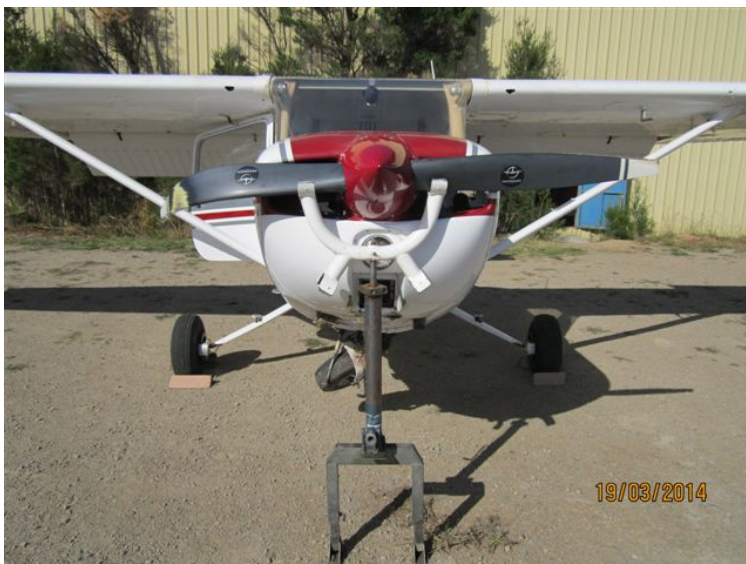
Figure 1: Damage to VH-EAV

The aircraft veered off the runway to the left, rolled down the slope to the eastern side, and collided with a tyre marking the location of a drain. The aircraft continued into the culvert and the nose landing gear subsequently collapsed. The propeller struck the ground, resulting in substantial damage (Figure 1) and the aircraft came to rest on the grass.

After the accident, the pilot observed the windsock veering in an arc from the south-south-east to south-south-west and reported that windshear may have contributed to the incident.

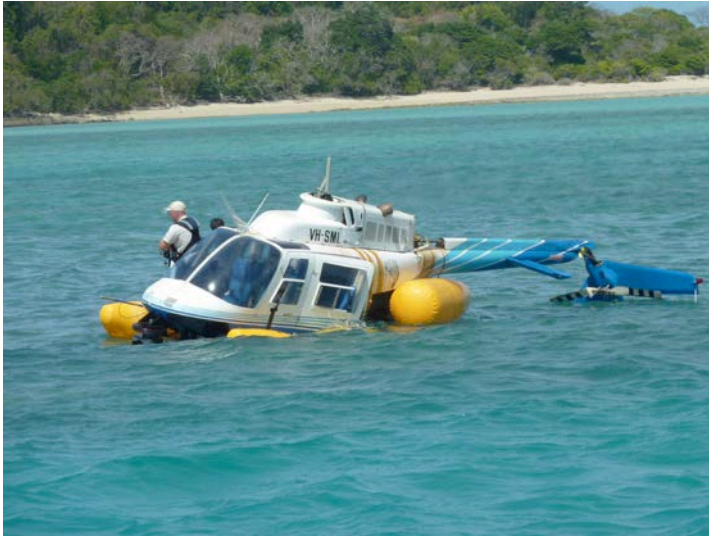
Figure 5: VH-SMI

During the landing, the left rear float was damaged and deflated. Consequently, the helicopter sat left rear skid low on the water. The main rotor blades and mast became separated, the tail rotor assembly sustained damage, and the oil reservoir fractured (Figure 5).

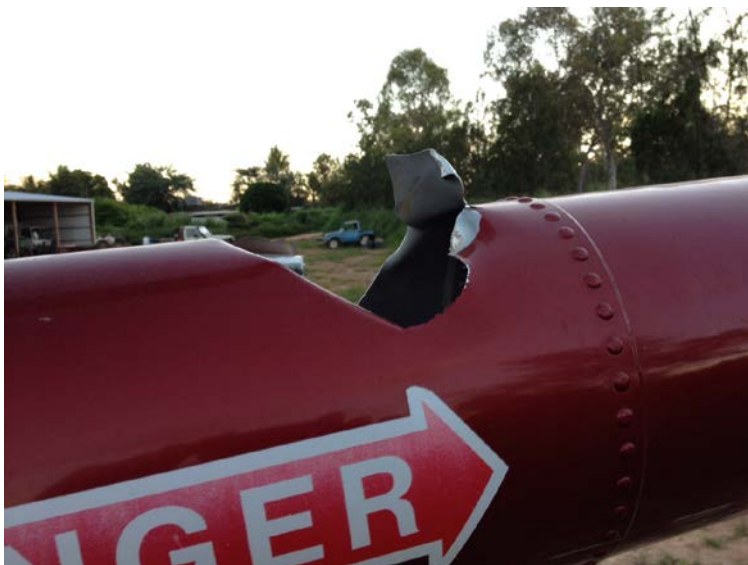
Figure 1: Damage to VH-YY5

The pilot eased the collective into the ground and as the helicopter touched down, it started to roll to the left. He moved the cyclic right, reduced the throttle and the helicopter rocked from side to side and then settled. During the event, the rotor blades contacted the tail boom resulting in substantial damage (Figure 1).

A post-accident engineering inspection did not find any defects other than those resulting from the incident.
