Tail rotor malfunction involving a Robinson R22, registration VH-HPH

La Belle Downs Station, Northern Territory on 18 November 2014

ATSB Transport Safety Report
Aviation Occurrence Investigation
AO-2014-181
Final – 27 August 2015

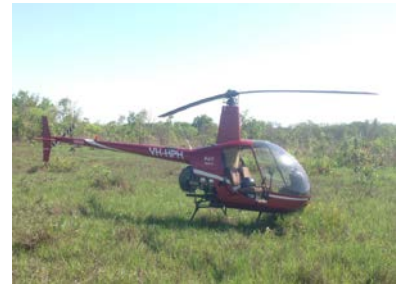
VH-HPH

About two minutes into the flight, on climb and at about 300 ft above ground level, the pilot felt a vibration through the tail rotor pedals. The pilot decided to return to La Belle Downs station, turned the helicopter to the right and started a descent. The pilot was unable to stop the turn and the helicopter continued to descend and turn to the right. The helicopter started to spin in a tight circle and completed between five and six rotations before landing hard, bouncing once and then coming to a stop. The pilot performed the shutdown procedure and the pilot and passenger exited the helicopter. The pilot and passenger were uninjured. The helicopter was substantially damaged, including damage to the tail boom and both skids.

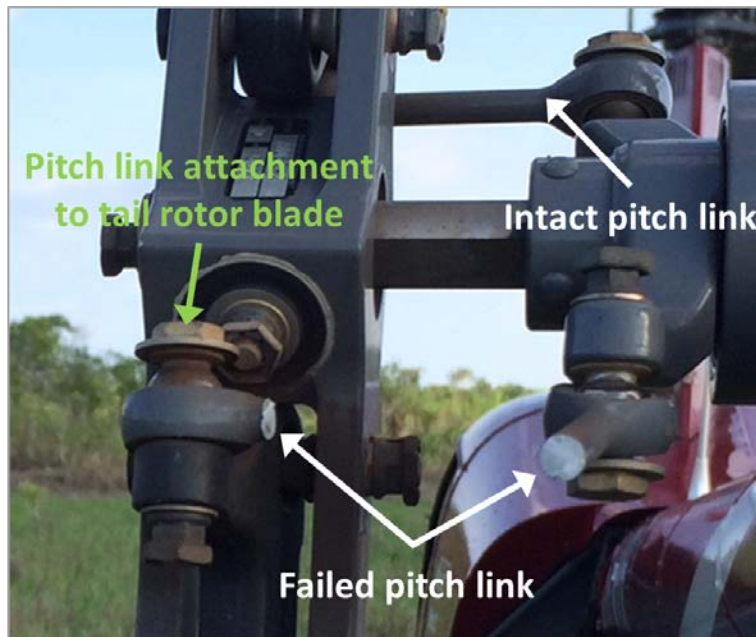
Figure 1: Failed tail rotor pitch link

After landing, the pilot observed that the tail rotor pitch link¹ had failed (Figure 1).

The helicopter manufacturer was only aware of one other similar failure that occurred about 10 years ago. The manufacturer believed that the failure was as a result of the axial wear (about five times more than permitted) allowed binding to occur, with resultant fatigue failure to the pitch link.

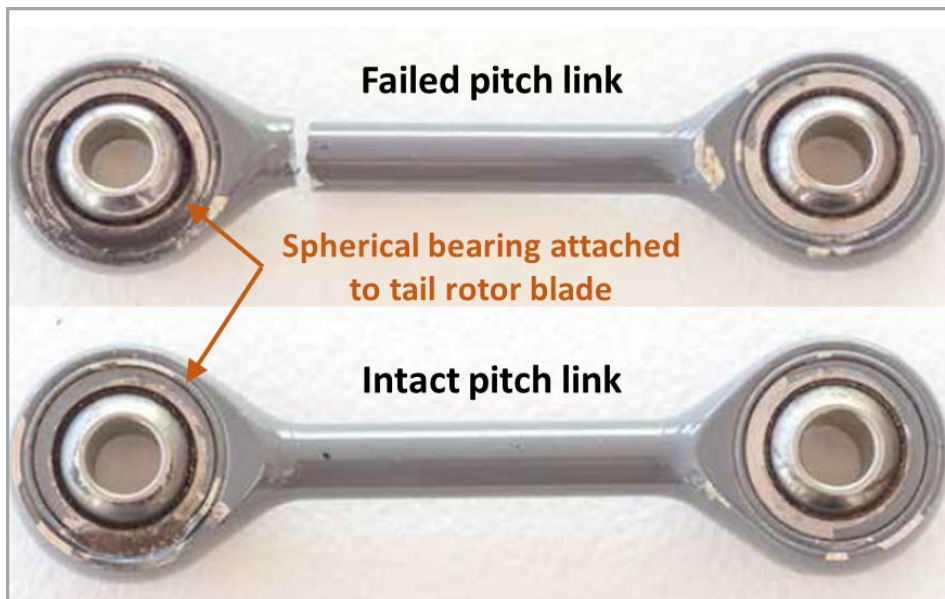
Figure 2: HPH tail rotor pitch links

An examination of the tail rotor pitch links was conducted on behalf of the helicopter operator by a consultant in engineered-system failure analysis and the following was found (Figure 2):

- Alternating stress in the failed pitch link resulted in the initiation and propagation of a fatigue crack.
- The alternating stress in the pitch link resulted from failure of the spherical bearing to provide a low friction connection between the end of the tail rotor blade and the pitch link.

- The failed pitch link spherical bearing attached to the tail rotor had extensive wear. Axial wear of the spherical bearing was measured to be about 0.108 inch (2.743 mm).

- The intact pitch link spherical bearing attached to the tail rotor also showed signs of extensive wear. Axial wear of the spherical bearing was measured to be about 0.041 inch (1.041 mm).

- No physical explanation was found as to why the specified inspection procedures (*R22 Maintenance Manual*, Chapter 2 Inspection, section 2.410) failed to detect bearing wear. Possible explanations beyond what could be ascertained by the examination were that the helicopter was operated in an exceptionally abrasive environment or the Teflon bearing lining was affected by some cleaning action.

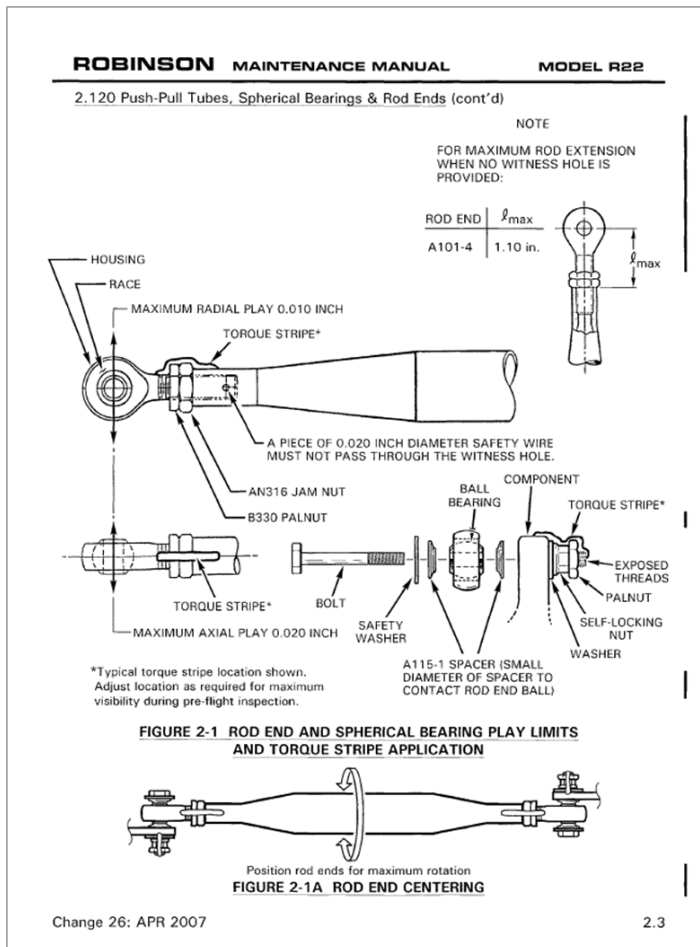
Figure 3: Robinson maintenance manual spherical bearing limits

The *Robinson Maintenance Manual Model R22* contains inspection requirements to be conducted at the 100-hour or annual inspection. Section 2.410 *Inspection procedures and checklist* item 12. *Rotor Hub Hinge Bolts*, dated October 2014, required the condition of the pitch links and rod ends to be inspected. This inspection was to be in accordance with section 2.120 *Push-Pull Tubes, Rod Ends, and Spherical Bearings* (dated October 2014), with reference to Figure 2-1 (reproduced below in Figure 3). The inspection needed to meet the following conditions:

- the maximum allowed axial play of 0.020 inch (0.508 mm). The axial play of HPH's failed pitch link was about 0.108 inch (2.743 mm) and the intact pitch link was about 0.041 inch (1.041 mm)
- the maximum radial play of 0.010 inch (0.254 mm) for the rod end spherical bearings
- with no looseness between the bearing outer race and the rod end housing.

The maintenance manual also contained a caution that the Teflon-lined bearings must not be lubricated or cleaned with solvent.
