Wirestrike involving a Robinson R44, VH-LOL

142 km WSW of Adelaide, South Australia, 10 April 2015

ATSB Transport Safety Report
Aviation Occurrence Investigation
AO-2015-037
Final – 27 August 2015

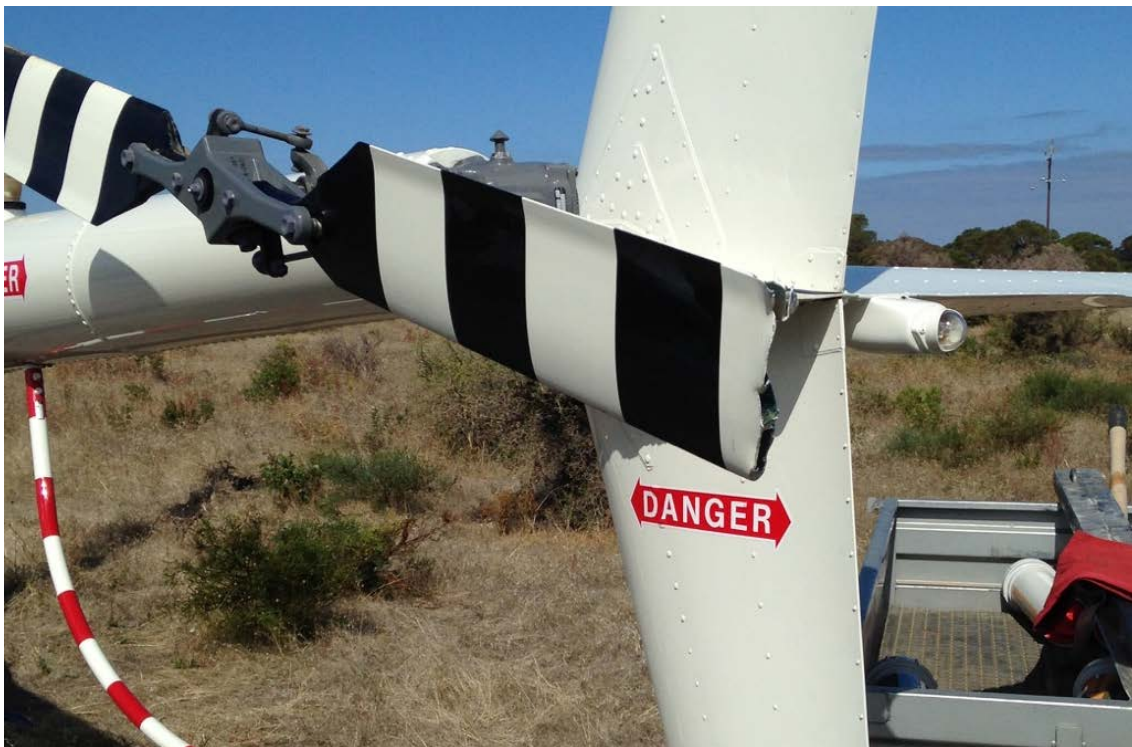
Also on board were client representatives who were directing the noxious weed management operation and manually dispensing the chemical into each bush. In the course of traversing the field at low level in search of the weed, the helicopter struck a previously unidentified power line. The helicopter's main rotor blade made initial contact with the power line and during the avoidance manoeuvre, the tail rotor blades also made contact, severing the blade tips (Figure 1). The pilot landed the helicopter safely. The helicopter was substantially damaged but the occupants were uninjured.

Figure 1: Tail rotor blade damage to VH-LOL

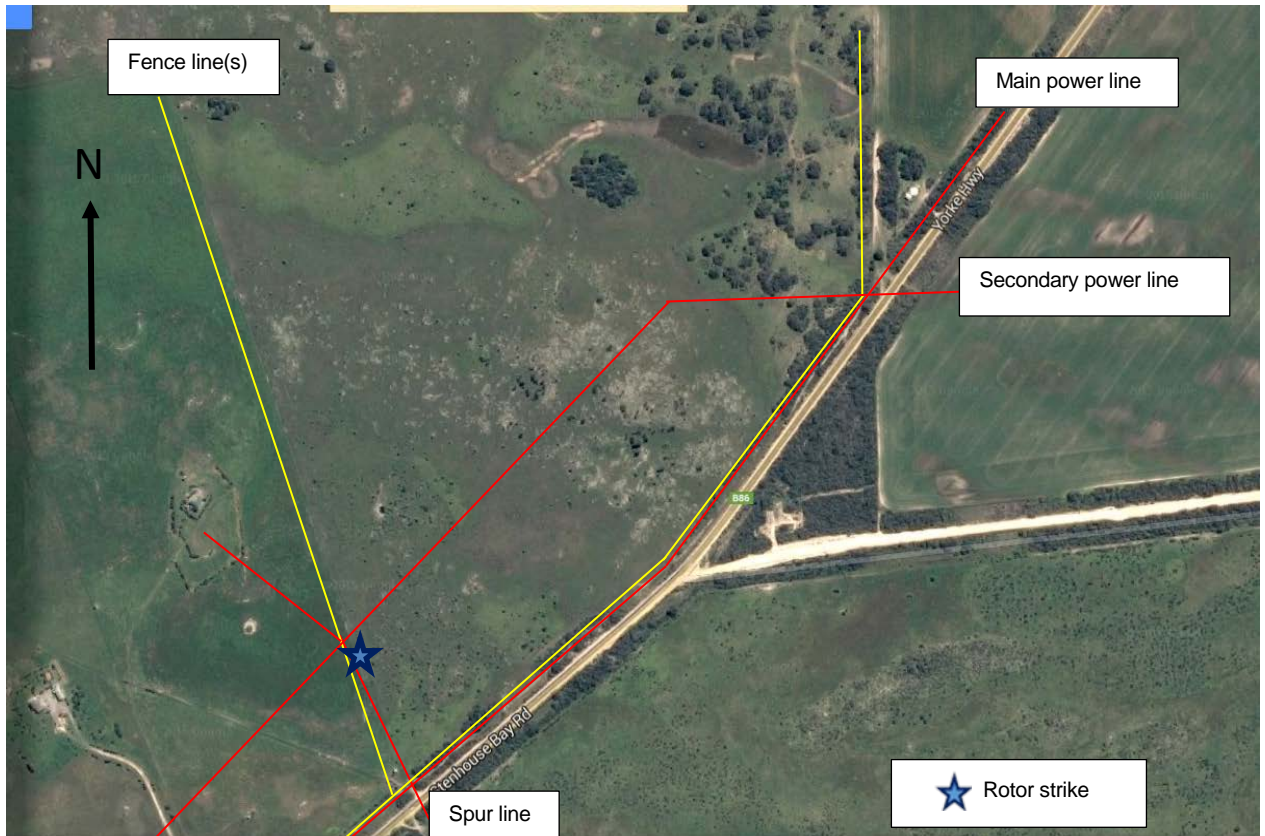
The unidentified powerline was a single wire that was strung between the poles supporting the main and secondary powerlines and traversed, unsupported, through the southern boundary of the operational area. It was not mentioned by the locals, nor marked on the data logger map. It was not readily discernible from the air although additional support poles did lead the wire away from the secondary power line towards a distant building.

Figure 2: Powerlines and boundary fencing
