Wirestrike and collision with terrain involving Robinson R22, VH-LYW

88 km NE Roma, Queensland, 20 February 2016

ATSB Transport Safety Report
Aviation Occurrence Investigation
AO-2016-013
Final – 27 May 2016

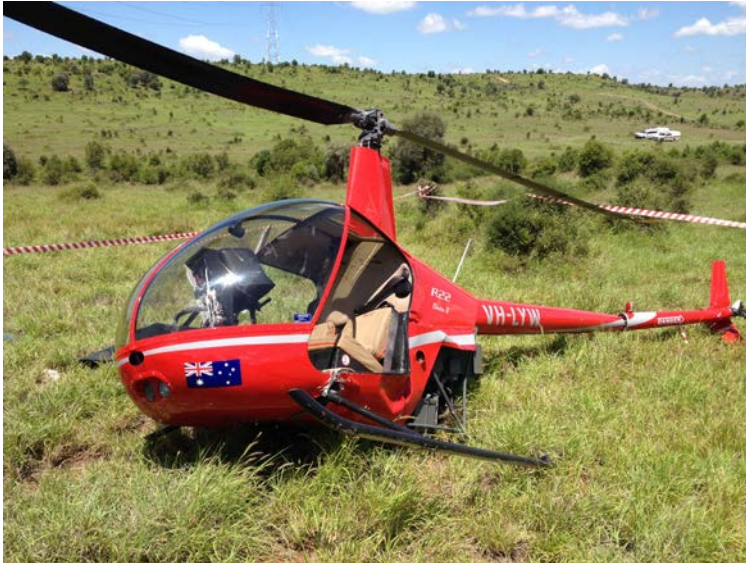
The helicopter was vibrating and the pilot turned it away from the wires. The tail rotor then failed and the helicopter yawed around. The helicopter descended rapidly and continued to rotate. The pilot entered an autorotation, and closed the throttle, overriding the governor. As the helicopter neared the ground, the low rotor revolutions per minute warning horn sounded, and the pilot raised collective¹ to try to cushion the landing. The helicopter collided with the ground nearly upright, and sustained substantial damage (Figure 1). The pilot was seriously injured.

Figure 1: Accident site showing damage to VH-LYW
