## TECHNICAL ANALYSIS REPORT

Report No. 05/04

# **Examination of failed Integrated Nozzle Assembly and Thrust Reverser components from a RB211-524 Turbofan Engine**

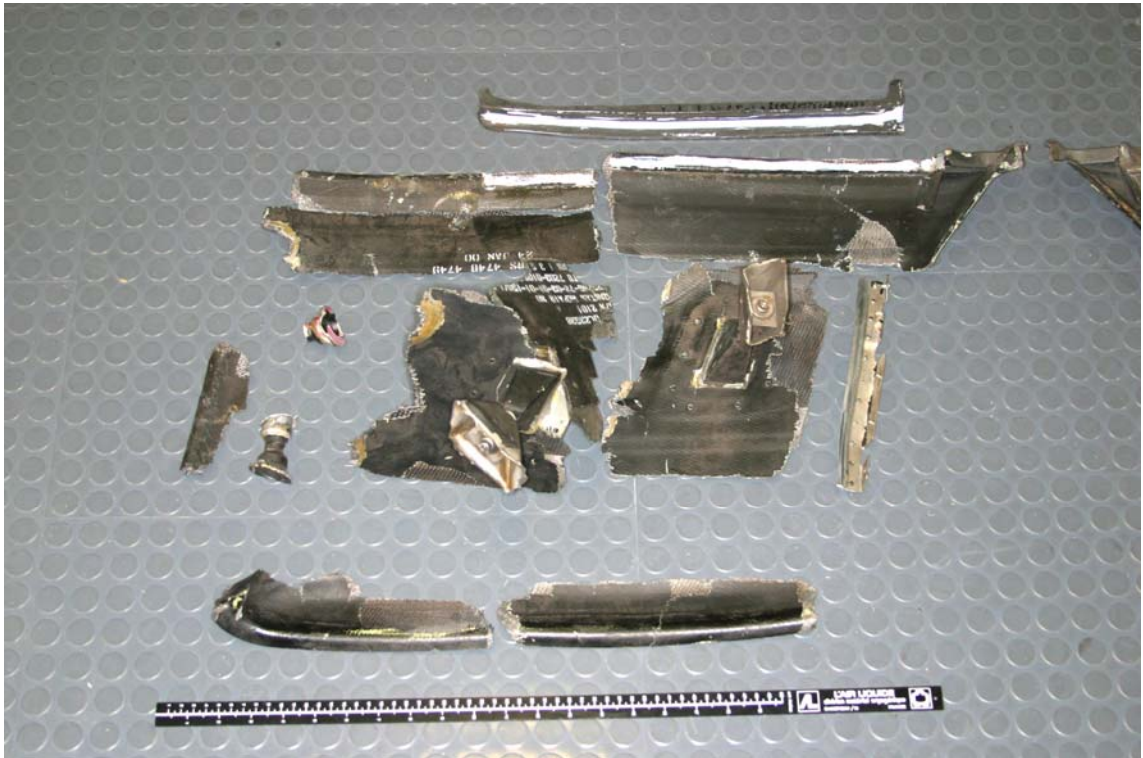
The items received by the ATSB included fragments of both INA drive fairing shells (figures 1 & 2), a mostly complete thrust reverser blocker door and pieces of a second blocker door that had broken into multiple sections (figure 3).

**Figure 1.** Received remnants of the INA drive fairing – side 1.

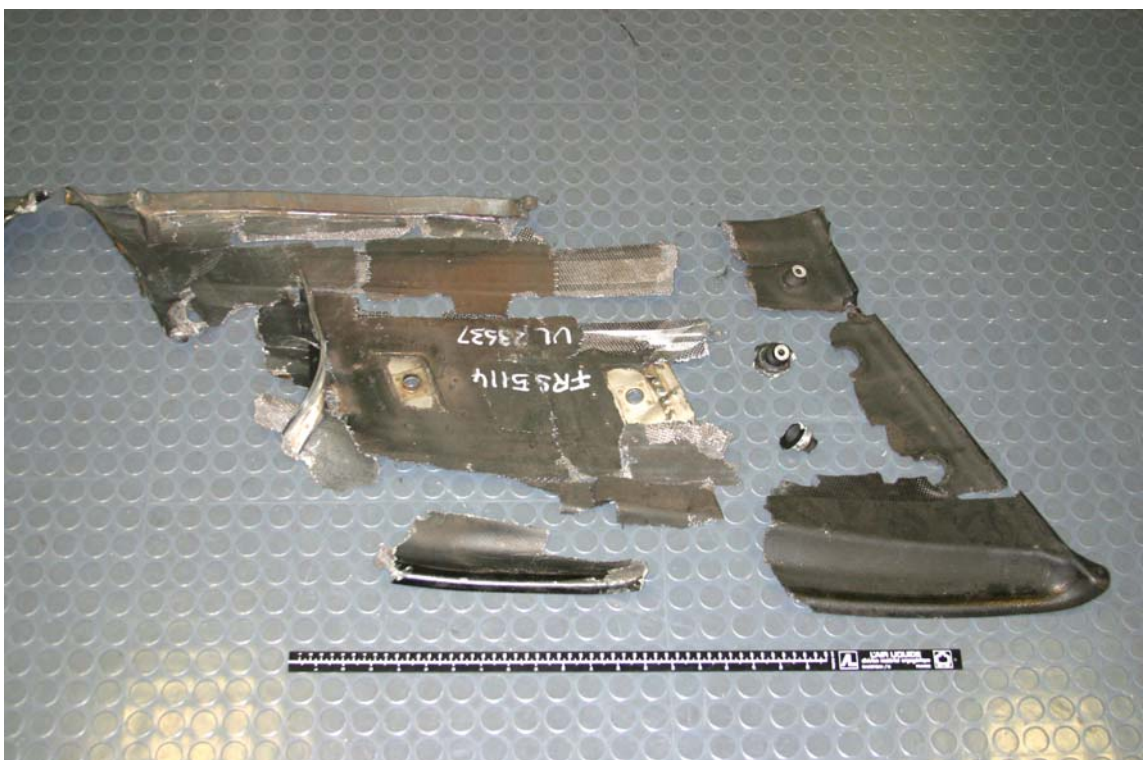
**Figure 2.** Received remnants of the INA drive fairing – side 2.

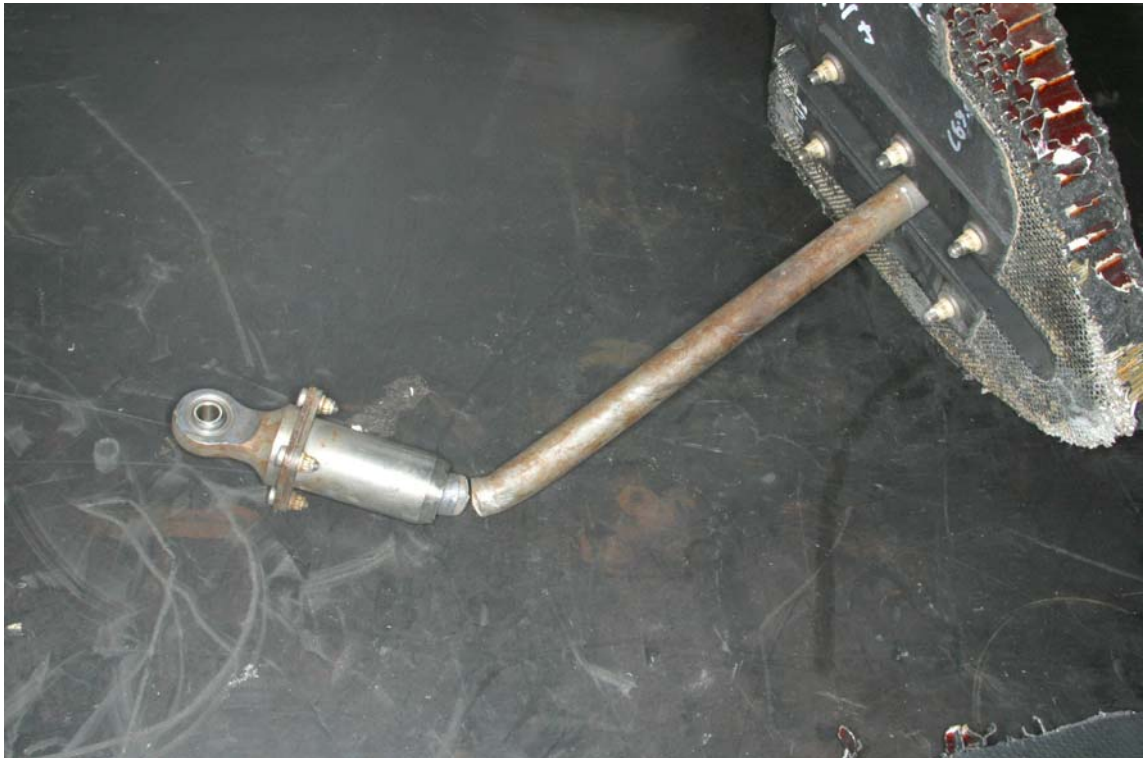
All of the fractures and disruptions presented by the blocker door sections were consistent with physical overload failures. There was no evidence of progressive cracking, disbonding or other degenerative type failure modes.

**Figure 6.** Blocker door actuator rod bending failure.

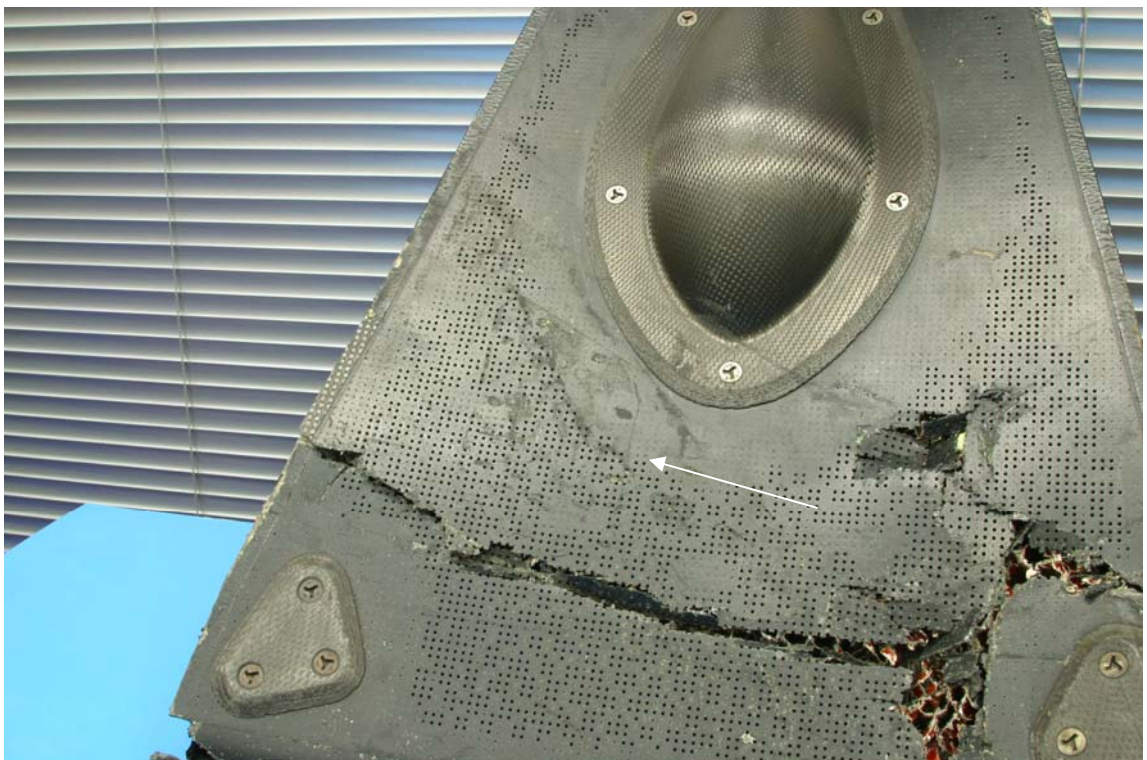
The impact witness marks left on the external door surfaces were examined closely under directional lighting. Using that technique, it was possible to distinguish an imprint from a reinforcing panel that made up part of the INA fairing shell sections (figures 7, 8).

**Figure 7.** Inward facing surface of blocker door showing impact witness mark from a drive fairing panel (arrowed).

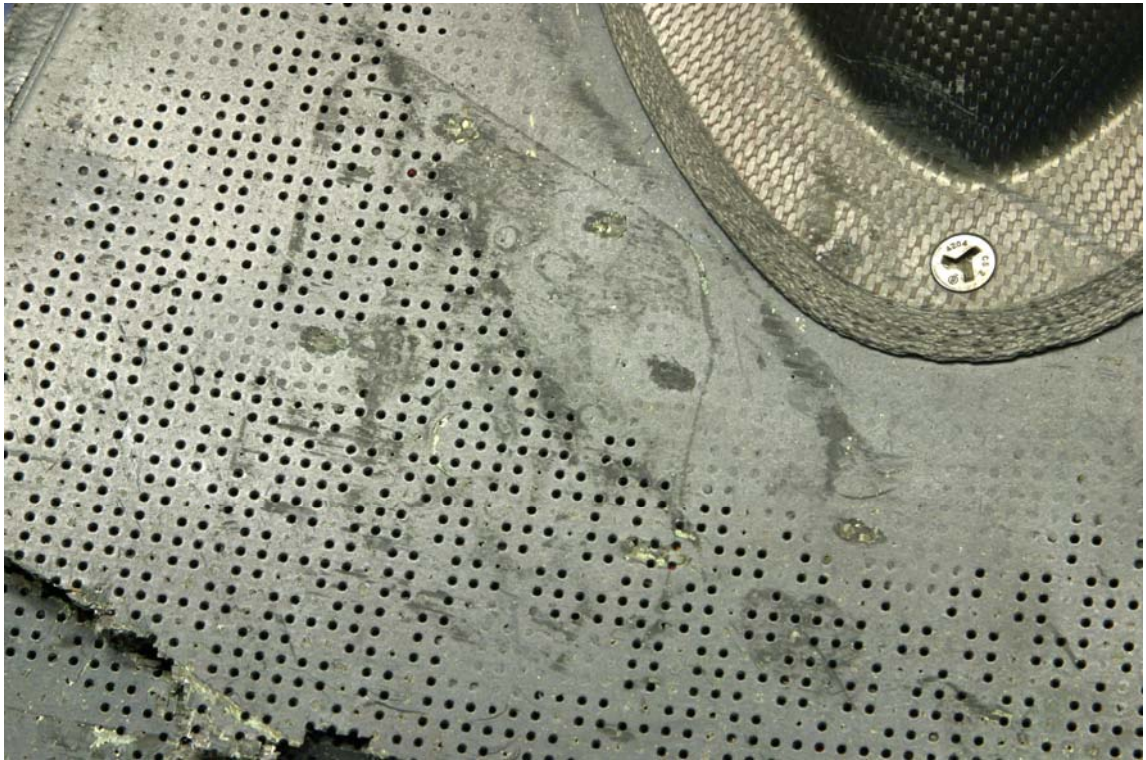
**Figure 8.** Close view of the impact mark shown in figure 7 above. Compare with figure 14 showing the drive fairing panel.

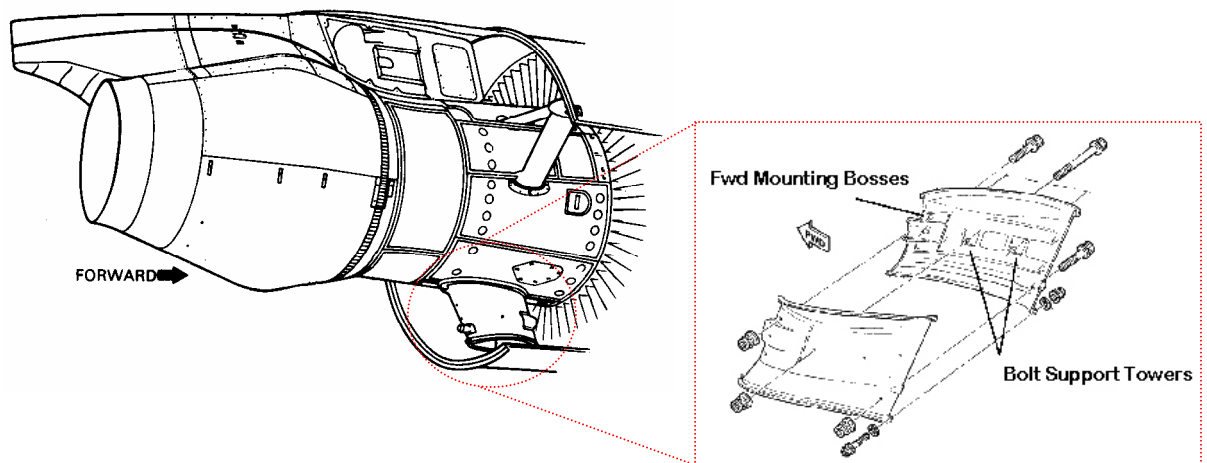
The RB211-524 accessory transfer drive was faired through the INA cold-stream duct by two symmetrical fibre composite shells, adjoined by two central bolt tower fittings and a number of peripheral tie bolts and bosses (figure 9). The part numbers carried by the two fairing halves were *UL23538* and *UL23537* respectively. Both panels also carried stencilled or written information relating to repair operations conducted by the aircraft operator.

**Figure 9.** Basic schematic of the drive fairing shells and bolting arrangement. Enlarged diagram courtesy of the operator's Power Plant Engineering department report S-AB1/1.

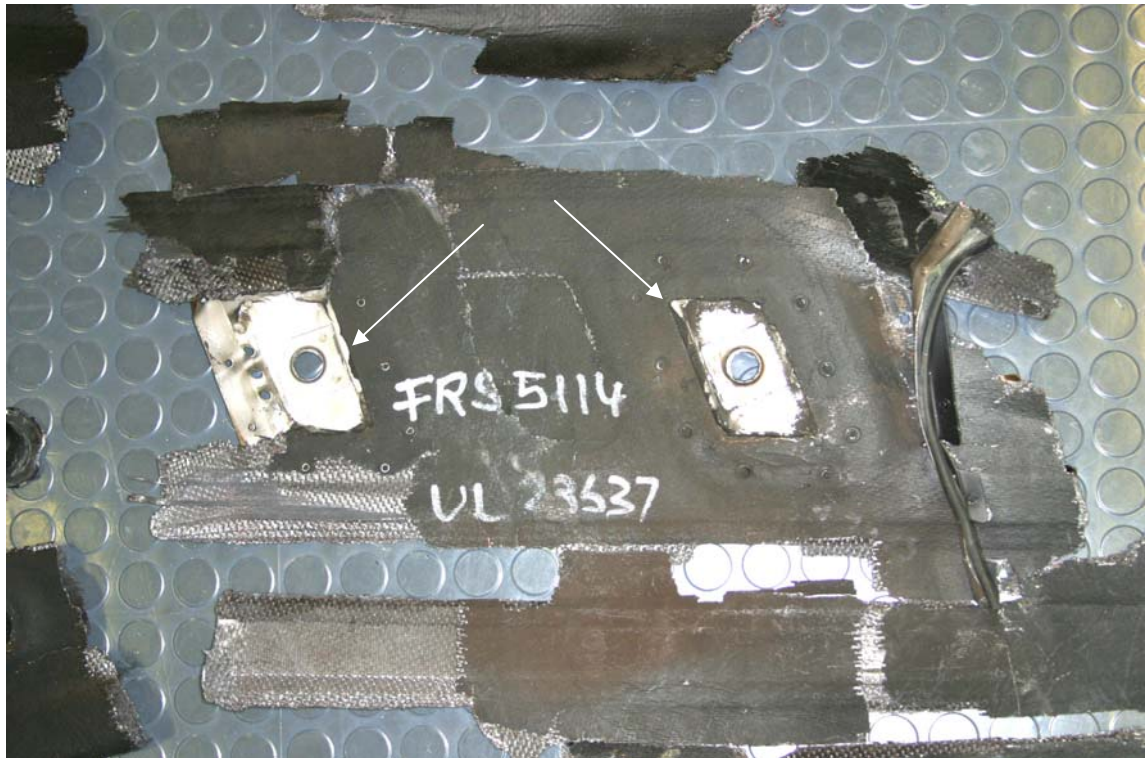
Destruction of the fairing shells was extensive, with many small fragments produced during the failure sequence. Both central towers had separated from their base flanges on the inside of one panel half (figures 10, 11). Closer inspection revealed evidence of progressive cracking around the separated bases of both towers, with one tower showing evidence of that cracking around the complete circumference (figure 12). The adjacent tower presented mixed areas of ductile overload failure of the riveted connection and cracking around the edges of the base flanges (figure 13). The cracked areas showed minimal associated ductility. The outside faces of the fairing shells where the bolt towers had been affixed were reinforced with a rhomboidal shaped plate through which the fitting had been riveted (figure 14). The impression of one of these plates was found on the external surface of one of the thrust reverser blocker doors (figure 8).

**Figure 10.** Inside surfaces of a drive fairing panel. Note the complete separation of the central bolt towers from their base panels.

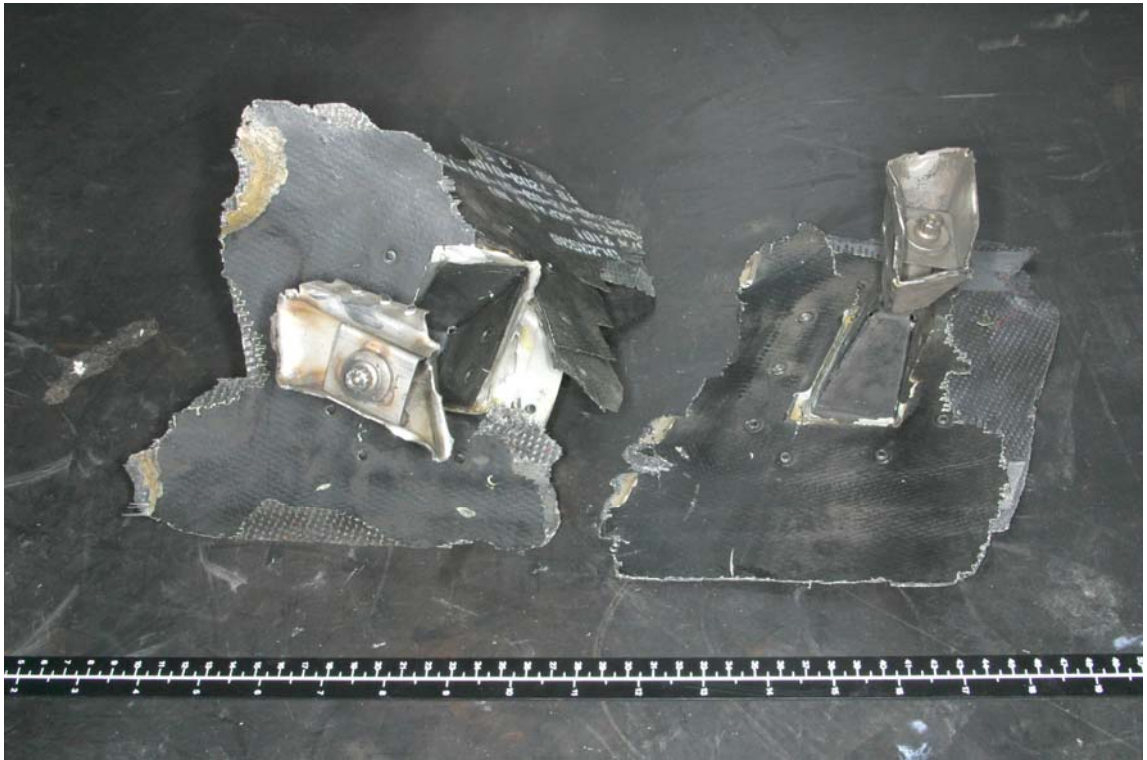
**Figure 11.** Separated drive fairing bolt towers.

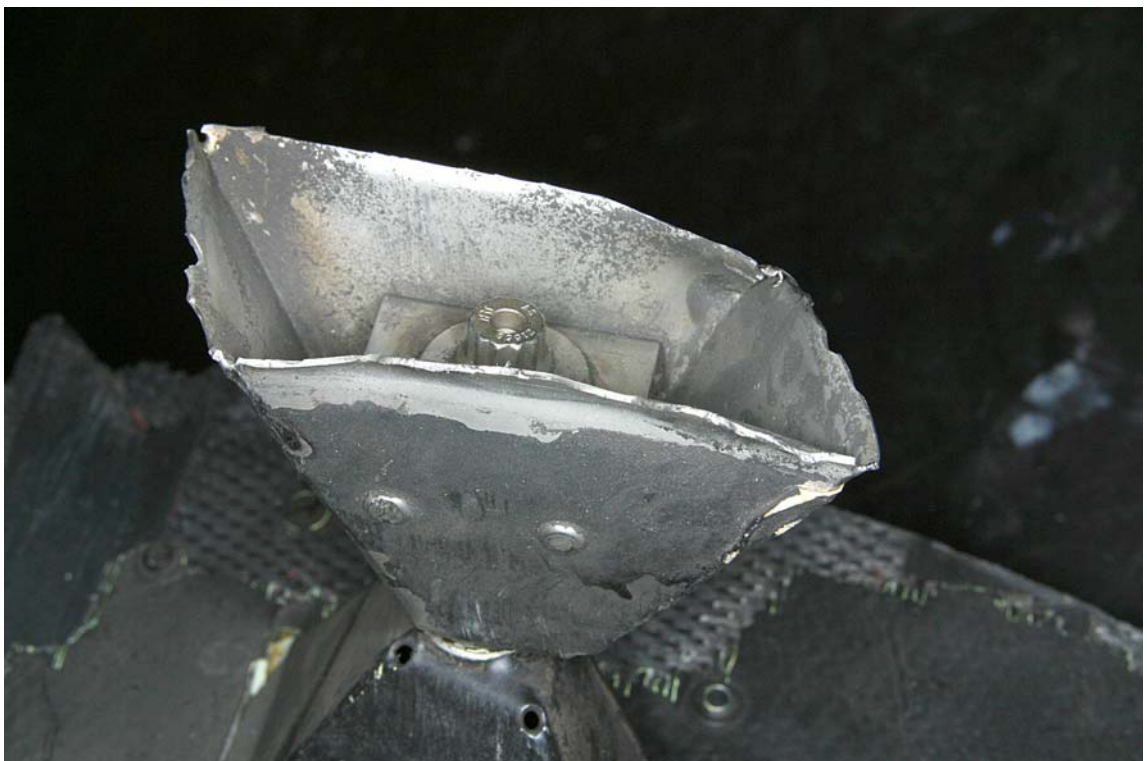
**Figure 12.** Base of a bolt tower illustrating the failure and separation from the flange transition.

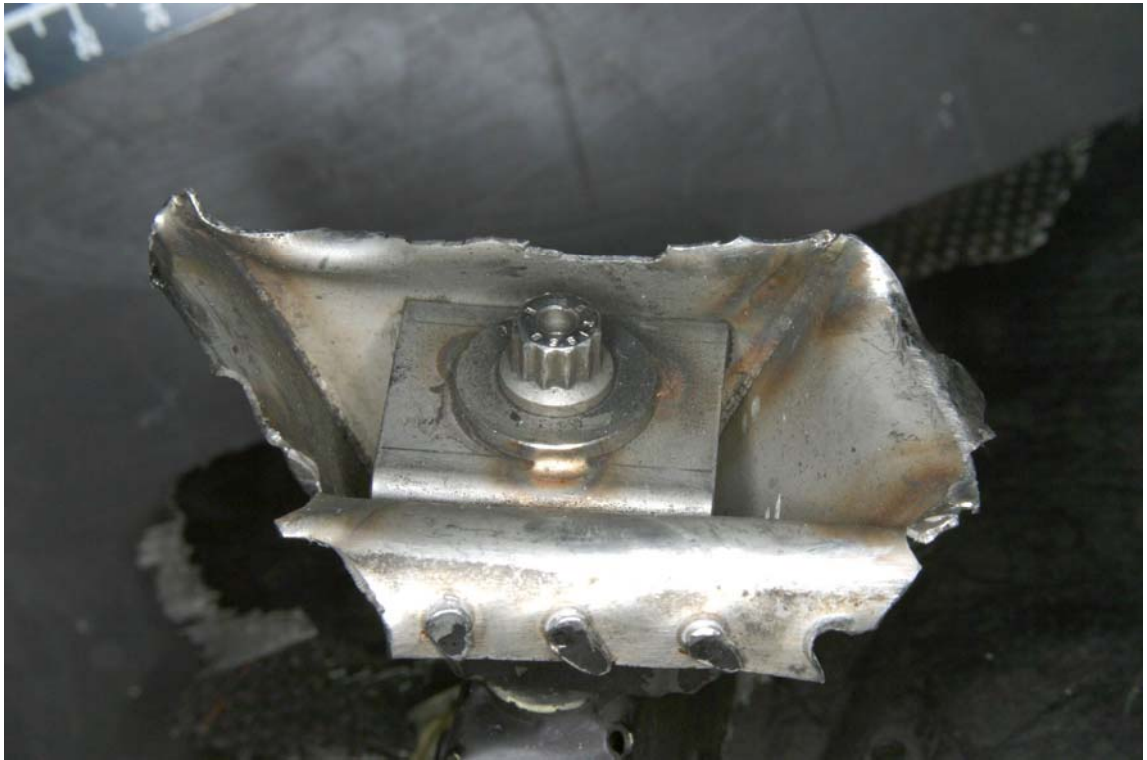
**Figure 13.** Base of the other bolt tower showing a combination of cracking around the flange transition and ductile tearing and pull-through of the riveted connection.

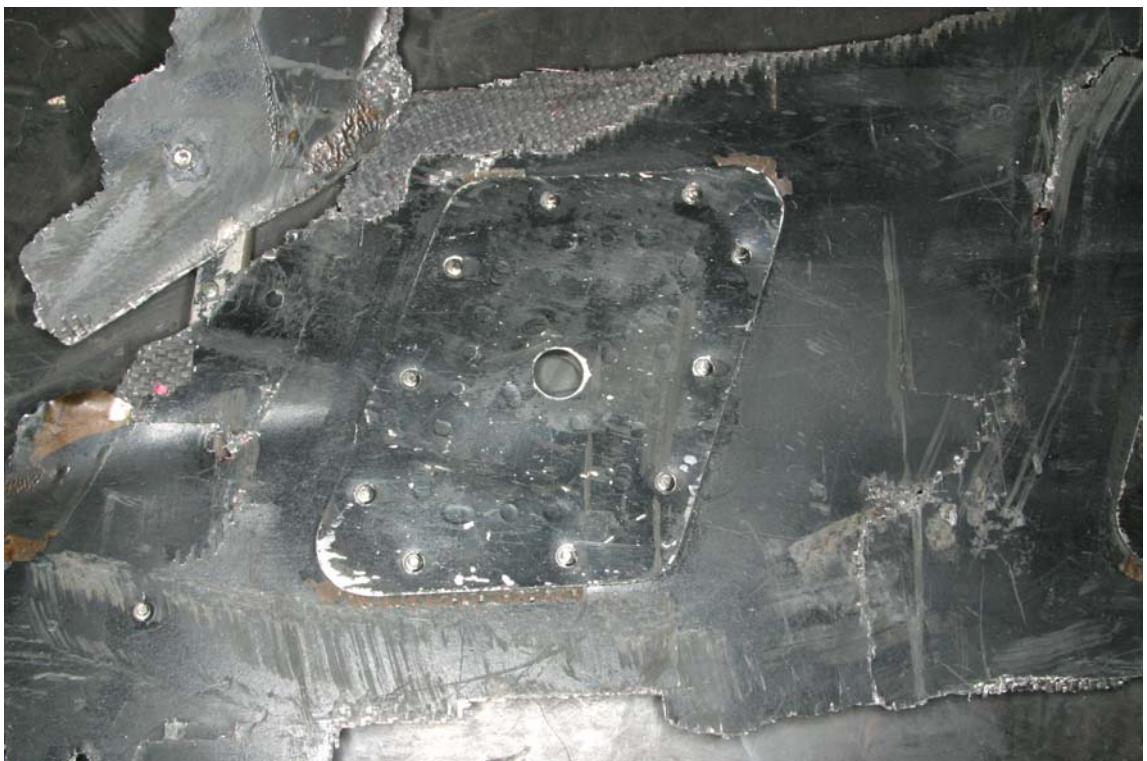
**Figure 14.** External drive fairing panel showing the reinforcing plate associated with the bolt towers. Compare the appearance of this plate with the impact witness mark found on one of the thrust reverser blocker doors (figures 7 & 8).

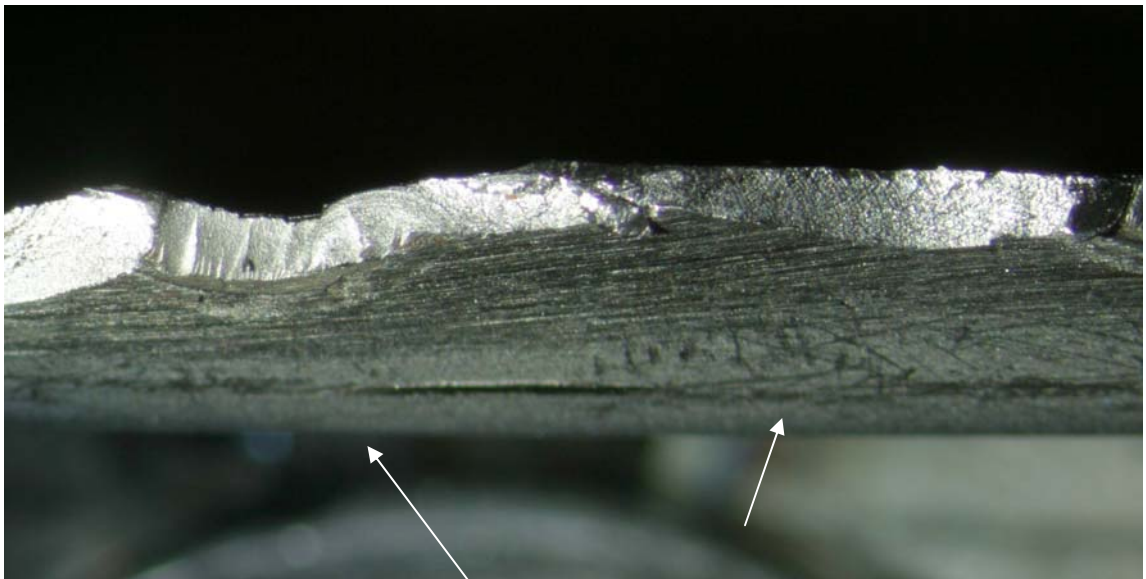
Low-power stereomicroscopic examination of the cracked and fractured drive fairing bolt towers found clear evidence of fatigue cracking along the folded transitions between the tower body and the mounting flanges (figures 15, 16).

**Figure 15.** Typical area of cracking / fracture presented along the bolt tower flange transition radius region. Note the clear fatigue crack progression marks and the ratchet marks associated with a crack initiation site.

The separation and loss of the drive fairing panels was attributed to the growth of fatigue cracking around the base of both central bolt towers that held the fairing shell halves together. The development and growth of that cracking had resulted in the separation of one tower completely from its base and the partial separation of the other. It was likely that the insecurity resulting from this resulted in the increased flexure and weakening of the remaining structure and the eventual overload failure and separation of the fairings as observed.

Fatigue cracking of the bolt towers was attributed to a vibratory loading environment acting at the local physical stress-raising features inherent to the bolt tower design and fabrication. The welded corners and folded seams associated with the base of the tower components provided ideal sites for the initiation of fatigue cracking. It is noted that the cold stream duct environment in which the drive fairings are located, would inherently expose the fairings to a range of mechanical and aerodynamically induced vibratory loads that potentially could contribute to the fatigue cracking as sustained. Those stresses were likely to be at a maximum during application of reverse thrust, where the extension of the thrust reverser blocker door panels into the air stream would produce turbulence and elevated vibration of the nacelle structures. Also of note was the design of the bolt tower components, which inherently placed the outer flange sections under tensile loads when the two fairing halves were pulled together and bolted. Static tensile loads of that nature would be expected to compound any vibratory induced stresses, thus increasing the potential for fatigue cracking.

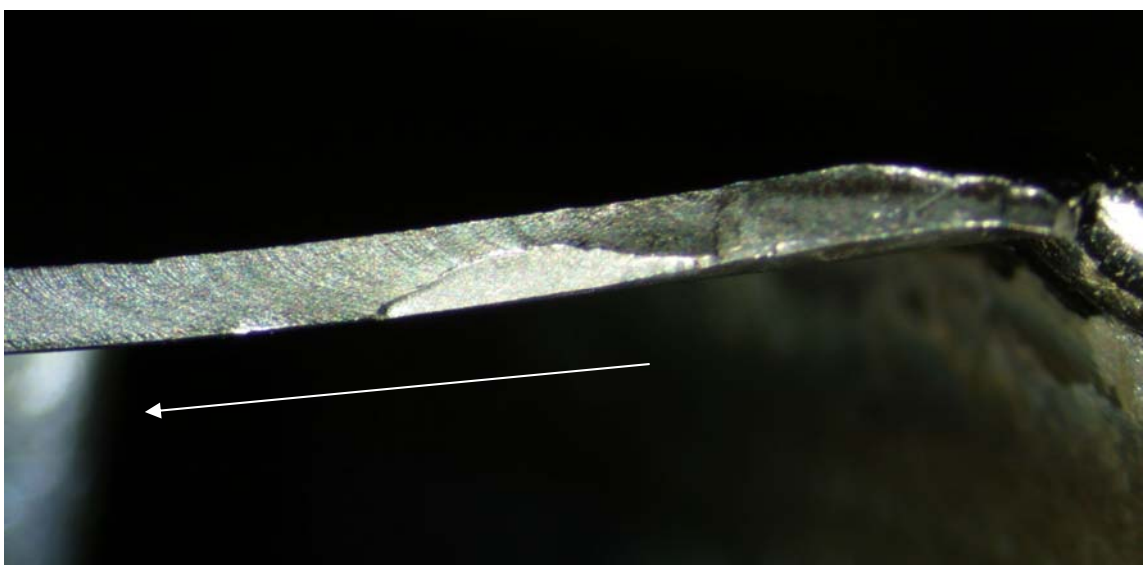
**Figure 16.** Fatigue crack progression marks extending away from a corner welded region of a fairing bolt tower (arrowed).

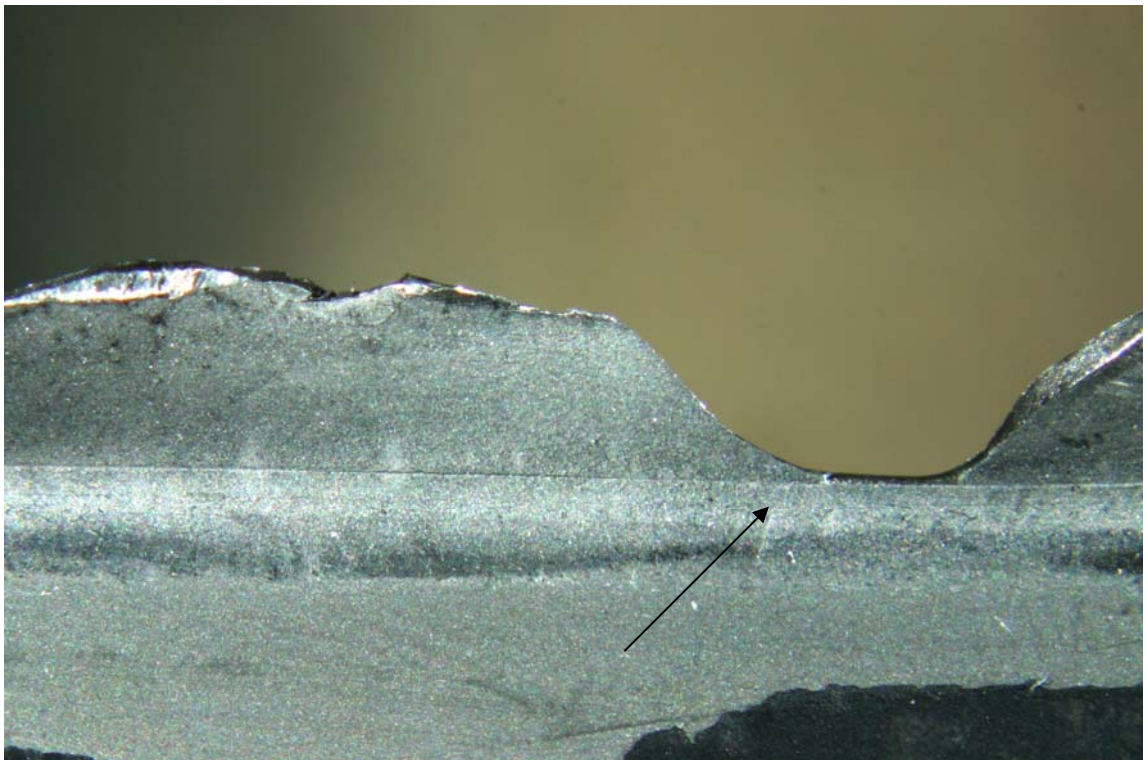
The bolt towers had been produced as fabricated items from folded and welded stainless steel plate. In some areas, the folding operation used to produce the base flanges had created shallow embossed lines from which fatigue cracking had initiated (figure 17). The weld terminations at the base of the tower corners were also a source of crack initiation (figure 18). Stereomicroscopic examination revealed several regions of crack propagation along the tower bases, extending away from the corner welds.

**Figure 17.** Fracture profile along the transition radius. Note the tooling mark from which fatigue cracking had initiated in some areas.

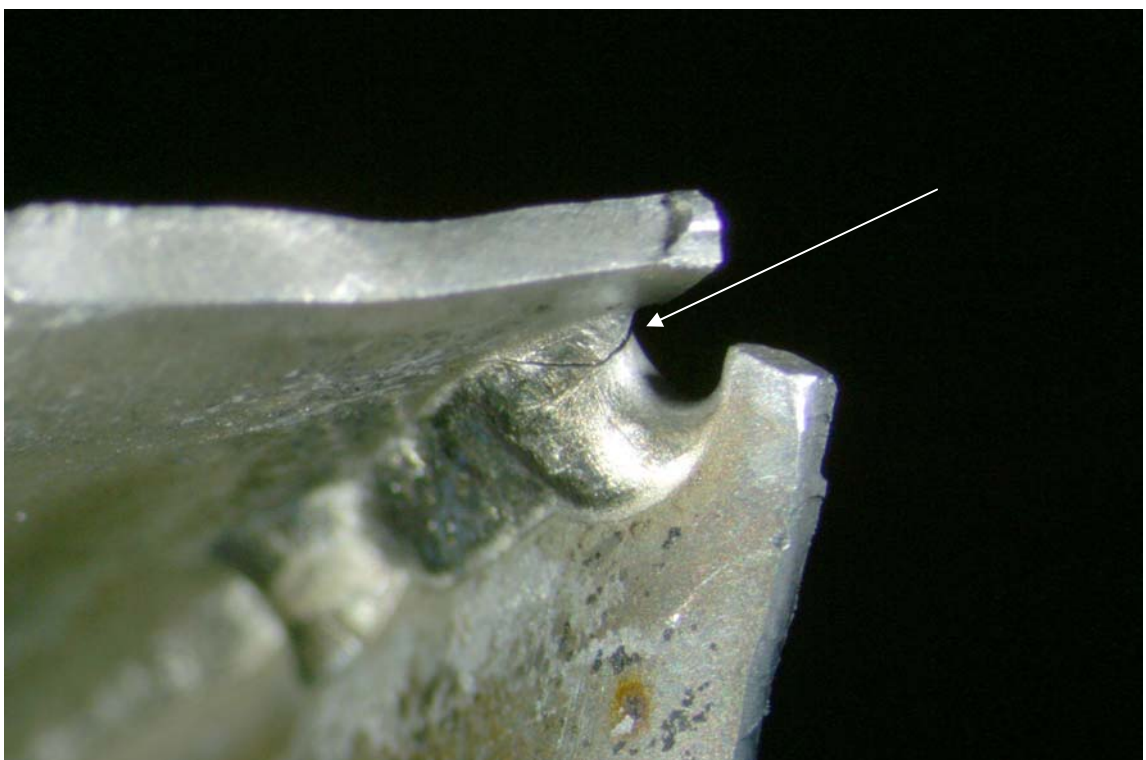
**Figure 18.** Fatigue cracking associated with a weld termination at the base of a bolt tower corner.
