AVSCOM Report No. 76-22

EVALUATION OF SCRATCH- AND SPALL-RESISTANT WINDSHIELDS

AMMRC TR 76-39

December 1976

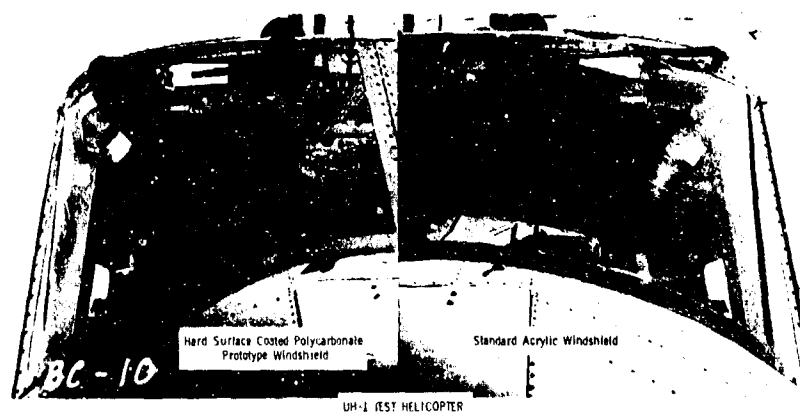
Figure 2. Windshields during flight testing - 385 flight hours.
19-066-141/AMC-74

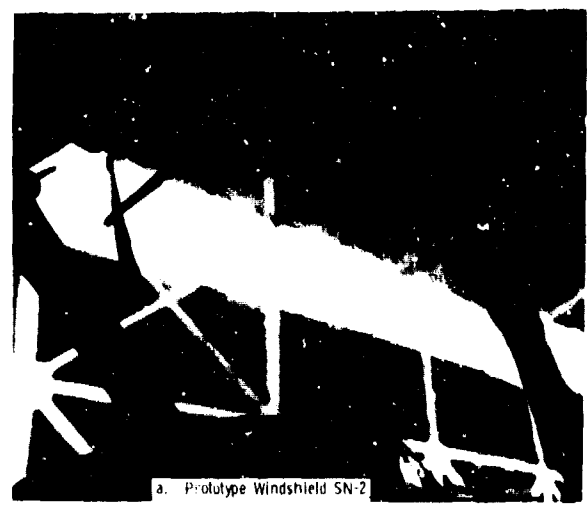
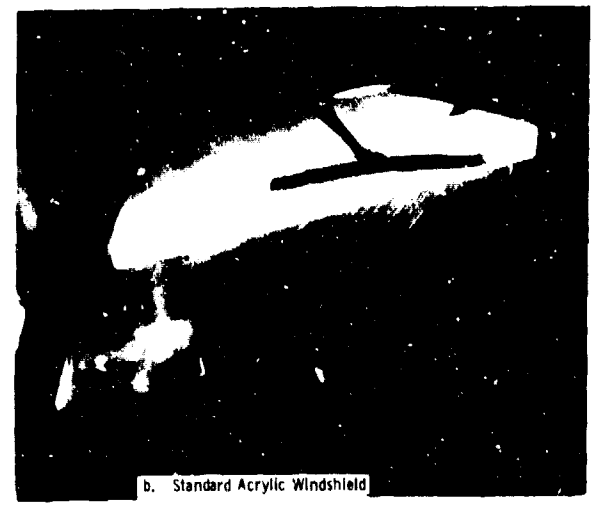
Figure 4. Prototype windshield SN-2 (a) and acrylic windshield (b) at 967 flight hours.

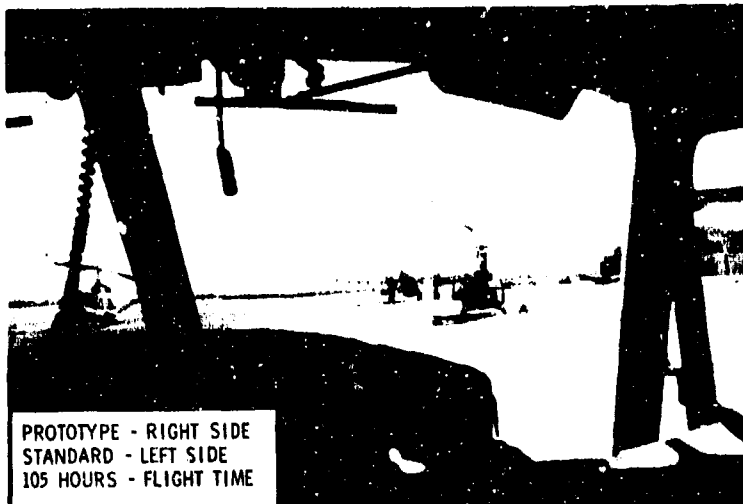
General comments made by the flight test pilots of each of these windshields stated although the distortion was small and in a usually noncritical portion of the windshield (see Figure 5), it caused some eye strain and some orientation difficulties. Other pilots' comments noted the parallax error (due to differences in right-hand and left-hand windshield thicknesses) as a visual annoyance. This could not be resolved within the scope of the program as it would require glass/plastic windshields in both left- and right-hand configurations but would not be a problem in production windshields.

Figure 5. Prototype windshield SN-5, 105 flight hours.
 19-066-1728/AMC-75

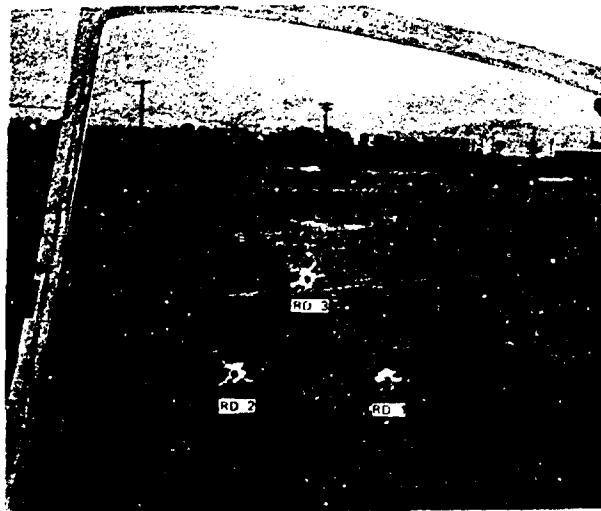
a. UH-1 standard acrylic windshield.

2. Standard acrylic windshield. The acrylic windshield fractures locally at the impact site. A wide variety of particle sizes is removed and widely dispersed. The acrylic particles are sharp edged and potentially dangerous. The extreme dispersion of the particles caused some of them to miss the witness sheet. None of the particles which struck the witness sheet resulted in a potentially lethal perforation.

The combined factors of quantity, dispersion, and cutting nature of the spall from the acrylic windshield are very unfavorable. The use of helmet visors by the aircrew would add significant eye protection against this type of spall. The

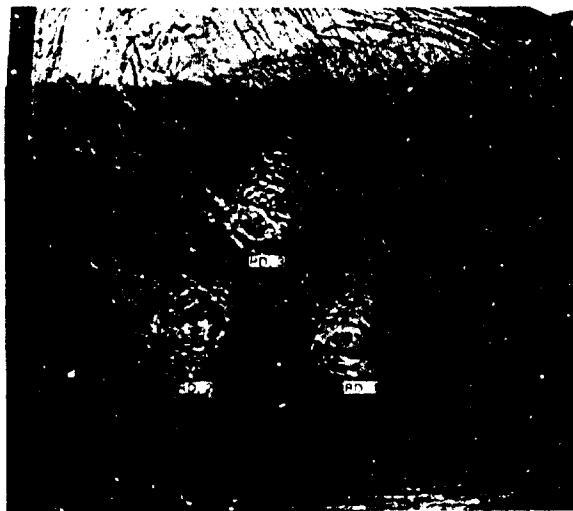
c. UH-1 Chemcor-plastic windshield.

1. Chemcor-plastic composite windshield. The ballistic penetration of this windshield generated many spall particles, a number of which had potentially lethal penetrating characteristics. These penetrating particles are probably both glass and bullet fragments.

The glass outer layer acts to partially break up the projectile. The glass particles and bullet fragments, both having relatively high density, comprise the most hazardous spall. The ductility of the plastic backing ply restricts the dispersion of the spall. The higher-density glass and bullet spall strike the witness sheet at nearly the same instant as the bullet.

This is followed by a cloud of slower, extremely fine particles consisting mostly of glass. The post-hit structural integrity and vision qualities of the windshield appear adequate.

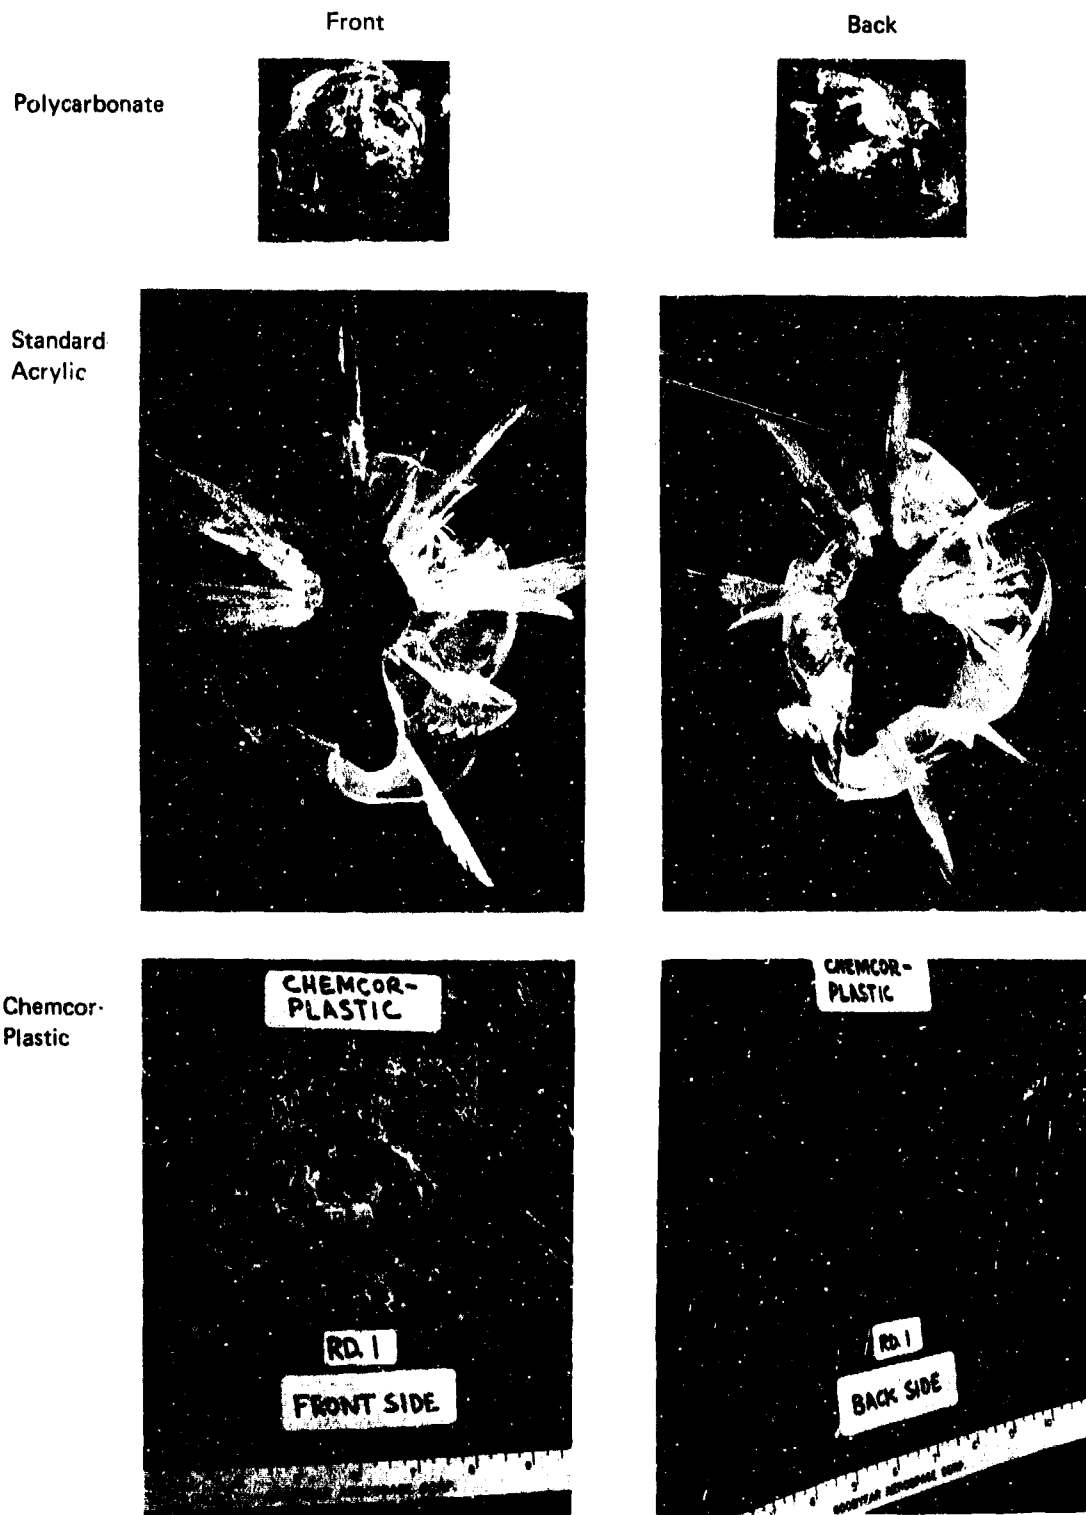
Additional details of the comparative material behavior are shown in the front and back-side closeup photographs, Figure 10. The witness sheets from each test are shown in Figure 11. Spall data reported for each test excluded the single perforation of the witness sheet caused by the bulk of the projectile.

Figure 10. Ballistic penetration of UH-1 windshields, front- and back-side details.

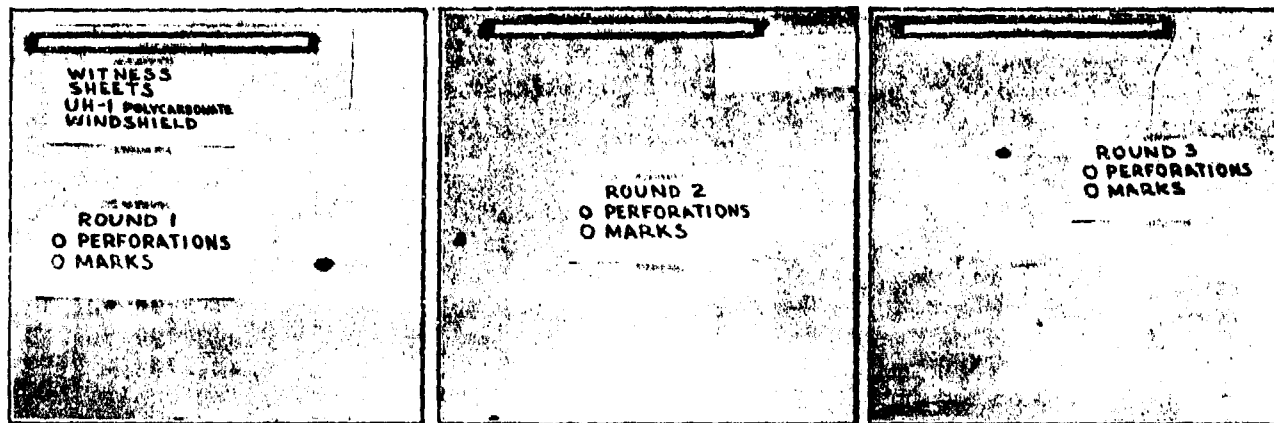
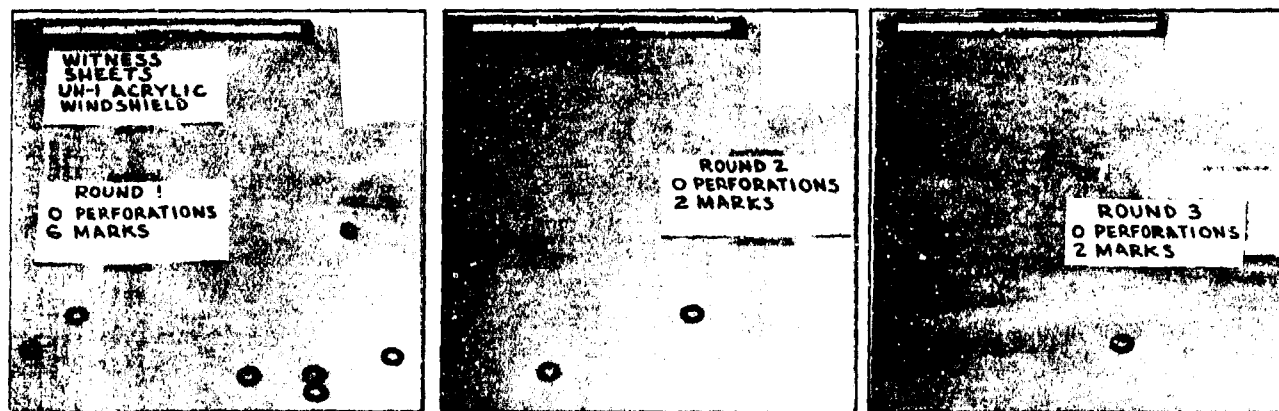
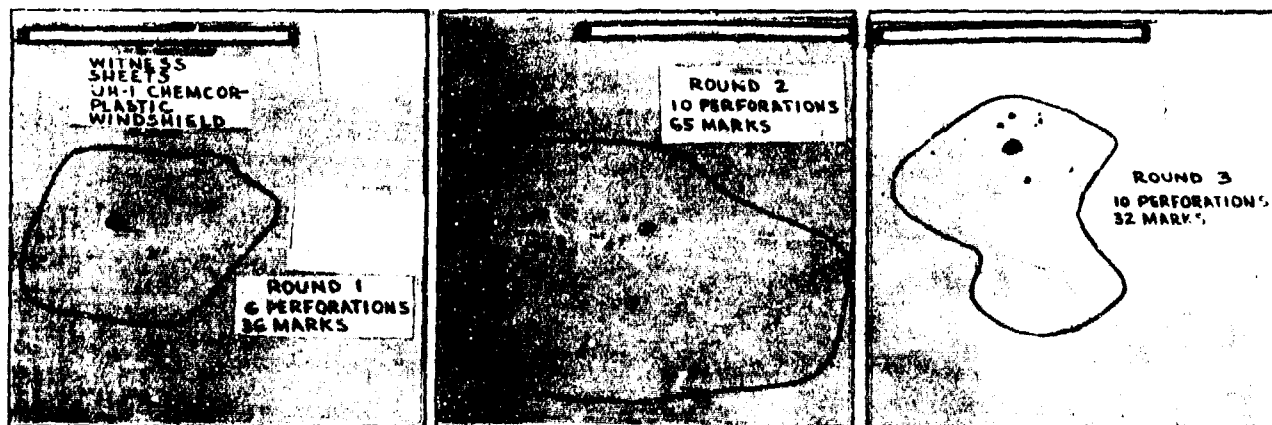
Figure 11. Ballistic spall witness sheets, post-test display.

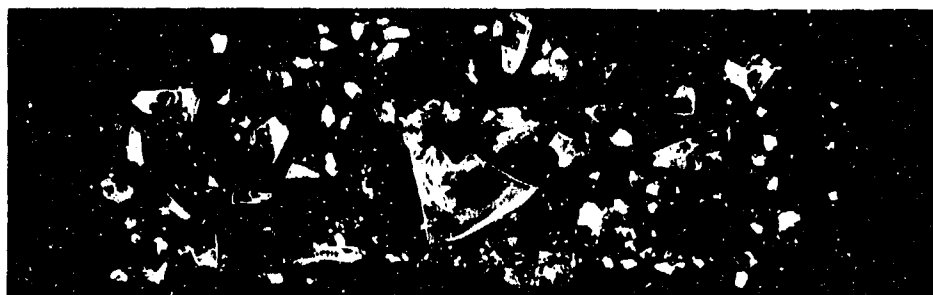
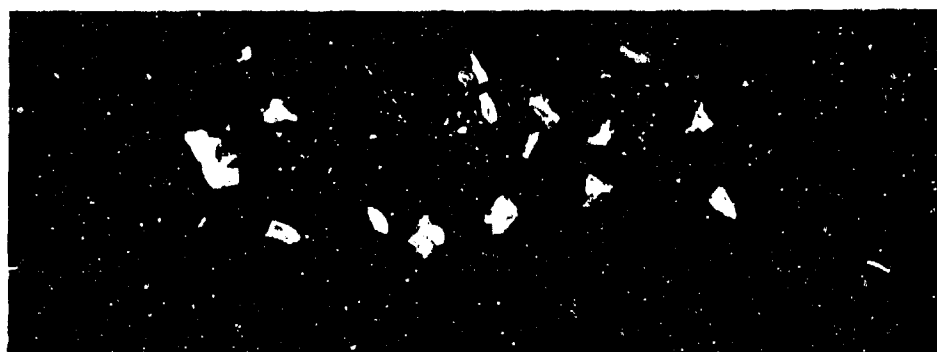
Typical back-side spall particles collected following one ballistic penetration of each type of windshield are illustrated in Figure 12. After both the physical evidence and photographic data collected were reviewed, the following summary of performance was prepared.

Figure 12. Typical ballistic spall particles, single penetration.

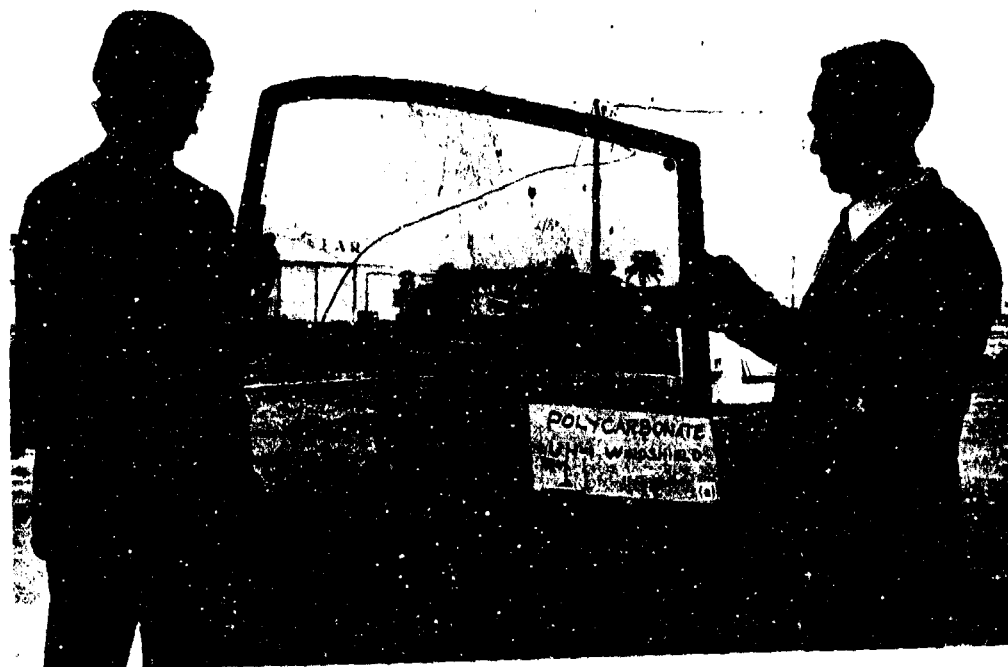
Windshield No. 1 was impacted at 114.5 knots with a four-pound bird. This impact resulted in a diagonal crack running from the upper right-hand corner to the lower left-hand edge of the windshield when viewed from the front (see Figure 15a). The bird bounced into the air, and there was no debris in back of the windshield.

Upon close examination of the part, it was noticed that the aircraft structure had bent directly above the spot where the crack terminated. The movies taken confirm the crack initiated in the center of the windshield. The fuselage was bent out into the proper position and readied for the next test.

Monolithic polycarbonate windshield No. 2 was then installed and impacted in the same manner. The impact velocity was 120.8 knots. This impact resulted in several cracks forming and the loss of two pieces of polycarbonate, one in

Figure 15. Bird-impacted UH-1 polycarbonate windshields.

each upper corner of the windshield. The two pieces fell outboard away from the fuselage. A break in the polycarbonate occurred along the upper edge attachment. This edge break permitted the remaining polycarbonate to flex inboard and allowed the bird to deflect upward into the pilot's compartment. The bird hit the top of the pressure box before falling to the floor. The center polycarbonate flexed back into position and was firmly held in place by the lower edge attachment (see Figure 15b). The fuselage again bent inward in the same upper inboard area, and the windshield cracks seemed to initiate from this area.

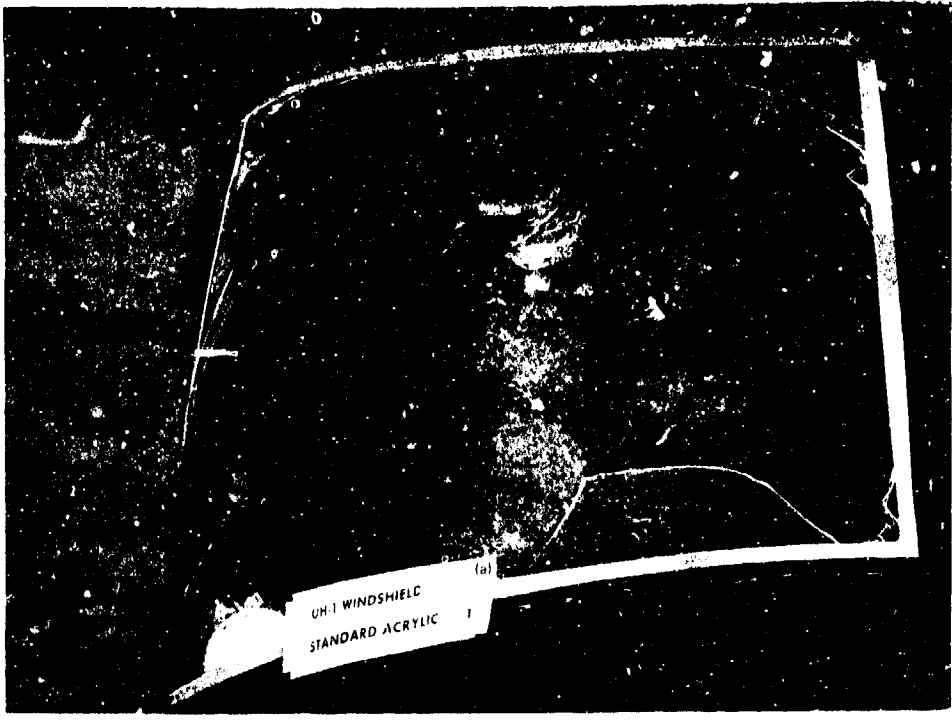
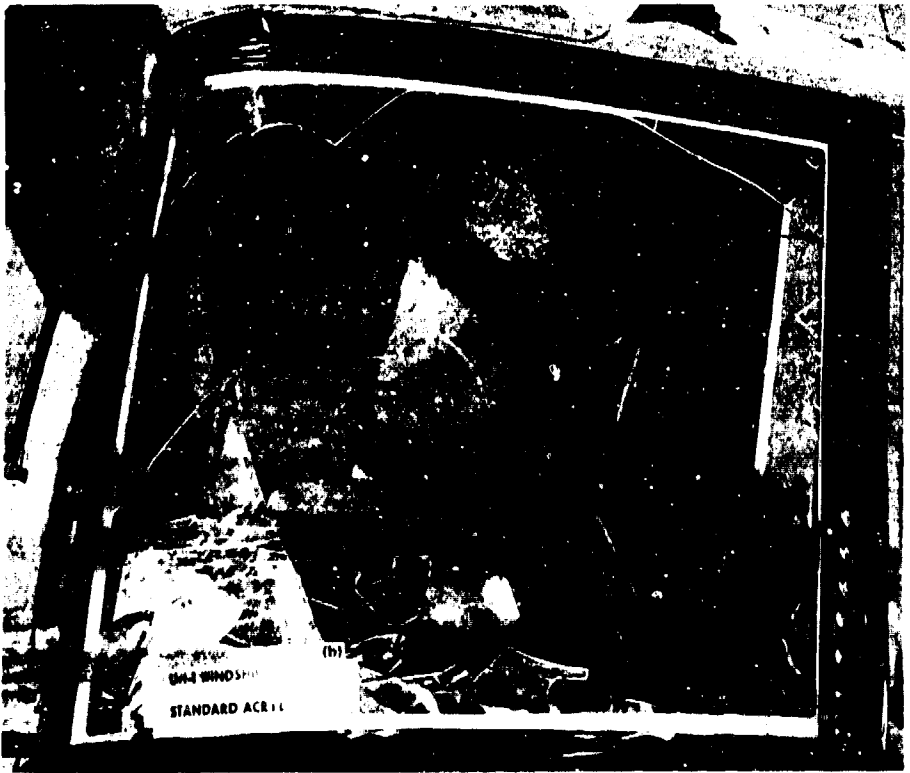
Standard acrylic windshield No. 1 was then mounted in the fuselage and was impacted with the four-pound bird traveling at 121.9 knots. The bird penetrated the windshield and hit the back of the vacuum chamber. The Plexiglas broke out of the frame with only a few jagged fragments remaining along the edge (see Figure 16a). The fuselage was not damaged by the impact.

Because of the catastrophic failure mode of the first standard acrylic windshield, the second standard windshield was fired at 85.6 knots, which is nearer the cruising speed of the UH-1 aircraft. The bird also penetrated this windshield, breaking out nearly 80 percent of the acrylic (see Figure 16b).

Figure 16. Bird-impacted UH-1 standard acrylic windshields.

b. The standard acrylic windshield at both the cruising speed (90 knots) and the maximum speed of the UH-1 is incapable of defeating a bird strike. The as-cast Plexiglas breaks into large, sharp-edged fragments which could cause serious injury to the aircrew.
