CAP 747

Safety and Airspace Regulation Group

Mandatory Requirements for Airworthiness

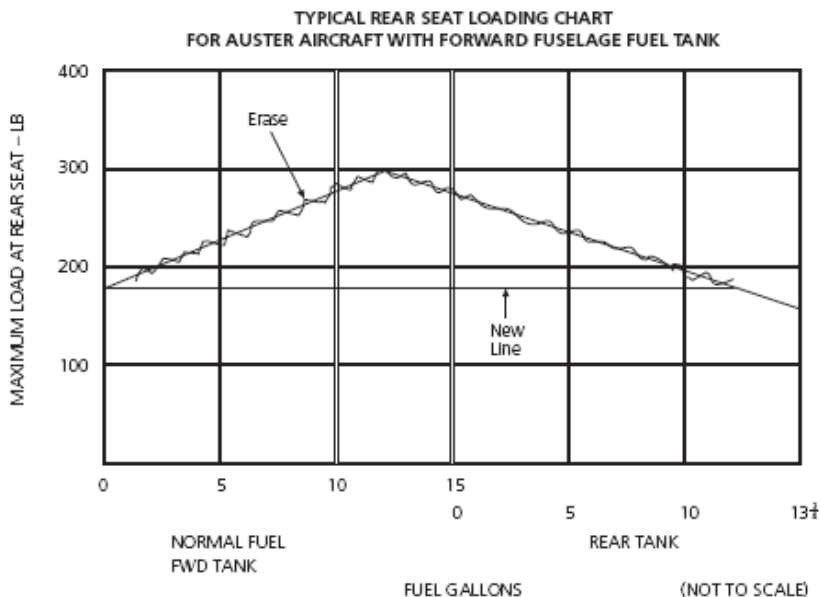
NOTE: The following sketch illustrates an amended loading chart. If the existing loading chart should differ significantly from this illustration, advice must be obtained from the CAA prior to amendment. This Directive hereby authorises the Operator to make an entry in the aircraft Log Book, quoting the AD number, and this entry must be made when the loading chart has been amended in accordance with these instructions.

(2) Erase all that part of the original loading limitation line, which lies above the new line (drawn in accordance with 1).
