**Comparison of the Chromium Distribution in New Super Koropon  
Primer to 30 Year Old Super Koropon Using Focused Ion  
Beam/Scanning Electron Microscopy**

Janice K. Lomness and Luz Marina Calle  
Corrosion Technology Laboratory  
NASA, Kennedy Space Center

Eric Eichinger  
Materials & Processes/Test & Evaluation  
Huntington Beach Development Center  
Huntington Beach Engineering

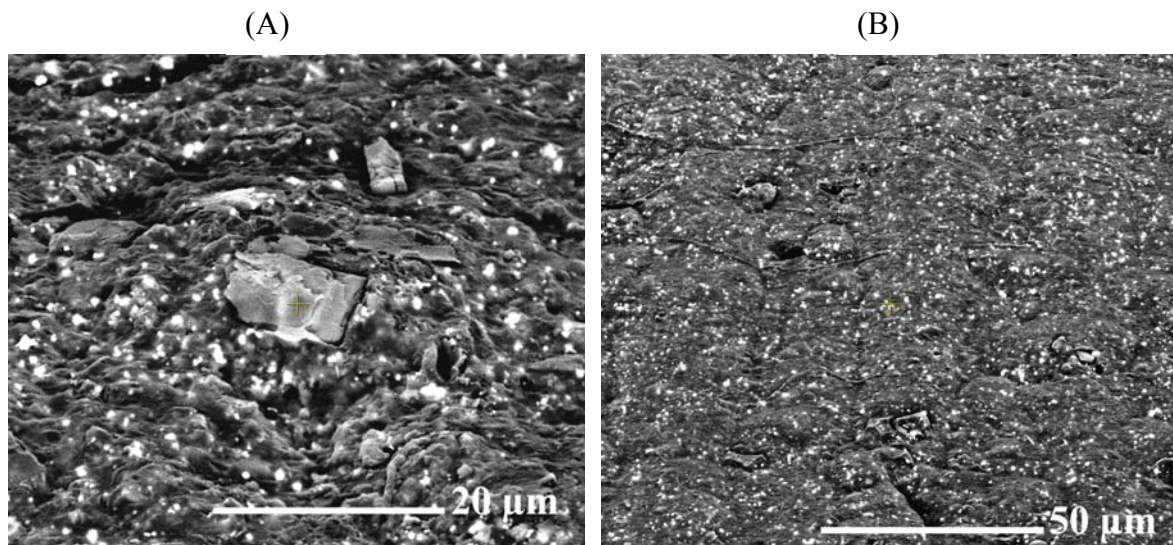
The SEM images of the surface of the Koropon sample from the Orbiter Enterprise and the control Koropon sample are shown in Figures 1(A) and 1(B), respectively. Even though the SEM image of the surface of the Enterprise sample is at a slightly higher magnification, the differences in the two surfaces are readily apparent. The surface of the Enterprise sample is very rough and “flakey” while the surface of the control sample appears to be much smoother. The chromium is very visible on both surfaces. The chromium appears as light “dots” on the surface of both samples. A higher magnification

Figure 1. (A) BSE-SEM image of the surface of the Koropon sample from the Orbiter Enterprise. (B) BSE-SEM image of the surface of the Koropon from the control sample.

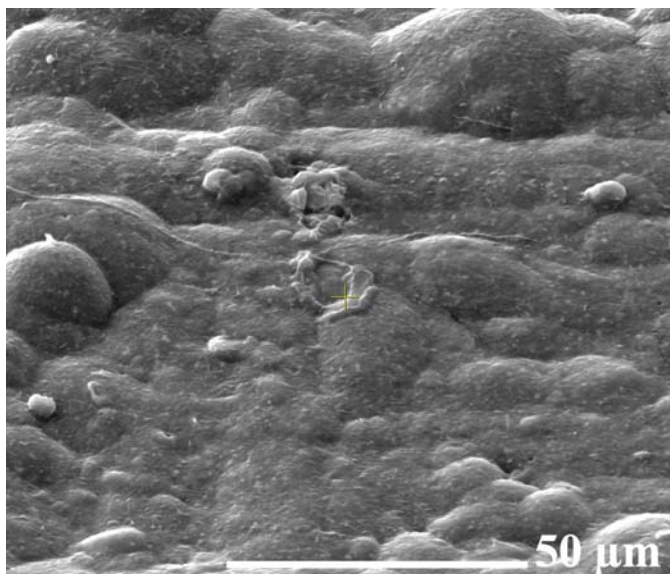
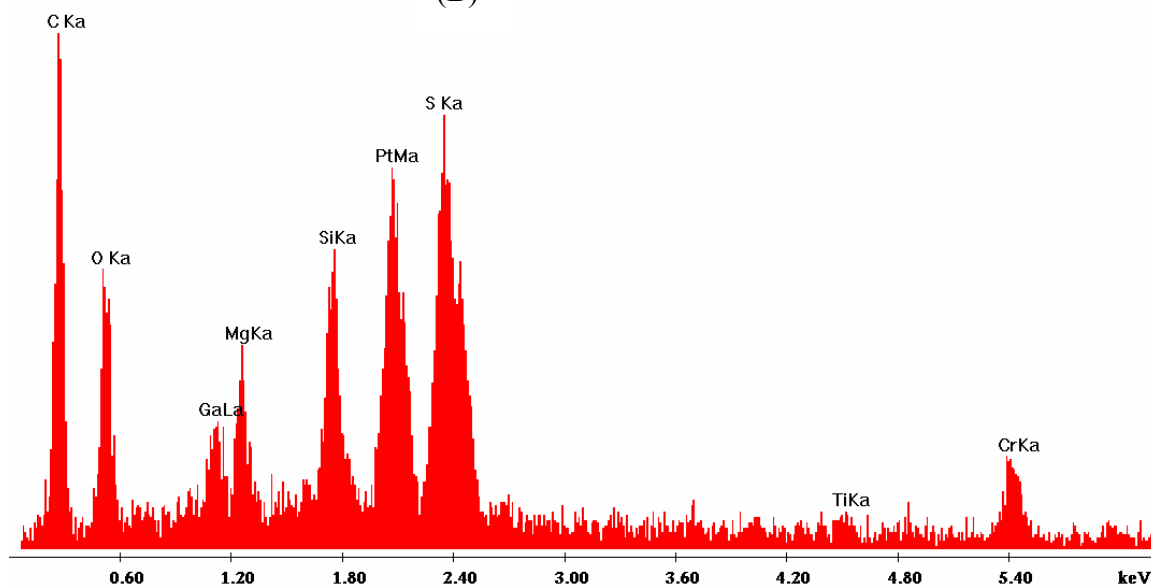
FIB image of the surface of the control Koropon sample is shown in Figure 2(A). The smooth surface can be seen in much greater detail in this image. A region containing chromium is also labeled in the image and the SEM/XEDS spectrum obtained from this region is shown in Figure 2(B). The platinum in the spectrum may be attributed to the platinum that was deposited on the surface to protect the region of interest from damage during the milling process. The gallium may be attributed to the gallium ion beam used to image in FIB mode and also used to mill the SEM trench cut. The titanium and oxygen in the spectrum may be attributed to the paint used to mount the sample. The sulfur, silicon, magnesium, and carbon may be attributed to the epoxy resin of the Koropon matrix.

Figure 2. (A) FIB image of a region of the surface on the control Koropon sample. (B) SEM/XEDS of the chromium region of the surface of the control Koropon sample shown in (A).

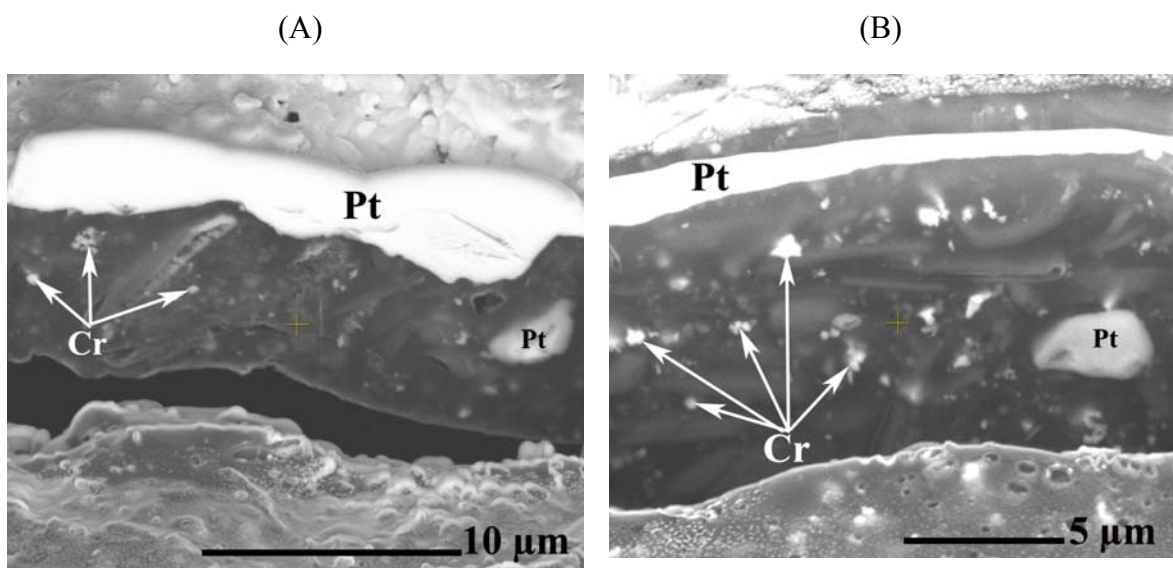
The cross-section BSE-SEM images for the Enterprise Koropon and the control Koropon films are shown in Figure 3(A) and 3(B), respectively. The platinum pad that was deposited to protect the surface of the region of interest from the gallium ion beam during milling is labeled in both images. There was also a void (labeled Pt in the bulk matrix)

that filled with redeposited platinum during milling. Again, the chromium appears as light “dots” and/or very light regions in both images. There are some regions of chromium just beneath the surface that appears as light gray areas. The overall particle size distribution varies widely, however some of the chromium particles were larger than expected. This may be due to some particle agglomeration.

The SEM image of the Enterprise Koropon sample shows that there is a significantly reduced level of chromium in the coating in this region as compared to the new Koropon film. A region  $25\text{ }\mu\text{m} \times 8\text{ }\mu\text{m} \times 5\text{ }\mu\text{m}$  was milled (each slice was 162 nm thick) to determine the distribution of chromium over a selected area. SEM images were obtained after each slice. These SEM images show that the chromium appears to be poorly distributed within the film. In fact, there were areas of the old Koropon film that had even less chromium than was observed in Figure 3(A), while other areas had higher chromium content.

The control sample appeared to have a considerably increased quantity of chromium as compared to the Enterprise sample. The chromium in the control film also appeared to be more evenly distributed. Examples of the SEM-XEDS data obtained from the chromium regions of both samples are shown in Figure 4(A) and 4(B). The chromium K $\alpha$  energy for both Koropon samples can be observed at 5.414 keV in the spectra. Because the electron beam is large and the chromium regions are small, XEDS data from the surrounding matrix and platinum layer can be observed in the spectra.

Figure 3. (A) BSE-SEM image of the Enterprise Koropon sample showing the chromium distribution throughout the matrix in this region. (B) BSE-SEM image of the control Koropon sample showing the chromium distribution throughout the matrix in this region.

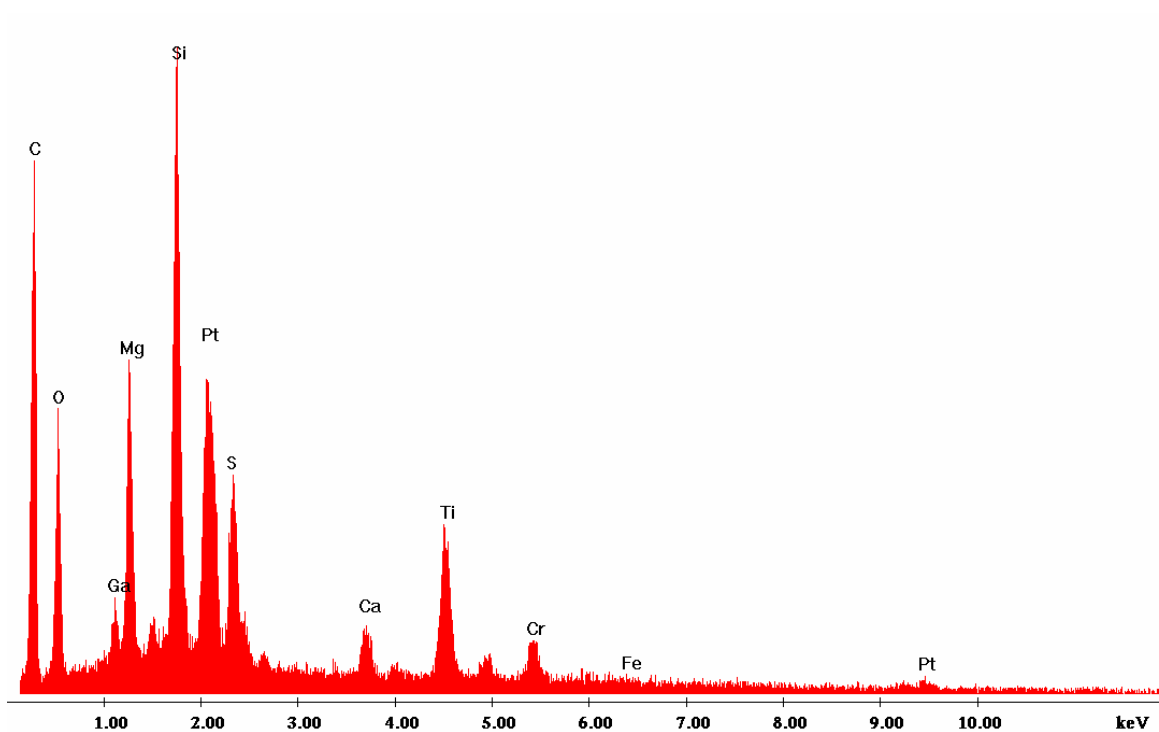
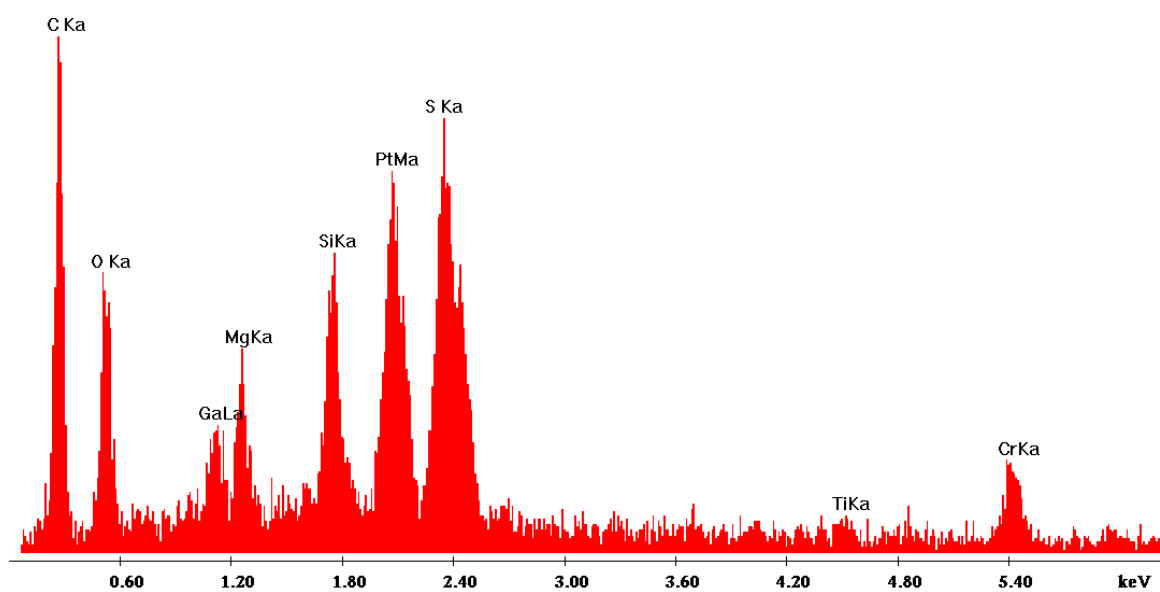
Figure 4. (A) SEM/XEDS Spectrum of the region denoted by the middle arrow in Figure 3(A). (B) SEM/XEDS Spectrum of the region denoted by the second arrow from the right in Figure 3(B).

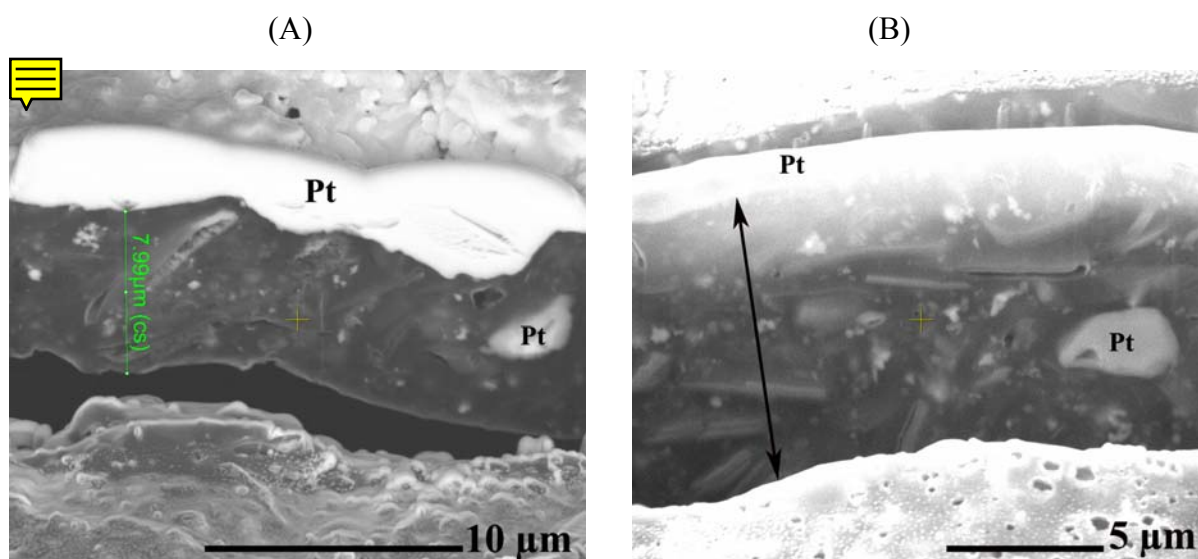
Another interesting observation was the difference in coating thickness. The Enterprise Koropon film, Figure 5(A), was approximately 8  $\mu\text{m}$  (0.000315 inches) thick where as the control Koropon coating, Figure 5(B), was more than 10.5  $\mu\text{m}$  (0.000413 inches) thick. Note that the sample was not cut all the way through. This measurement suggests that the old Koropon film was much too thin since the specified Koropon thickness is 0.0006 to 0.0009 inches). One possible explanation for this discrepancy is degradation of the polymer matrix of the Enterprise Koropon film as a result of aging and/or as a result of interaction with the stripper used to remove the coating from the panel. This is very plausible since the physical appearance of the Enterprise Koropon sample and the control Koropon sample differed. The old Koropon film was slightly darker in color and appeared to be more brittle than the control Koropon film.

Figure 5. (A) BSE SEM image of the cross-section of the Enterprise Koropon sample used for the measurement of the thickness of the film. (B) SEM image of the cross-section of the control Koropon sample used for measurement of film thickness. (Note that the measurement bar would not save on this image. The location of the thickness measurement is denoted by the arrow).

The inconsistency in the thickness of the coating of the Enterprise Koropon and the specified Koropon thickness may be due to degradation of the polymer as a result of aging and/or the degradation as a result of chemical interaction between the polymer and stripper used to remove the coating from the access panel.
