REPORT 1363

ORIGIN AND PREVENTION OF CRASH FIRES IN TURBOJET AIRCRAFT ¹

By I. IRVING PINKEL, SOLOMON WEISS, G. MERRITT PRESTON, and GERARD J. PESMAN

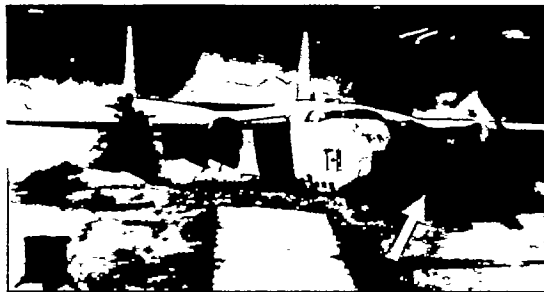
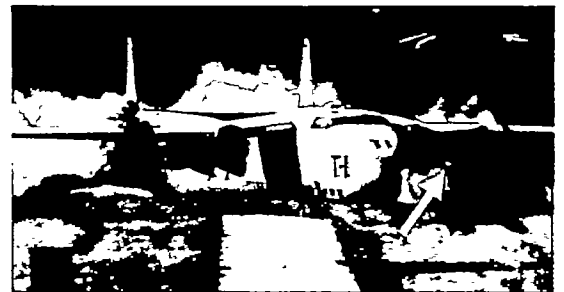
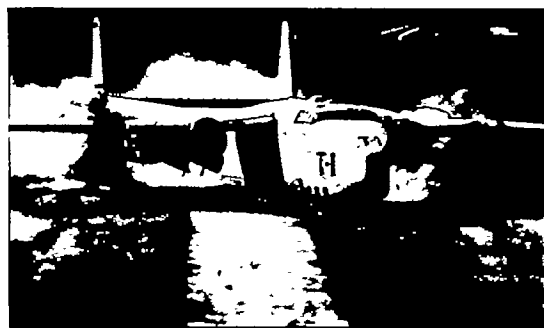
FIGURE 2.—Development of crash fire in simulated jet bomber.

(a) Airplane contacting barrier.

(b) Fuel-mist cloud, 0.8 second after initial impact.

(c) Fuel mist entering left engine, 2.5 seconds after initial impact.

(d) Fire at engine inlet and tailpipe of left engine, 2.6 seconds after initial impact.

(e) Fire spread to fuel mist issuing from left wing, 2.8 seconds after initial impact.

(f) Spread of fire, 4.0 seconds after initial impact.

Flames originating within the engine may also appear at the engine inlet as observed in figure 2(d). The appearance of this inlet flame may be explained in the following way. Burning of ingested fuel in the combustor flame reduces the turbine-inlet gas density. A higher pressure in the combustor is required to pass the gas through the turbine. When an abrupt change in over-all combustor fuel-air ratio is provided by the ingested fuel, the pressure in the combustor required to pass the combustor gas through the turbine may exceed the capability of the compressor at the existing rotor speed. The compressor flow may stall before the turbine can accelerate the rotor to a speed that will provide the necessary pressure. At this moment the combustor flame may propagate upstream through the ingested combustible mixture that fills the stalled compressor and exit at the engine inlet.

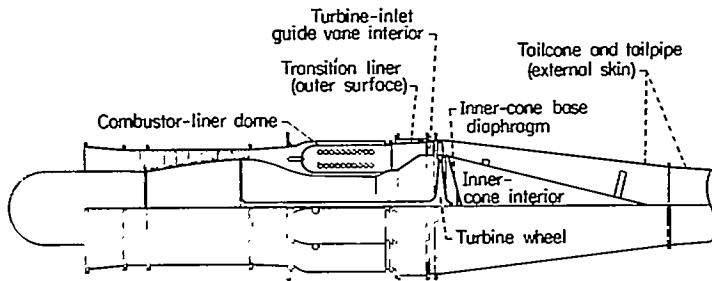
FIGURE 11.—Hot-metal ignition sources found in J35 engine.

The ignition zones were identified in test-stand engines by the method discussed in detail in appendix C. The technique employed involved the use of fuel sprays local to the engine zone suspected as an ignition source. Following engine operation at rated conditions for a time sufficient to establish temperature equilibrium, the fuel flow to the combustor was turned off and the fuel spray was turned on local to the zone under study. The fuel flow was programmed to maintain a combustible atmosphere in the zone. If ignition occurred, inerting means were installed to prevent the ignition in subsequent tests of upstream zones. By starting at the downstream end of the engine and proceeding upstream in this way, each ignition zone was identified and inerted in turn. As a final check after all the zones were inerted, fuel was injected into the main gas stream to determine whether ignition would occur. In this manner, ignition zones were found on the combustor liner, transition liner, turbine, inner cone, and tailcone and tailpipe (fig. 11).

Combustor liner: The ignition zone found on the combustor liner was the dome, which lies close to the primary

combustion zone. The metal adjacent to the dome is heated by the combustor flame and attains unsafe temperatures in spite of the cooling provided by the adjacent air. Also, in this region the engine air is caused to recirculate by design to provide a zone of low transitional speed and promote good combustion. Both the hot metal of the combustor liner adjacent to the dome and the residual flames previously discussed make this zone particularly hazardous. The size of this zone is difficult to define, since it depends on the air temperature at the compressor outlet, the combustor design, and the ignition characteristics of the combustibles sucked into the engine.

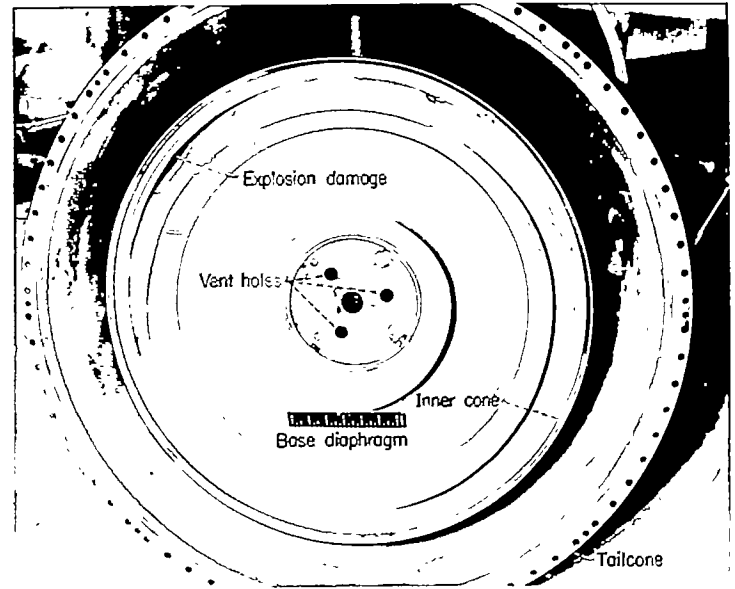
FIGURE 12.—J35 Inner-cone base diaphragm.

Inner cone: Combustible atmospheres delivered to the turbine wheel from the compressor can enter the interior of the inner cone through vent holes. In some engines these vent holes are located at the base of the tailcone as shown

in figure 12. The plane of the inner-cone base is parallel to the turbine wheel. Combustibles entering the cone could ignite on the hot walls of its quiescent interior. The slight damage to the base diaphragm, indicated in the figure, followed ignition in the interior. The resulting flame might ignite the combustible atmosphere streaming through the engine to produce the dangerous flames at the engine inlet and tailpipe shown in figure 13.

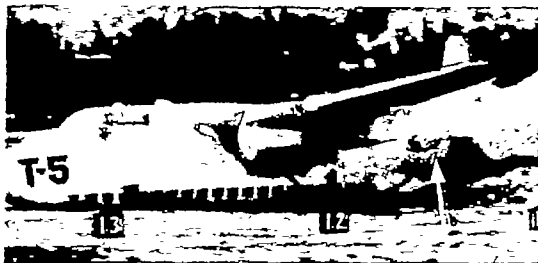
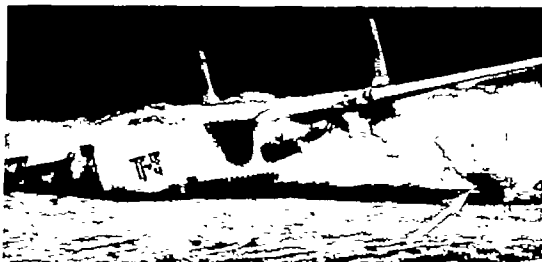
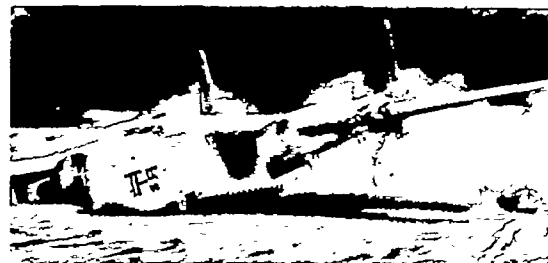
FIGURE 24.—Separation of J47 engine from C-82 wing in crash.

wake of the damaged wing (figs. 24(b) and (c)) and came to rest in the fuel-wetted slide path of the airplane (fig. 24(d)). The plume of condensed water vapor at the tailpipe (fig. 24(b)) shows that the water inerting system was actuated. No fire occurred.

(a) 1.3 Seconds after initial impact.

(b) 1.8 Seconds after initial impact.

(c) 3.1 Seconds after initial impact.

(d) 4.4 Seconds after initial impact.

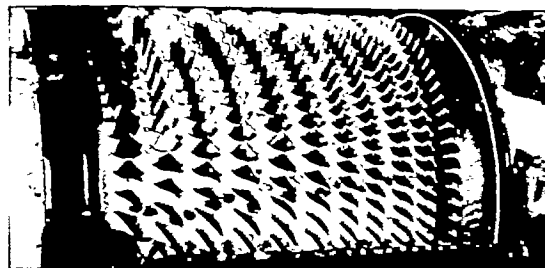
The sequence of events following crash was the same for the F-84 as for the cargo airplanes. Poles at the crash barrier ripped open the wing fuel tanks and produced the fuel mist shown in figure 25(a). Collapse of the nose gear allowed fuel from the torn forward fuselage tank to enter the engine inlet. Vapor issuing from the tailpipe (fig. 25(b)) was provided in part by the fuel that passed through the engine from the damaged fuel tank adjacent to the engine inlet. Evaporation of water from the fire protection system contributed a large part of the vapors formed (fig. 25(b)). Inspection of the engine after crash showed the telltale dye stains left by the red-dyed fuel flowing through the compressor (fig. 26). No fire occurred.

FIGURE 26.—Fuel-dye stains on J35-engine compressor following F-84 crash.
