NACA TN 3190

TECHNICAL NOTE 3190

FATIGUE INVESTIGATION OF FULL-SCALE  
TRANSPORT-AIRPLANE WINGS

SUMMARY OF CONSTANT-AMPLITUDE TESTS THROUGH 1953

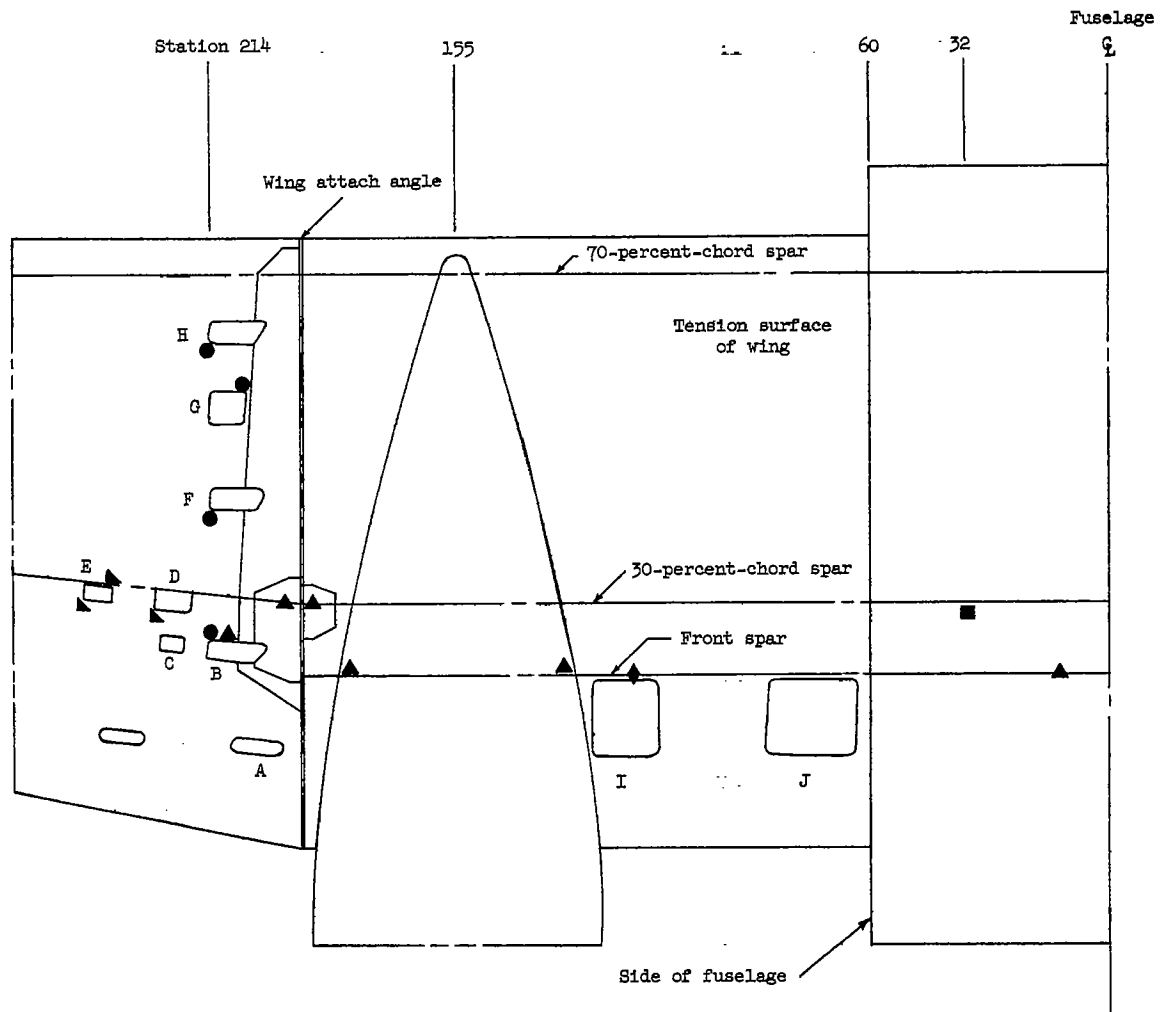
Figure 5.- Locations and types of fatigue failures.

The five types and their locations are shown in the plan view of the tension surface in figure 5, and are illustrated in figures 6 and 7. Most of these types of failures occurred in stress raisers which would be present in similar form on almost any metal aircraft structure.

- Type I Failures originating at the corners of inspection cutouts
- Type II Failures originating in riveted tension joints
- ◆ Type III Failures originating in riveted shear joints
- ▲ Type IV Failures originating in inspection cutout reinforcements
- ▲ Type V Failures originating in miscellaneous discontinuities

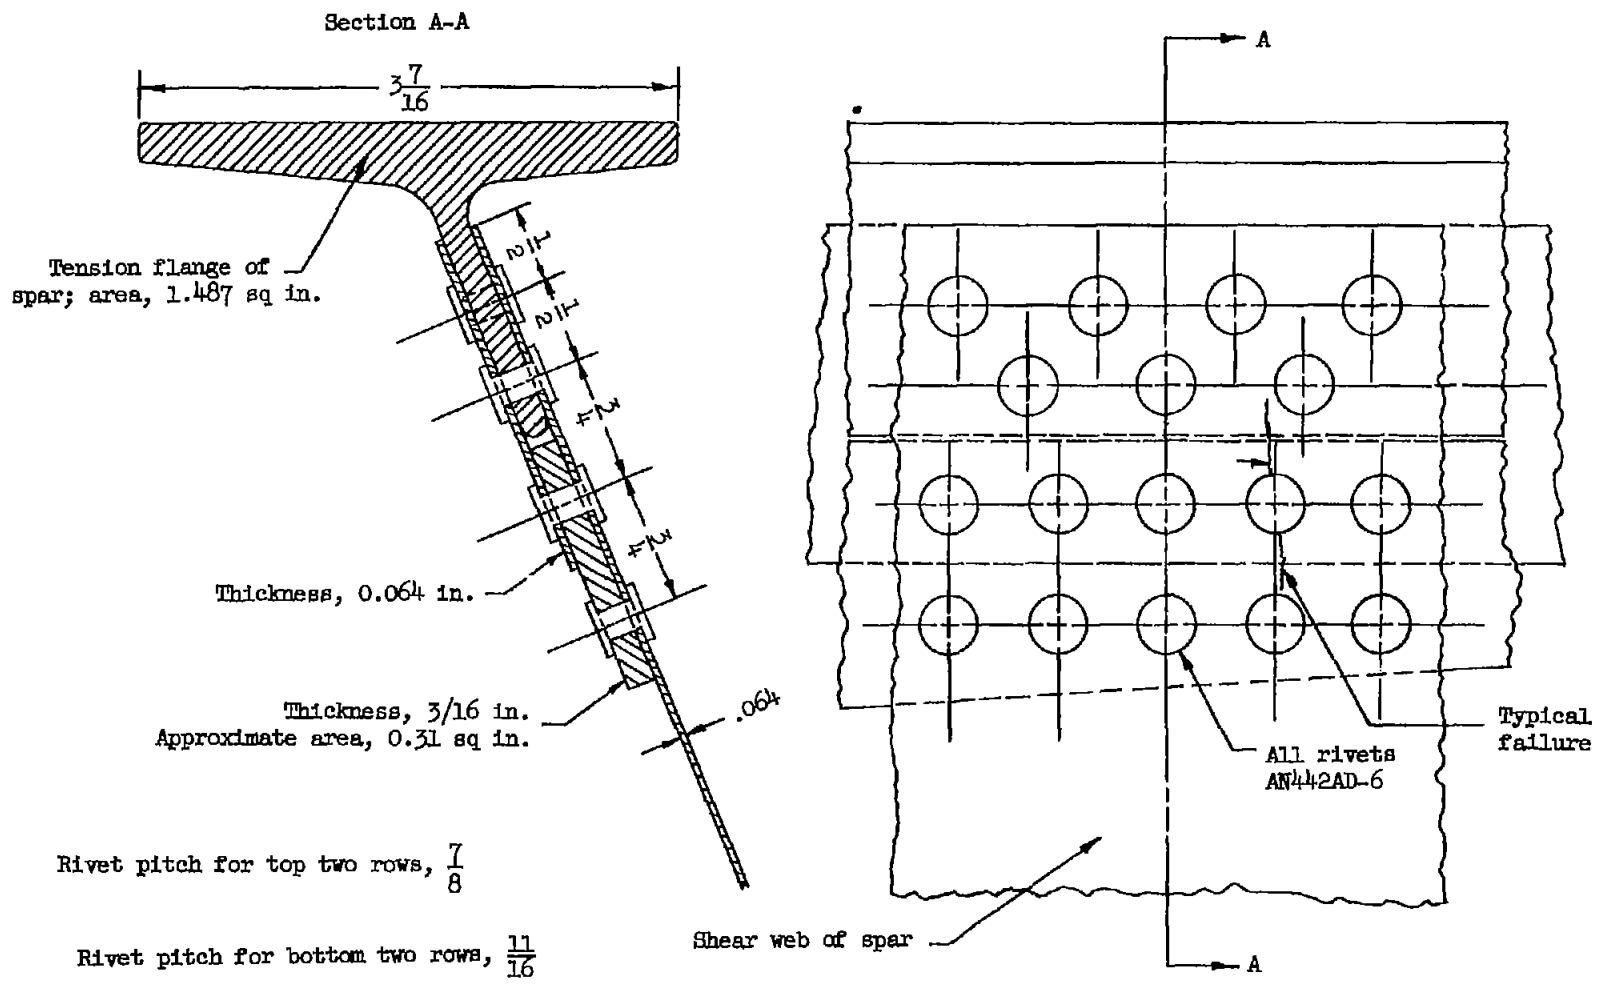
The type III failures occurred at span station 120 in the riveted joint connecting the shear web to the tension flange of the front spar. Since this location was very difficult to photograph, a drawing of the details of this joint is shown in figure 7. The cracks usually progressed vertically through the shear web and were accompanied by a crack in a small piece of skin over the spar cap.

Figure 7.- Details of riveted shear joint at span station 120 in which type III failures occurred.

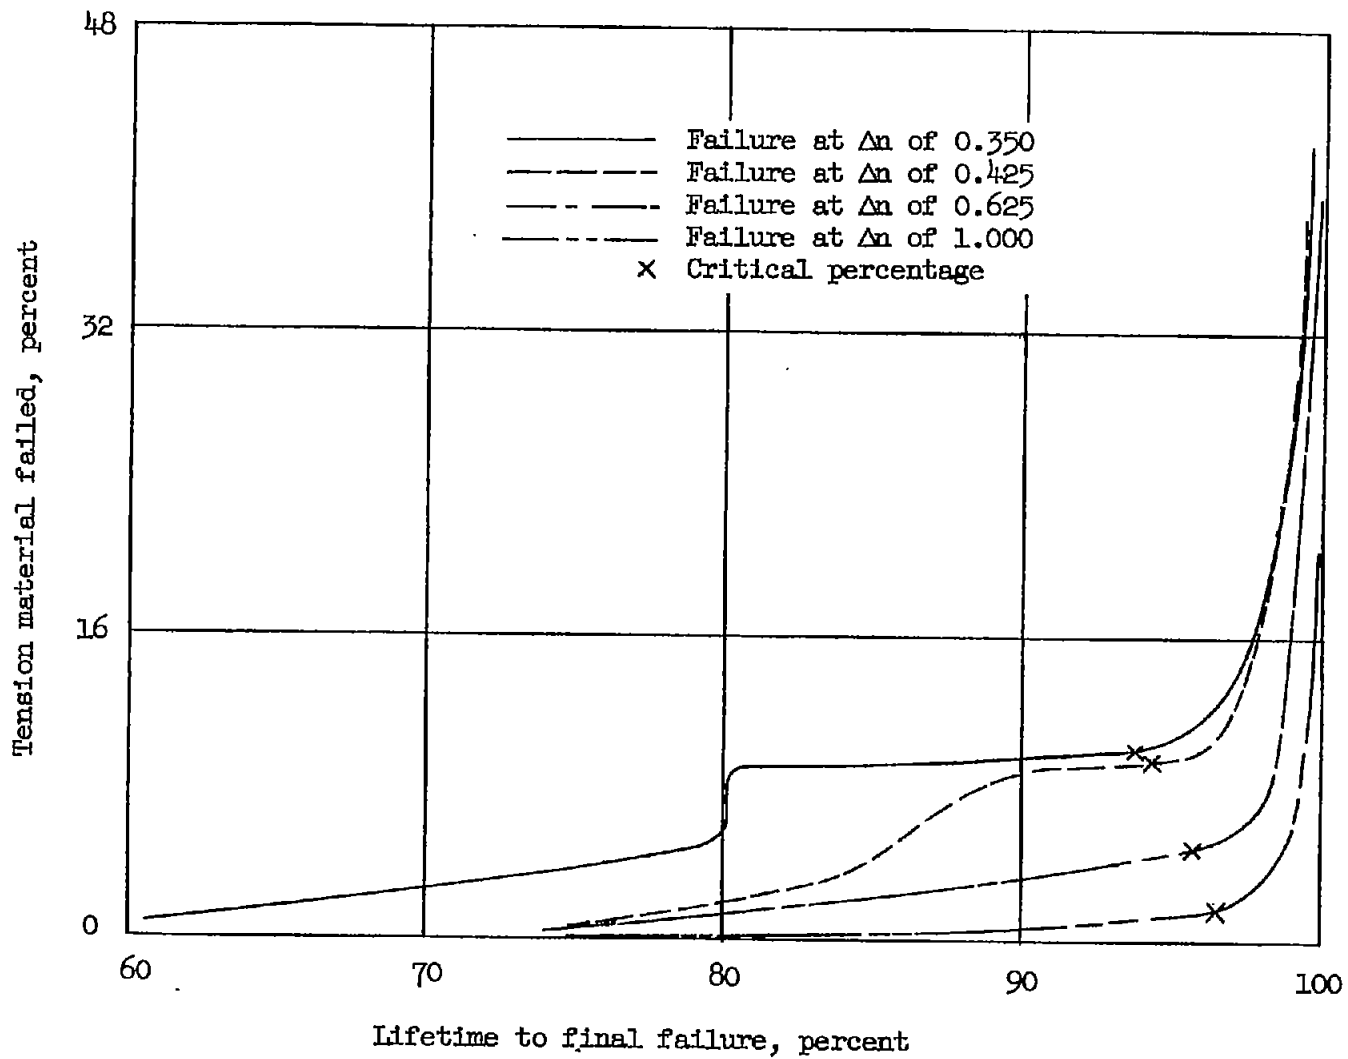
The growth of all fatigue cracks was observed during the course of the tests. In figure 11 the growth of typical failures is plotted for each of the test levels. In order to put all failures on the same comparative basis, the percentage of tension material failed in a cross section of the wing is plotted against the percentage of lifetime to final failure. In this figure it can be noted that all of the curves have the same general shape. In each case the failure grew slowly until a certain percentage of the tension material had failed. At this point, defined as the critical point, the growth of the cracks became very rapid. The percentage of tension material that had failed at the critical point decreased with increasing load level. For the 0.35g level the amount of tension material that had failed at the critical point was about 10 percent; for the 0.425g level, about 9 percent; for the 0.625g level, about 6 percent; and for the 1.0g level, about 2 percent. This critical point occurred at about 95 percent of the lifetime to final failure for all test levels. Tests of all specimens were continued until the critical point had been determined.

The propagation curves for the tests at the higher load levels were smooth and regular while the curves for the lower load levels had a tendency to be somewhat irregular. Stiffeners in the wing caused the crack growth to be temporarily retarded at the lower load levels, whereas the crack growth was not retarded by stiffeners at the higher load levels.

It can be seen from this figure that as much as 25 to 40 percent of the final lifetime remains after the inception of the fatigue failure. This situation might indicate that considerable time would exist in a service airplane of similar construction in which to detect and repair a fatigue crack before the failure reached serious proportions. It should be emphasized, however, that the data presented were obtained from constant-amplitude tests and are not necessarily representative of the propagation of a crack under variable-amplitude service loadings.

Figure 11.- Typical fatigue-crack propagation.

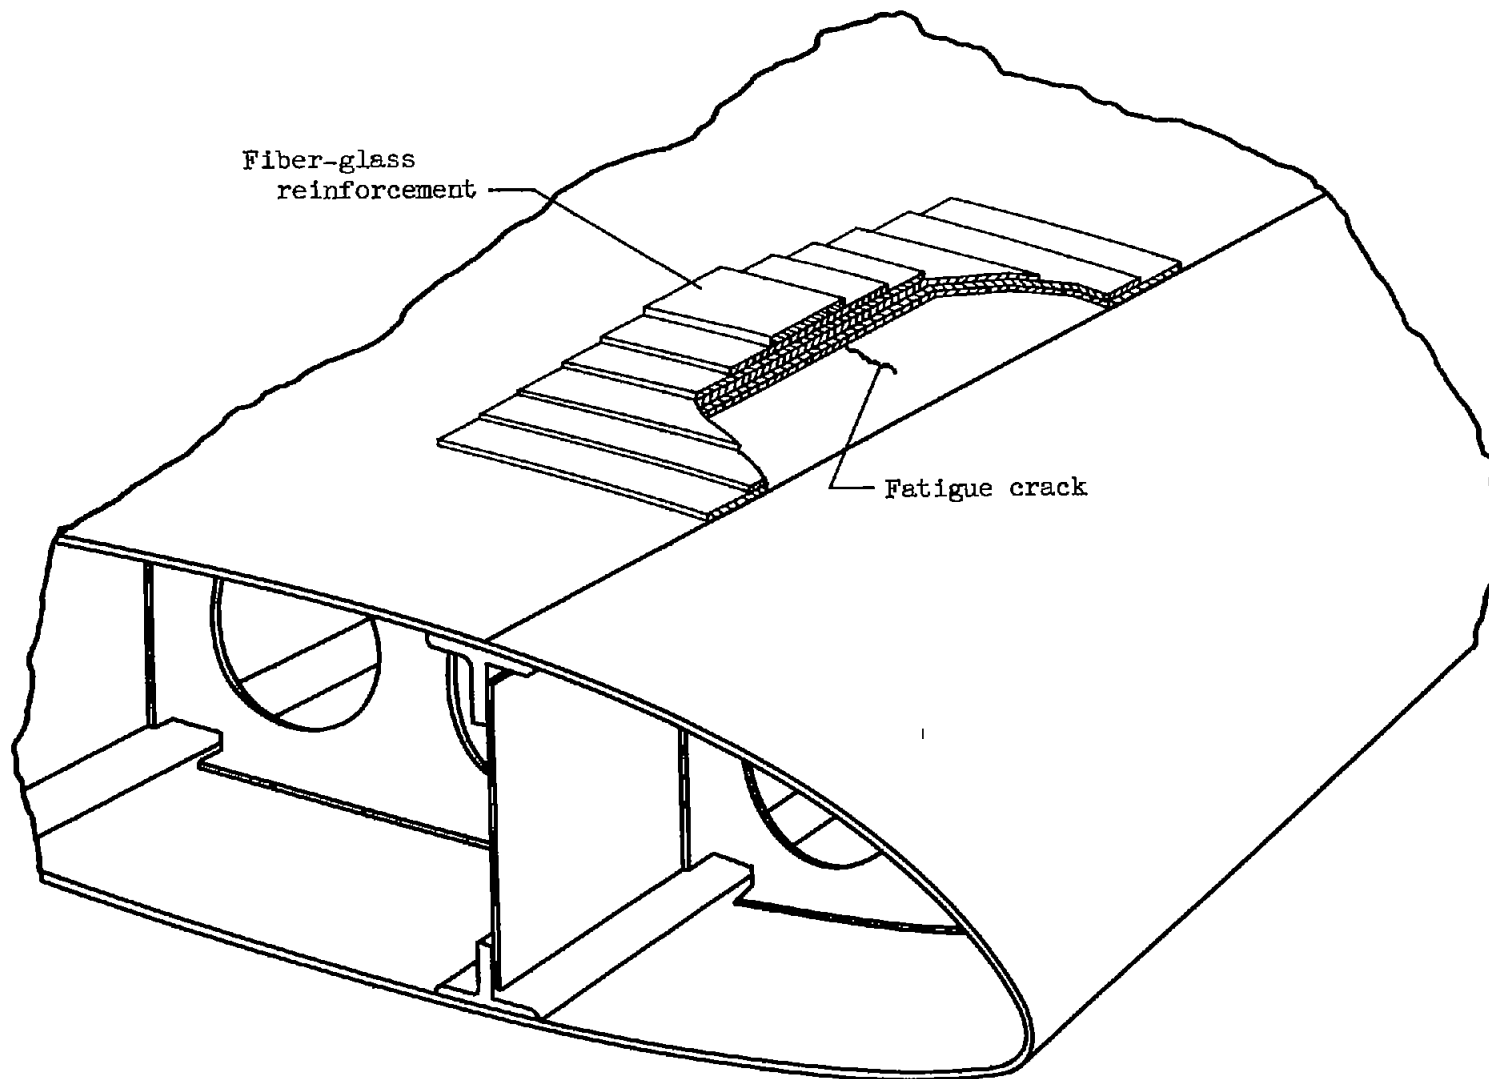
Figure 16.- Typical arrangement of fiber-glass reinforcement.

All fatigue cracks which were repaired by this method extended in essentially a chordwise direction on the tension surface of the wing. The patches were therefore designed principally to carry tension loads in a spanwise direction. For these fatigue tests the tension surface of the wing was the upper surface since the wing was mounted in the inverted position. The size of the patch required for satisfactory reinforcement naturally depended to some extent on the size of the fatigue crack to be repaired. The length and width of the reinforcement were determined by a generous estimation of the bond area necessary to secure adequate transfer of load from the wing structure to the fiber-glass reinforcement. Since the modulus of elasticity of the reinforcing material was considerably less than that of the aluminum wing structure, the thickness of reinforcement used was about five times the thickness of the structure to be repaired, so that both had about the same stiffness. All reinforcements were laminated from 10 to 16 layers of fiber-glass cloth arranged in a tapering stack which reached its maximum or design thickness over the fatigue crack. This arrangement is shown schematically in figure 16.
