TECHNICAL NOTE 3973

ORIGIN AND PREVENTION OF CRASH FIRES IN TURBOJET AIRCRAFT

By I. Irving Pinkel, Solomon Weiss, G. Merritt Preston,  
and Gerard J. Pesman

Lewis Flight Propulsion Laboratory  
Cleveland, Ohio

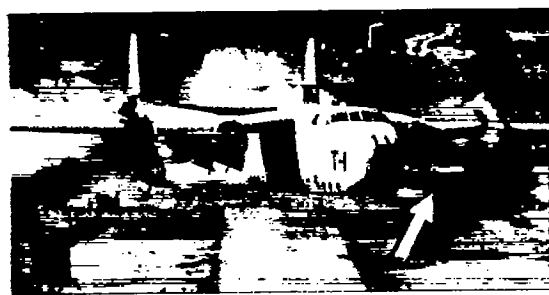
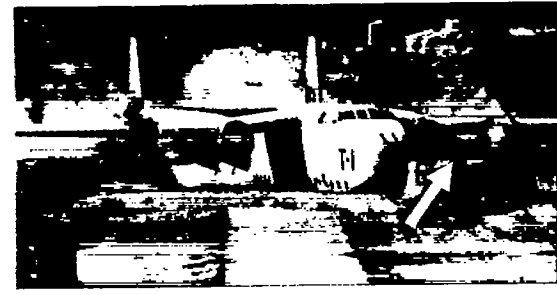
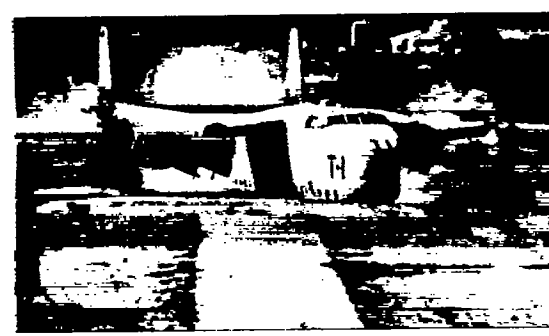
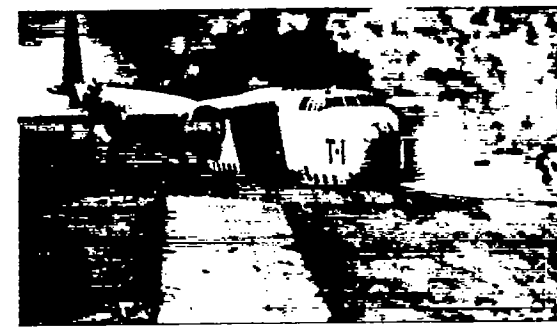
Figure 2. - Development of crash-fire in simulated jet bomber.

The appearance of the airplane as it struck the barrier is shown in figure 2(a). The cloud of fuel mist (liquid droplets suspended in air) that appeared when fuel spillage occurred while the airplane was in motion is evident at the breach in both wings (fig. 2(b)). Red dye in the fuel accounts for the bright color of the fuel cloud. As the crashed airplane slowed, the fuel mist moved forward of the wing and reached the air inlet on the left engine (fig. 2(c)). A strong cross wind swept the fuel mist away from the engine on the right wing.

Fuel mist ingested by the left engine was ignited somewhere within the engine. The ignited fuel mist produced the flames at the tailpipe and inlet shown in figure 2(d). These exposed engine flames ignited the fuel spilling from the wing (fig. 2(e)). The flame spread through this fuel to the wing to produce the stable fire shown in figure 2(f).

(a) Airplane contacting barrier.

(b) Fuel-mist cloud, 0.8 second after initial impact.

(c) Fuel mist entering left engine, 2.5 seconds after initial impact.

(d) Fire at engine inlet and tailpipe of left engine, 2.6 seconds after initial impact.

(e) Fire spread to fuel mist issuing from left wing, 2.8 seconds after initial impact.

(f) Spread of fire, 4.0 seconds after initial impact.

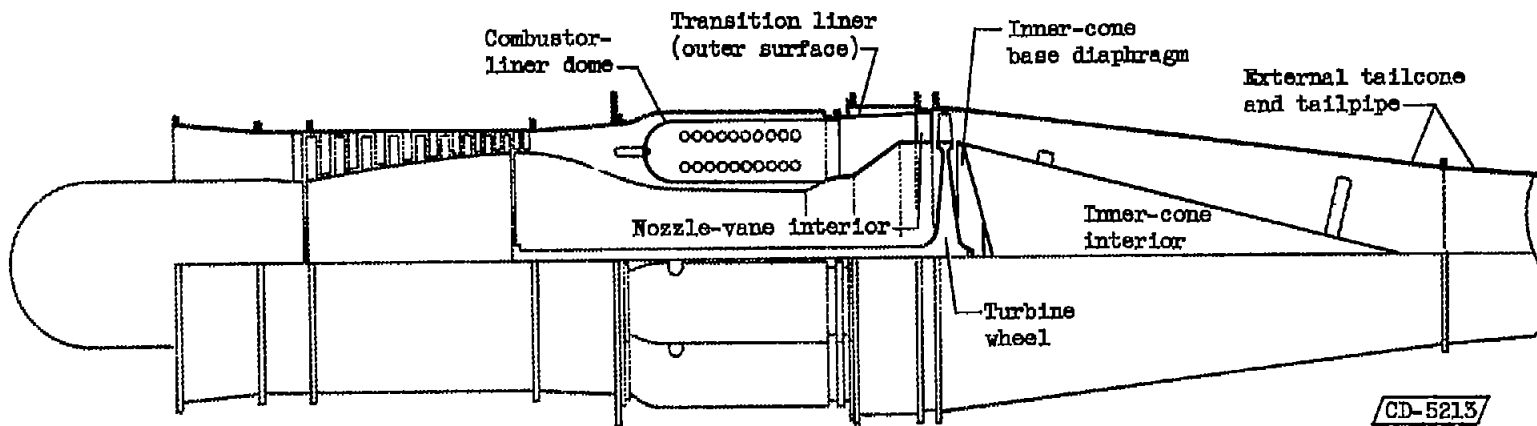
Figure 11. - Hot-metal ignition zones found in J35 engine.

The ignition zones were identified in test-stand engines by the method discussed in detail in appendix C. The technique employed involved the use of fuel sprays local to the engine zone suspected as an ignition source. Following engine operation at rated conditions for a time sufficient to establish temperature equilibrium, the fuel flow to the combustor was turned off and the fuel spray was turned on local to the zone under study. The fuel flow was programmed to maintain a combustible atmosphere in the zone. If ignition occurred, inerting means were installed to prevent the ignition in subsequent tests of upstream zones. By starting at the downstream end of the engine and proceeding upstream in this way, each ignition zone was identified and inerted in turn. As a final check after all the zones were inerted, fuel was injected into the main gas stream to determine whether ignition would occur. In this manner, ignition zones were found on the combustor liner, transition liner, turbine and inner-cone base diaphragm, and tailcone and tailpipe (fig. 11).

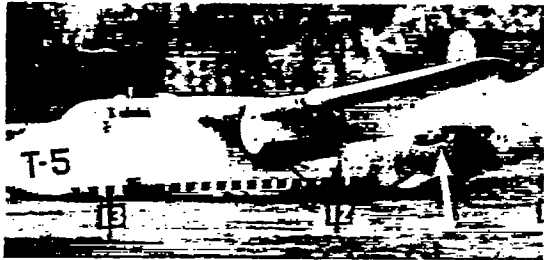
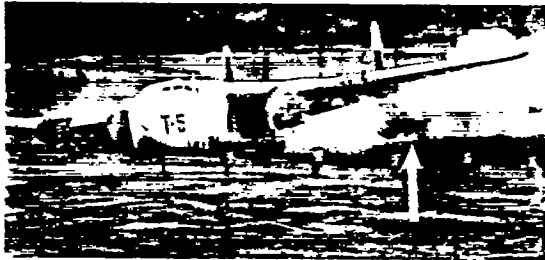
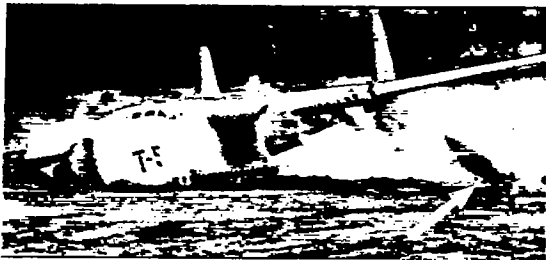
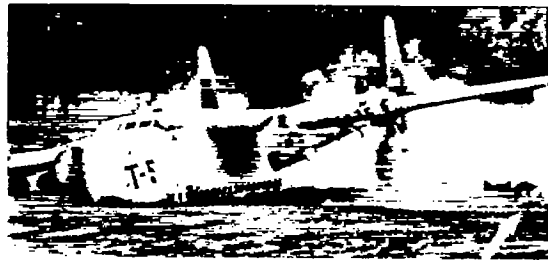
Figure 24. - Separation of J47 engine from C-82 wing in crash.

Separation of the engine from the wing is shown in the picture sequence of the crash in figure 24. After separation (fig. 24(a)) the engine tumbled in the fuel spraying into the wake of the damaged wing (figs. 24(b) and (c)) and came to rest in the fuel-wetted slide path of the airplane (fig. 24(d)). The plume of condensed water vapor at the tailpipe (fig. 24(a)) shows that the water inerting system was actuated. No fire occurred.

(a) 1.3 Seconds after initial impact.

(b) 1.8 Seconds after initial impact.

(c) 3.1 Seconds after initial impact.

(d) 4.4 Seconds after initial impact.

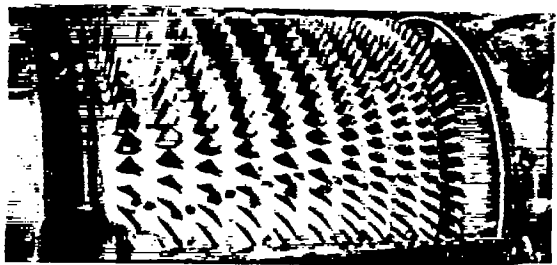
The sequence of events following crash were the same for the F-84 as for the cargo airplanes. Poles at the crash barrier ripped open the wing fuel tanks and produced the fuel mist shown in figure 25(a). Collapse of the nose gear allowed fuel from the torn forward fuselage tank to enter the engine inlet. Vapor issuing from the tailpipe (fig. 25(b)) was provided in part by the fuel that passed through the engine from the damaged fuel tank adjacent to the engine inlet. Evaporation of water from the fire protection system contributed a large part of the vapors formed (fig. 25(b)). Inspection of the engine after crash showed the telltale dye stains left by the red-dyed fuel flowing through the compressor (fig. 26). No fire occurred.

Figure 26. - Fuel-dye stains on J35-engine compressor following F-84 crash.
