NASA TECHNICAL NOTE

NASA TN D-7775

LIGHTNING DAMAGE TO A GENERAL AVIATION AIRCRAFT - DESCRIPTION AND ANALYSIS

by Paul T. Hacker
Lewis Research Center
Cleveland, Ohio 44135

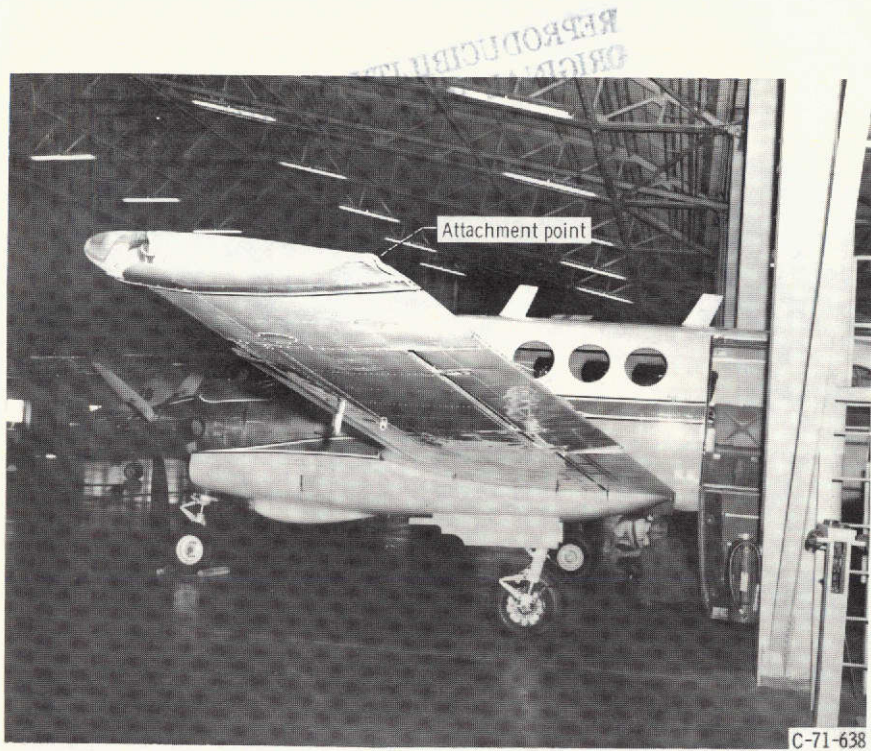
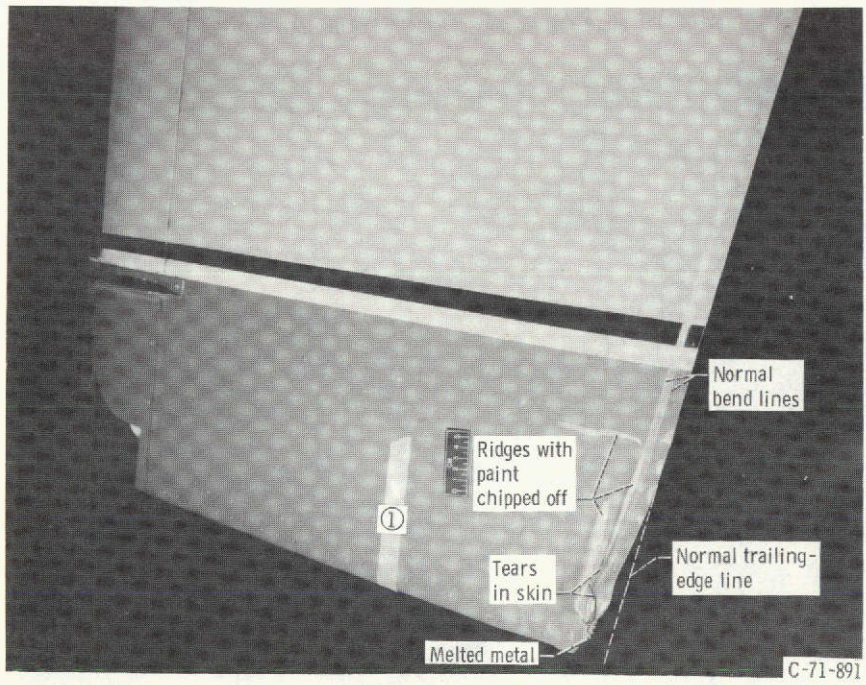
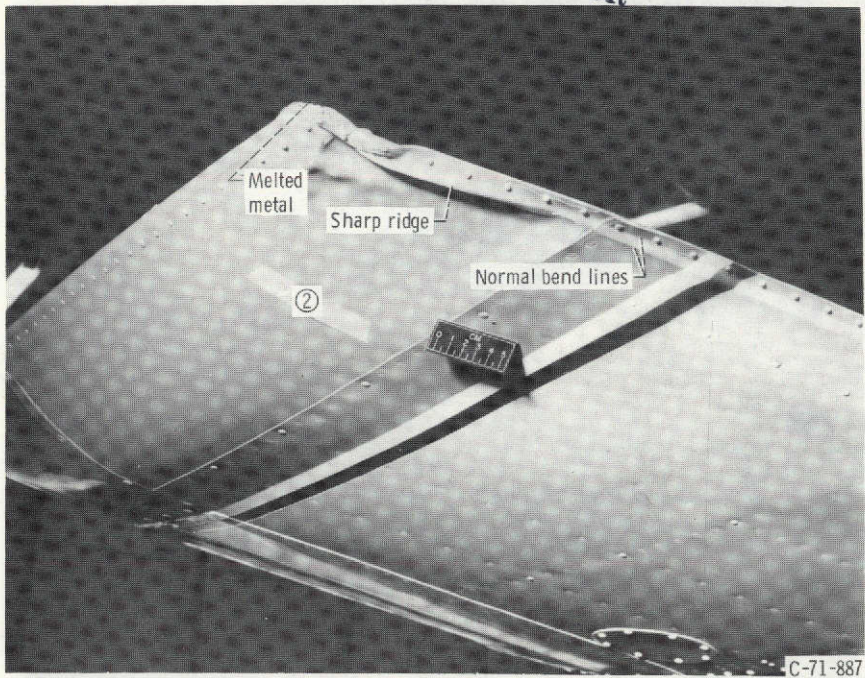
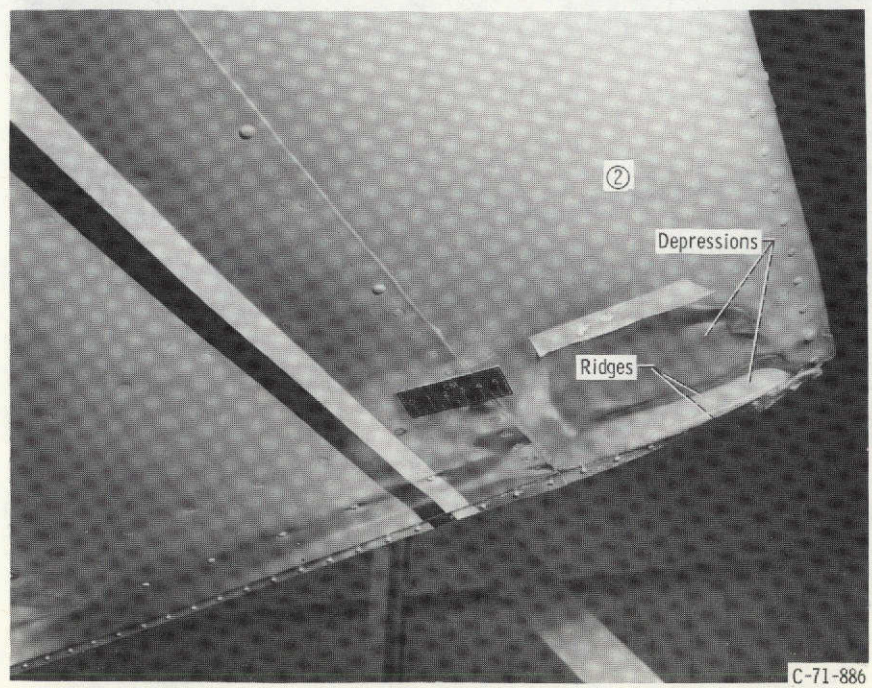
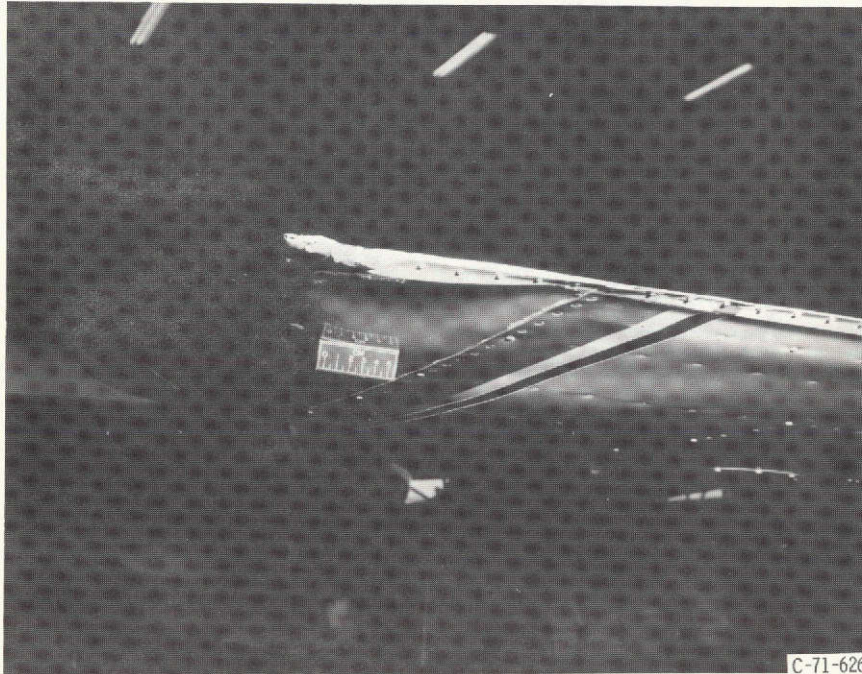
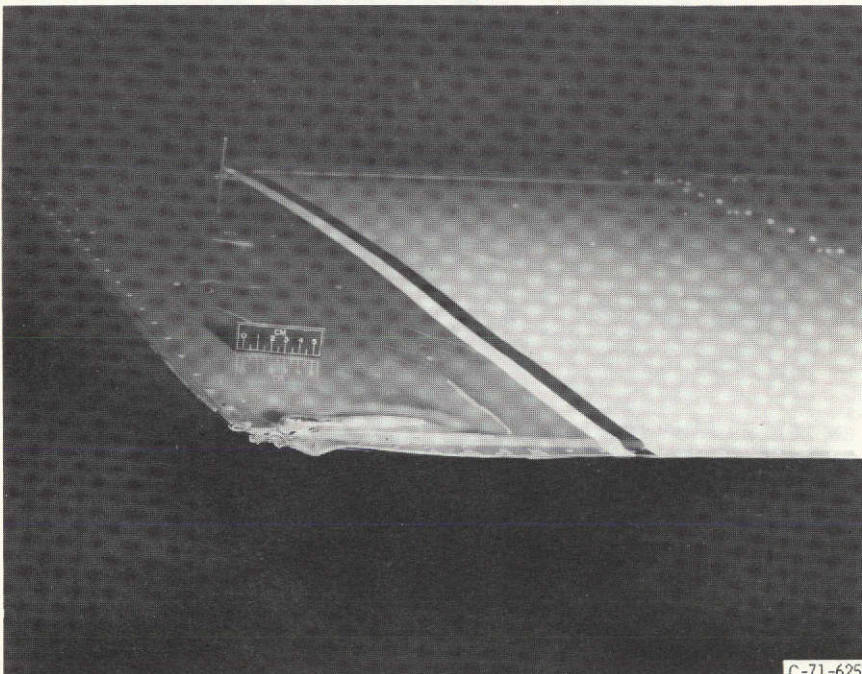
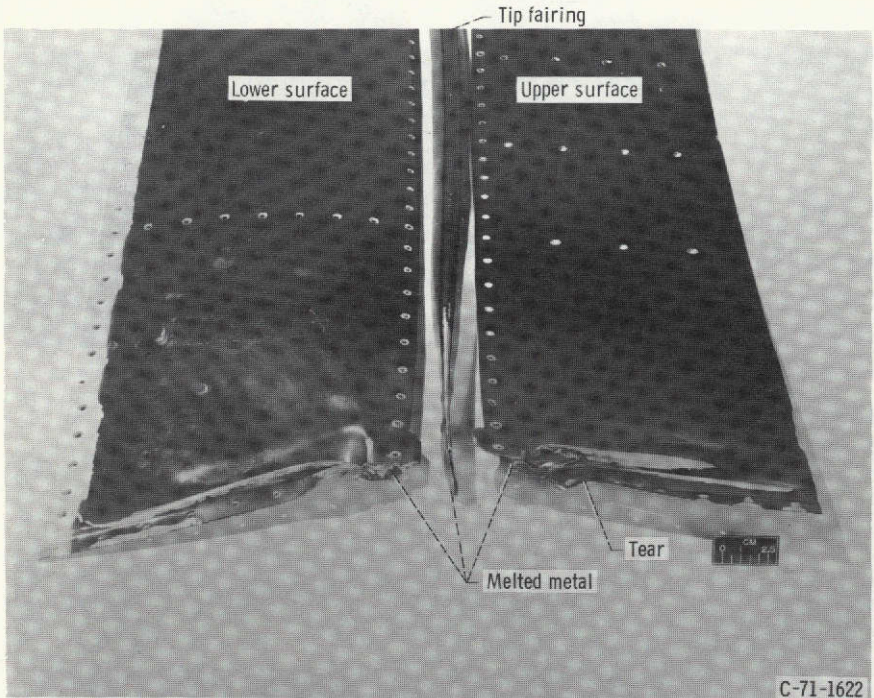
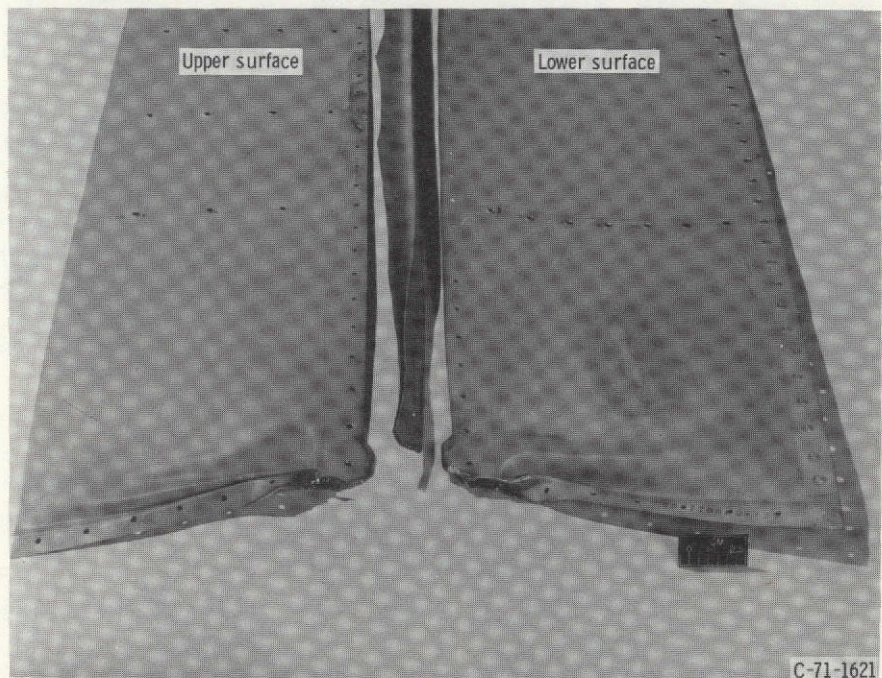
Figure 2. - Damage at lightning attachment point on trailing edge of left wingtip.

Left wingtip. - One attachment point of the lightning strike was at the trailing edge of the left wingtip. The damage at this point is shown in figure 2. Besides the metal being melted (figs. 2(b) and (g)), which is typical lightning discharge damage, the trailing edge has been pushed forward (fig. 2(b)). This forward motion of the trailing edge created two pronounced ridges in both the upper and lower surfaces of the wing which were approximately parallel to the trailing edge. The rearmost ridge coincided with a normal bend line in the wing and was so sharp that the metal was torn (figs. 2(b) and (g)). Forward of the ridges, both surfaces of the wing skin were pushed inward. This crumpling damage is probably due to electromotive forces created by the interaction of magnetic fields generated by the lightning electrical currents flowing in the upper and lower surfaces of the wing. This phenomenon is commonly called the "magnetic pinch effect." An analysis and an estimation of the magnetic forces involved in the magnetic pinch effect are presented in a later section.

The crumpling-type damage sustained at the lightning attachment point on the trailing edge of the left wingtip (fig. 2) appears to have been caused by an impact on the trailing edge since the trailing edge has been pushed downward and forward. The approximate geometry of a chordwise cross section of the wingtip trailing edge before and after the lightning strike is shown in figure 30. In the analysis that follows, it will be shown that the damage probably resulted from magnetically induced forces created by the lightning current as it flowed through the aircraft wing skin.

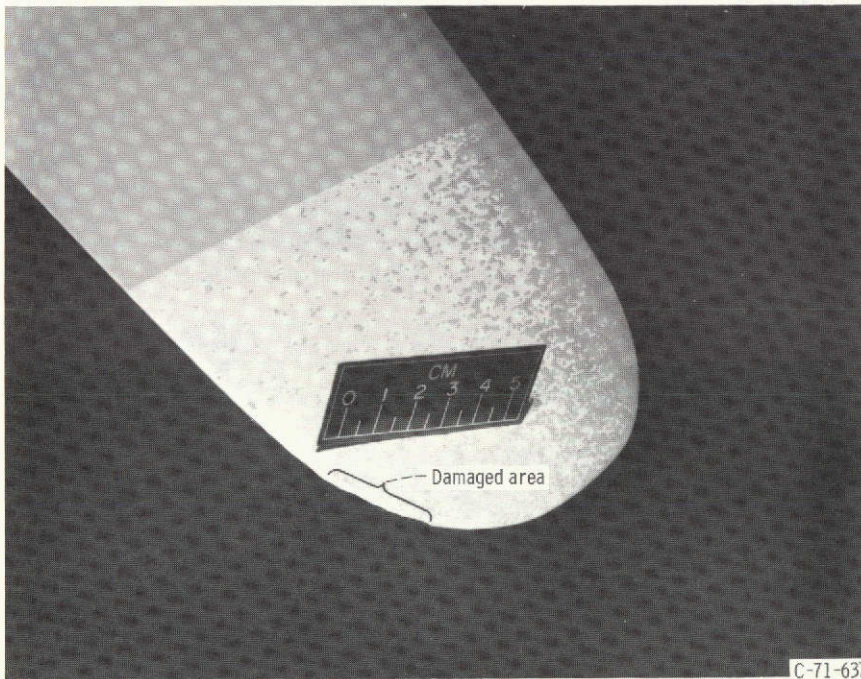
Propeller. - One blade of the right propeller was another lightning attachment point. Damage to the aluminum propeller was minor, as can be seen in figure 3. The amount of damage is typical for lightning strikes to propellers. The massiveness of the propeller provided a good heat sink and thus not much melting of material occurred.

Figure 3. - Tip of blade on right propeller, showing lightning erosion damage.

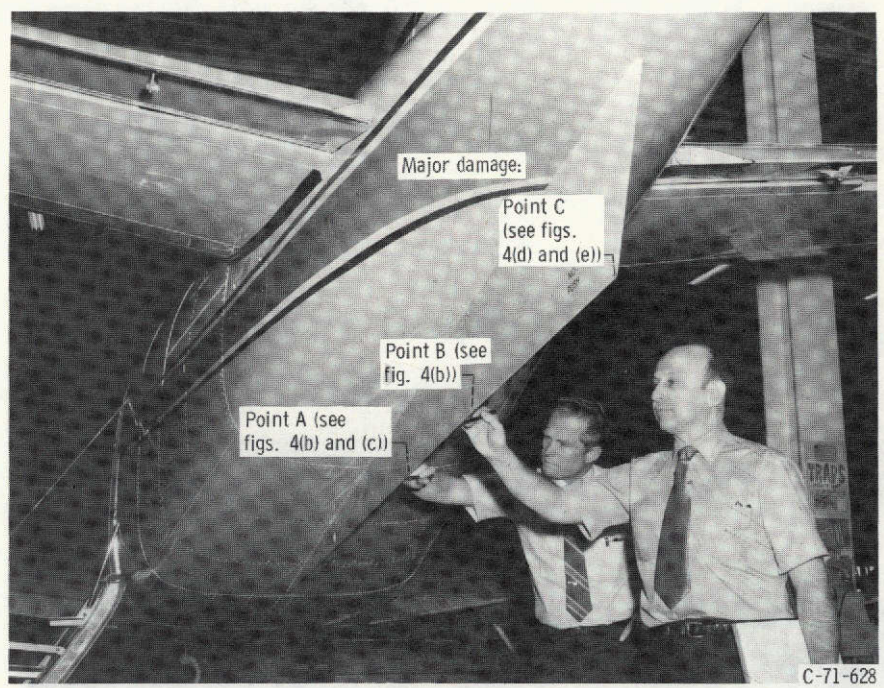
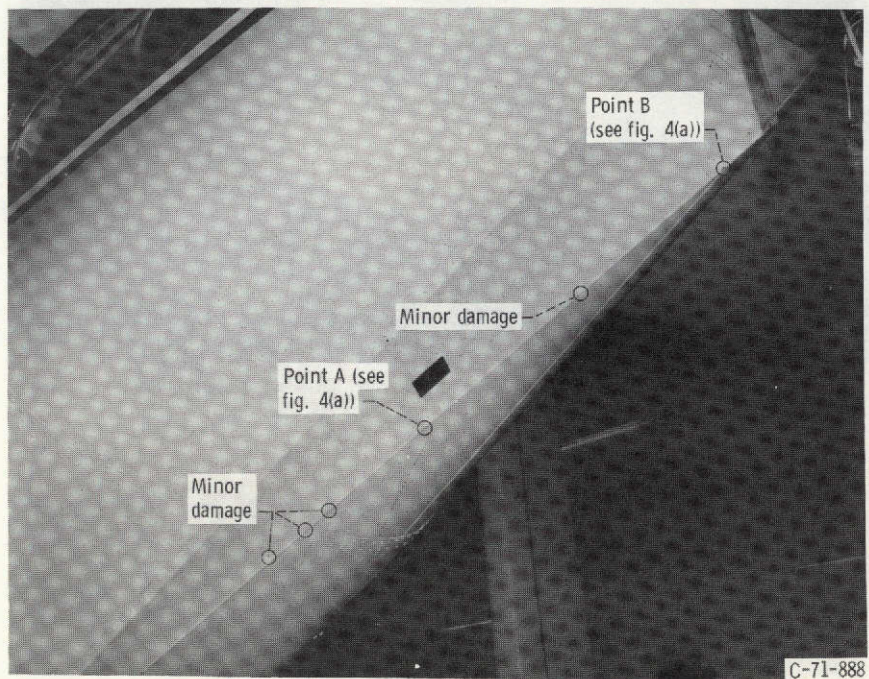
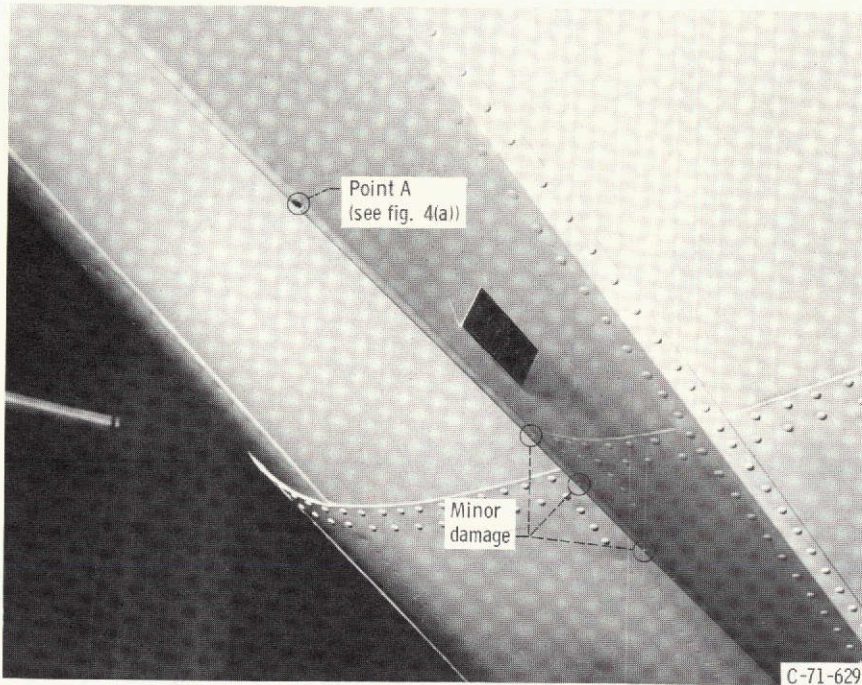
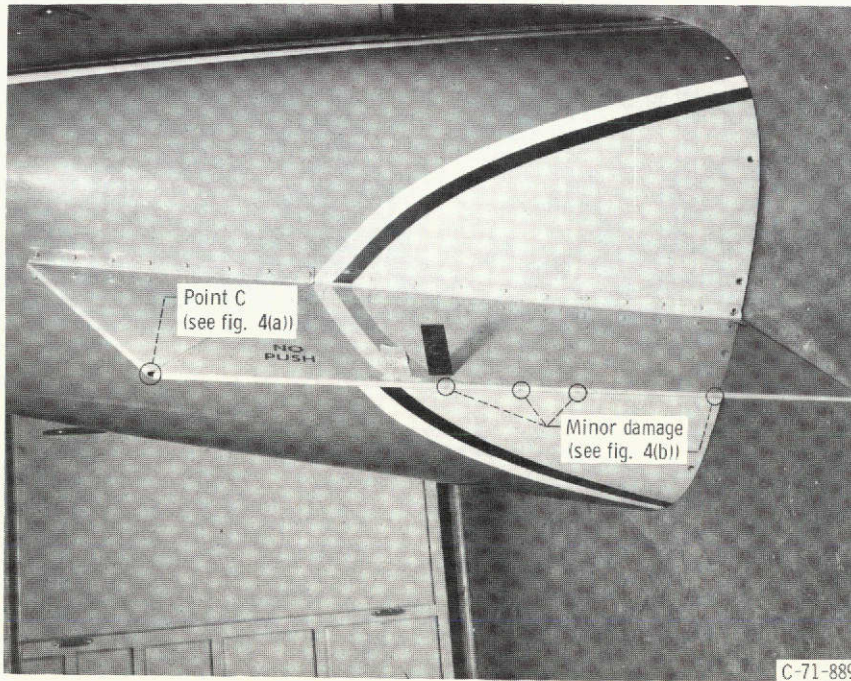
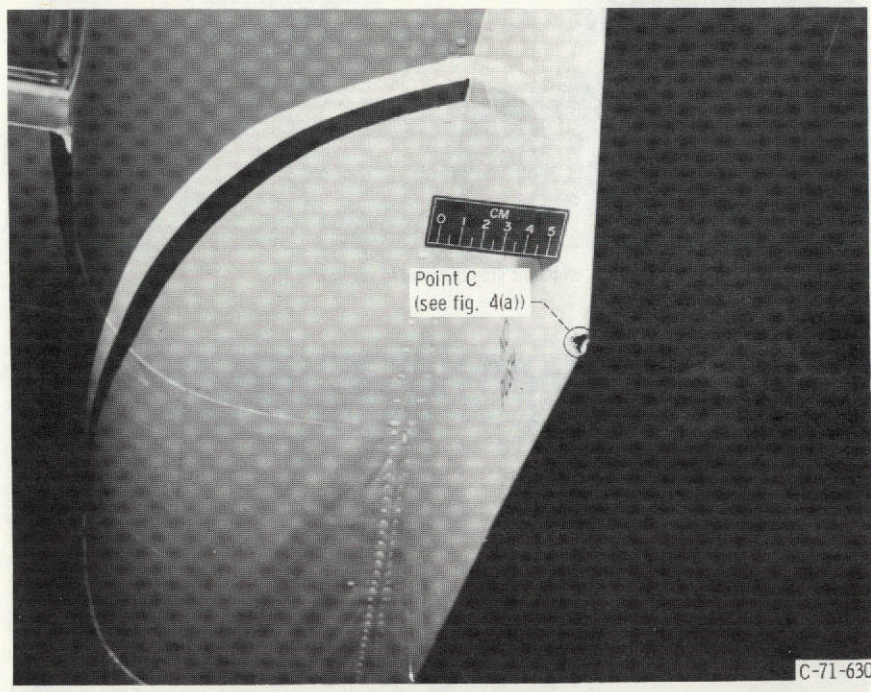
Figure 4. - Lightning attachment points on ventral fin.

Ventral fin. - Another area of lightning attachment was the bottom edge of the ventral fin. These damage points are shown in figure 4. The lightning attachment on the fin is typical of what is generally referred to as a "swept stroke." The stroke first attached itself at a forward position on the fin. Then, because of the motion of the aircraft relative to the nearly stationary lightning discharge path, the attachment point moved rearward along the fin, creating damage that ranged from small pitmarks to relatively large holes.

The lightning attachment point did move to the lower edge of the ventral fin and became what is generally referred to as a swept stroke, as shown in figure 4. The swept stroke left a series of damaged areas that ranged from scorched paint with small pits in the metal to large holes through the sheet metal. The positions of the damaged areas along the ventral fin are shown in figure 28. The relative magnitude of the damage at each position is qualitatively indicated by the length of the line marking the position. Altogether there were 12 damaged areas, with six of these more pronounced than the others. The spacing of these pronounced damaged areas along the fin was fairly uniform, 35.6 to 43.2 centimeters (14 to 17 in.), except the one at the aft end which was 20.3 centimeters (8.0 in.) from the preceding area. The average spacing, not including the 20.3 centimeters (8.0 in.), was 39.7 centimeters (15.6 in.). At the time of the lightning strike, the aircraft speed was 82.3 m/sec (160 knots). The time required for the aircraft to move 39.7 centimeters (15.6 in.) was 4.8 milliseconds. This is very close to the 4.5 milliseconds calculated earlier for the time between the high-amperage strokes of the discharge. This suggests that the change in attachment point for a swept stroke is triggered by the high-amperage strokes. After attachment, the continuing current flow caused the melting-type damage. The amount of current flow required to melt aircraft structural materials is discussed in reference 5. Meanwhile, because of the motion of the aircraft, the lightning discharge path near the aircraft was stretched and bent with respect to the original path which was relatively fixed in space. When the next stroke occurred, the large magnetic field created around the path ruptured the discharge path at the bend, causing a new attachment at a point on the aircraft near the original discharge path. The minor damage occurring between the major damage positions (fig. 28) could have been caused either by momentary contact between the discharge path and the structure as the attachment point was carried forward with the aircraft or by momentary contact as the attachment point changed position.

The last attachment point for the ground portion of the lightning strike was probably the aft end of the ventral fin. How long it remained attached here cannot be estimated but was probably fairly long since the damage here was the greatest. During most of the time interval between the attachment of the ground portion of the lightning discharge to the propeller tip until it moved to the aft end of the ventral fin, the cloud portion of the discharge was probably attached to the left wingtip. Near the end of the discharge, the cloud-portion attachment point moved to the plastic light housing on the tip of the vertical stabilizer. The probable lightning path with respect to the aircraft as a function of time is shown in figure 29.

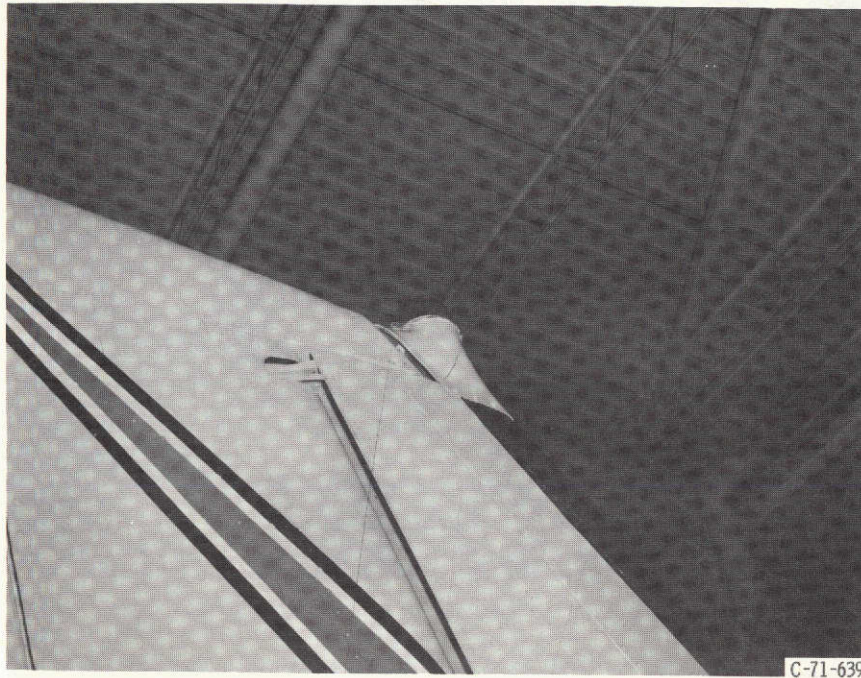
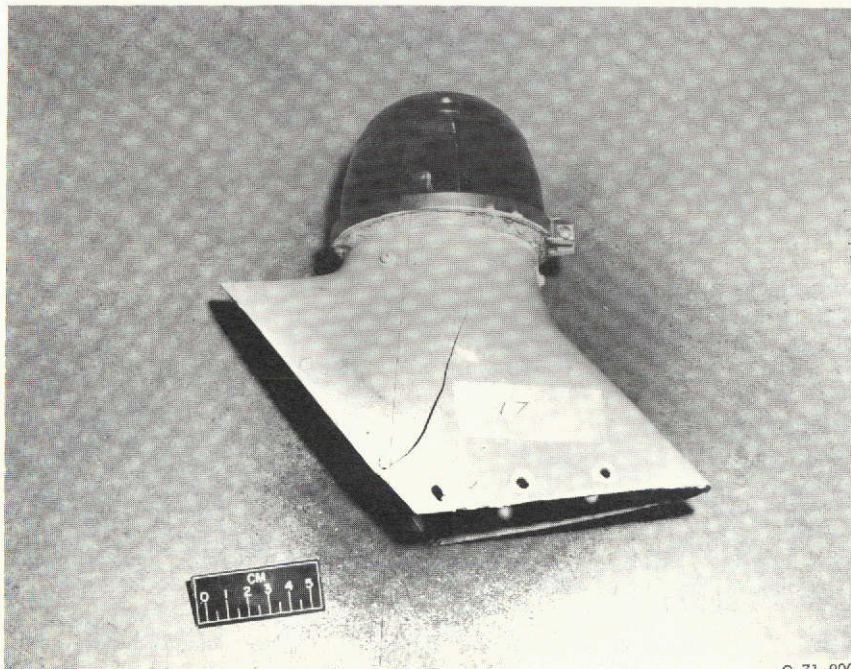
Vertical stabilizer. - Another possible lightning attachment point was the navigation light on the top of the vertical stabilizer. There was no evidence of burning or melting, but the plastic mounting for the light was cracked, as can be seen in figure 5.

The crack in the plastic mounting for the navigation light on the top of the vertical stabilizer (fig. 5) is typical of damage produced when lightning strikes an electrical insulating or dielectric material. When the lightning attaches to the exterior of the plastic housing, the insulating plastic is in the current path and an electric field is generated across the material. When the electric field exceeds the dielectric strength or breakdown potential of the dielectric material, the material is punctured or cracked. The dielectric strength of most insulating materials ranges from 10^3 to 10^7 volts per centimeter. Potential gradients of this order of magnitude are easily obtained when the dielectric material is a part of a lightning discharge path. Dielectric material can be protected by use of electrical conductive paints or metallic strips bonded on the exterior surfaces and connected electrically to the metal aircraft.

Figure 5. - Crack in plastic mount for navigation light located on top front of vertical stabilizer.

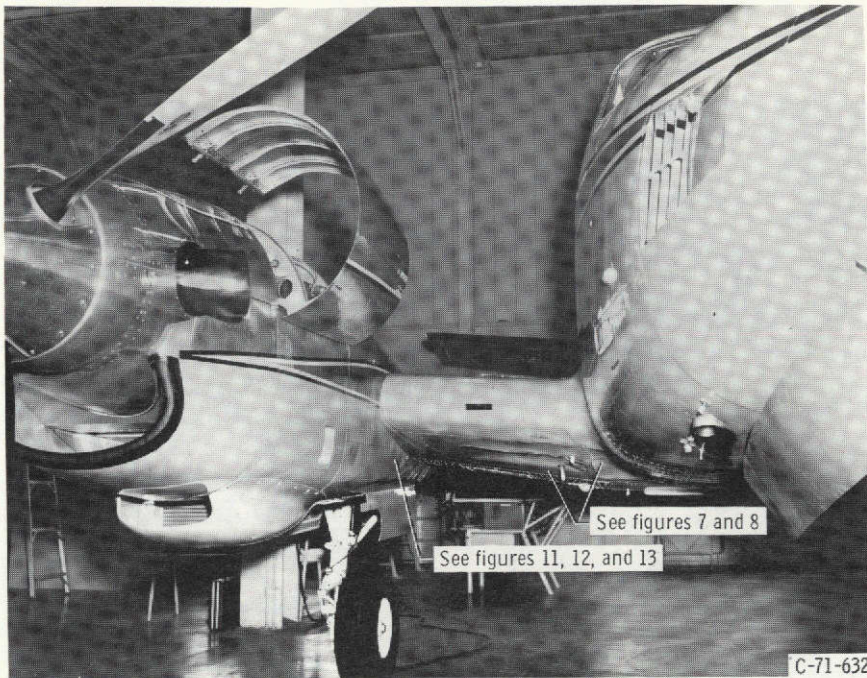
Figure 6 is a general view of the damage to the lower surface of wing and the inboard side of the engine nacelle. The major damage on the wing occurred to two skin panels: the hatch cover for the battery compartment and a wing root fairing. Closeup views of the implosion-type damage to these panels are shown in figures 7 and 8. The inward force on the fairing panel was sufficient to pull the skin over the rivet heads. The fairing panel had no internal stiffeners, but the hatch cover had a stiffener as is evidenced by the rows of weld spots visible in figure 7. All the damaged skin panels were aluminum alloy. Typical thicknesses of damaged skin panels are given in table I. In addition to the implosion-type damage, the paint in an area containing a part of the hatch cover, the wing root fairing, and a section of the fuselage was discolored as though it had been exposed to high temperature. This area of discoloration is shown in figures 8 and 9. Most of the discoloration was slight, except on the fuselage, where it was moderate. The longitudinal black streak on the bottom of fuselage (fig. 9) is not paint discoloration but exhaust deposits from the cabin heater.

Figure 6. - General view of damage to lower surface of wing and inboard side of engine nacelle.

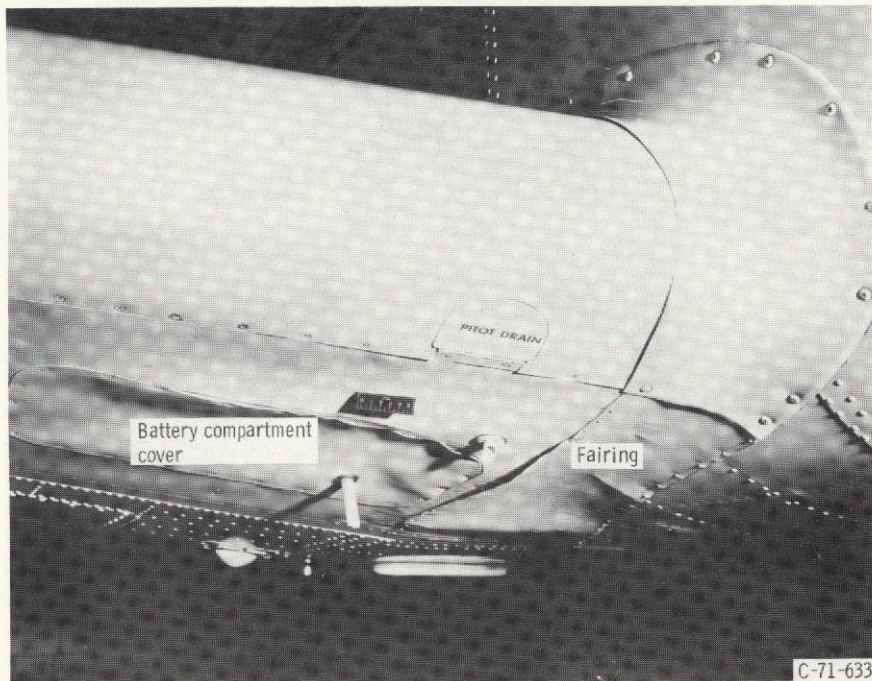
Figure 7. - Damage to battery compartment cover and wing-to-fuselage fairing.

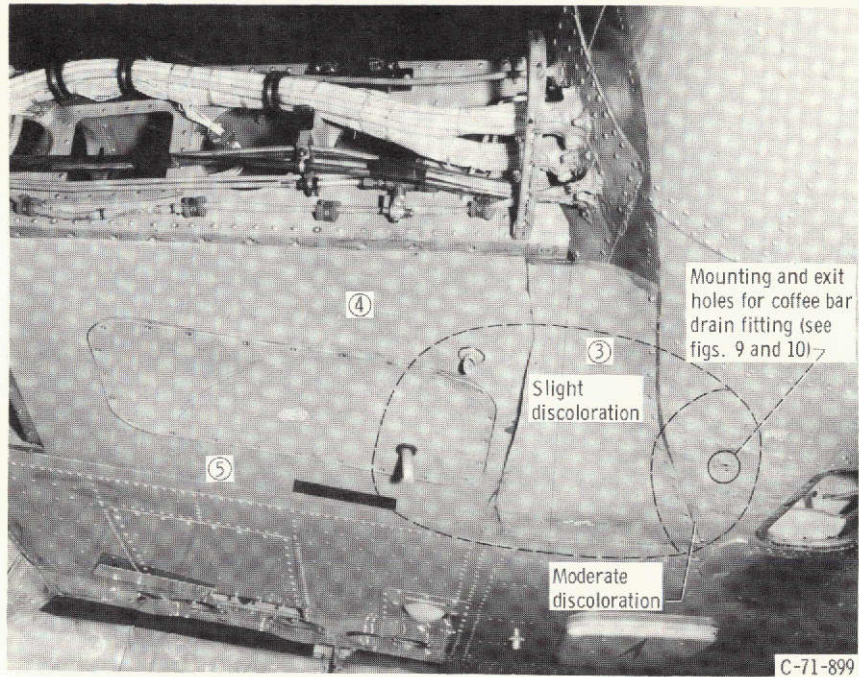
Figure 8. - Area of paint discoloration on wing and fuselage.

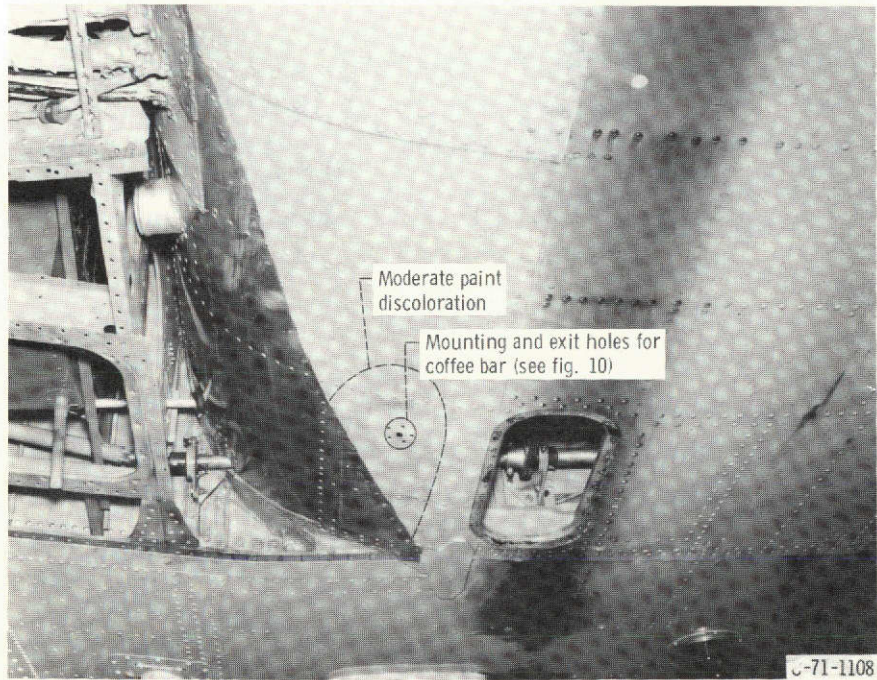
Figure 9. - Area of moderate paint discoloration around mounting and exit holes for coffee bar drain fitting on bottom of fuselage.

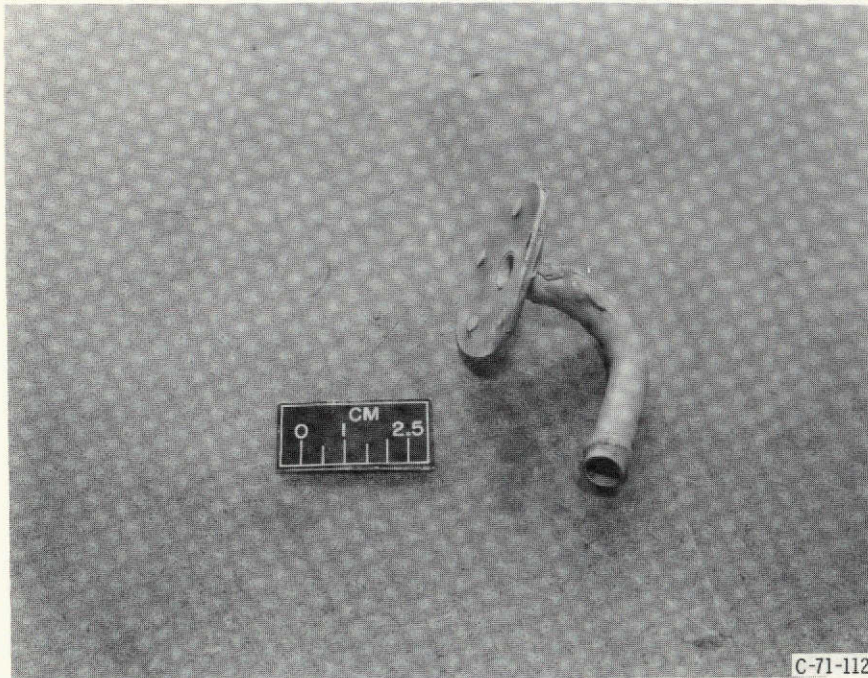
A drain fitting for a cabin coffee bar was located in the area of moderate paint discoloration. The mounting holes for this fitting are shown in figures 8 and 9. The fitting is shown in figure 10. The fitting flange was mounted on the internal surface of the skin with five rivets. The fitting was found inside the fuselage skin and completely separated from it.

Figure 10. - Coffee bar drain fitting. (See fig. 9 for location on bottom of fuselage.)

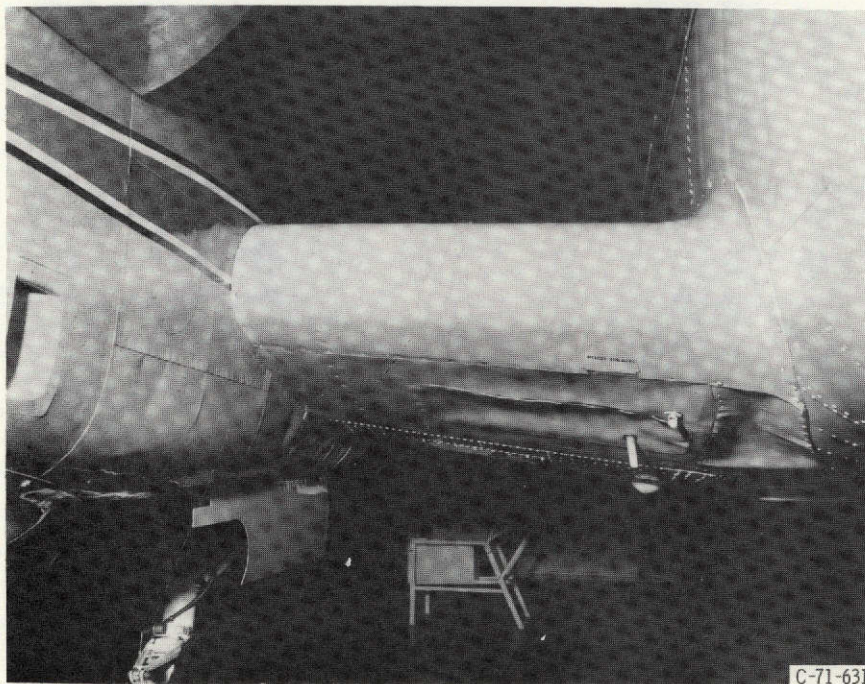
Damage to the lower inboard side of the right engine nacelle is shown in figures 11 to 13. The damaged area was below the wing chord line and extended from about 35 centimeters (13.8 in.) in front of the wing leading edge to the aft end of the nacelle (fig. 12). The severity of the damage increased markedly in the aft direction. The forward panels showed some wrinkling and sharp creases at an internal structural member. The aft skin panels were severely buckled. The landing gear doors showed no evidence of damage. However, the bottom of the nacelle aft of the landing gear doors was damaged, as is shown in figure 13.

Figure 11. - Damage to lower inboard side of right engine nacelle and wing.

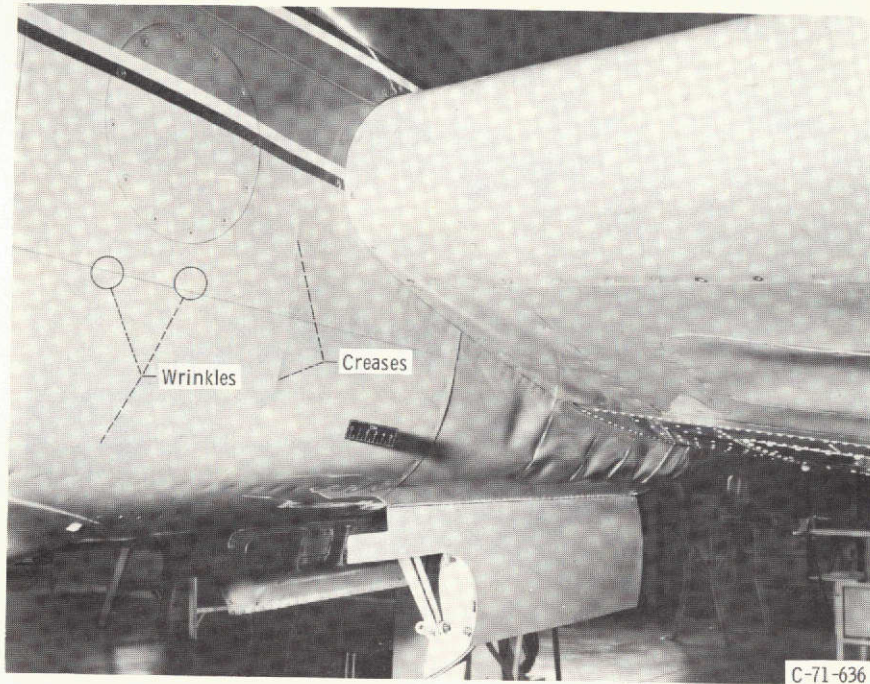
Figure 12. - Damage to lower inboard side of right engine nacelle.

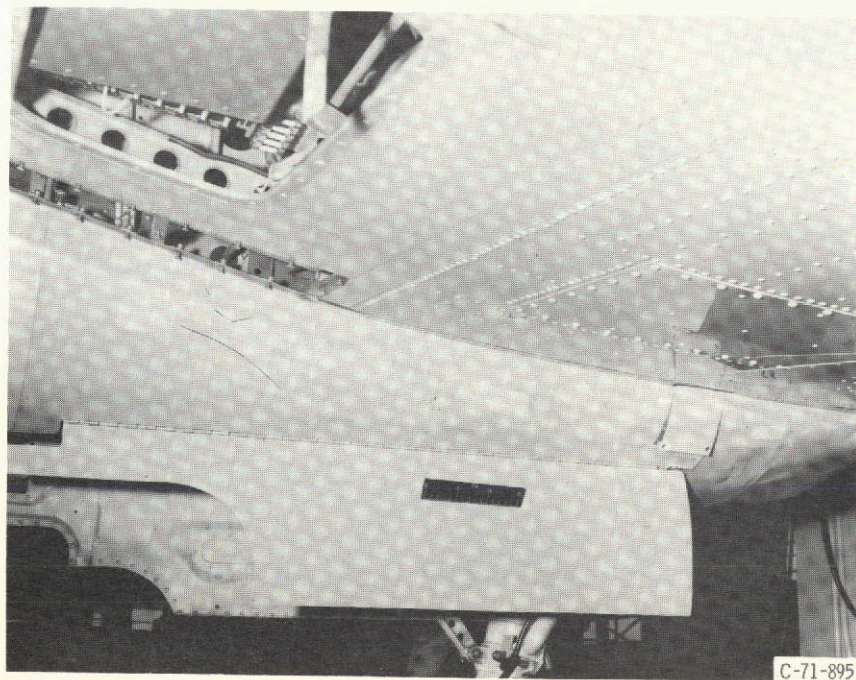
Figure 13. - Inboard view of damage at aft bottom of right engine nacelle. (See also figs. 15 and 16.)

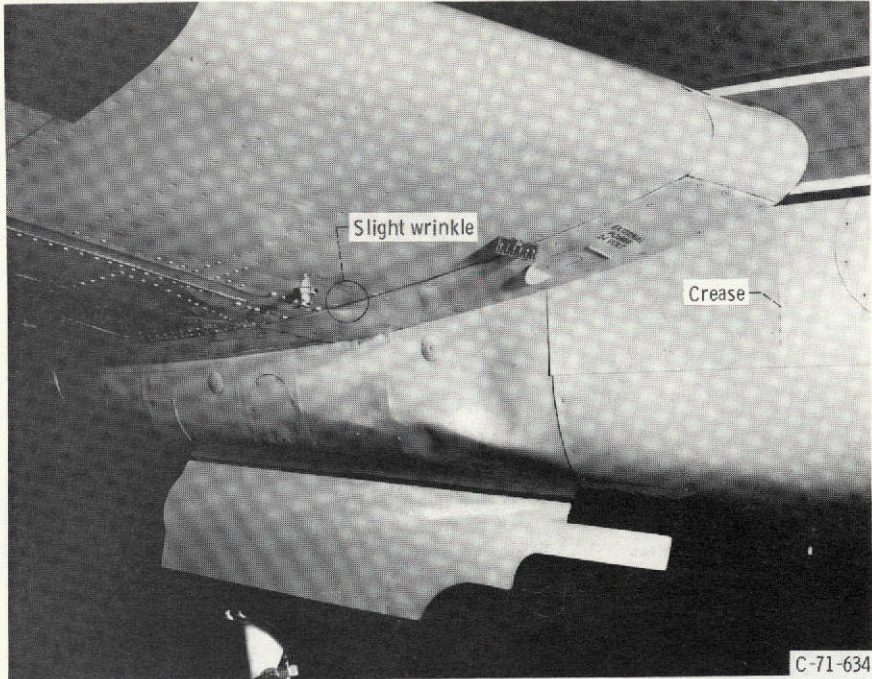
The damage to the outboard bottom side of the right engine nacelle is shown in figures 14 and 15. The area of damage is almost identical to that on the inboard side of

the nacelle. The magnitude of the damage also increased in the aft direction but overall was not as severe as that on the inboard side. Damage to the lower wing surface on the outboard side of the engine was minor, as shown in figure 14. Figure 15 presents another view (see fig. 13) of the damage to the aft bottom of the nacelle.

Figure 14. - Damage to outboard bottom side of right engine nacelle and lower wing surface.

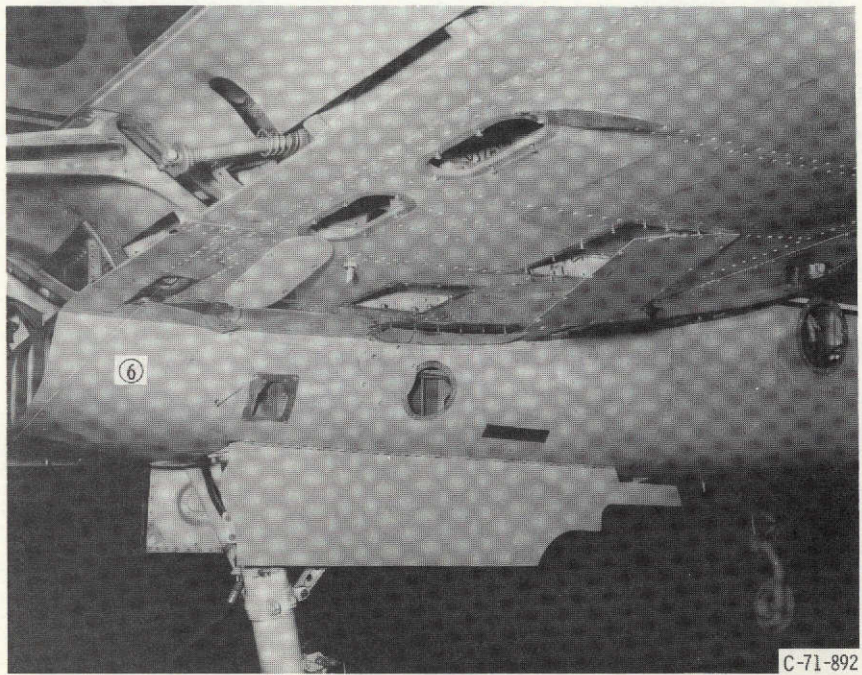
Figure 15. - Outboard view of damage at aft bottom of right engine nacelle. (See also figs. 13 and 16.)

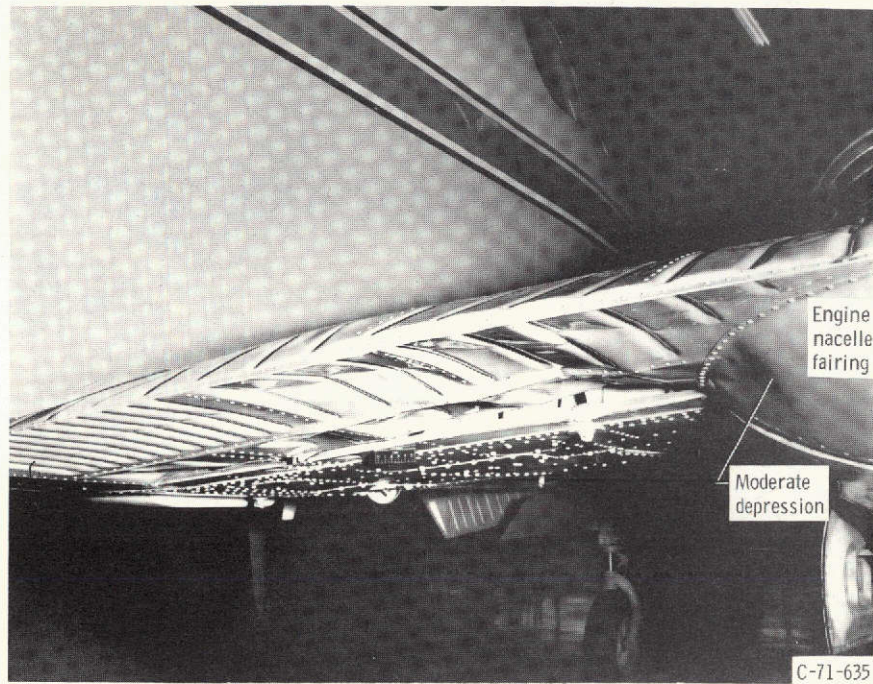
As might be expected from the damage shown in previous photographs of the wing and nacelle, the inboard flap received the greatest damage. In general, the inboard flap was bowed upward, as can easily be seen in figures 16 and 17. The centerline of the bow appears to be oriented in approximately the chordwise direction and located about 13 centimeters (5.1 in.) from the inboard side of the engine nacelle fairing that is attached to the flap (figs. 16 and 18). In addition to the bowing, both upper and lower surfaces sustained extensive damage in the form of buckling and dents. The severest buckling occurred at the leading edge of the flap near the centerline of the bow. Both the lower surface (point A, fig. 18) and the upper surface (point A, fig. 19) were sharply creased inward. The creasing was sufficient to tear the metal on the leading edge. A depression in the metal at the inboard end of the inboard flap at the leading edge (point B, fig. 18) was sufficient to create a sharp crease in the metal on the leading edge. There was a similar depression in the lower-surface leading edge of the inboard flap at the outboard end (point C, fig. 20). The trailing edge of the inboard flap near the midsection was sharply bent downward, as can be seen in figures 16 and 17. The skins of the flaps, especially on the upper surface at the aft end of the flap attachment fittings, were distorted (figs. 19 and 21). The metal on each side of the engine nacelle fairing adjacent to the lower flap surface was dented inward (figs. 16 and 20).

Figure 16. - Forward view of damage to lower surface of right inboard flap and engine nacelle fairing.

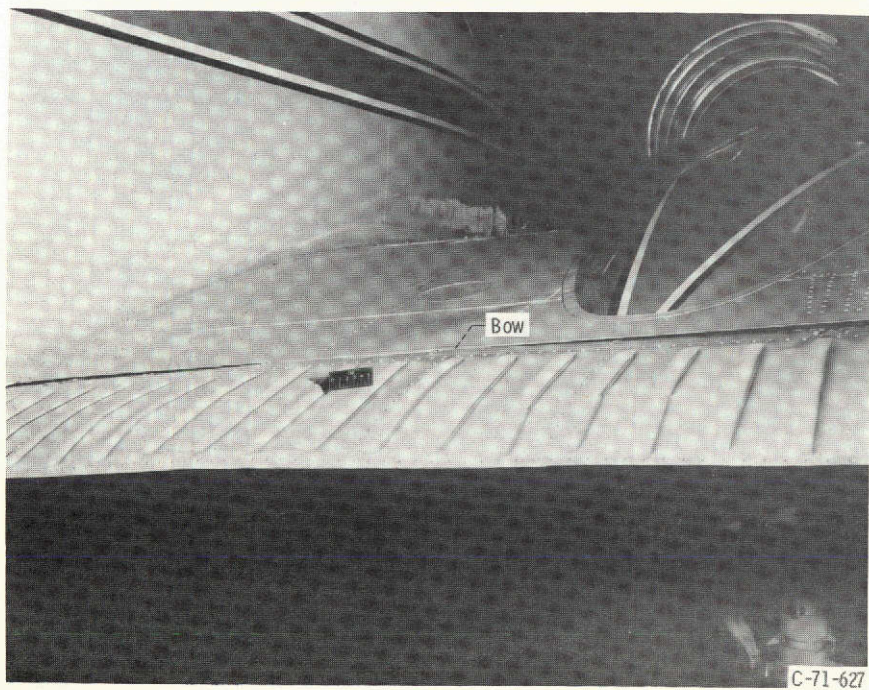
Figure 17. - Damage to top surface of right inboard flap.

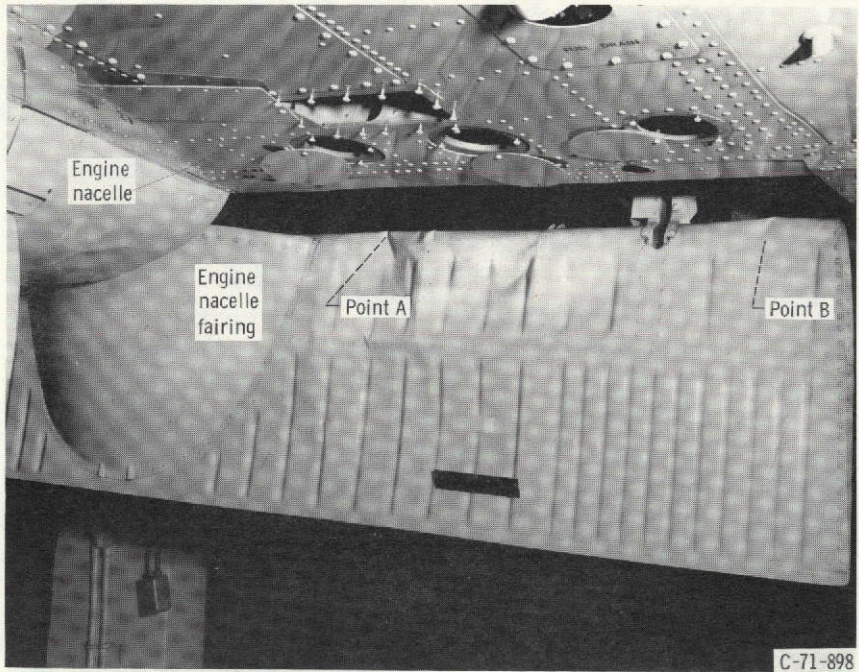
Figure 18. - Rearward view of damage to lower surface of right inboard flap and aft end of engine nacelle. Flap control rod disconnected with flap hanging from flap track. (See fig. 19.)

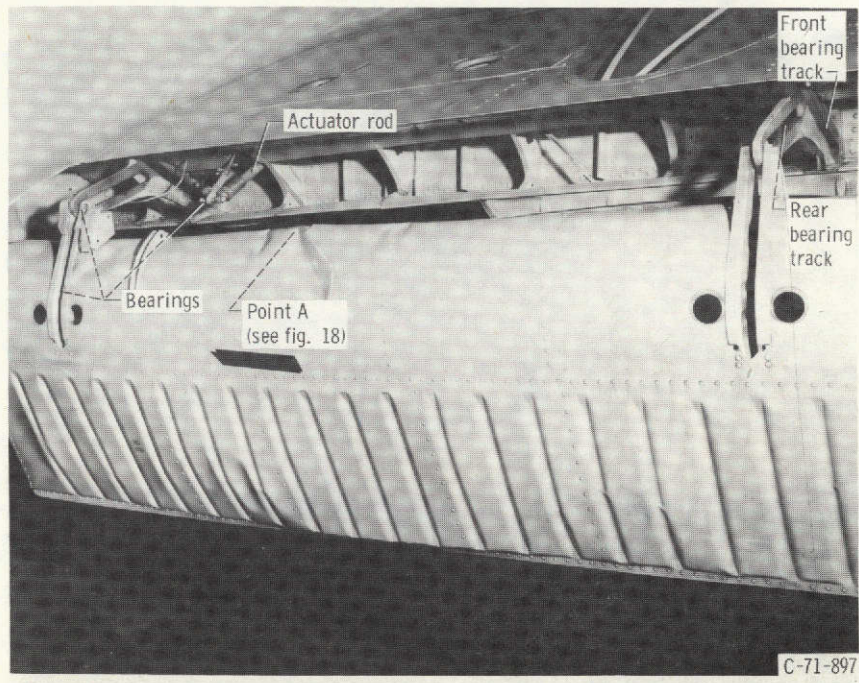
Figure 19. - Damage to top surface and leading edge of right inboard flap. Flap control rod disconnected with flap bearing normally in forward track supporting flap in rear track.

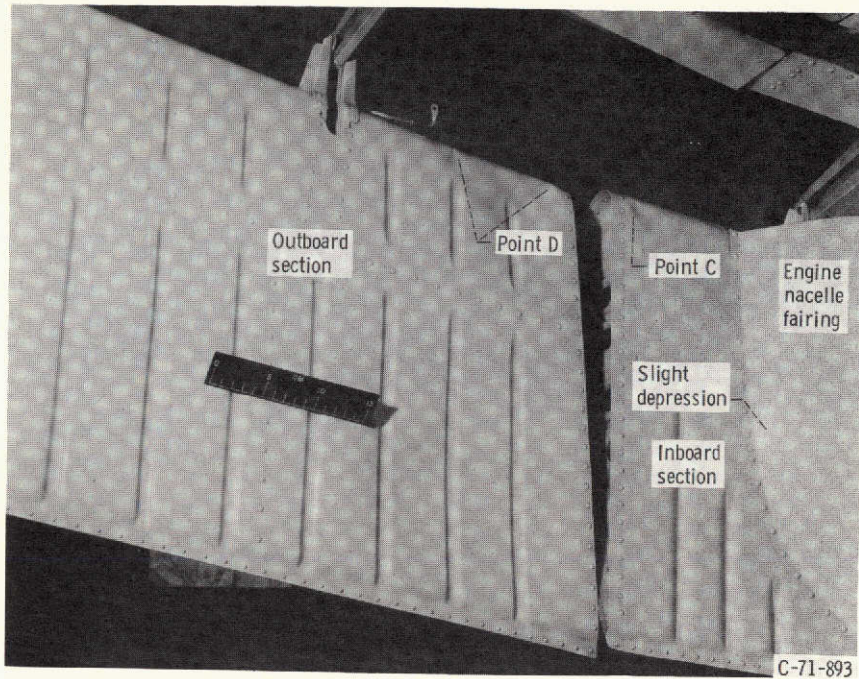
Figure 20. - Damage to lower surfaces of right inboard and outboard flaps. Flap control rod disconnected with flaps hanging from flap tracks.

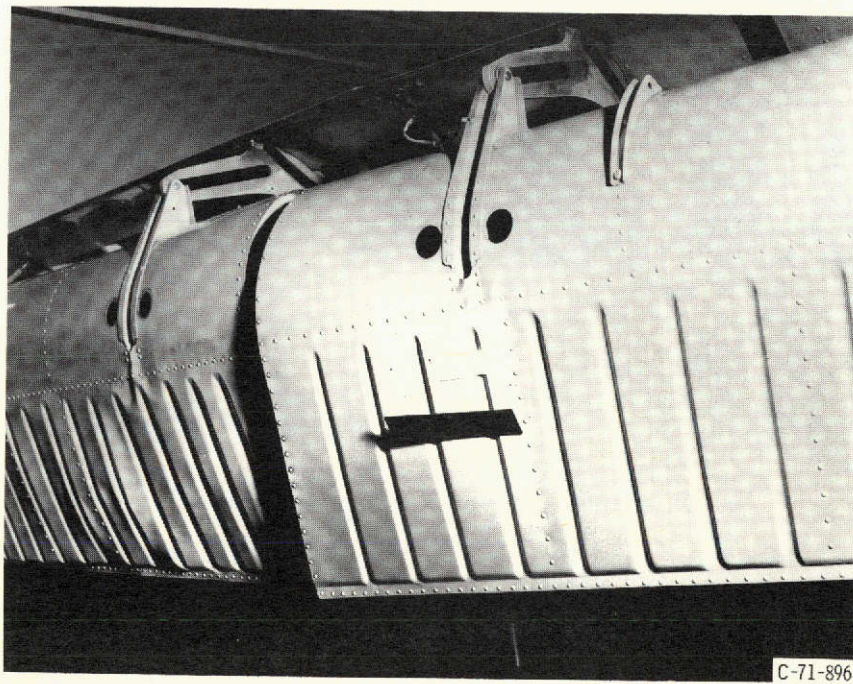
Damage to the outboard flap was minor compared with that to the inboard flap. There was no evidence of general bowing or widespread buckling. The lower surface near the leading edge was dented inward in three areas. These are shown at points D, E, and F in figure 22. Point D is also shown in figure 20. There was also some distortion of the upper surface flap skin at the aft end of the flap attachment fitting on the inboard side (fig. 21).

Figure 21. - Damage to upper surfaces of right inboard and outboard wing flaps. Flap control rods disconnected with flaps hanging from flap tracks.
