NASA TECHNICAL NOTE

NASA TN D-7775

LIGHTNING DAMAGE TO A GENERAL AVIATION AIRCRAFT - DESCRIPTION AND ANALYSIS

by Paul T. Hacker
Lewis Research Center
Cleveland, Ohio 44135

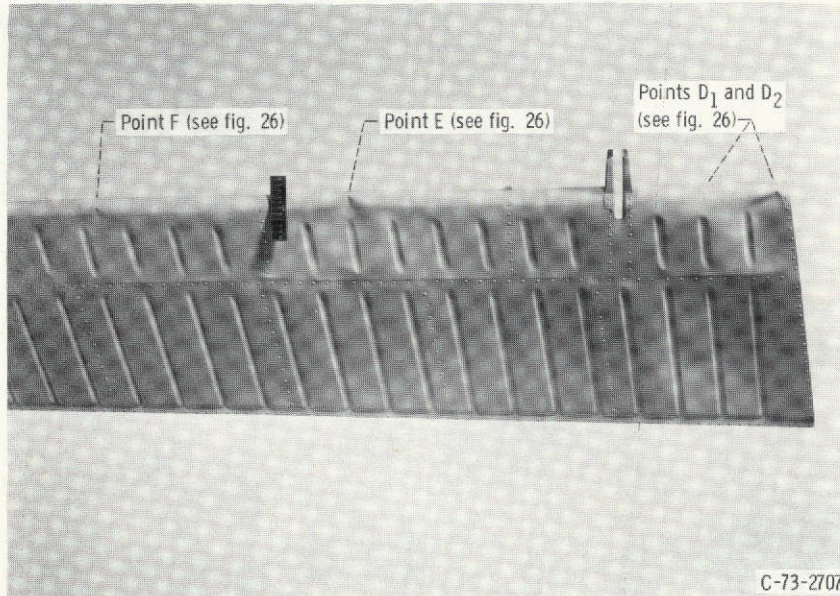
Figure 22. - Damage to lower-surface leading edge of right outboard flap.

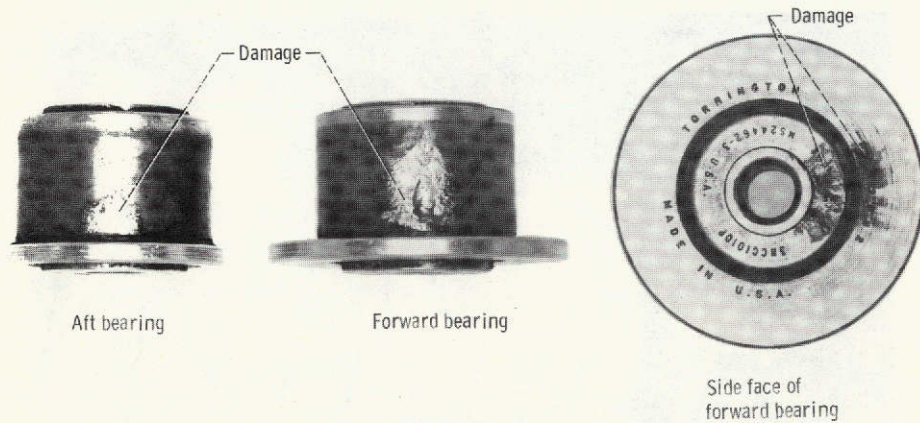
The pitting of the left wing-flap bearings (figs. 23 and 24) by electrical arcing is typical of damage that can occur on mating surfaces which are not adequately electrically bonded. Bonding in this case is difficult because the flaps have to be free to move with respect to the wing. The bonding provided on the aircraft consisted of flexible cables, one for each of the four flap support and attachment points (two per flap). These cables were about 0.5 centimeter (3/16 in.) in diameter and 25 centimeters (10 in.) long and were connected to the main wing structure near the flap support structure and to the sheet metal structure to which the flap bearings were attached, as shown in figures 33 and 20. The flap actuators (fig. 19) also provided, through the bearing surfaces, a connection between the flaps and the main wing structure.

Figure 23. - Damage to outboard pair of bearings on left outboard flap.

Although bonding cables were provided around each of the flap bearing assemblies, they were obviously inadequate for the lightning strike encountered. Electrical arc pitting damage of mating surfaces on movable components may not immediately create a serious problem but with time may lead to a serious problem unless the damage is detected and repaired. Detection of arcing on internal or hidden components such as these bearings may be a time-consuming task. Arcing inside integral fuel tanks is a hazard to be avoided. Thus, not only is good electrical bonding required in the design and fabrication of an aircraft, but periodic inspection and maintenance of bonds should also be made.

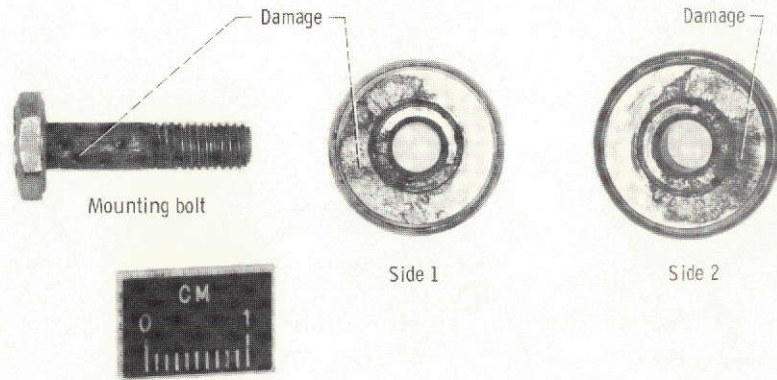
C-73-2668

Figure 24. - Damage to flap control rod bearing on left outboard flap.
