Lessons Learned from
Accidents Involving
Remotely Piloted and
Autonomous Aircraft

Crash Course

Peter W. Merlin

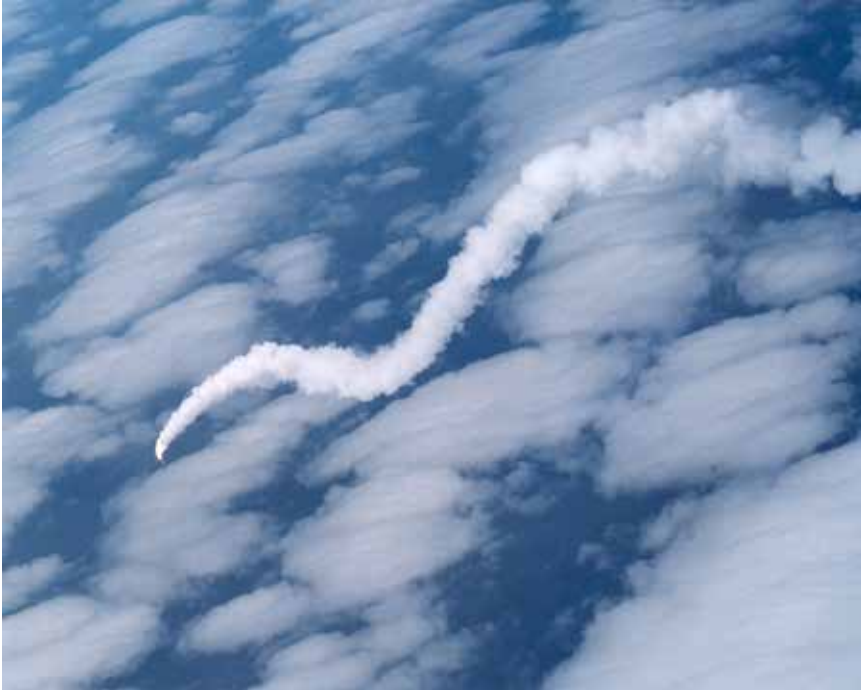
Divergent roll oscillatory motion caused by excessive control-system gain resulted from inadequate analytical modeling that allowed engineers to overestimate system safety margins. NASA

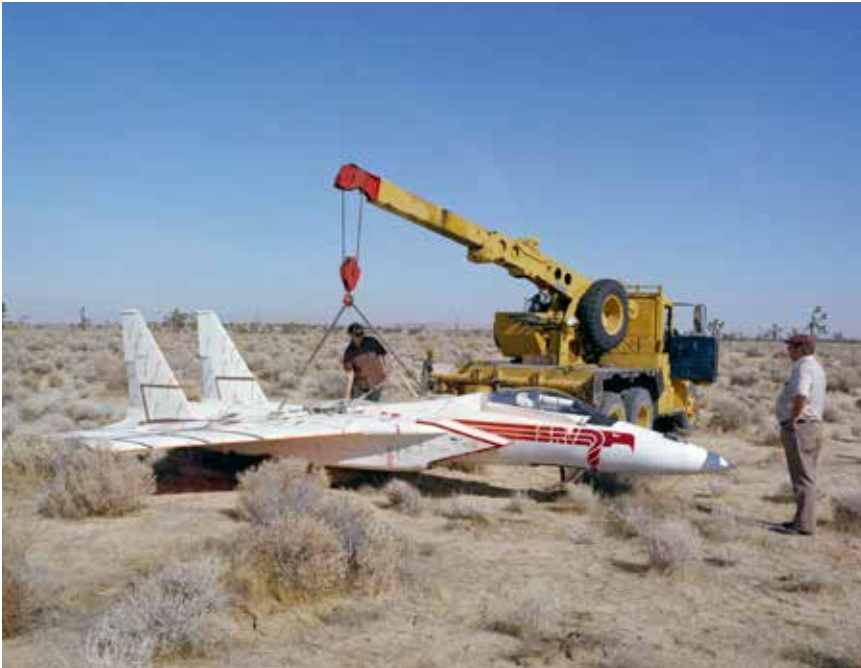
Recovery personnel prepare to lift the F-15 SRV off the Edwards Air Force Base PIRA after the vehicle's spin chute became entangled with the pitot tube. NASA

When flights resumed on February 18, 1981, the new nose parachute caught on the airplane's pitot tube after deployment. Einar Enevoldson guided the vehicle to a landing on the Edwards PIRA with only minor damage. No further problems were encountered during the remaining flights.²⁵

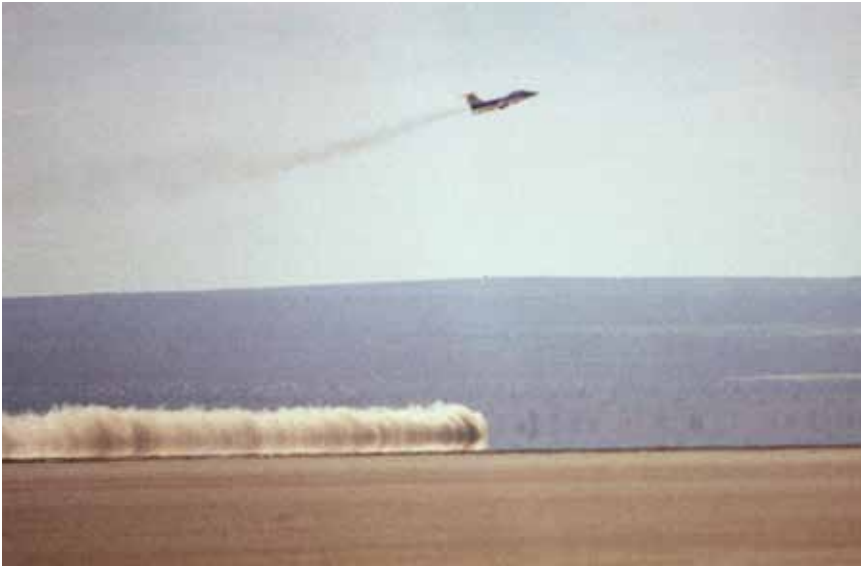
Observers aboard the TF-104G chase plane watch as the HiMAT slides across the dry lakebed on its belly. NASA

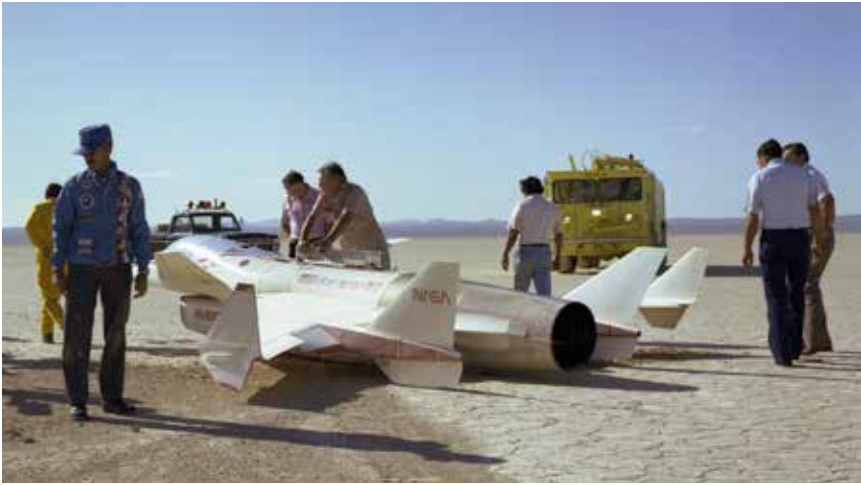
Investigators examine the HiMAT following its belly landing. Fortunately, damage was not extensive. NASA

The HiMAT PCS failure was caused by a mechanical malfunction. The landing gear malfunction stemmed from a software issue.

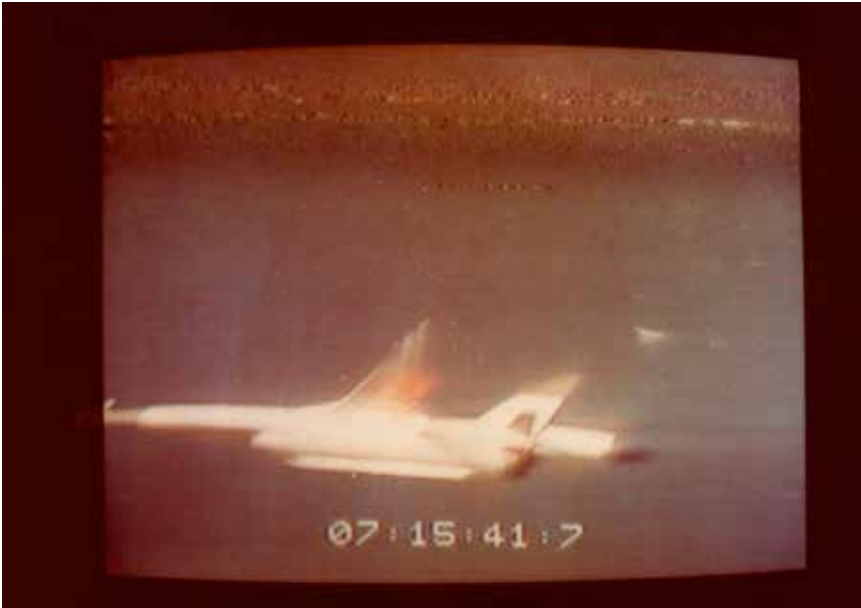
The DAST-1 experienced explosive flutter at Mach 0.825, leading to catastrophic failure of the right wing. NASA

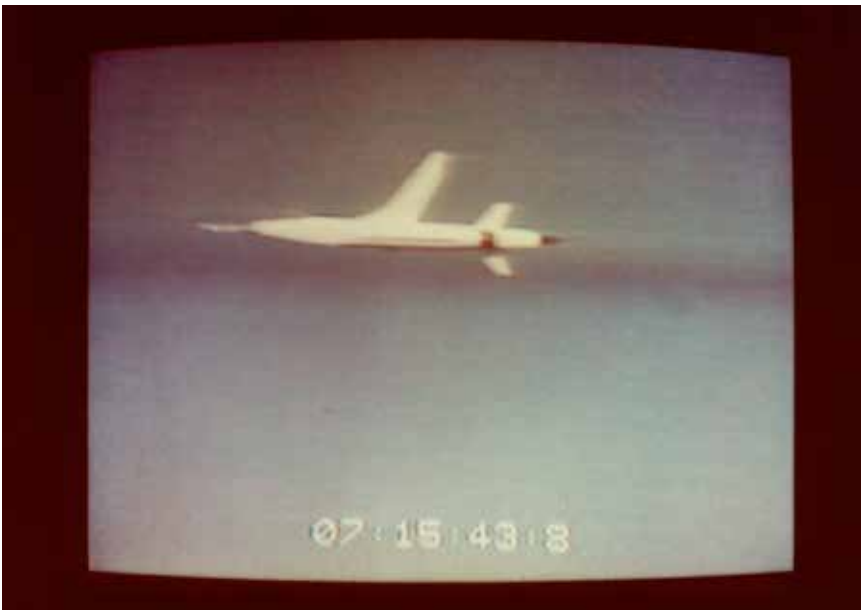
With only one remaining wing, the DAST-1 plummeted toward the ground. NASA

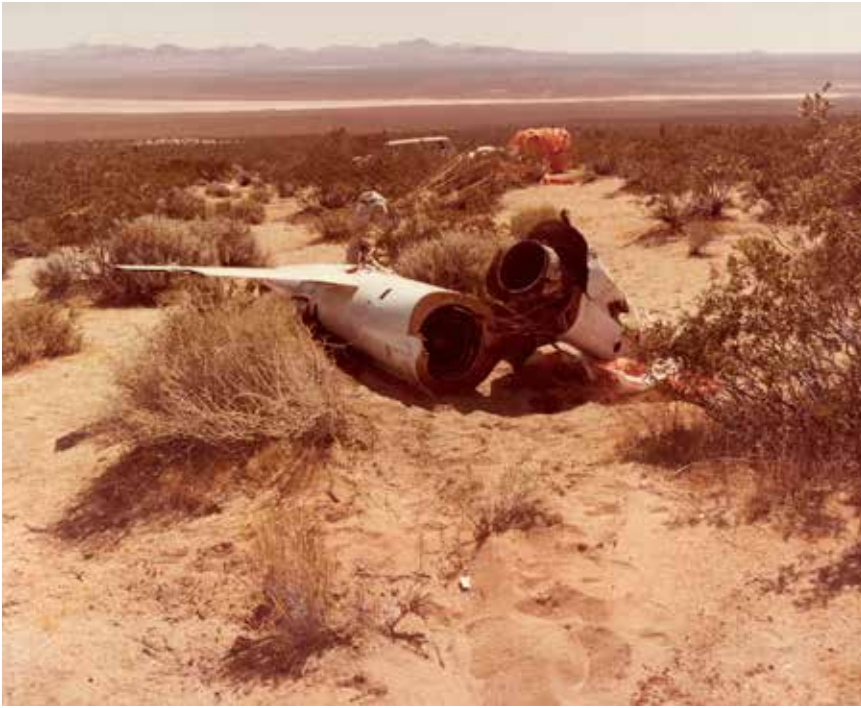
Because high-speed deployment conditions prevented full inflation of the main-parachute canopy, the DAST-1 was badly damaged when it struck the ground. NASA

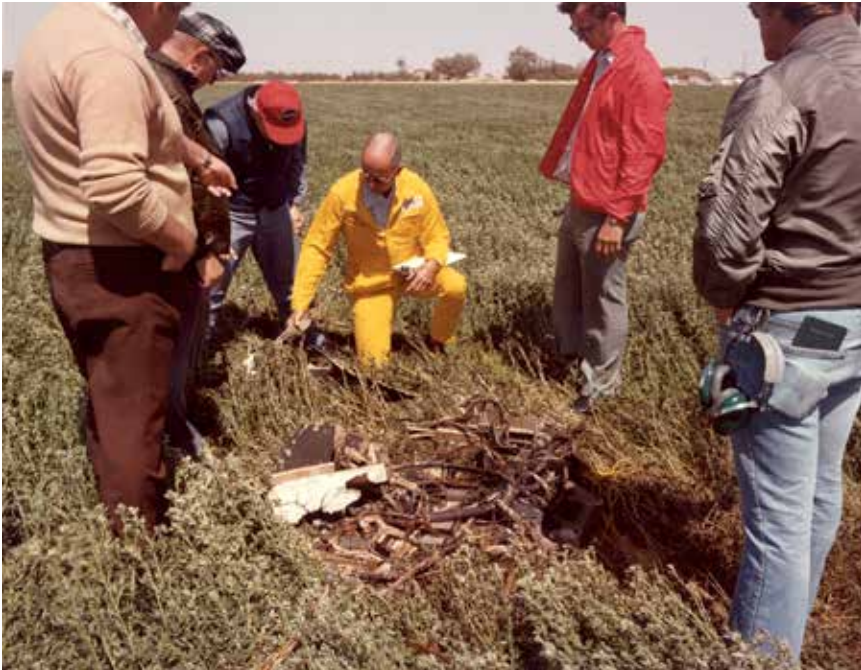
Investigators examine the DAST-2 wreckage at the crash site. The primary cause was traced to an electrical problem. NASA

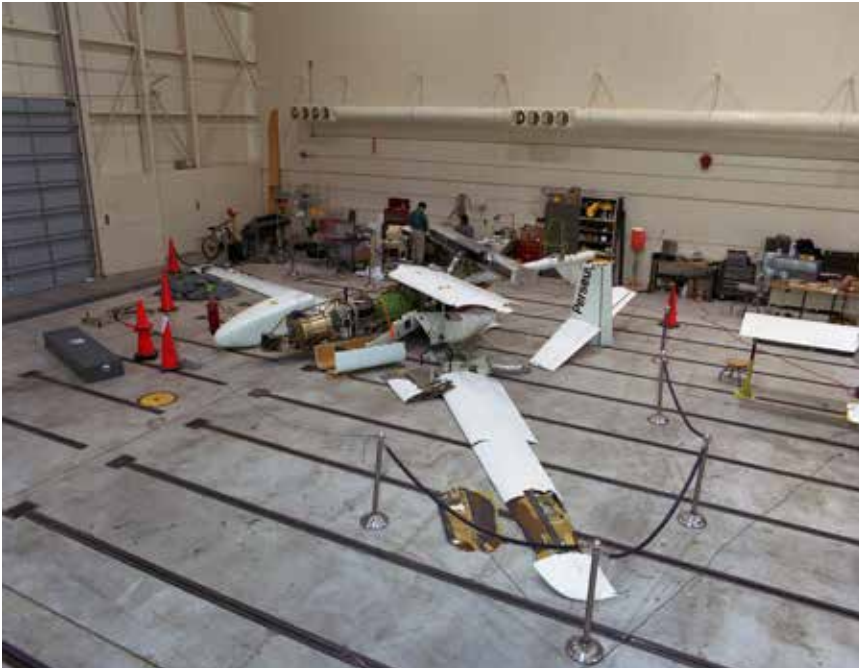
Investigators recommended that the Perseus vehicles not be flown again until the vertical gyro failure was resolved. NASA

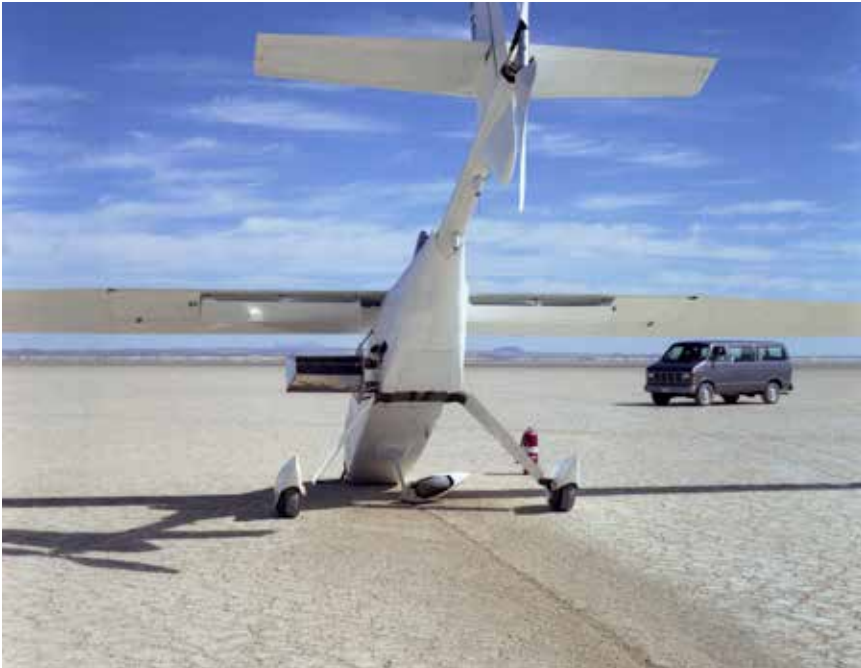
Nose-gear collapse following the maiden flight of Perseus-B damaged the vehicle's composite nose assembly. NASA

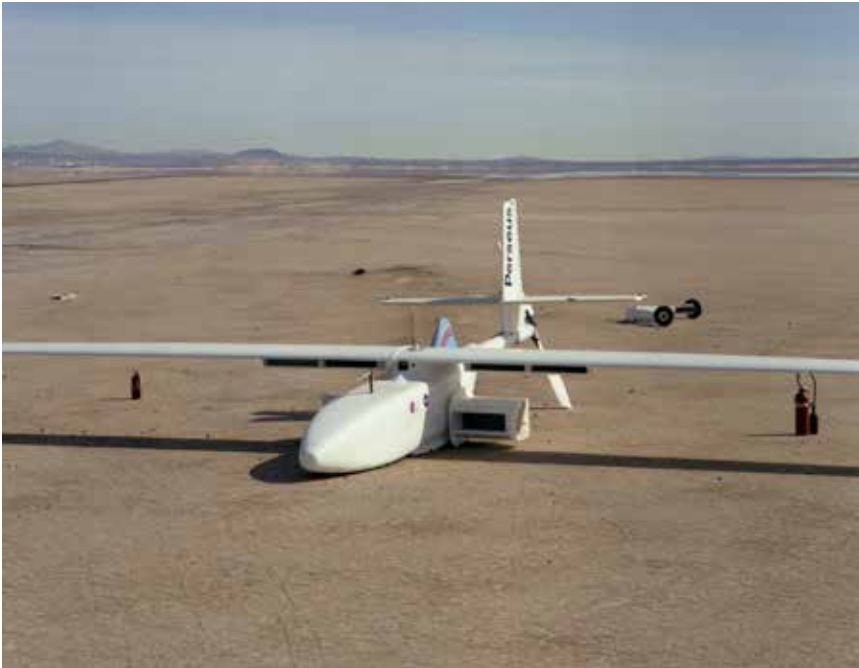
During a 1996 flight, a hard touchdown on the lakebed resulted in major damage to the landing gear, nose, and propeller tips. NASA

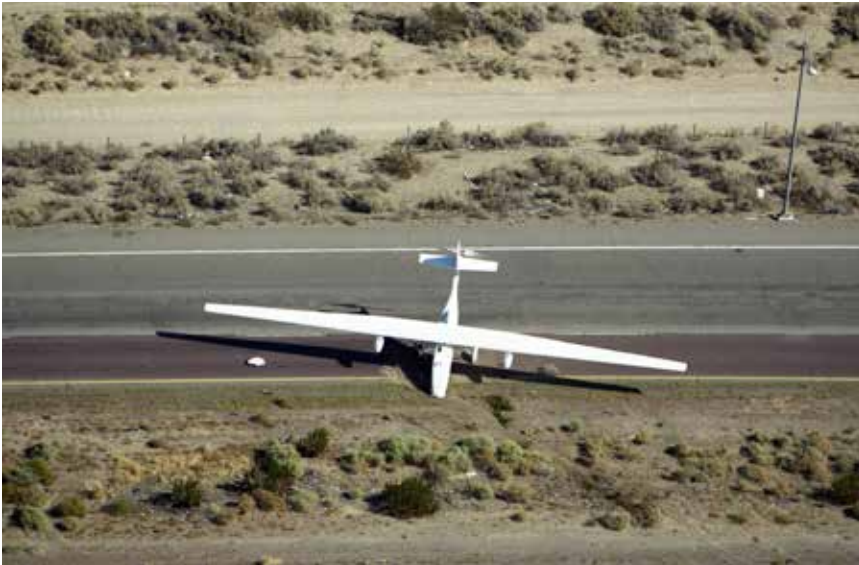
Failure of the flight-termination system led to an unplanned landing of Perseus-B on a major highway. NASA

- Provide a backup FTS capability.
- The host agency should take an active role in regard to safety, engineering oversight, inspection, and monitoring.

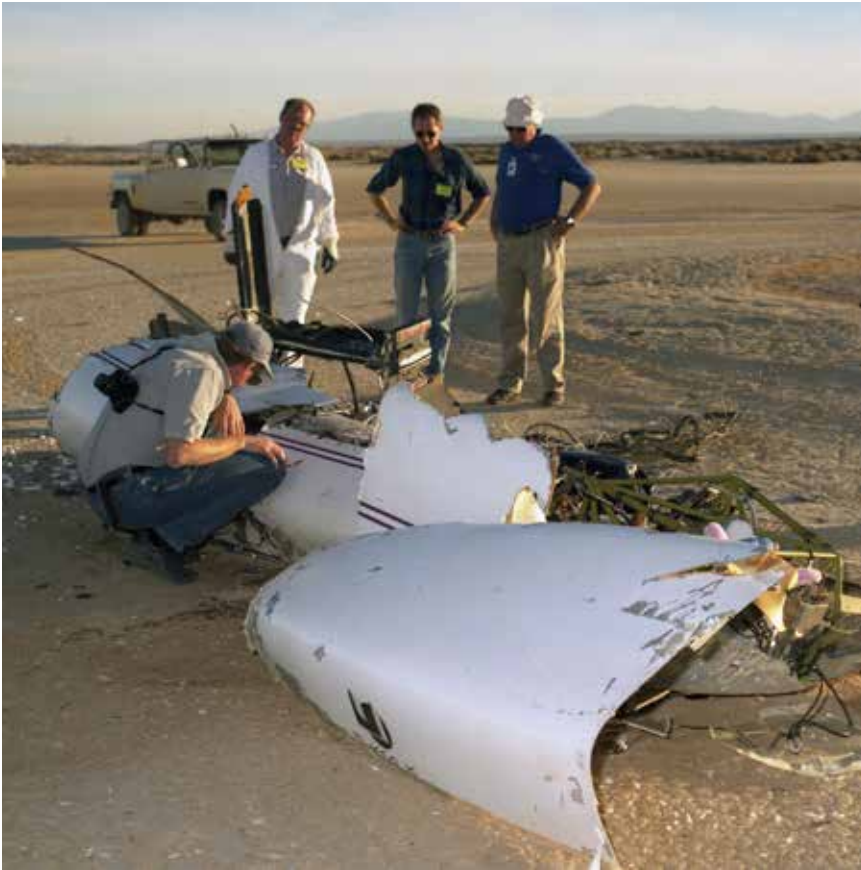
Investigators examine Theseus wreckage at the crash site near the north end of Rogers Dry Lake, within the boundaries of Edwards Air Force Base. NASA

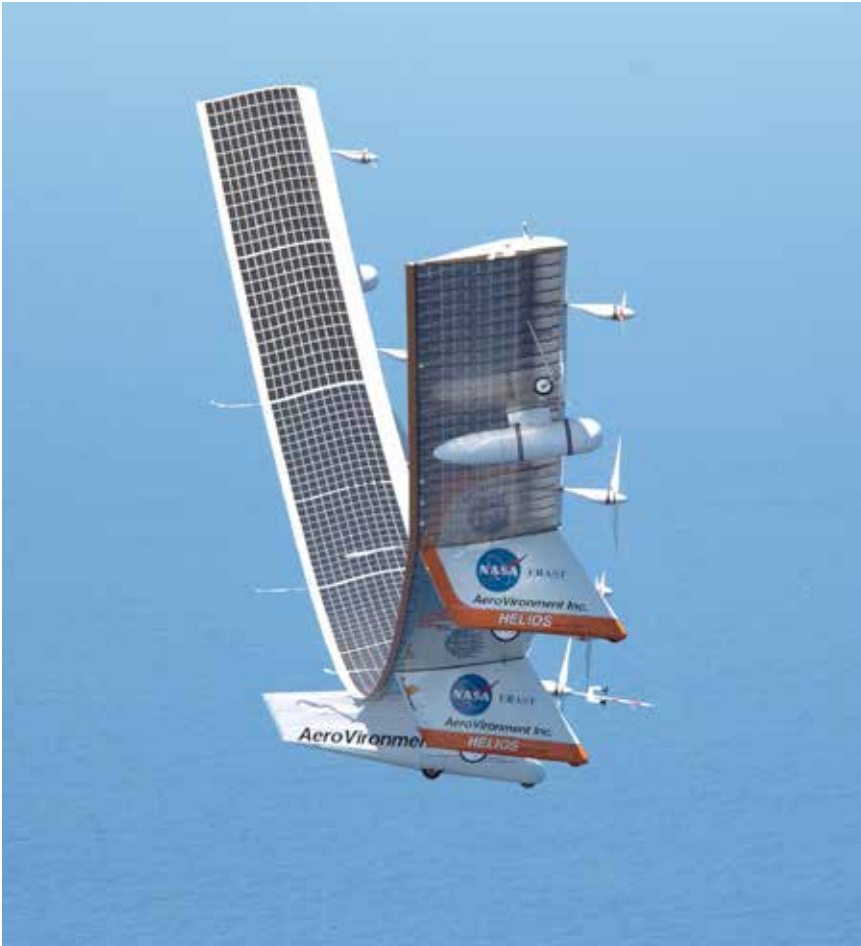
During a flight with excessively turbulent conditions, the Helios Prototype's wing structure experienced extreme dihedral. NASA

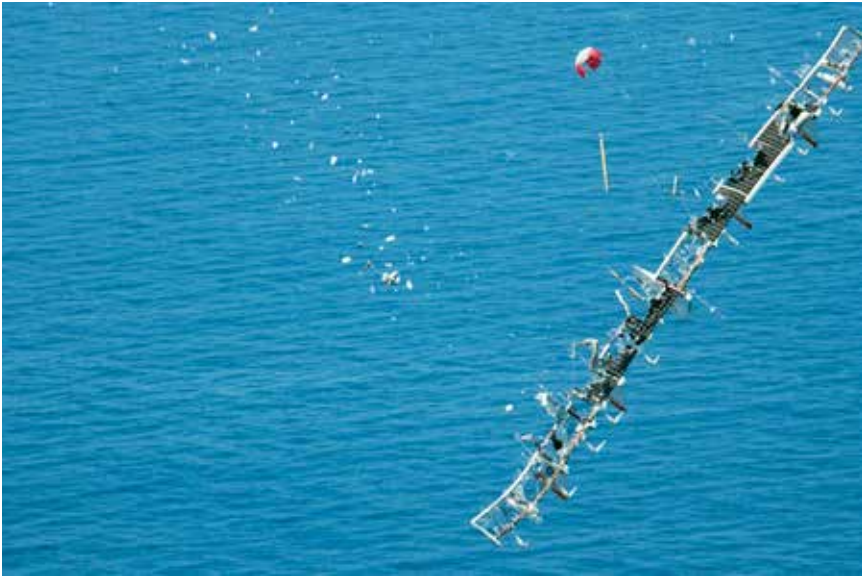
The Helios Prototype sheds parts as it plummets toward the ocean. The FTS worked exactly as designed. NASA

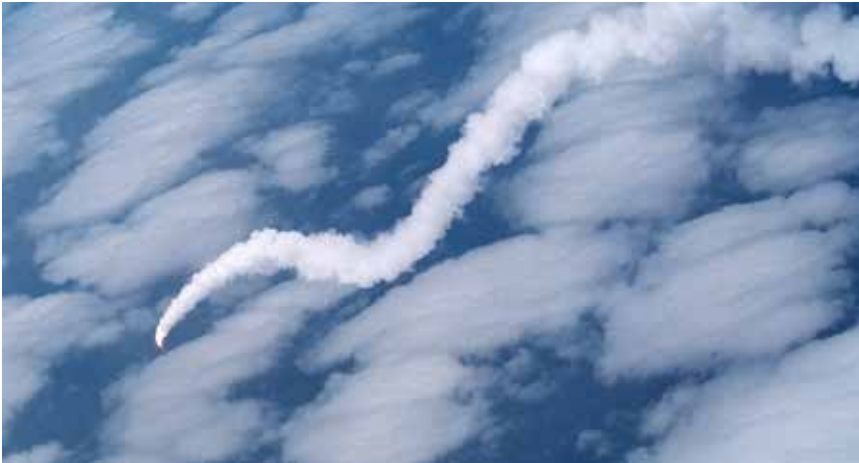
Divergent roll oscillatory motion caused by excessive control-system gain resulted from inadequate analytical modeling that allowed engineers to overestimate system safety margins. NASA

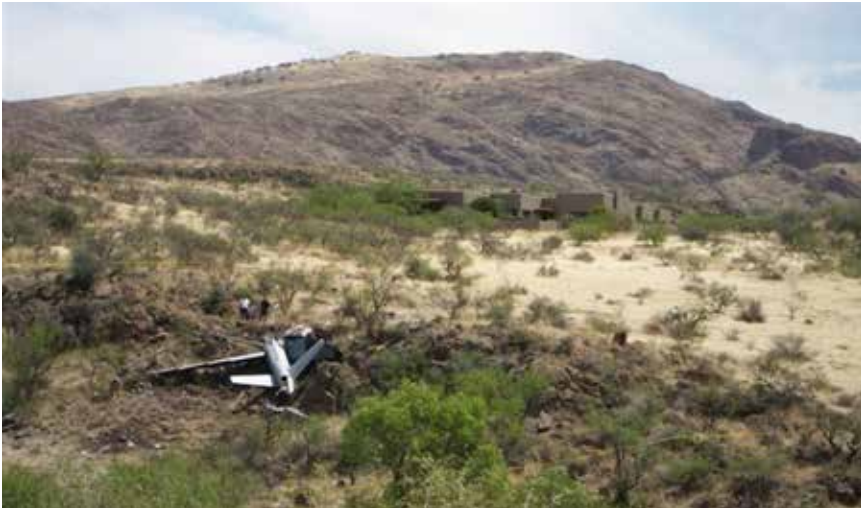
The MQ-9 crashed in a sparsely populated residential area, but there were no injuries or damage to private property. Mae Duggin
