Report SAM-TR-77-19

OPTICAL EVALUATION OF F/FB-111
FIELD-SERVICE-TEST WINDSHIELDS

September 1977

Progress Report for Period 17 April 1975-16 November 1976

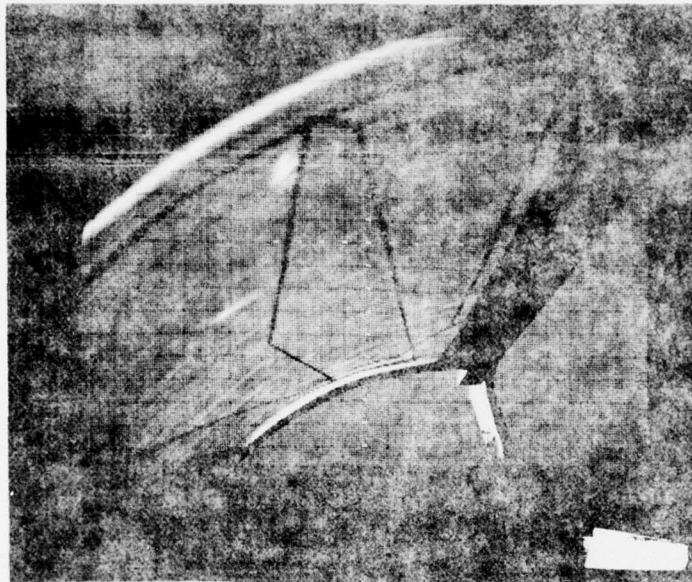
Figure 3. Grid-board distortion photograph--prefield test.

All but two of the original 20 field-test windshields met optical specifications (late in the study three replacement windshields exceeded displacement-grading specifications). The two originals exhibited slightly higher-than-acceptable deviation values near the fore-arch area, and one displayed a "bull's eye" at the upper left area near the optical free zone, as seen in Figure 3. These properties were not considered a compromise to flight safety, and the subspecification windshields were included in the field test. Questionnaires were distributed to the using squadrons, and responses on these two windshields were not particularly different from the flyer reactions on the rest of the windshields. Roll or band distortion, apparent in all windshields, was most pronounced near the edges and toward the lower one-third of the windshield, i.e., toward the fore arch. Windshields of later production runs showed less severe distortion bands.

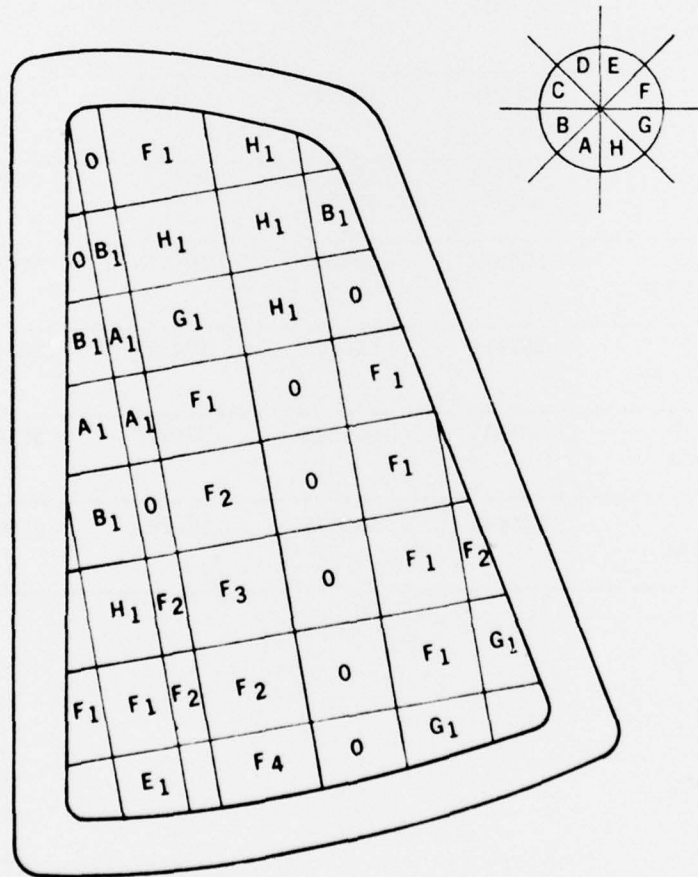
Figure 4. Pre-service-test deviation map.

Postservice evaluations of seven windshields are included in the data section (see Table 1). As had been forecasted, haze values of these sets increased due to exterior surface erosion caused by the flight environment and improper cleaning procedures. Surface scratching is presumed to be the primary causative factor, since hand polishing of windshields 503929 and 504995 reduced the haze. Comparisons of prism-deviation maps of three windshields (504990, 504995, 503931) before and after field use are within instrument-error tolerance, indicating no change in optics due to aging or environmental factors. Figures 4 and 5 are pre- and postservice maps of one typical windshield (504995). Distortion photographs before and after field use of the three windshields also show no changes.
