Engine malfunction involving Cessna 208B, VH-LNH

near Kununurra Airport, Western Australia, 8 August 2015

ATSB Transport Safety Report
Aviation Occurrence Investigation
AO-2015-094
Final – 27 May 2016

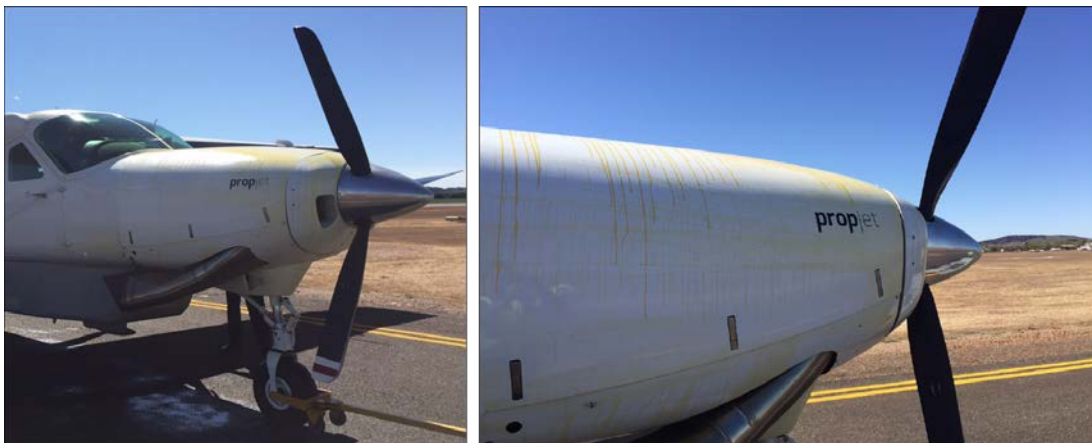
After exiting the runway and coming to a stop, the pilot completed the engine shut-down checks. No reaction was felt or heard when the pilot selected the propeller lever to the feather position as part of the shutdown procedure (normally, there was an audible change as the pitch of the propeller changed). After exiting the aircraft, the pilot found that the propeller was in the feather position, and had seized. The extent of oil loss was also apparent, with oil smeared over much of the forward fuselage, particularly the engine cowls and windscreen (Figure 1).

Figure 1: Photographs of VH-LNH after the aircraft had landed, with oil visible on the engine cowl and forward fuselage

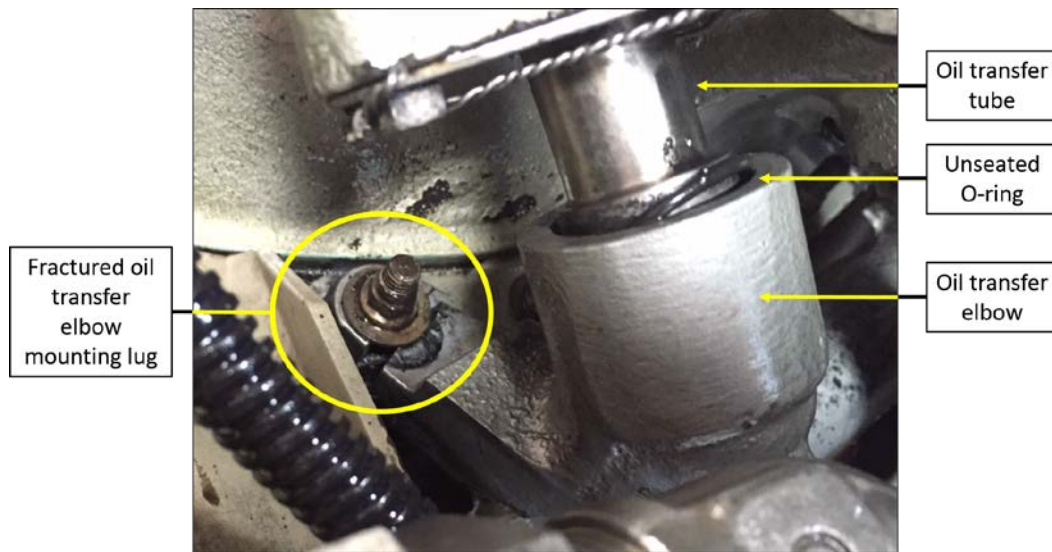
Subsequent on-site inspection of the engine by engineering staff revealed that an oil leak had developed at a join between the oil transfer elbow and oil transfer tube at the forward end of the engine. This assembly was part of a larger assembly that transferred oil under pressure to the reduction gearbox at the front of the engine. One of the oil transfer elbow mounting lugs (that secured the elbow to engine assembly) was found to be fractured, allowing the oil transfer elbow to move and unseat the O-ring between the elbow and the tube (Figures 2 and 3).

Figure 2: Photograph (in situ) showing fractured oil transfer elbow mounting lug and the unseated O-ring seal

- The fracture of the lug occurred due to fatigue originating from multiple locations on the side of the mounting lug that meets with the face of the mounting flange. The fatigue mode was found to be high-cycle, under unidirectional bending.

- Wear and imprint marks on the securing assembly (bolt, nut and washer) and the fractured lug suggested that the bolt was sitting askew in the bore of the flange to which the elbow mounting lug was secured. The report commented that this wear pattern was consistent with a lack of pre-load on the bolt.

- The lack of pre-load on the bolt that secured the mounting lug to the flange was considered to be the initiating factor that led to fracture of the mounting lug. The reason for the lack of pre-load on the bolt could not be ascertained.

- Paint-free lug and flange mating surfaces: Paint on the elbow mounting lug and/or the mating face of the flange to which the lug is secured may wear with working and vibration. This wear has the potential to loosen the fastener and amplify the effects of vibration on lug security.
- Lug strengthening: The construction of the elbow transfer tube is such that the mounting lug itself is substantially narrower than the stem leading to the lug (see Figure 4). Added thickness/material depth would strengthen the lug.
- Expanded and mandated inspection: Mandating inspection of the elbow mounting lug (see CASA Airworthiness Bulletin 72-004 below), and including oil transfer elbow mounting lug inspection as a specific task during relevant engine servicings.

Prior to this incident, the operator was already in the practice of periodically inspecting the area of the fractured lug (although those inspections did not alert the operator to the problem in this case). In response to this incident, the operator intends to expand the periodic inspection to include removal of the bolt and an inspection of the internal radius of the mounting lug for signs of crack development.

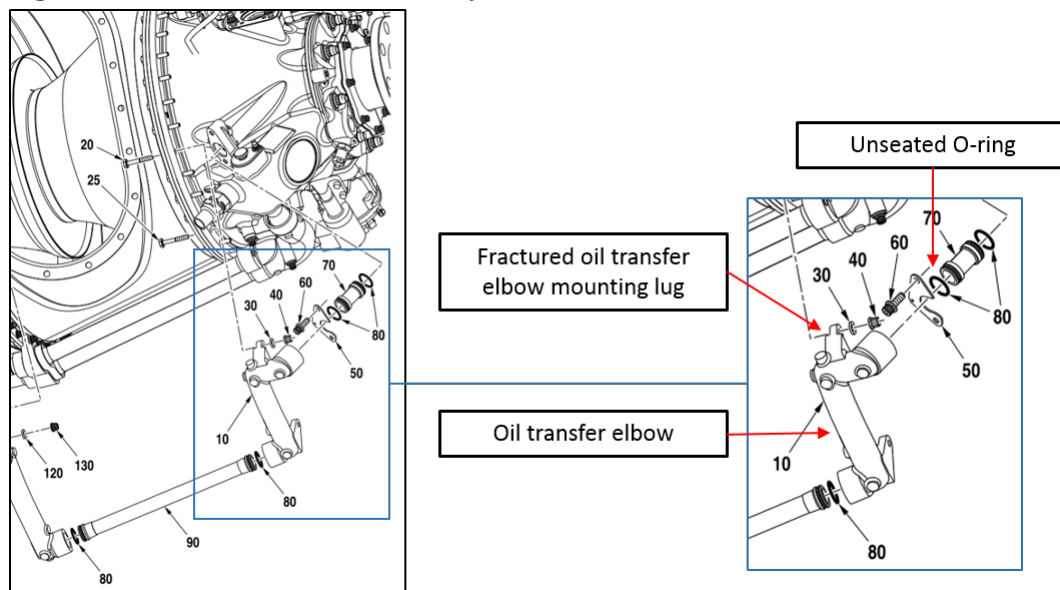
Figure 3: Oil transfer elbow assembly

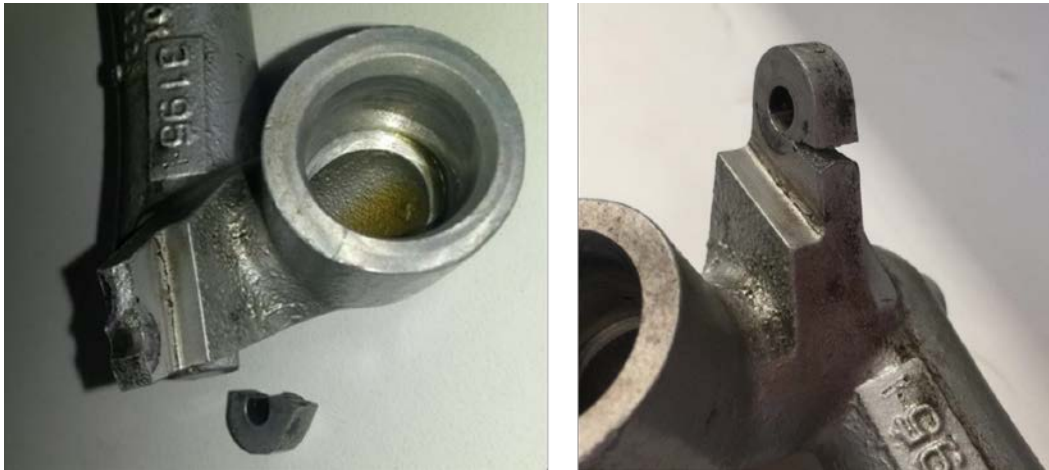
Inspection of the engine confirmed that an oil transfer elbow mounting lug had fractured and the report noted that the 'hardware holding it in place was loose'. The lug was found to have completely broken through, and it was noted that a segment of the lug was missing (Figure 4). The report also noted that the O-ring (see Figures 2 and 3) had moved.

Figure 4: Fractured lug (the figure on the right shows that a segment of the lug was missing)
