Flight Trials of a Rocket-propelled Transonic Research Model: The R.A.E.-Vickers Rocket Model

Parts I to IV

The Staff of the Supersonics Division, Flight Section,
Royal Aircraft Establishment

*Reports and Memoranda No. 2835**

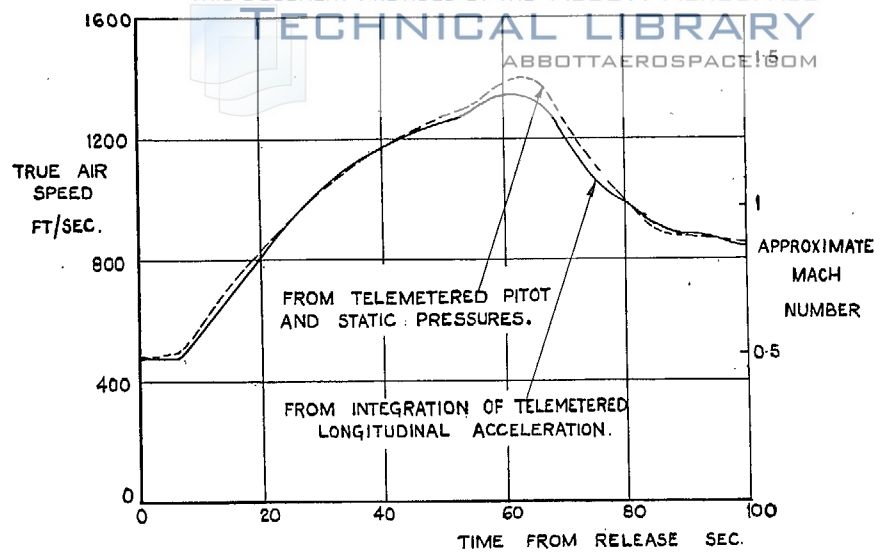
FIG. 7. Variation of speed during flight.

The speed histories obtained in the two ways are in very good agreement except at the end of burning and just after, when the speed as computed from the pitot and static pressures is about 4 per cent greater than that computed from the longitudinal acceleration. The discrepancies which exist are probably explained largely by the fact that no correction was applied to the longitudinal accelerometer record to allow for the effect of the component of gravity when the test vehicle was not at zero attitude. Naturally, at the time of the first computation of the velocity the variation of the attitude during the flight was not known, and as subsequent computation showed that there was some doubt about the accuracy with which the attitude could be obtained (*see* section 7) no retrospective computation of the speed from the longitudinal accelerometer record was made. The evidence suggests that the corrections, if applied, would tend only to increase the speed by a small amount at one instance and reduce it at another, without affecting the general variation with time. The maximum correction to the longitudinal acceleration would be of the order of $0.1g$, and corrections of this order should strictly be applied from 80 seconds after release onwards, when there is evidence (*see* Fig. 18) that the test vehicle was pitching appreciably. This pitching probably explains the kicks in the longitudinal acceleration record from 80 seconds onwards shown in Fig. 8. However, any corrections would not alter the speed by more than 2 per cent, and as the effects on the aerodynamic quantities of a speed error of this order are very much less than the possible errors in the quantities which are considered below, it is considered that the agreement shown by Fig. 7 is sufficient.

It will be observed that the maximum speed of the test vehicle occurred about 62 seconds after release, and was about 1,350 ft/sec, corresponding to a Mach number of about 1.4.

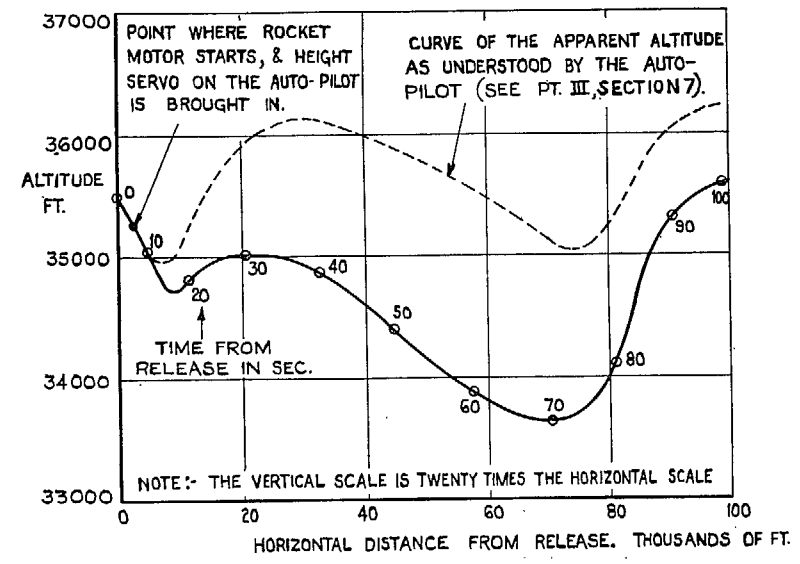
FIG. 9. Variation of altitude during flight.

The disturbing feature, however, was that the amount of drift that was implied was considerably more than one would expect from purely electrical causes, even although the frequency channel used for telemetering normal acceleration was the one most subject to drift. There may have been some other cause of error that was showing itself as 'drift', but naturally the matter cannot be investigated, and one can but accept the result obtained as the most probable record of the flight path. There are, however, two points which suggest that the probable flight path, as shown in Fig. 9, may not be far from the truth.

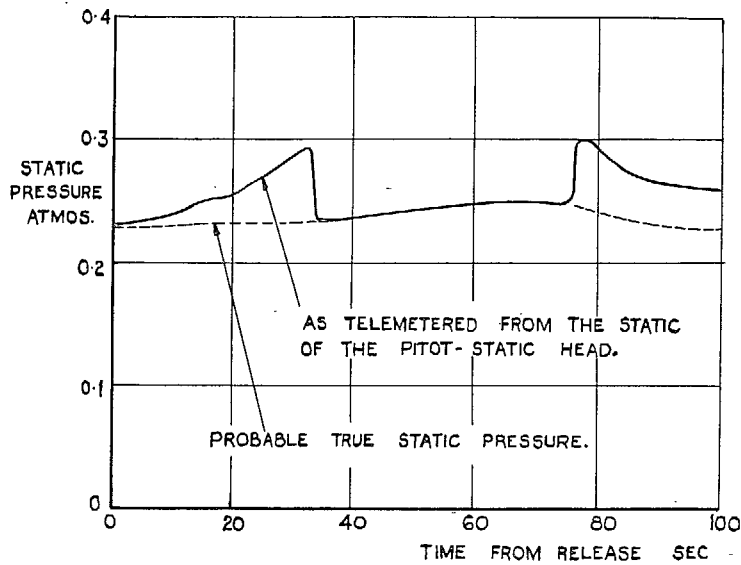
FIG. 11. Variation of static pressure during flight.

Up to 33 seconds after release, and from 76 seconds onwards, the probable true static pressure was deduced from the altitude, as mentioned in section 3, and is shown by the broken line in Fig. 11. It is therefore possible to calculate the position error, or difference between true and measured static pressures, over the speed range. The result is shown in Fig. 12, where the static pressure, expressed as a coefficient, is plotted against Mach number. As the static-pressure coefficient is obtained from the difference between two quantities of roughly the same order of magnitude, it is subject to a probable error of about 0.02, and to this order of accuracy there was no difference between the static-pressure coefficient at a certain Mach number obtained whilst the test vehicle was accelerating and the value obtained at the same Mach number during deceleration.

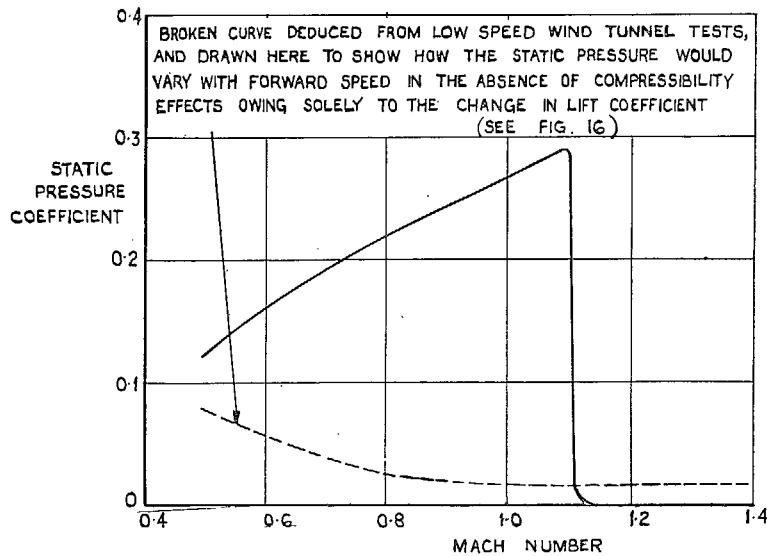
FIG. 12. Variation of static pressure at the position of the static of the pitot-static head with Mach number.

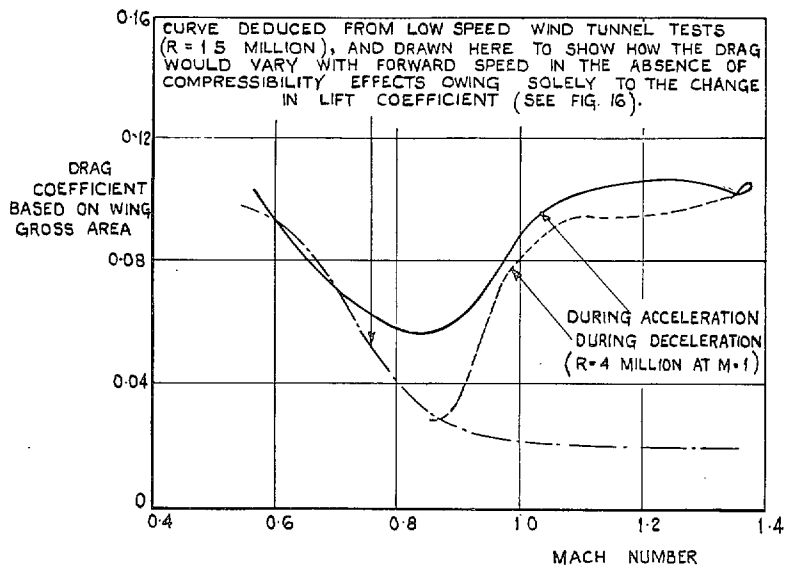
FIG. 15. Variation of drag with Mach number.

6. *Drag*.—From a knowledge of the thrust of the rocket, shown in Fig. 14, the weight of the test vehicle, which decreased linearly from 937 lb at the start of burning to 663 lb at the end, and the longitudinal acceleration, shown in Fig. 8, the drag of the test vehicle during the flight was determined. It is shown in Fig. 15 as a curve of drag coefficient against Mach number. A curve of lift coefficient against Mach number is shown in Fig. 16.

The agreement in the values of drag coefficient obtained during acceleration and deceleration is fair only, and this is probably due to the lower accuracy of the results during the deceleration period owing to the uncertainty regarding when, exactly, the rocket ceased burning.

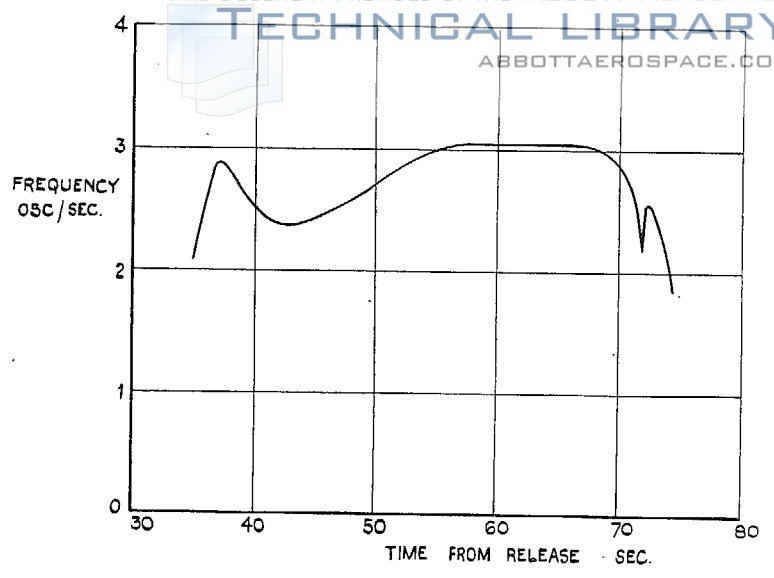
FIG. 19. Variation of frequency of oscillations in tailplane angle and normal acceleration during flight.

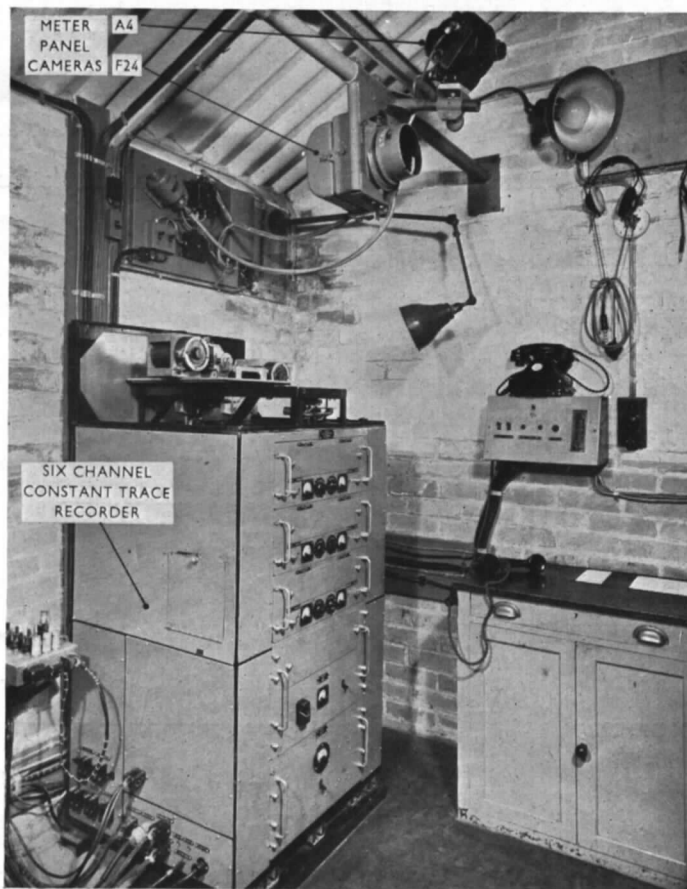
a. Filters, power packs, counter panels.

b. Constant trace recorder.

FIGS. 32a and 32b. Telemetry reception equipment at Scilly Isles.

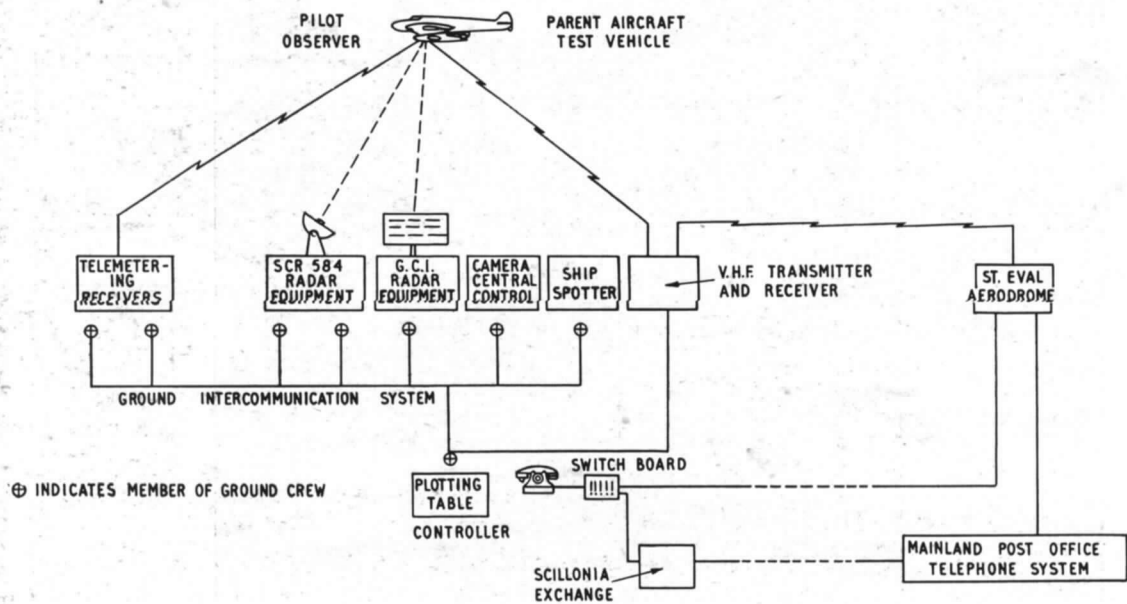
FIG. 34. Arrangement of communications at Scilly Isles ground station.
