MINISTRY OF SUPPLY  
AERONAUTICAL RESEARCH COUNCIL  
REPORTS AND MEMORANDA

# Improvements in the Fatigue Strength of Joints by the Use of Interference Fits

*Reports and Memoranda No. 2874\**

*May, 1952*

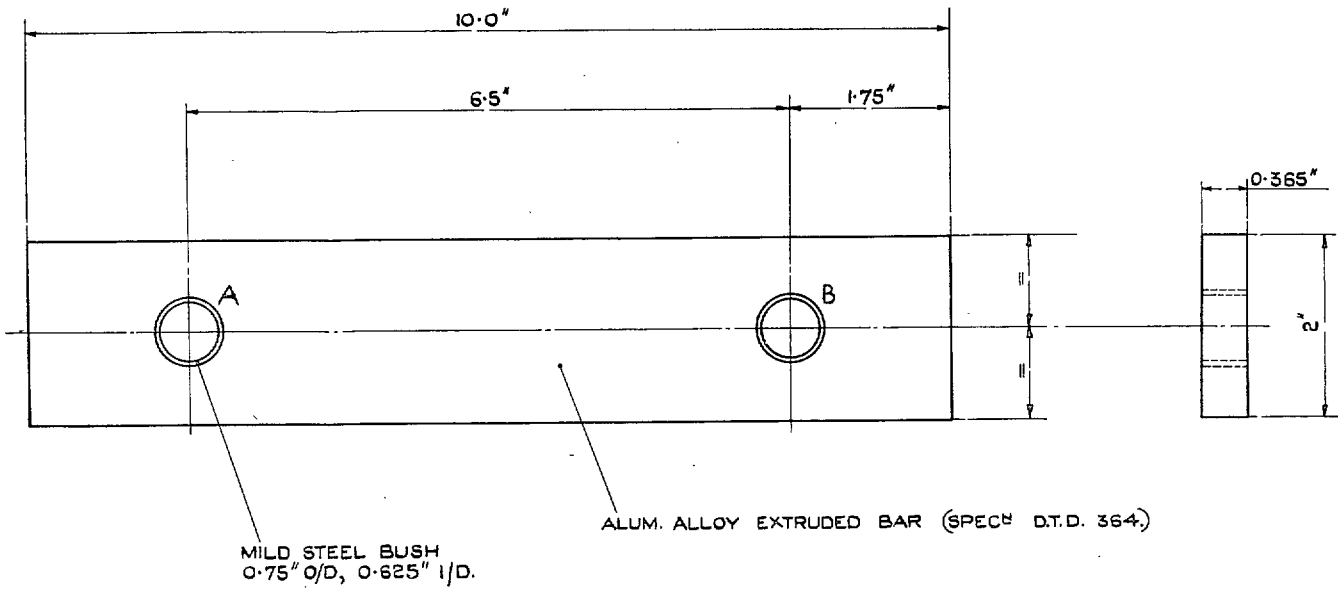
NOTE. THE ABOVE DIMENSIONS ARE NOMINAL  
 ACTUAL DIMENSIONS OF INDIVIDUAL  
 SPECIMENS ARE GIVEN IN TABLE I.

FIG. 1. Loaded bushed hole fatigue test specimen.

*2.1. Test Specimens.*—As indicated on Fig. 1, the test specimens were simple links made from aluminium alloy extruded bar (D.T.D.364) of 2-in.  $\times$   $\frac{3}{8}$ -in. cross-section, the original surface having been removed by grinding. The  $\frac{3}{4}$ -in. holes in the bars were reamed and burrs removed. Prior to assembly, the holes and the ground-finish mild steel bushes were accurately measured and subsequently matched to give a series of specimens with a variety of interference fits ranging from 0.0009 in. to 0.0028 in. in diameter. The loads required to insert the bushes, which were lightly greased prior to assembly, are given in Table 1 and Fig. 3. The measurements across two diameters of each bush and hole are given in Table. 1.

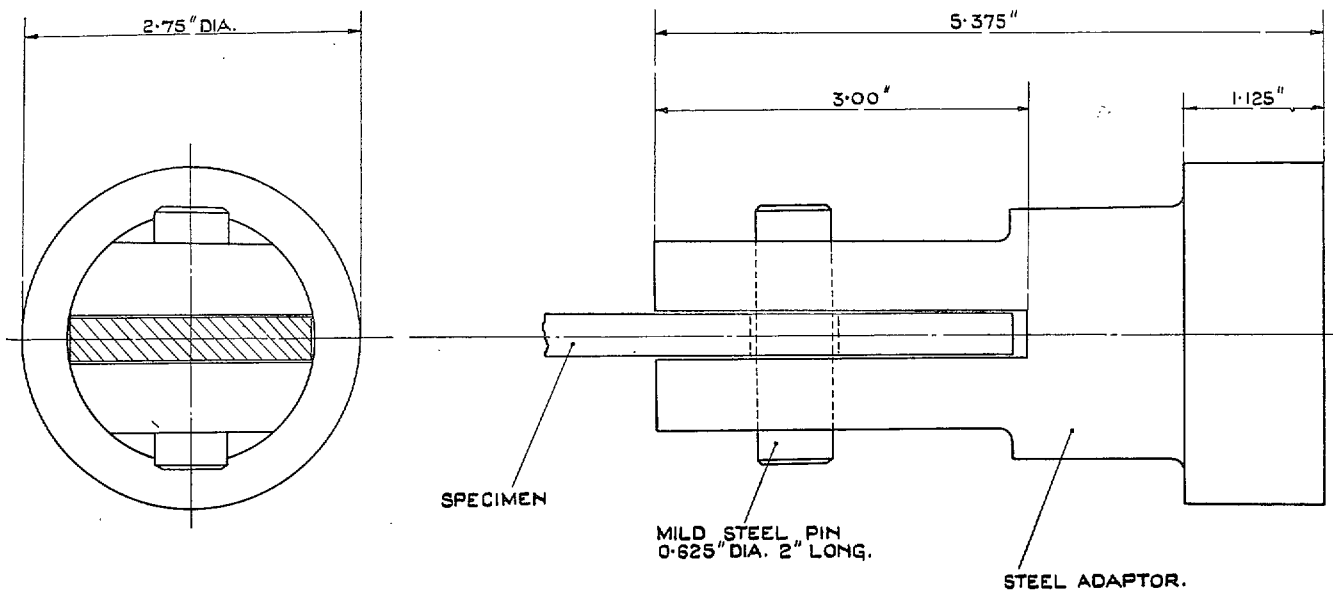
FIG. 2. Specimen adaptor fitting. Loaded bushed holes.

*2.2. Method of Testing.*—Steel adaptor fittings, as shown in Fig. 2, were used for mounting the specimens in the 20-ton Avery Schenck Fatigue-Testing Machine.

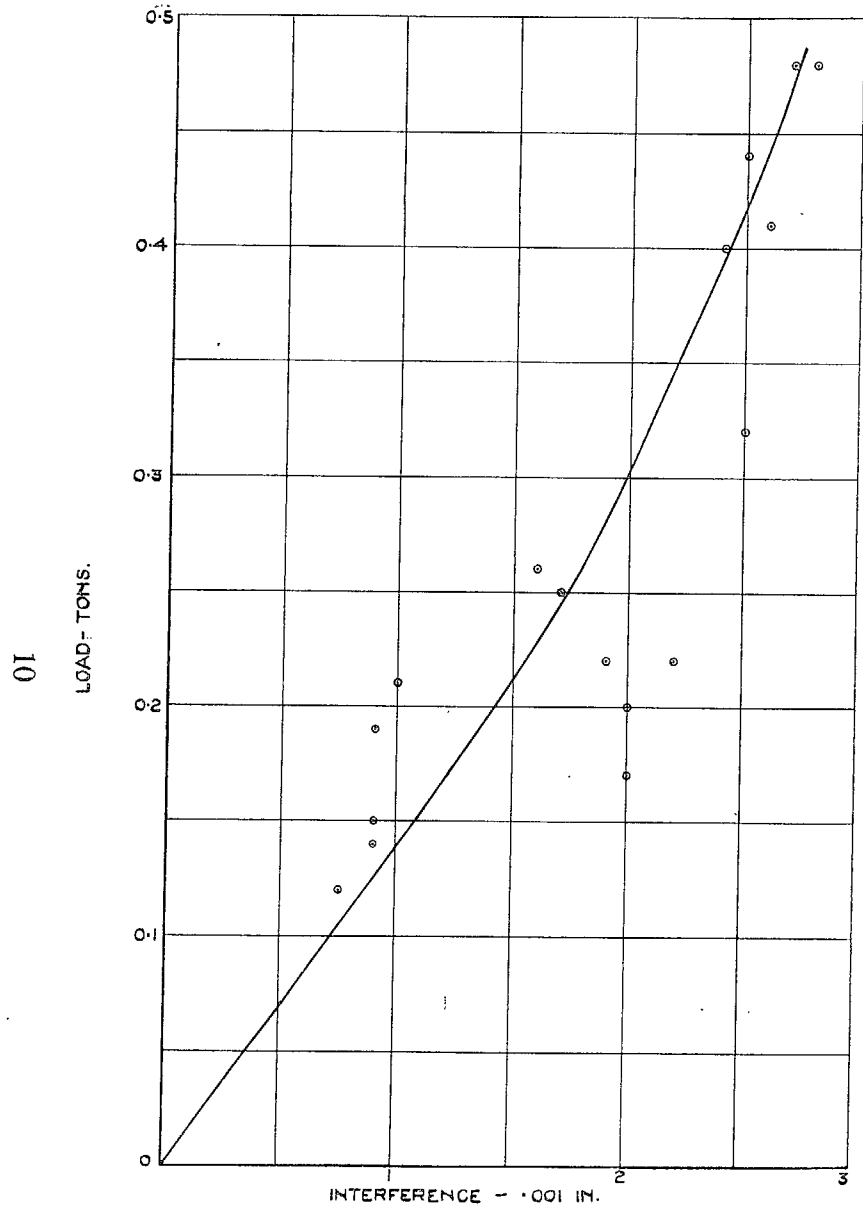
FIG. 3. Relationship between the load required to insert the bush and the interference between the bush and the hole. (Fatigue tests on loaded bushed holes.)

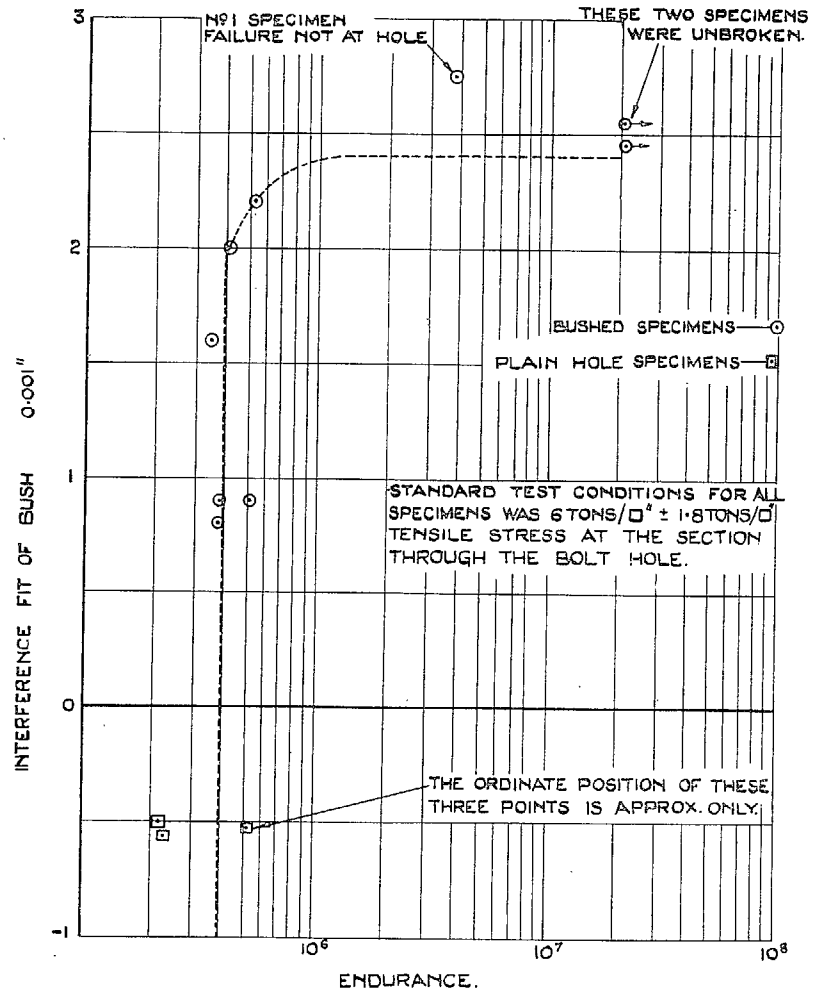
FIG. 4. Relation between degree of fit and endurance. Loaded bushed holes.

*2.4. Test Results.*—The test results are shown on Table 2 and Fig. 4. It will be seen that lugs with bushed holes with interference fits of up to 0.002 in. give endurance values neither appreciably better nor worse than those of the similar plain-hole specimens Nos. 10 to 12, whereas interference fits of more than approximately 0.0025 in. produce a great increase in endurance. In Fig. 5 the results are plotted as stress against endurance. The endurance curve shown for comparison is representative of some of the best aircraft structural joints tested to date. Photographs of typical specimen failures are shown on Fig. 6. Photographs of the fractured surfaces are shown on Fig. 7.

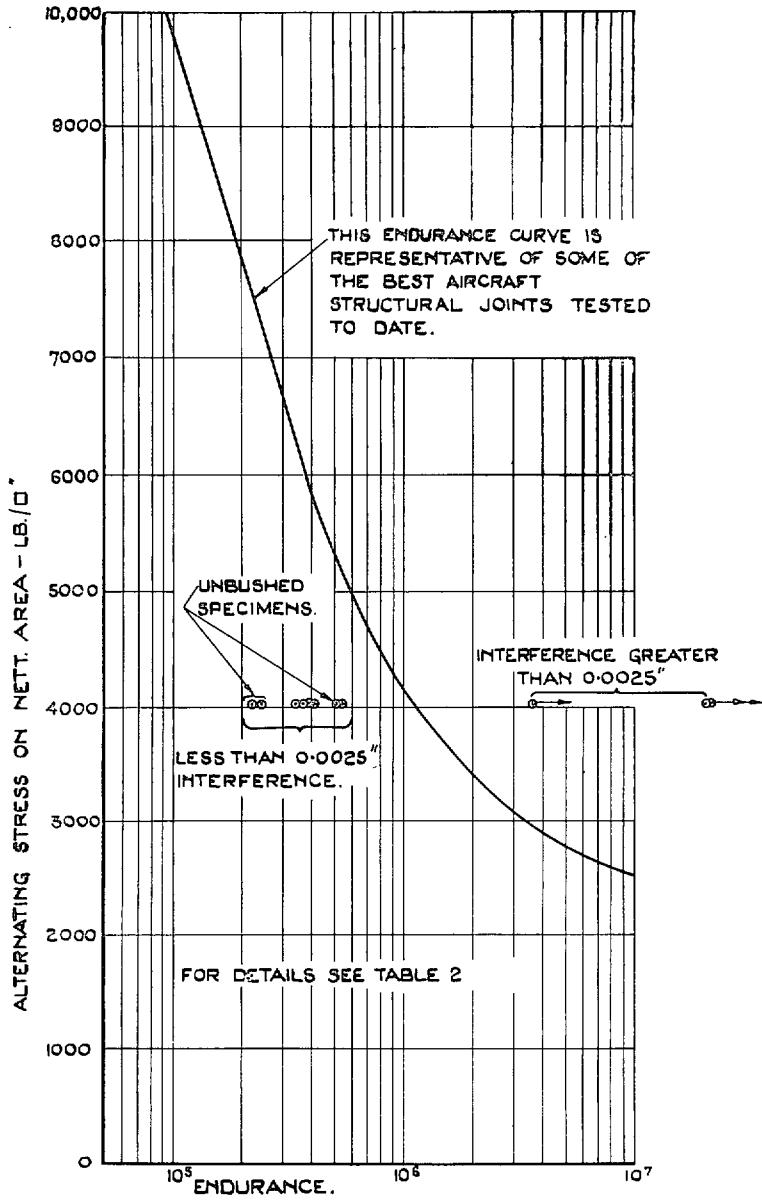
FIG. 5. Comparison of test results with similar data from aircraft structural joints of good fatigue strength. Loaded bushed holes.

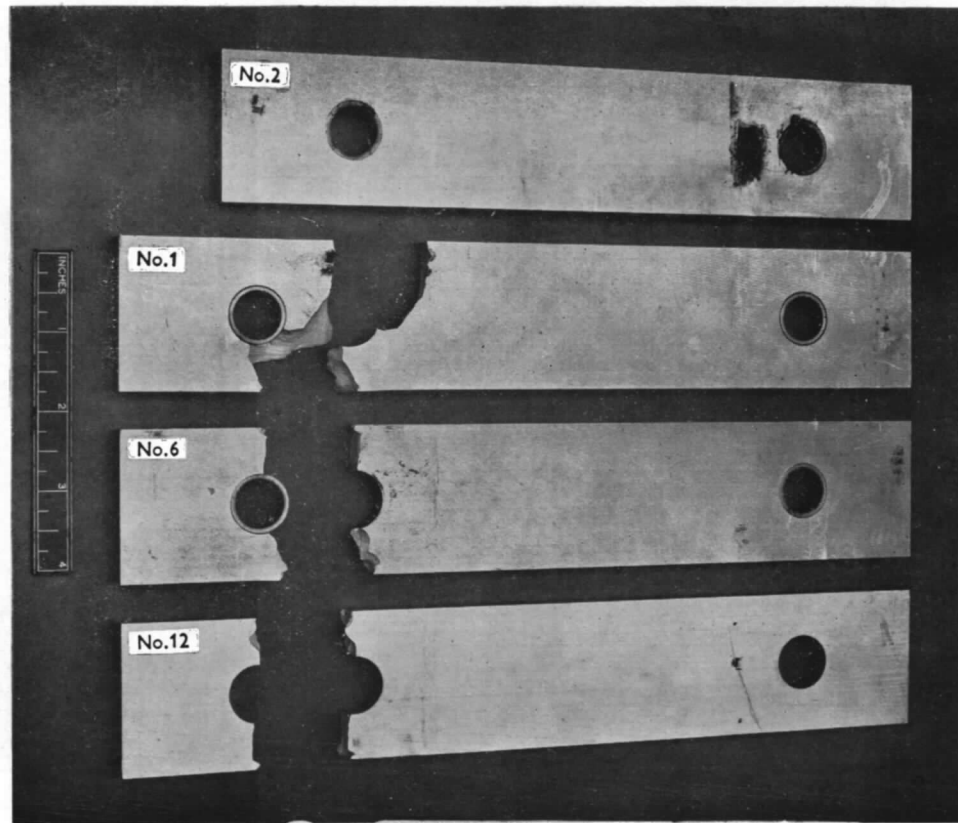
SPECIMEN	INTERFERENCE BETWEEN BUSH & HOLE	ENDURANCE (CYCLES)
No.2	0-0025"	20,891,500
No.1	0-0028"	3,650,000
No.6	0-0016"	341,100
No.12	NO BUSH	239,800

FIG. 6. Failure of test specimens. Loaded bushed holes.

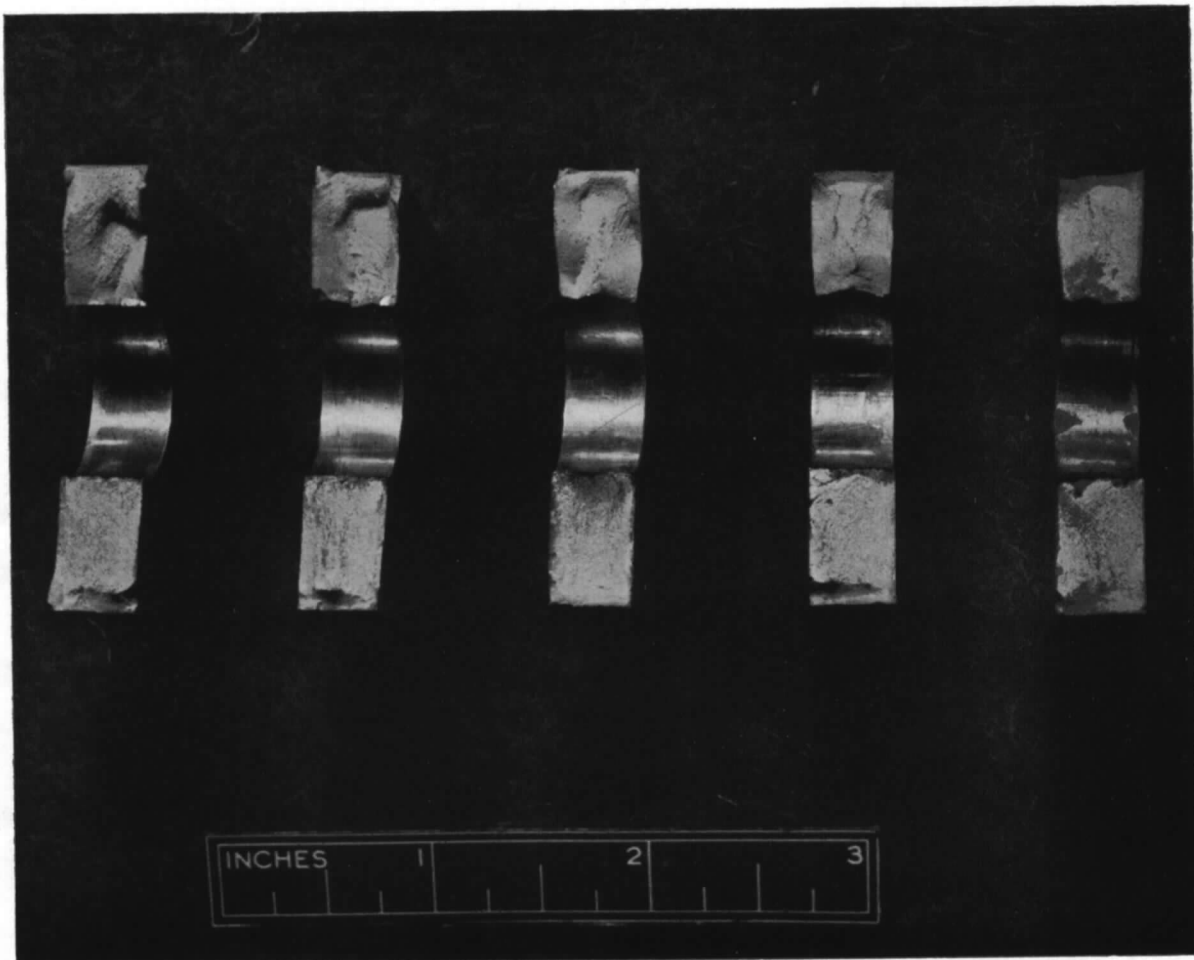
FIG. 7. Mode of fracture of bushed-hole specimens. Fatigued portion of fracture is confined to only one side of the hole. Loaded bushed holes.

It may be observed that the bushed specimens tended to fracture in fatigue on only one side of the hole, the other side failing statically; plain-hole specimens, on the other hand, consistently produced areas of fatigue on both sides of the hole as shown in Fig. 12.

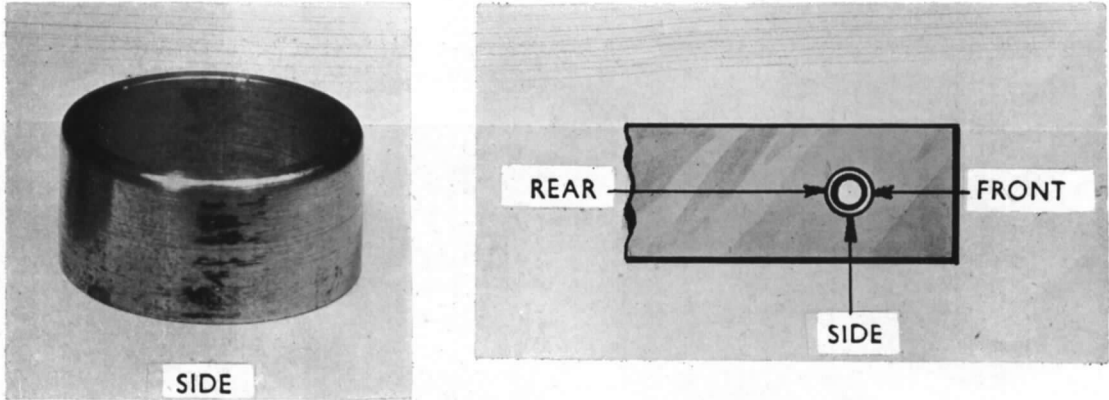
FIG. 8a. Small interference. 310,000 cycles.

FIGS. 8a and 8b. Comparison of fretting on bushes.

On the other hand, fretting between the bush and the light alloy bar occurs normally at the flanks, where the peak tensile stress in the bar is to be found. Fretting marks at the side of a bush which had low interference (approximately 0.001 in.) are shown in Fig. 8a. After only 310,000 cycles the flanks of the bush show strong fretting marks.

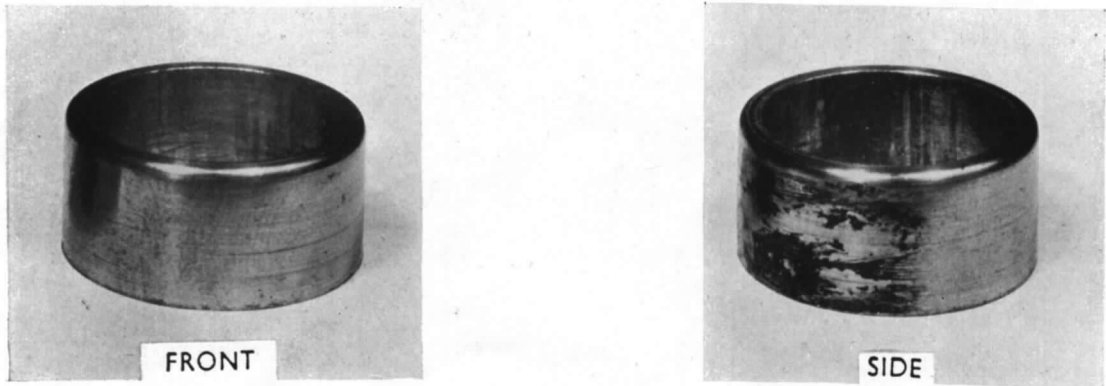
FIG. 8b. High interference fit over 12 million cycles.

Fig. 8b shows front and side views of a bush with high interference fit after more than 12 million cycles. Severe fretting is shown on the rear face. At the side, the fretting is no worse than in Fig. 8a, and the front is completely free from fretting.

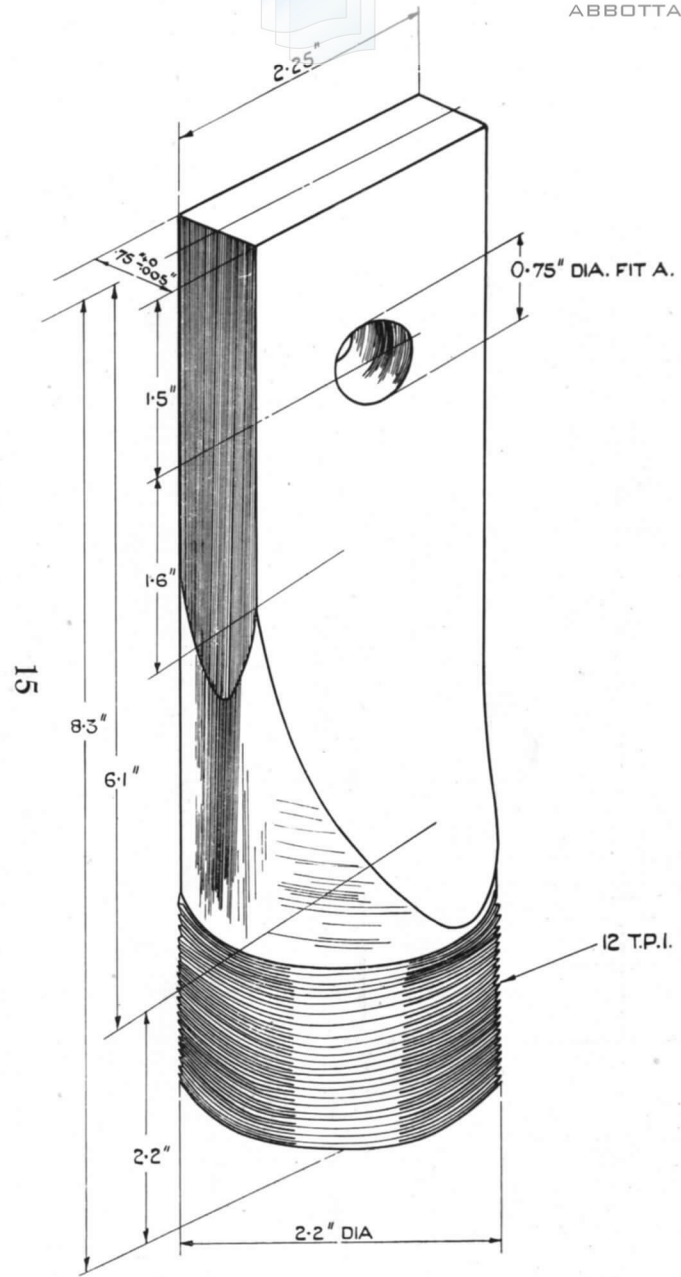
FIG. 9. Plain loaded hole fatigue test specimen

3. *Tests on Loaded Plain-Hole Specimens with Different Degrees of Interference Fit.*—3.1. *Test Specimens.*—The material for these specimens was aluminum alloy extruded bar to Specification D.T.D.364B. The flat surfaces were ground free from scratches and tool marks; the holes were reamed to size and burrs removed. Geometric details are given on Fig. 9. The  $\frac{3}{4}$ -in. diameter holes were accurately measured, and fine ground mild steel pins were selected to obtain fits varying between 0.0008 in. clearance to 0.0034 in. interference. The pins were greased on assembly and were inserted with a hammer.

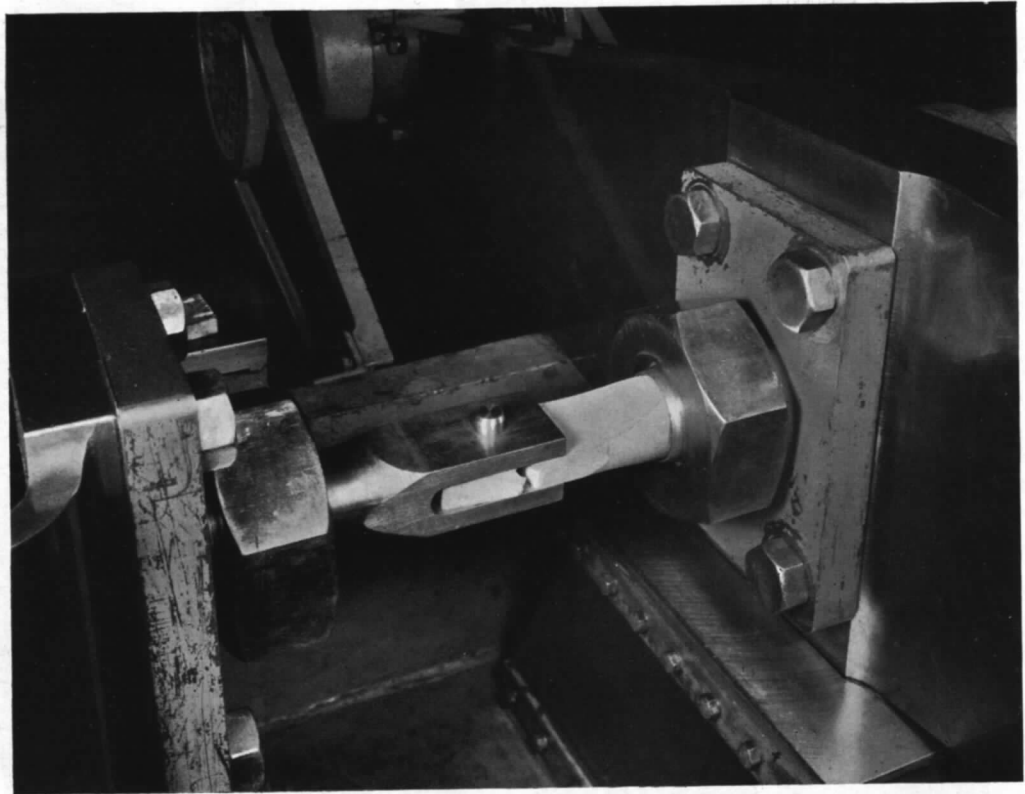
FIG. 10. Installation of test specimen in 20-ton Avery Fatigue Testing Machine. Plain loaded holes.

3.2. *Method of Testing.*—The tests were carried out in the 20-ton Avery Schenck Fatigue-Testing machine. Fig. 10 shows a fractured specimen in the machine.

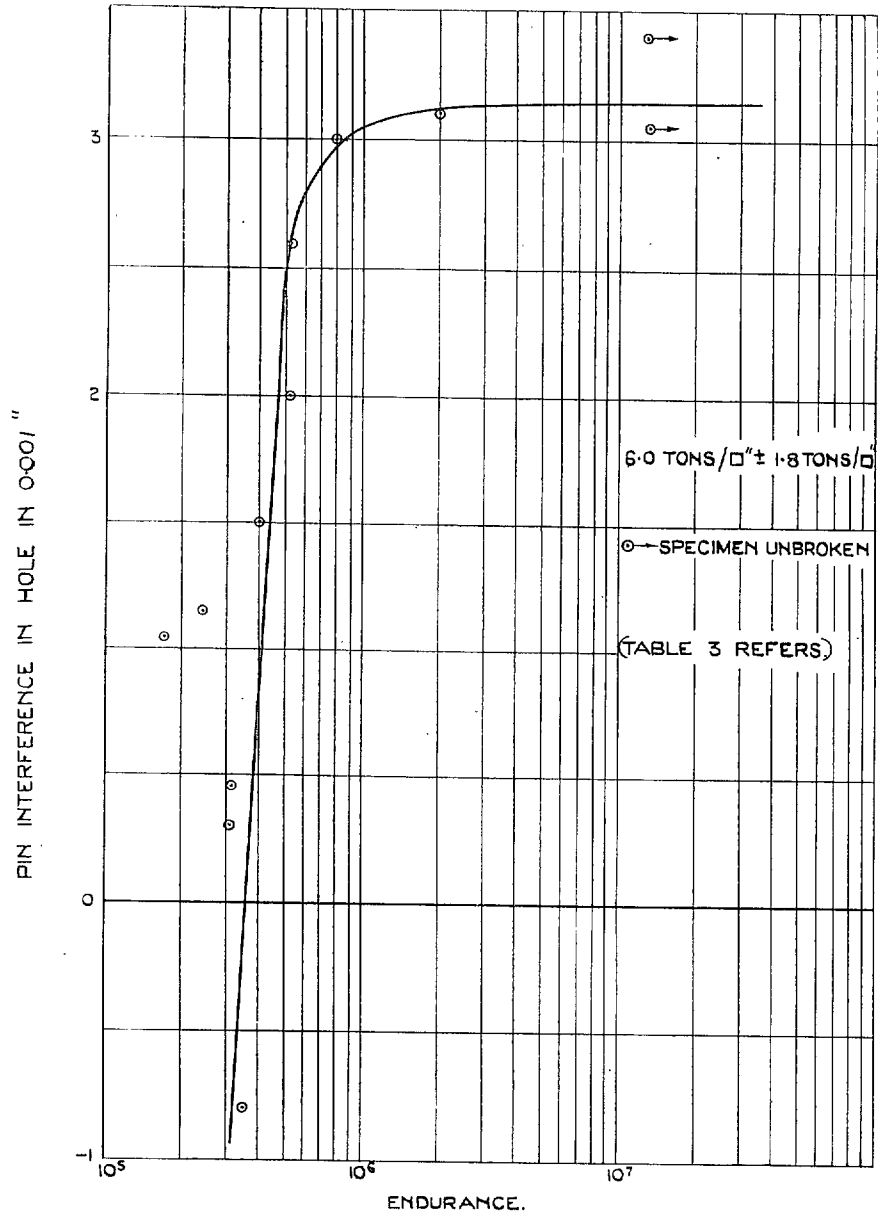
FIG. 11. Pin interference vs. endurance. Loaded plain hole fatigue tests.

3.4. *Test Results.*—The test results are given on Table 3 and on Fig. 11.

It will be noted that in these tests the large increase in endurance occurs at fits of 0.003 in. interference, compared with 0.0025 in. interference in the bushed hole tests.

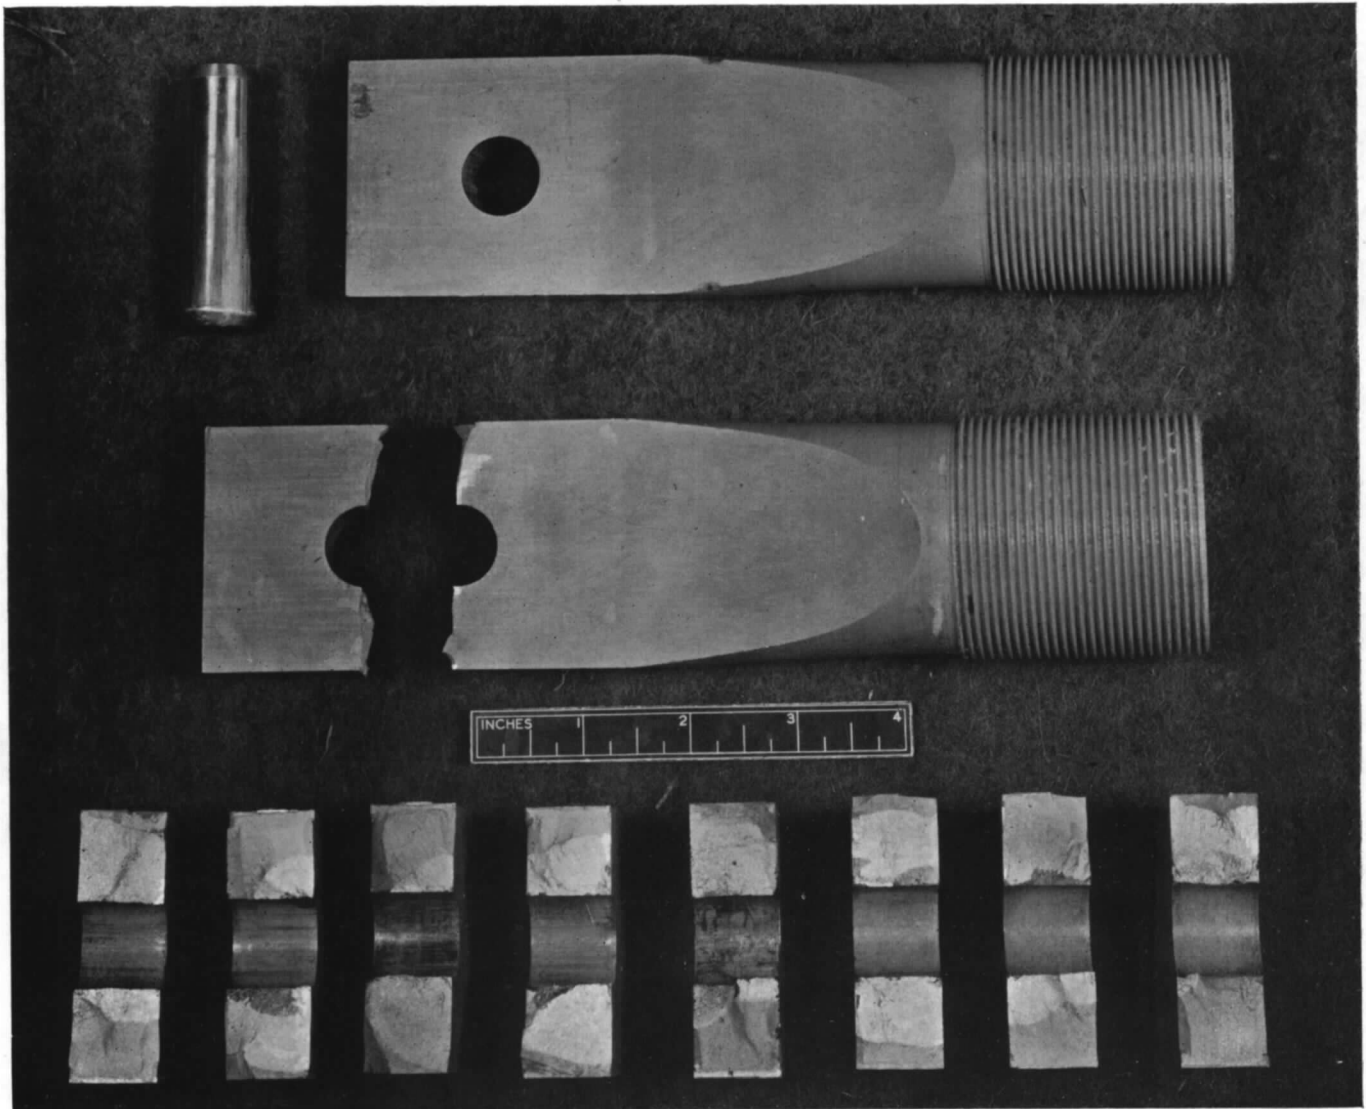
FIG. 12. Specimens after testing. Plain loaded holes.

All specimens had relatively large fatigue fracture areas on both sizes of the hole. Typical fractures are illustrated on Fig. 12.
