ATSB TRANSPORT SAFETY REPORT  
Aviation Research and Analysis Report – AR-2008-018(2)  
Final

# Runway excursions

**Part 2:  
Minimising the likelihood and consequences  
of runway excursions**

**An Australian perspective**

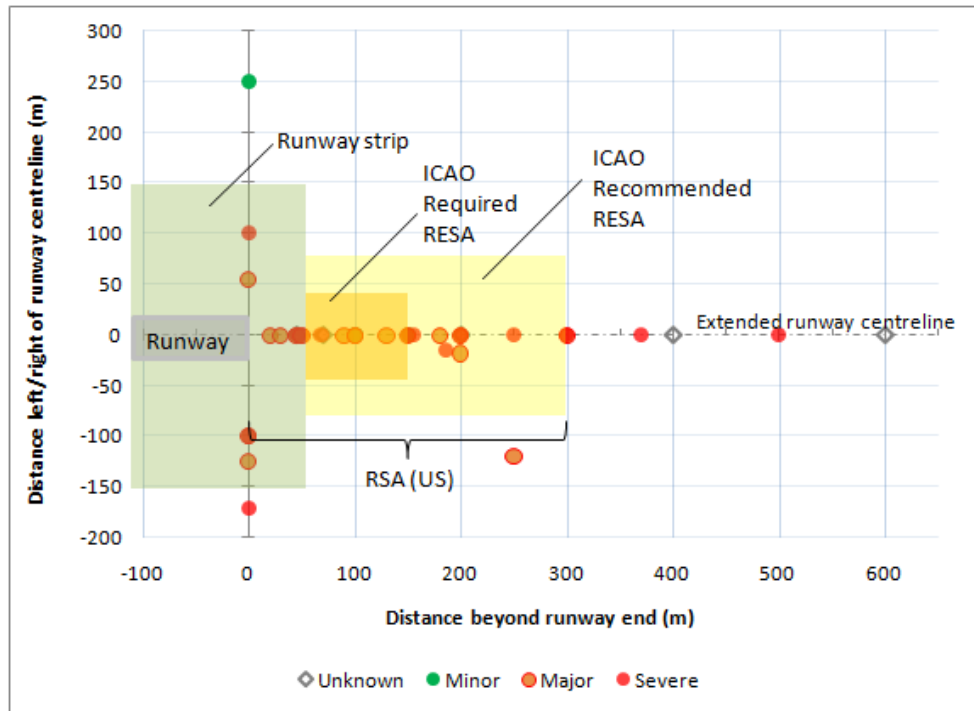
**Figure 1: Aircraft damage analysis and final stopping position from the runway end for 43 runway excursion accidents, 1998 to 2007**

- **Minor** – no structural damage to the airframe or landing gear was reported. Foreign object damage to the engines, undercarriage, and tyres were classed as minor damage;
- **Major** – partial undercarriage collapse, ground strike of wing or engine, minor structural damage to the fuselage; and
- **Severe** – complete collapse of the undercarriage, separation of engines, structural failure of the fuselage, post-impact fire.

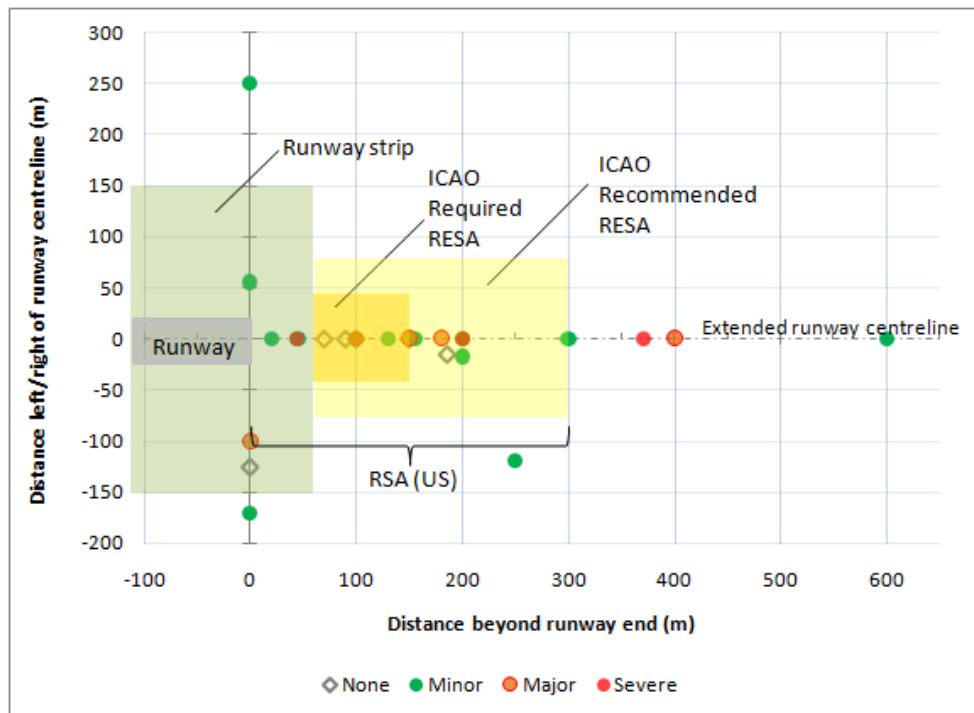
**Figure 2: Ground damage analysis and final aircraft stopping position from the runway end for 28 runway excursion accidents, 1998 to 2007**

Figure 2 shows the location and extent of ground damage caused for each accident where the ground damage was known (28 of the 43 accidents). The ground damage was coded from summary text accompanying each accident and investigation reports where available:

- **None** – no non-aircraft damage occurred/was reported;
- **Minor** – substantial damage to the runway strip, RESA or arrestor bed surfaces, and/or minor damage to airport infrastructure such as antennas, internal roads, or fences. Aircraft may impact and damage terrain obstacles such as ravines and drainage channels. No damage to airport perimeter fences or off-airport property;
- **Major** – aircraft impact with and significant damage to major airport infrastructure such as approach light stanchions, nav aids, instrument landing system (ILS) arrays, water tanks, buildings and hangars. No damage to airport perimeter fences or off-airport property; and
- **Severe** – aircraft overruns through airport perimeter fence and impacts off-airport property such as houses, warehouses, roads, vehicles and petrol stations.

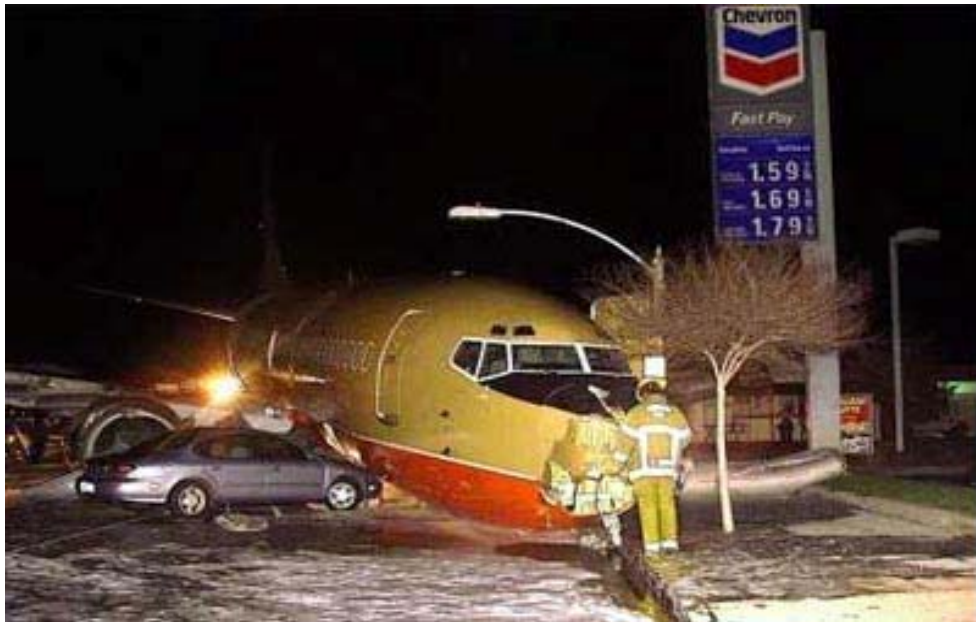
**Figure 3: Boeing 737-300 overrun accident at Burbank-Glendale-Pasadena Airport, California, 5 March 2000**

For example, the 2005 overrun of a Boeing 737-700 aircraft at Chicago Midway Airport resulted in a child in a passing car being killed when the aircraft came to rest on a nearby road intersection and collided with several vehicles. Similarly, Figure 3 shows another excursion accident in which a Boeing 737 aircraft overran the runway at Burbank-Glendale-Pasadena Airport in 2000, passed through the airport perimeter fence and came to rest a few metres from a petrol station (USA Today, 2005).

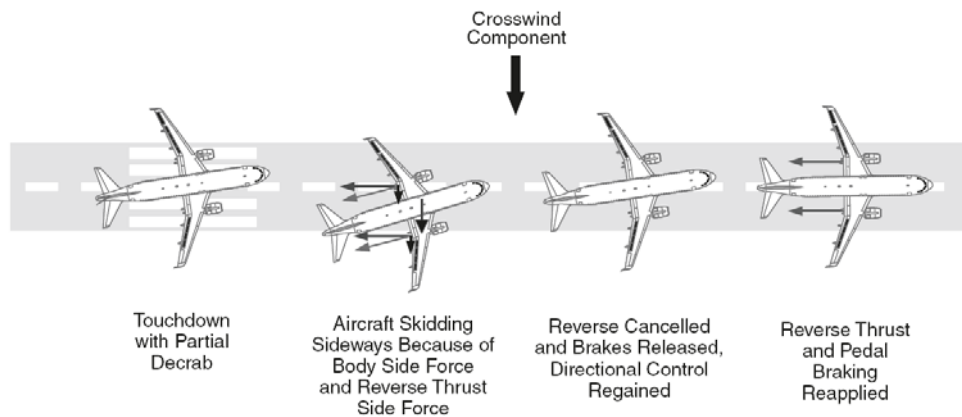
**Figure 4: Recovery from a skid caused by crosswind and reverse thrust side forces**

On a wet or contaminated runway, especially in crosswind conditions, the rudder and/or differential braking should be used to provide directional control. Use of the nosewheel may lead to loss of tyre cornering force and aquaplaning. If differential braking is required, braking should be applied on the required side and released on the other side. Use of reverse thrust should be carefully monitored in crosswind conditions, as the effect of the crosswind may cause the reverse thrust force to worsen sideways skidding. Differential reverse thrust may be required. Figure 4 shows the correct recovery procedure for a skid caused by crosswind and reverse thrust effect (FSF, 2000d).

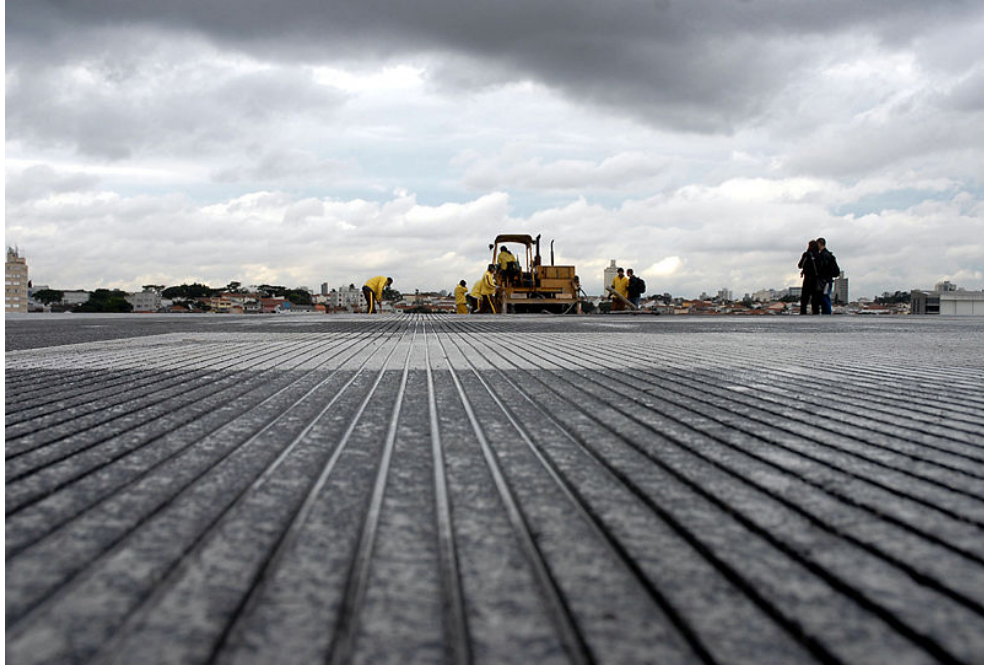
**Figure 5: Runway grooving at Congonhas International Airport, Sao Paulo, Brazil, July 2007**

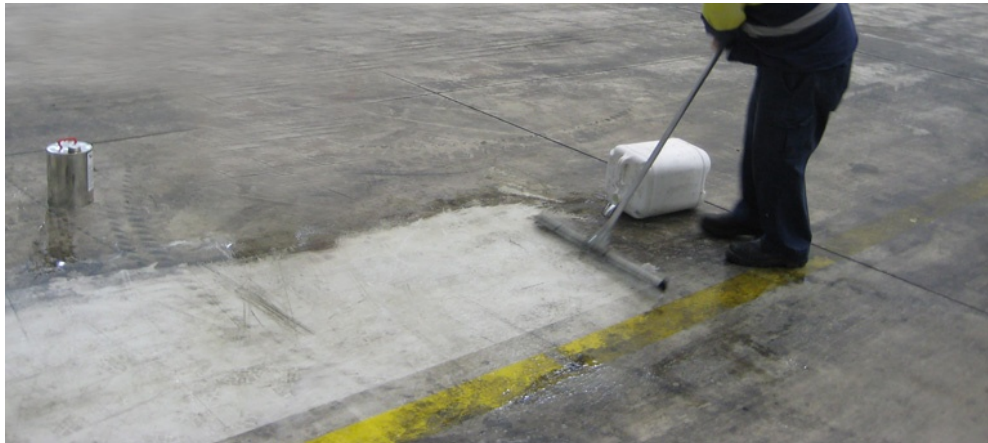
**Figure 6: Chemical removal of rubber deposits from a runway**

A number of methods are available for removing rubber deposits, such as high pressure water, chemical treatments (Figure 6), high velocity impact (sandblasting), and mechanical grinding. Following removal, the FAA recommends that the airport operator conduct runway friction measurements and ensure that the  $\mu$  value is within 10 per cent of that of the uncontaminated portions of the runway. Both measurements should be within the acceptable friction levels for safe aircraft operations (FAA, 1997).

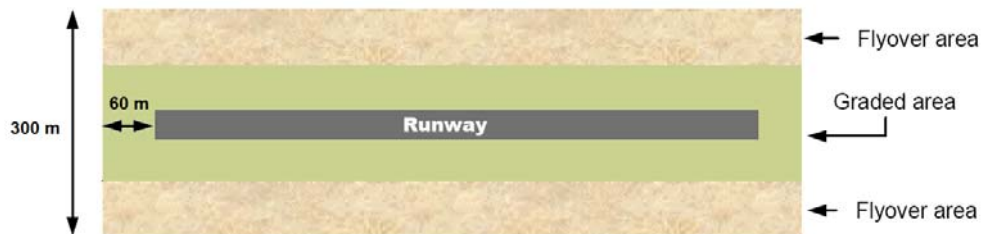
**Figure 8: Required runway strip dimensions for instrument runways in Australia (both graded and flyover area)**

For precision approach (ILS-equipped) runways, the runway strip is wider, and includes an additional flyover area to protect aircraft transiting across the aerodrome (Figure 8). All Code 3 and 4 instrument runways in Australia must have a runway strip at least 300 m wide (150 m either side of the runway centreline). This includes the graded area plus the flyover area.

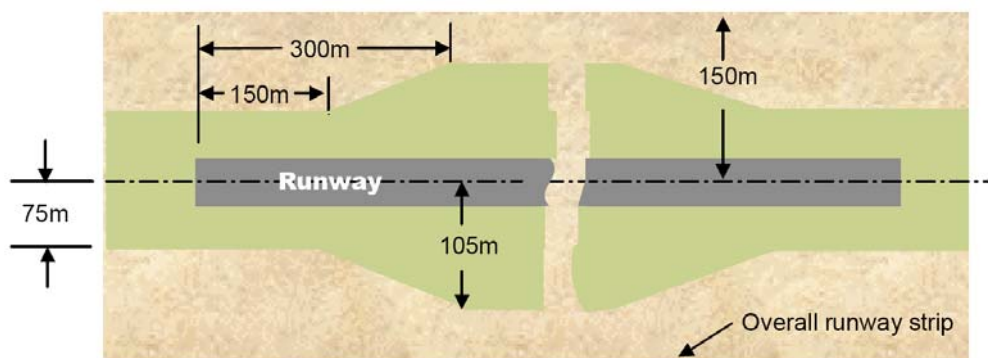
**Figure 9: CASA-recommended runway strip design for ICAO Code 3 and 4 precision approach runways in Australia**

CASA also recommends that an additional width of graded runway strip should be provided for runways with precision approaches, offering an additional level of safety if a runway veer-off occurs, or if an aircraft touches down beyond the runway edges. In this case, the graded width extends to a distance of 105 m on both sides of the runway centreline, except that the width is gradually reduced (over a distance of 150 m) to a width of 75 m from both sides of the centreline at both ends of the strip for a length of 150 m from the runway ends (Figure 9) (CASA, 2008).

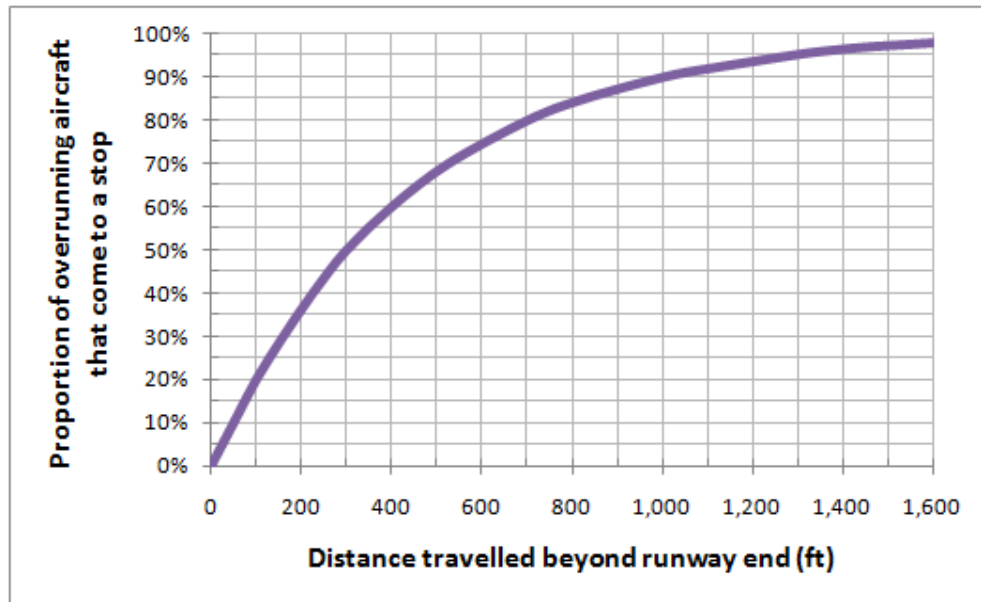
**Figure 10: Distribution of stopping distance of aircraft that overrun the runway end**

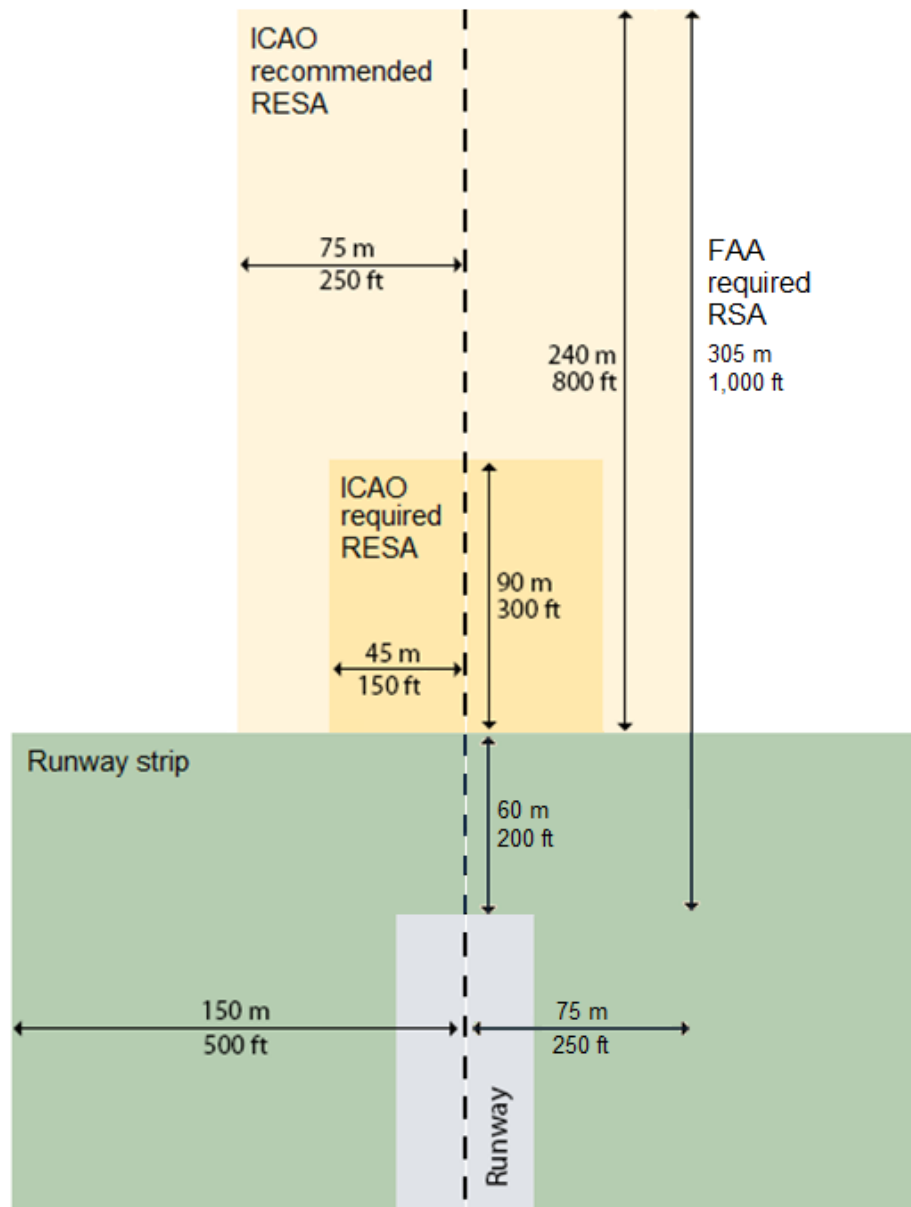
**Figure 11: Standard and recommended dimensions for RESAs (ICAO) and RSAs (FAA)**

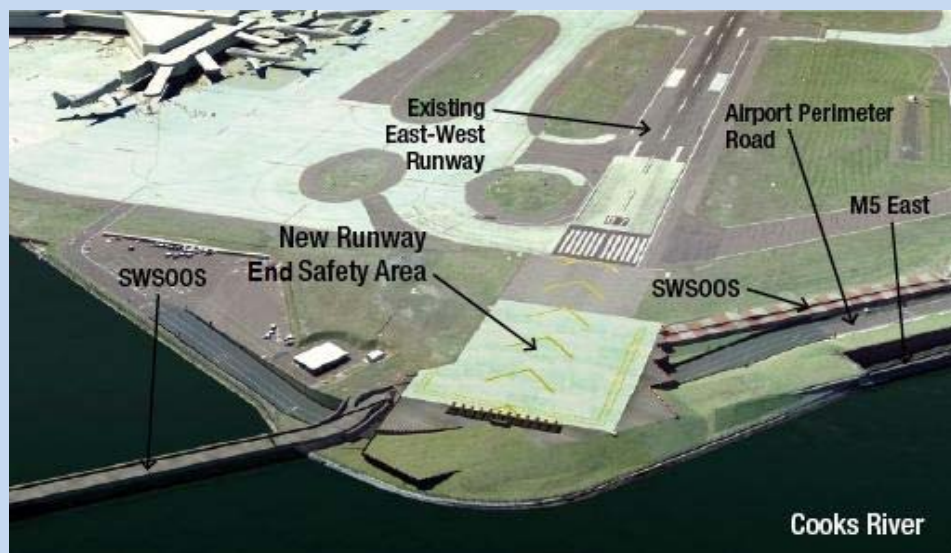
**Figure 12: Sydney Airport cross-runway RESA extension, runway 07 end**

During the construction works, the cross-runway will have limited operations, and noise sharing arrangements will be in place. The project is expected to be complete by the end of 2009.

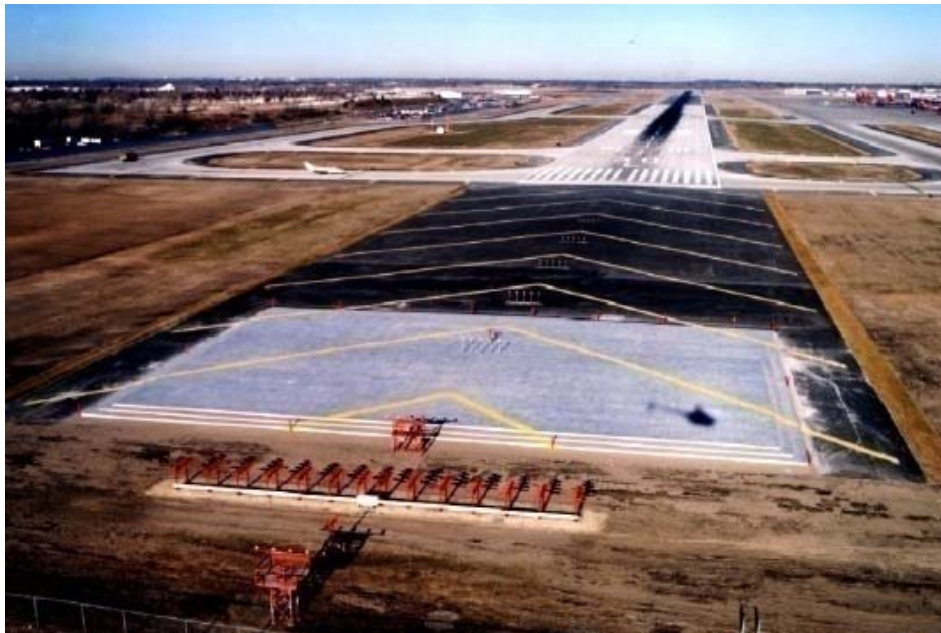
**Figure 13: An EMAS bed installed at Minneapolis-St Paul International Airport (KMSF), runway 12R end**

The EMAS soft ground arrestor bed is a surface of cellular, aerated concrete blocks that collapse under heavy load. They are able to support the weight of airport and airport rescue and fire fighting (ARFF) vehicles with none to minimal deformation, but collapse under the weight of an aircraft. An EMAS bed works by transferring the kinetic energy of the overrunning aircraft into the action of crushing the concrete blocks, creating drag at the leading edge of the wheel and decelerating the aircraft (ESCO, 2008a). Figure 13 shows an EMAS bed installed beyond the end of a runway.

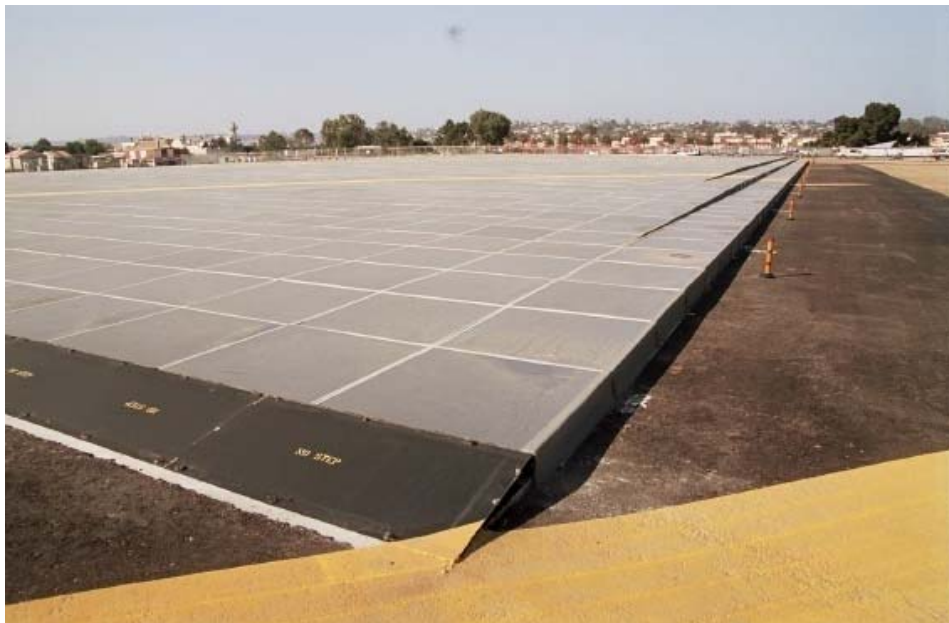
**Figure 14: An EMAS transition ramp at San Diego International Airport (KSAN), runway 09 end**

The EMAS beds are usually designed with a short entry ramp to give the overrunning aircraft a smooth transition from the RESA or RSA surface (Figure 14). To protect the EMAS bed from damaging jet blast, they must be set back a minimum of 75 ft (23 m) from the end of the runway surface, irrespective of the length of RESA or RSA provided. The surface is also coated with a special jet blast resistant coating by the manufacturer, which is designed to last between 5 and 10 years in service (Rosenkrans, 2006).

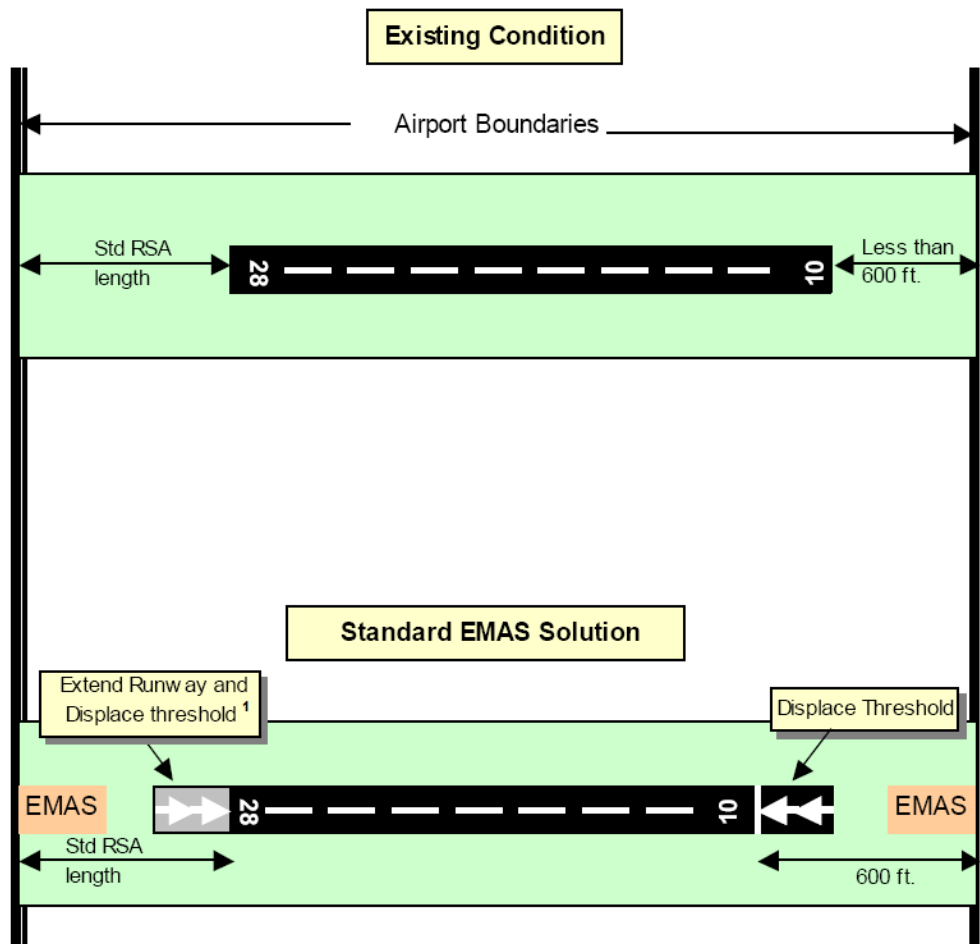
**Figure 15: Example of an FAA-approved EMAS (standard installation)<sup>45</sup>**

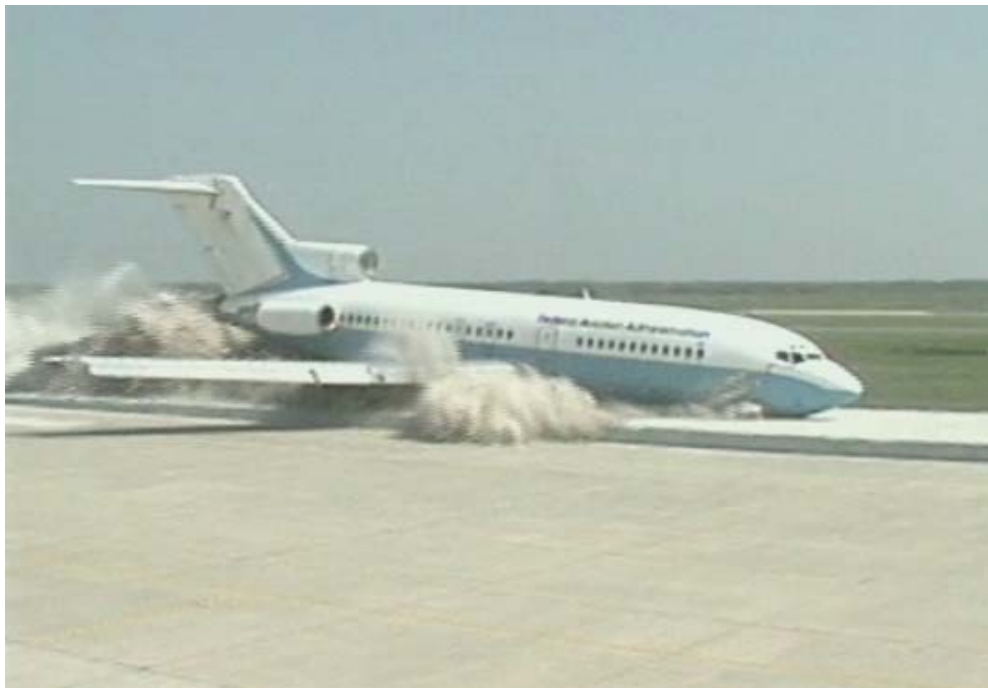
**Figure 16: FAA performance trials of the EMAS system, simulating a runway overrun of a Boeing 727-200 aircraft**

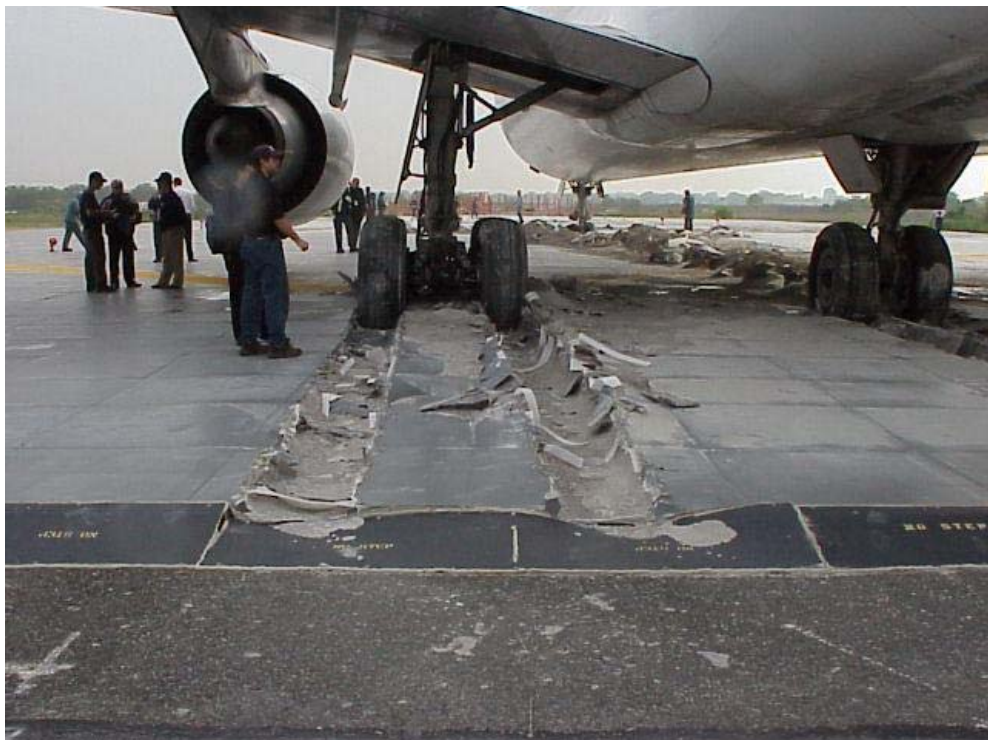
**Figure 17: McDonnell Douglas MD-11 runway overrun, John F. Kennedy International Airport, New York, 2003**

A 470,000 lb (213,191 kg) McDonnell Douglas MD-11 freighter aircraft landed long, and overran the end of the runway at low speed. The aircraft was stopped by the EMAS bed, with no injuries to the flight crew and no major aircraft damage. The aircraft was extracted from the EMAS bed within a few hours, and the runway returned to service (Figure 17).

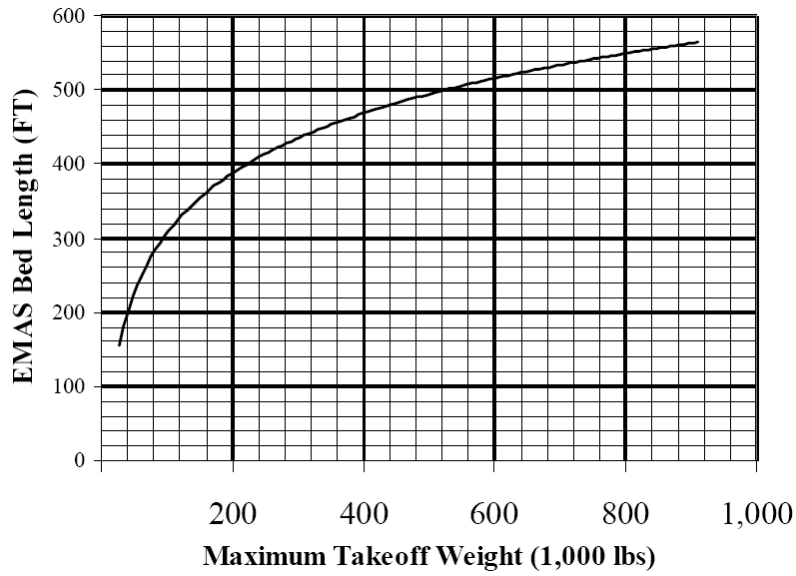
**Figure 18: FAA-estimated EMAS length requirements versus design/critical aircraft MTOW<sup>46</sup>**

- 1. EMAS bed length does not include the setback from the runway.*
- 2. This figure is conservative for aircraft with an MTOW less than 50,000 lb. The FAA recommends contacting the EMAS manufacturer for a more accurate EMAS bed length estimate for specific aircraft models.*
- 3. The EMAS bed length is based on aircraft leaving the end of the runway at a groundspeed of 70 kts, with a runway setback distance of 75 ft.*

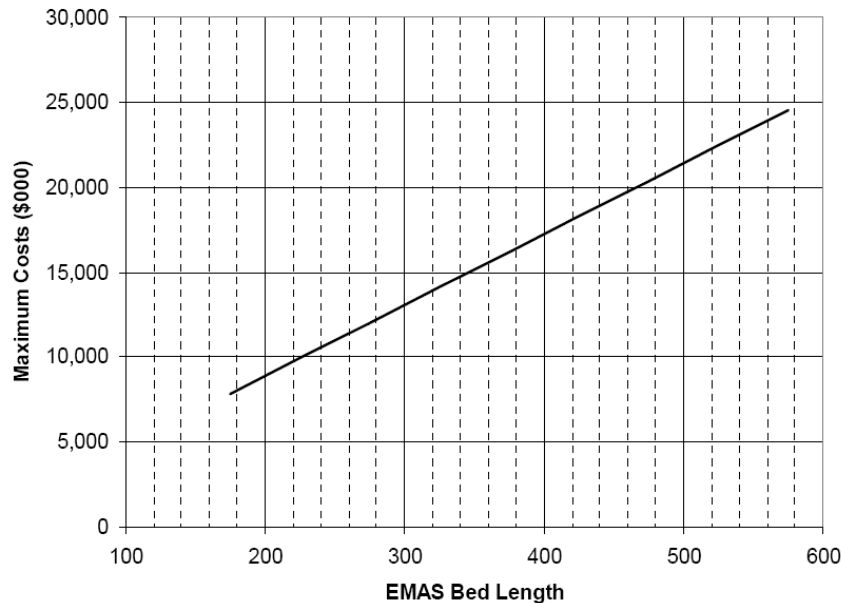
**Figure 19: FAA-estimated RSA improvement cost compared to EMAS bed length<sup>47</sup>**

If the actual costs of improving the RSA exceed those in Figure 19, then the FAA recommends that the best safety alternative be implemented (such as a non-standard EMAS) up to the feasible cost. The cost of the EMAS installation itself varies depending on site preparation required, and the required bed length (Figure 18). Based on existing EMAS installations and a 20 year lifecycle where the EMAS material is replaced every 10 years, the FAA suggests that the costs of installing an EMAS are approximately:

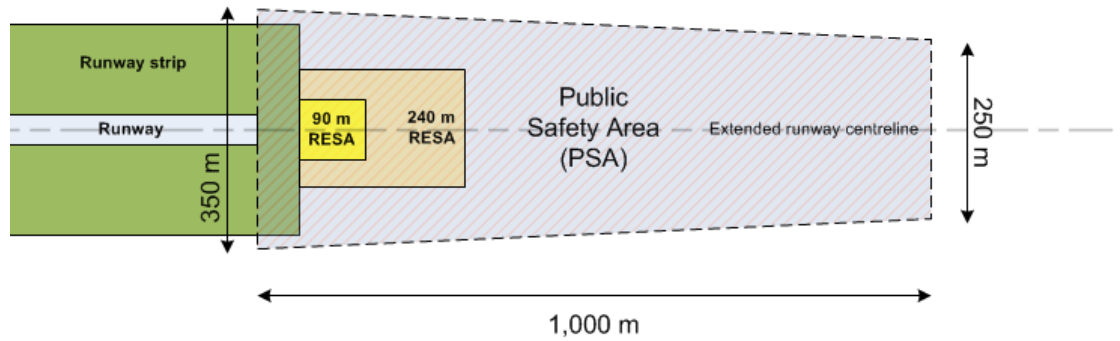
**Figure 20: Public safety area (PSA) dimensions relative to the RESA and runway strip<sup>49</sup>**

runway end, and tapers to 250 m (820 ft) in width. These dimensions enclose the full area where the safety risk to an individual resulting from an aircraft undershoot or overrun is in the order of one in 10,000 or higher (Figure 20).

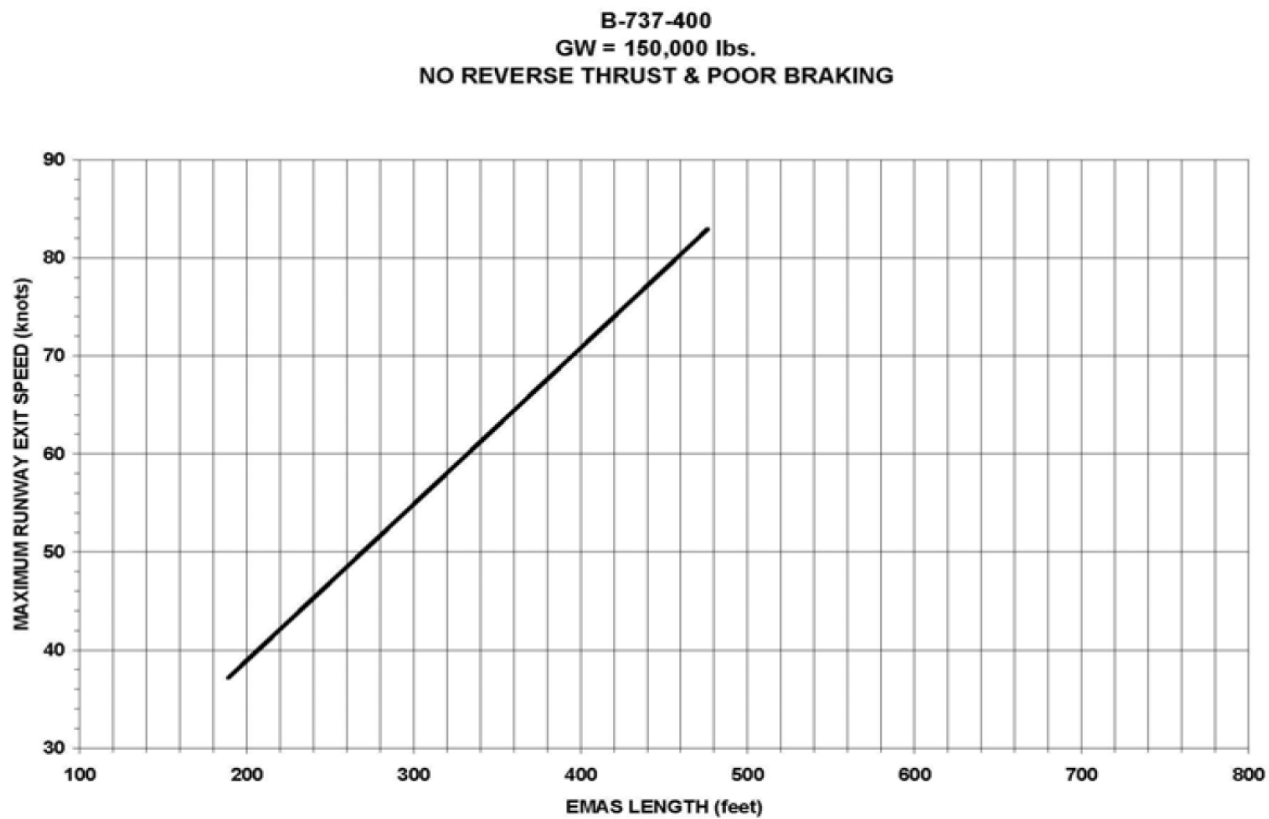
Figure F.1: Estimated EMAS stopping capability for a Boeing 737-400 aircraft (narrowbody)<sup>56</sup>

1. EMAS includes a 75 ft paved lead-in rigid ramp. A 35 ft setback can be used to improve performance for short safety areas.
2. Poor braking simulated using a braking friction coefficient ( $Mu = 0.25$ ).

In all cases, the modelled performance assumes the EMAS is set back 75 ft from the end of the runway, the flight crew is not using reverse thrust to decelerate the aircraft, and that the braking action is poor (Mu value of 0.25).

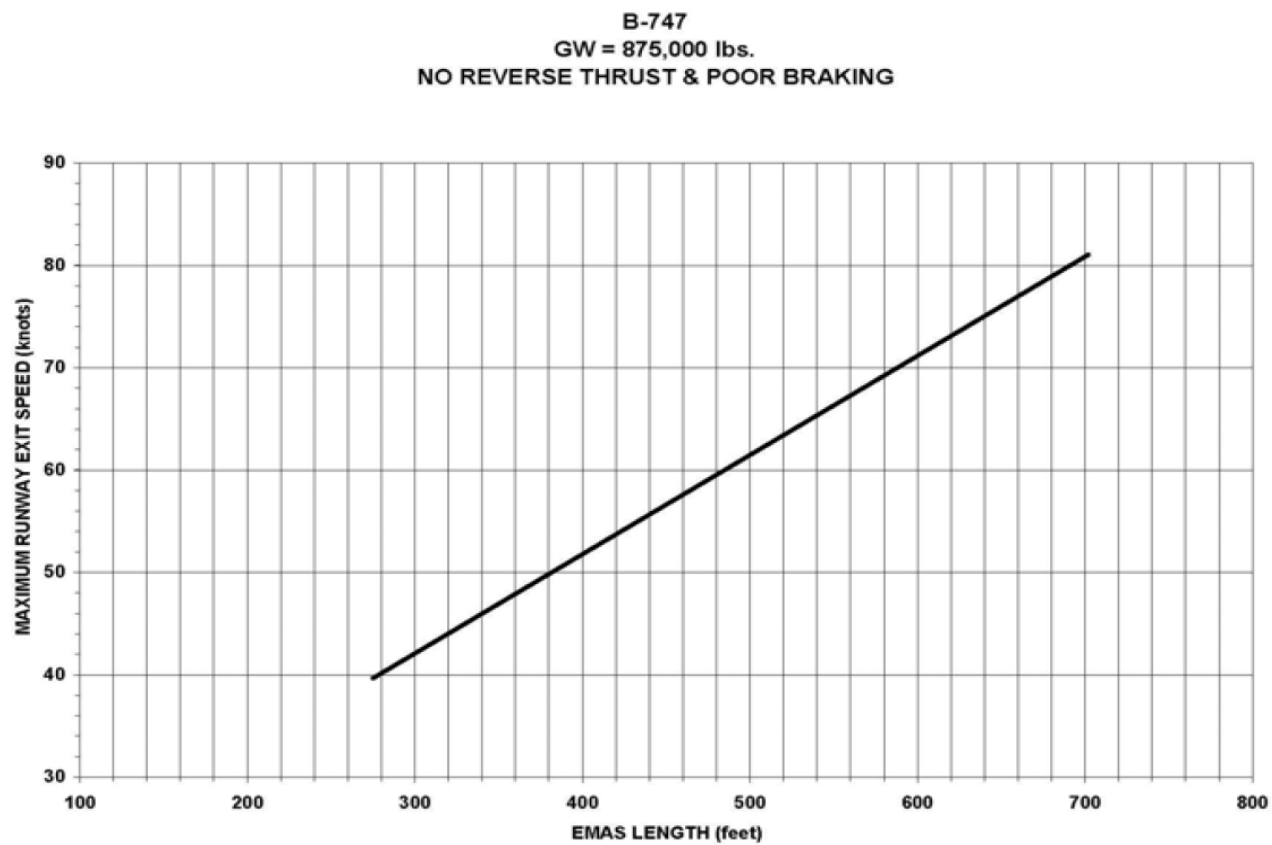
**Figure F.2: Estimated EMAS stopping capability for a Boeing 747 aircraft (widebody)<sup>57</sup>**

1. EMAS includes a 75 ft paved lead-in rigid ramp. A 35 ft setback can be used to improve performance for short safety areas.
2. Poor braking simulated using a braking friction coefficient ( $Mu = 0.25$ ).

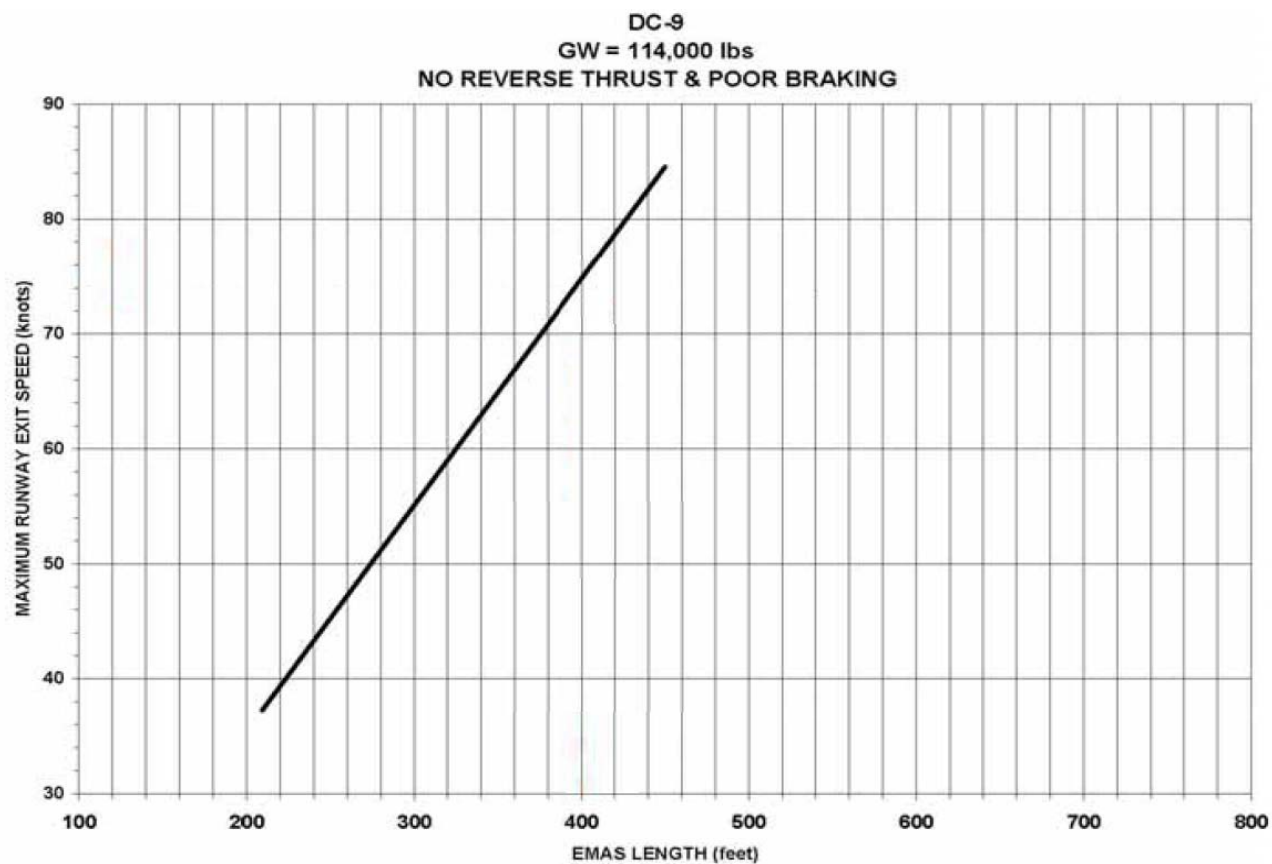
Figure F.3: Estimated EMAS stopping capability for a Douglas DC-9 aircraft (narrowbody)<sup>58</sup>

1. EMAS includes a 75 ft paved lead-in rigid ramp. A 35 ft setback can be used to improve performance for short safety areas.
2. Poor braking simulated using a braking friction coefficient ( $Mu = 0.25$ ).

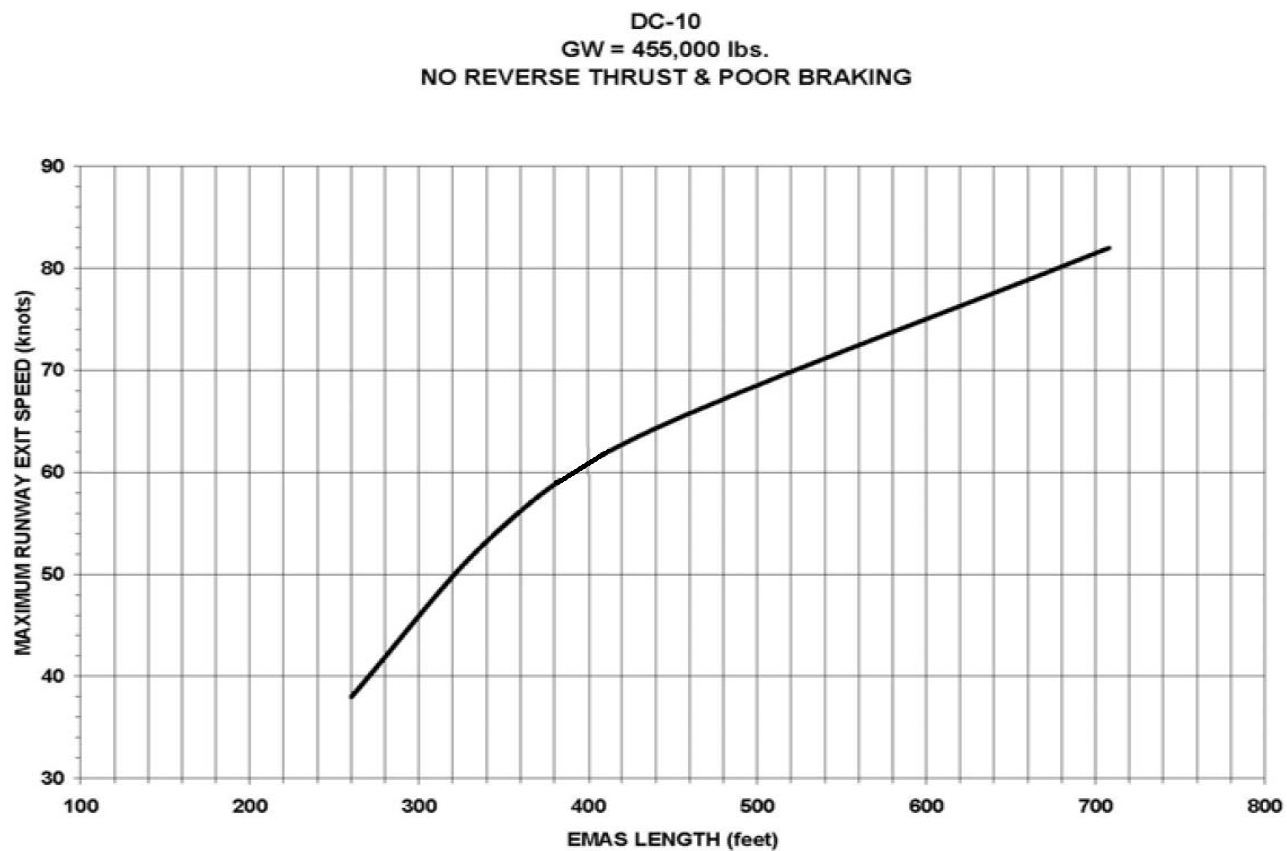
Figure F.4: Estimated EMAS stopping capability for a McDonnell Douglas DC-10 aircraft (widebody)<sup>59</sup>

1. EMAS includes a 75 ft paved lead-in rigid ramp. A 35 ft setback can be used to improve performance for short safety areas.
2. Poor braking simulated using a braking friction coefficient ( $Mu = 0.25$ ).

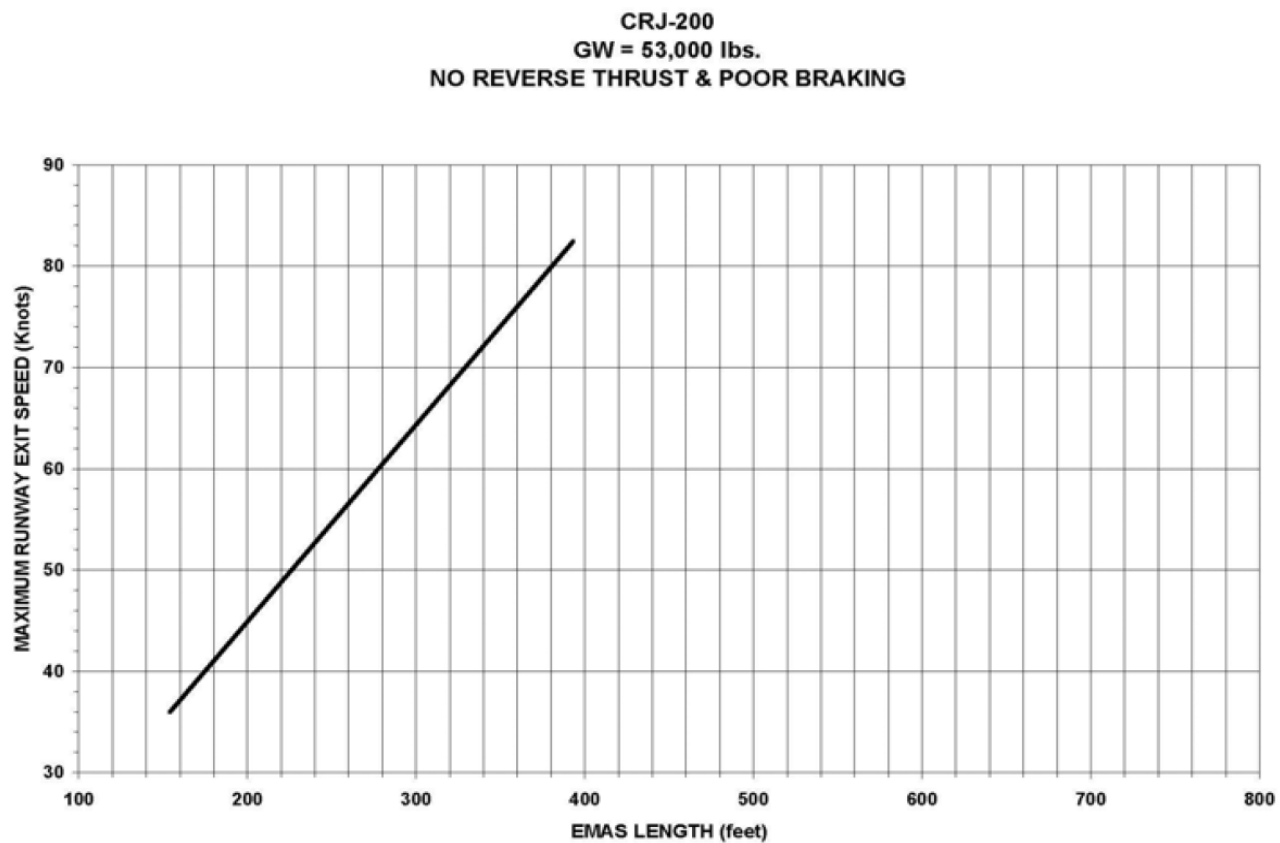
Figure F.5: Estimated EMAS stopping capability for a Bombardier CRJ-200 aircraft (narrowbody)<sup>60</sup>
