REPORT No. 248

**THE CORROSION OF MAGNESIUM AND OF THE
MAGNESIUM ALUMINUM ALLOYS
CONTAINING MANGANESE**

By J. A. BOYER
American Magnesium Corporation

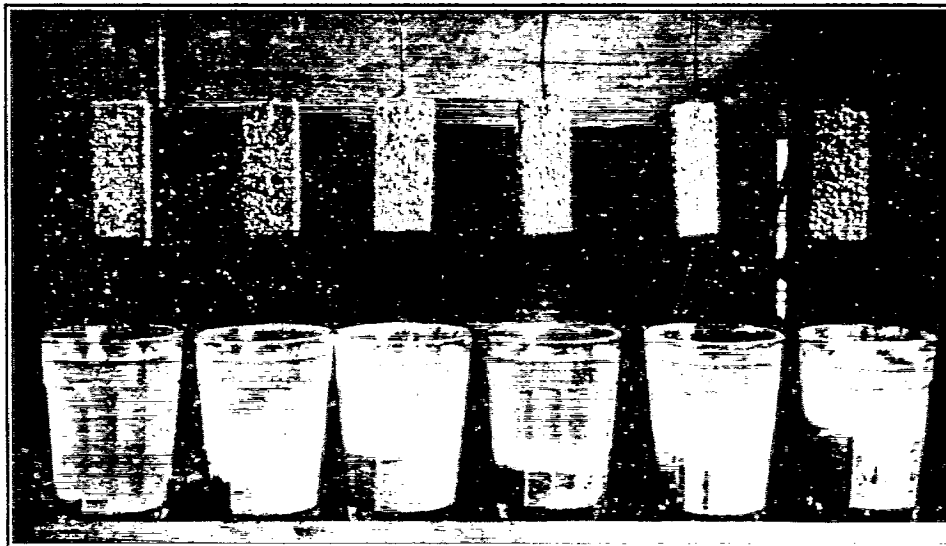
FIG. 2.—From left to right, 2, 3, 4, 5, 6, and 8 per cent aluminum, intermittent immersion, 2 per cent NaCl solution, 48 hours

With the addition of aluminum to magnesium the rate of corrosion increases enormously. A 4 per cent alloy of even half-inch thickness will be completely disintegrated in less than a week; the 8 per cent alloy corrodes even more rapidly. The effect of aluminum on corrosion is shown in Figure 2, which represents the result of a 48-hour intermittent immersion test, using 2 per cent sodium chloride solution.

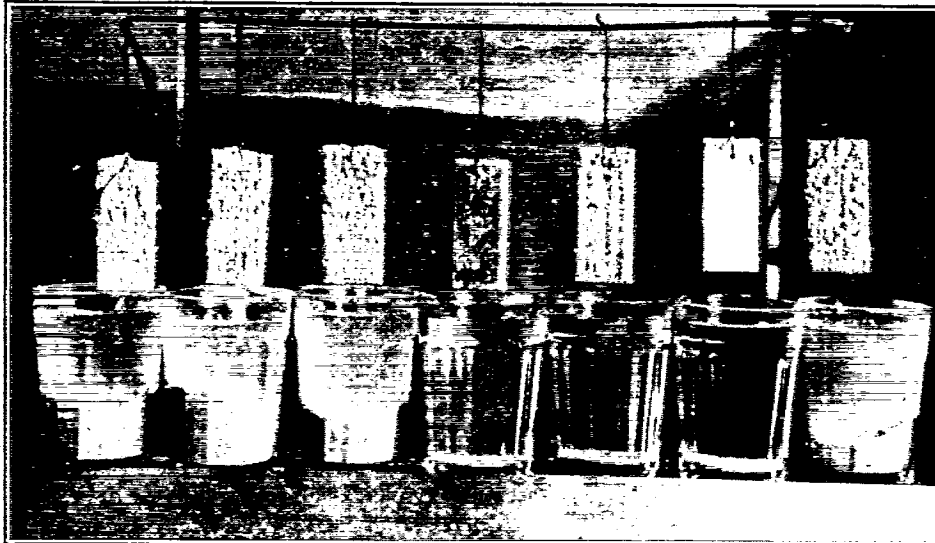
FIG. 3.—Specimens from left to right are numbers 1 to 7 of preceding table

The alloy chosen was specimen No. 7 of the corrosion test shown in Figures 3 and 4. This alloy differed from the three resistant test specimens by being chill cast while the others were cooled fairly slowly; it was also air cast and contained included films, while the resistant alloys were vacuum cast; in addition, it was slightly low in manganese. It was believed that the examination to determine whether coring was the cause of corrosion would also determine the influence of the other two factors by a process of elimination.

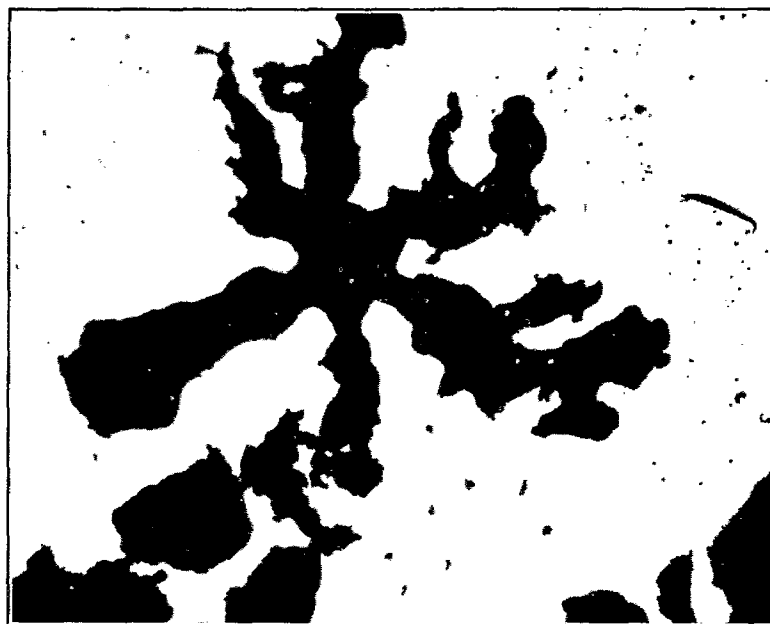
FIG. 14.—Mag. 100 X. Corrosion pit in the alloy in Figure 13

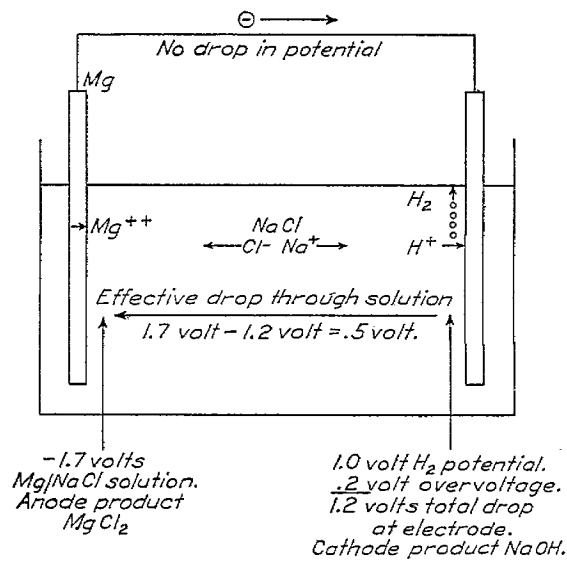
FIG. 39.—Diagrammatic representation of galvanic action with impurity of low overvoltage
