EFFECT OF VARIABLES IN WELDING TECHNIQUE ON THE STRENGTH OF  
DIRECT-CURRENT METAL-ARC-WELDED JOINTS IN AIRCRAFT STEEL

JOINTS IN SAE 4130 STEEL SHEET

TECHNICAL NOTE NO. 1261

By C. B. Voldrich and E. T. Armstrong

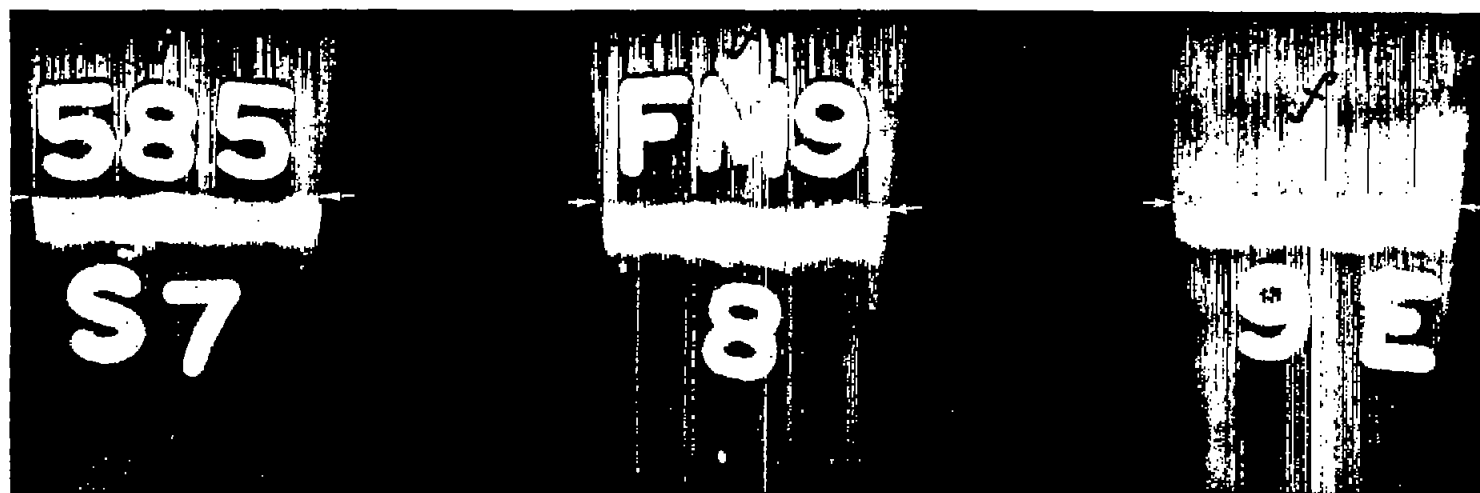
Fig. 23a

All failures at toe of face bead;  
no internal defects visible.

Figure 23a.—Radiograph of two-bead, interrupted, reinforced welds in  $\frac{1}{8}$ -inch SAE 4130 steel sheet (Group 3).

The interrupted-weld specimens with full reinforcement (group 3) also failed at the toe of the face bead. (See radiographs, figs. 23(a) and 23(b).) Probably there were internal defects at the point of interruption of the weld, but they are not visible in the radiographs and, if present, had no chance to influence the fatigue strength because of the greater influence of the external stress-raiser at the toe of the face bead. Figure 29 shows that the toe-of-weld stress-concentration effect was greater for the interrupted-weld specimens (group 3) than for the continuous-weld specimens (group 1). This is possible because the face bead in the group 3 specimens was higher and fuller with incipient overlapping at the weld interruption.

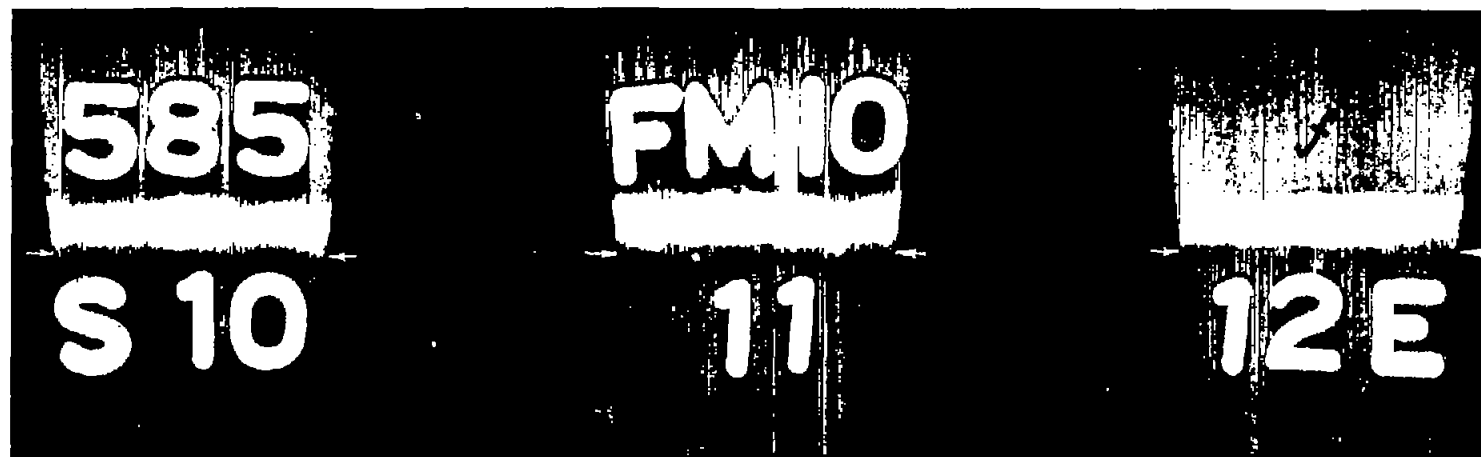
Fig. 23b

All failures at toe of face bead;  
minor sidewall blowholes or slag  
inclusive; no crater defects visible.

Figure 23b.—Radiograph of two-bead, interrupted, reinforced welds in  $\frac{1}{8}$ -inch SAE 4130 steel sheet (Group 3).

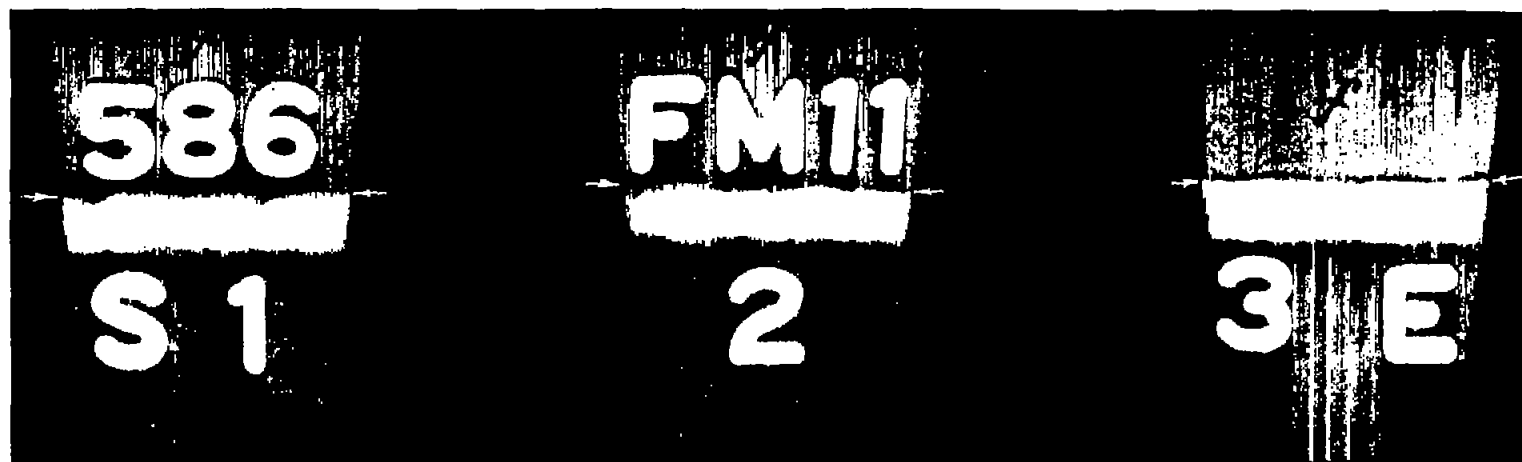
Fig. 25

All failures at toe of weld bead;  
no root defects or lack of pene-  
tration visible.

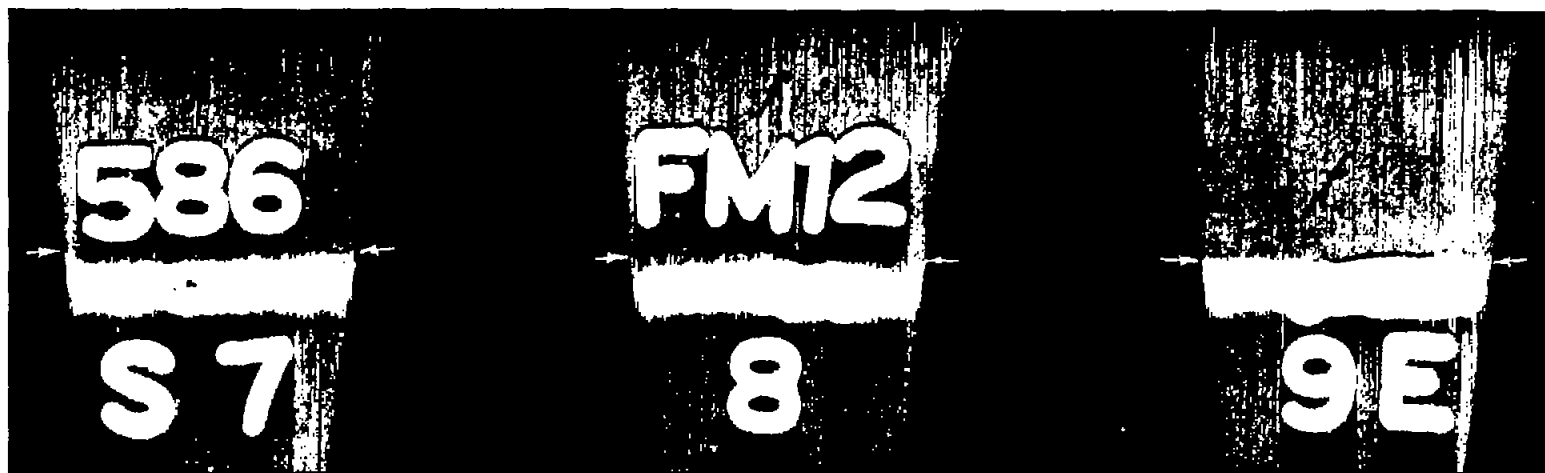
Failure at toe of weld;  
elongated crater blowhole and  
longitudinal crater crack.

Failure at toe of weld;  
small crater hole and transverse  
crater crack.

29132  
Failure at toe of weld;  
crater blowhole.

Figure 27.—Radiograph of single-bead, interrupted, reinforced welds in  $\frac{1}{8}$ -inch SAE 4130 steel sheet (Group 7).
