NATIONAL ADVISORY COMMITTEE FOR AERONAUTICS

TECHNICAL NOTE

No. 1261

EFFECT OF VARIABLES IN WELDING TECHNIQUE ON THE STRENGTH OF
DIRECT-CURRENT METAL-ARC-WELDED JOINTS IN AIRCRAFT STEEL

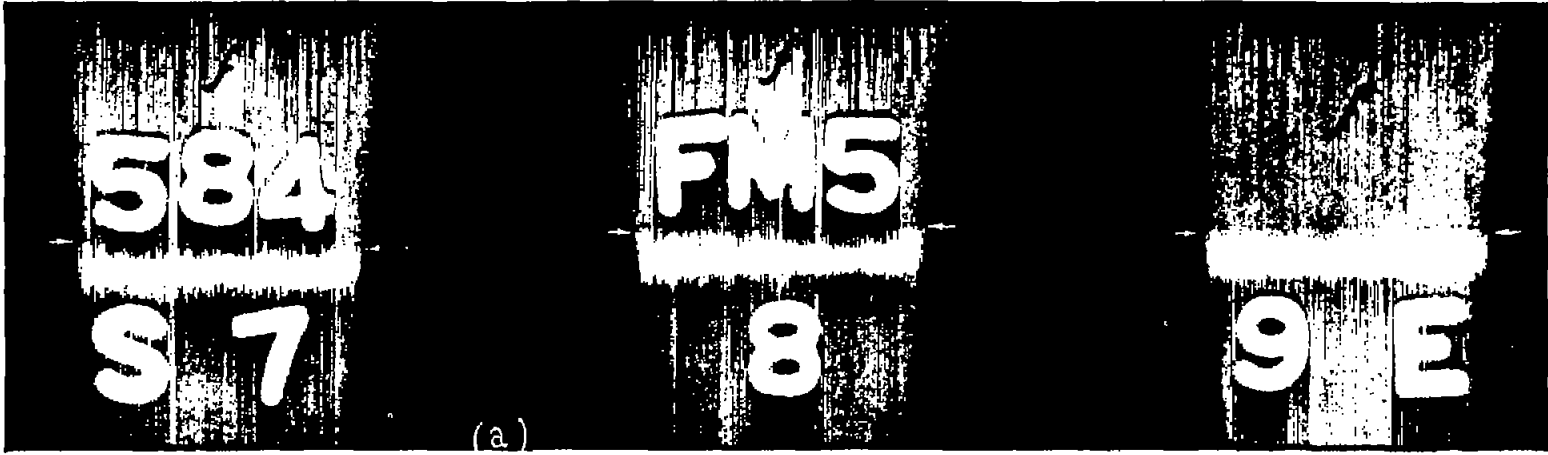
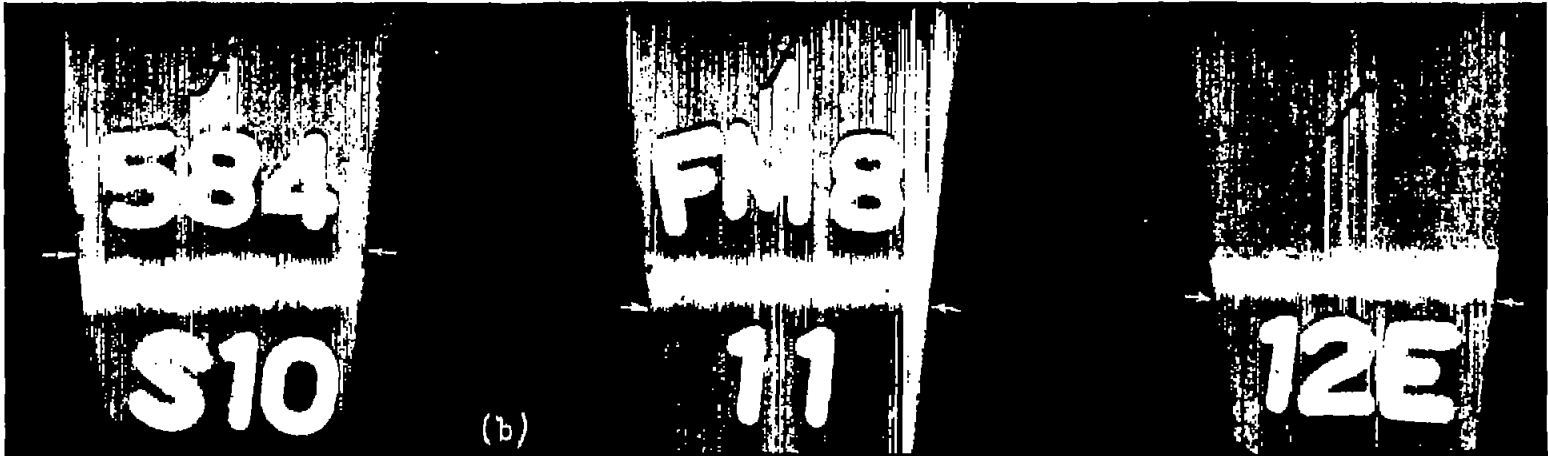
All fatigue failures at toe of face bead;
no internal defects.

Figure 21.—Radiograph of two-bead, continuous, reinforced welds in 1/8-inch SAE 4130 steel sheet (Group 1).

Continuous two-bead weld specimens with full reinforcement (group 1) had a much lower fatigue strength than similar surface-ground specimens (group 2). In all cases the specimens in group 2 failed at the toe of the larger (face) bead and thus indicated the pronounced effect of the stress concentration at that point. (See radiographs, figs. 21(a) and 21(b).)

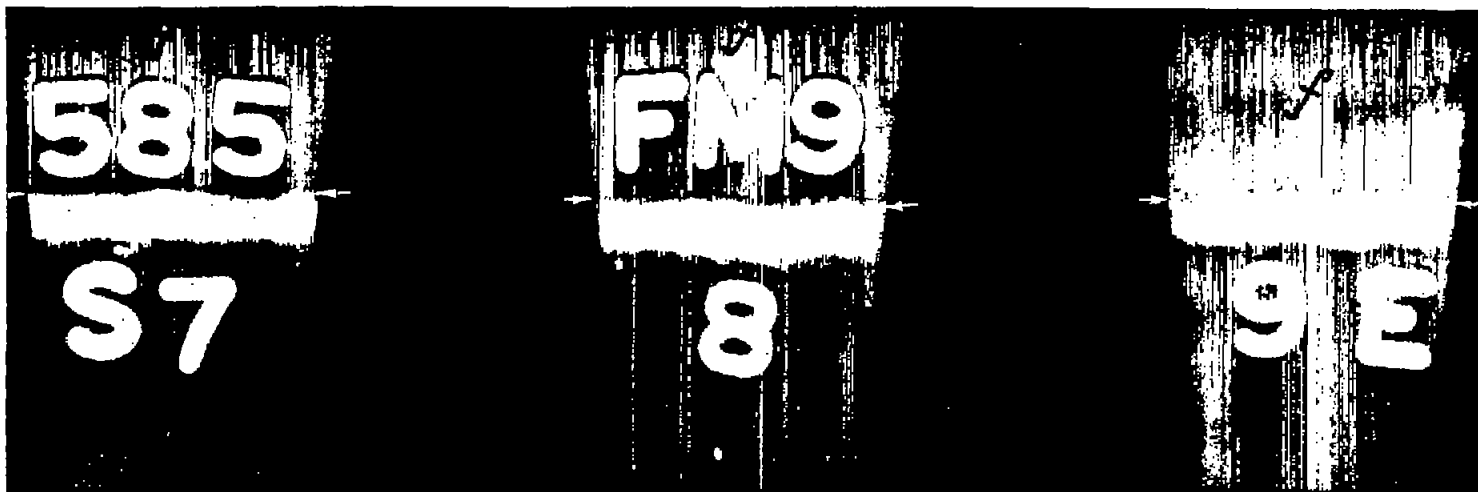
All failures at toe of face bead;
no internal defects visible.

Figure 28a.—Radiograph of two-bead, interrupted, reinforced welds in $\frac{1}{8}$ -inch SAE 4130 steel sheet (Group 3).

The interrupted-weld specimens with full reinforcement (group 3) also failed at the toe of the face bead. (See radiographs, figs. 23(a) and 23(b).) Probably there were internal defects at the point of interruption of the weld, but they are not visible in the radiographs and, if present, had no chance to influence the fatigue strength because of the greater influence of the external stress-raiser at the toe of the face bead. Figure 29 shows that the toe-of-weld stress-concentration effect was greater for the interrupted-weld specimens (group 3) than for the continuous-weld specimens (group 1). This is possible because the face bead in the group 3 specimens was higher and fuller with incipient overlapping at the weld interruption.

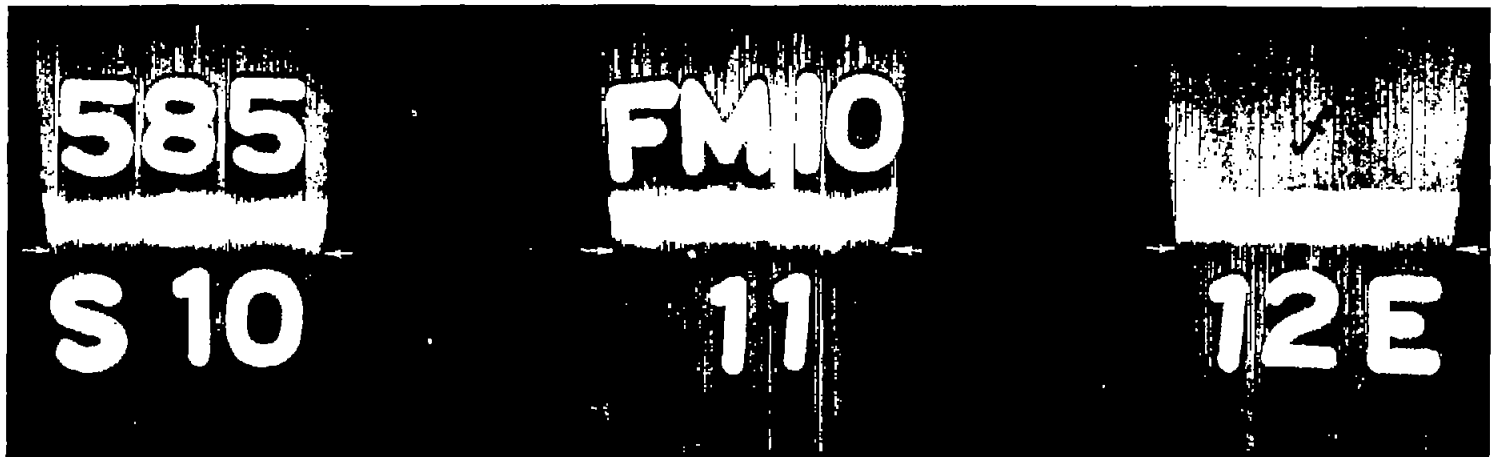
Fig. 23b

All failures at toe of face bead;
minor sidewall blowholes or slag
inclusive; no crater defects visible.

Figure 23b.—Radiograph of two-bead, interrupted, reinforced welds in $\frac{1}{8}$ -inch SAE 4130 steel sheet (Group 3).

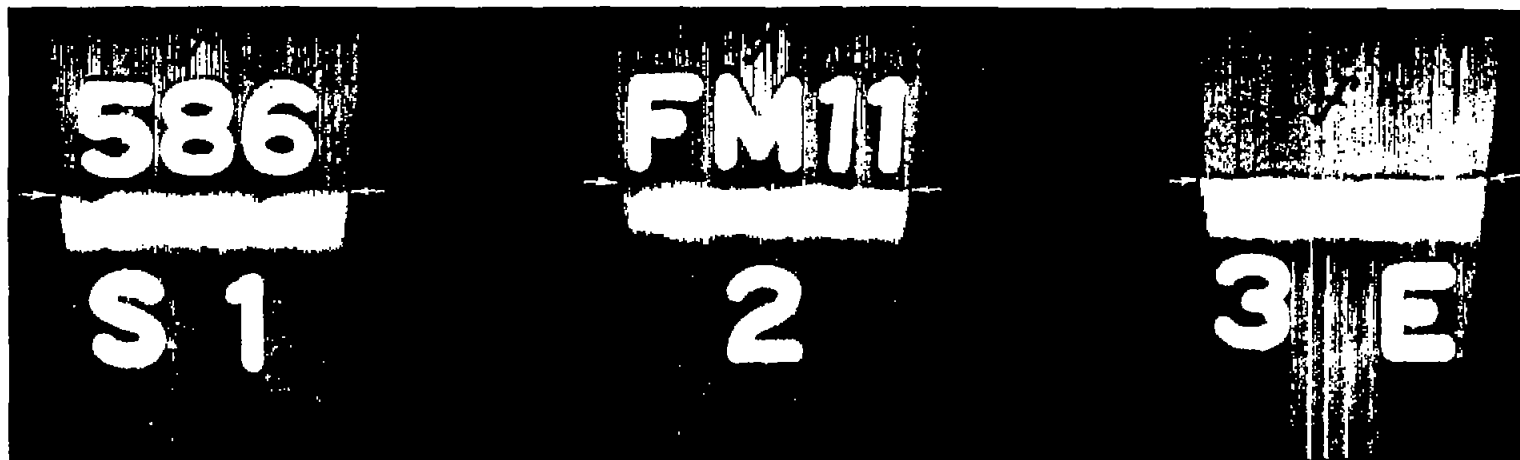
All failures at toe of weld bead;
no root defects or lack of penetration visible.

Figure 25.—Radiograph of single-bead, continuous, reinforced welds in $\frac{1}{8}$ -inch SAE 4130 steel sheet (Group 5).

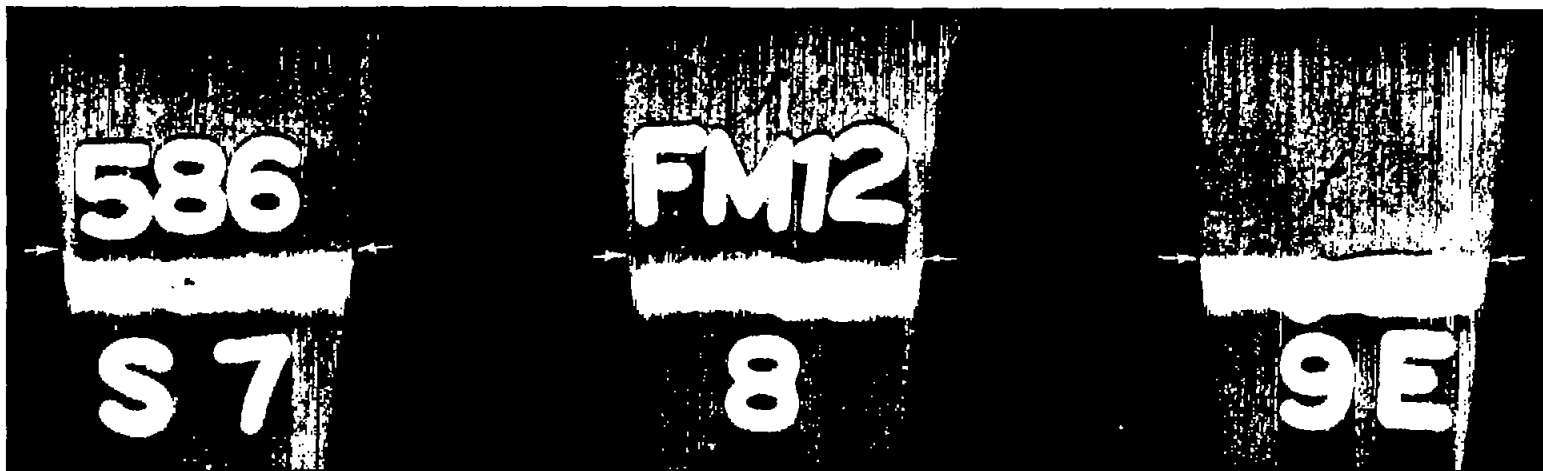
Failure at toe of weld ;
elongated crater blowhole and
longitudinal crater crack.

Failure at toe of weld ;
small crater hole and transverse
crater crack.

Failure at toe of weld ;
crater blowhole.

Figure 27.—Radiograph of single-bead, interrupted, reinforced welds in $\frac{1}{8}$ -inch SAE 4130 steel sheet (Group 7).
