NATIONAL ADVISORY COMMITTEE FOR AERONAUTICS

No. 1598

EFFECTS OF ICE FORMATIONS ON AIRPLANE PERFORMANCE
IN LEVEL CRUISING FLIGHT

By G. Merritt Preston and Calvin C. Blackman

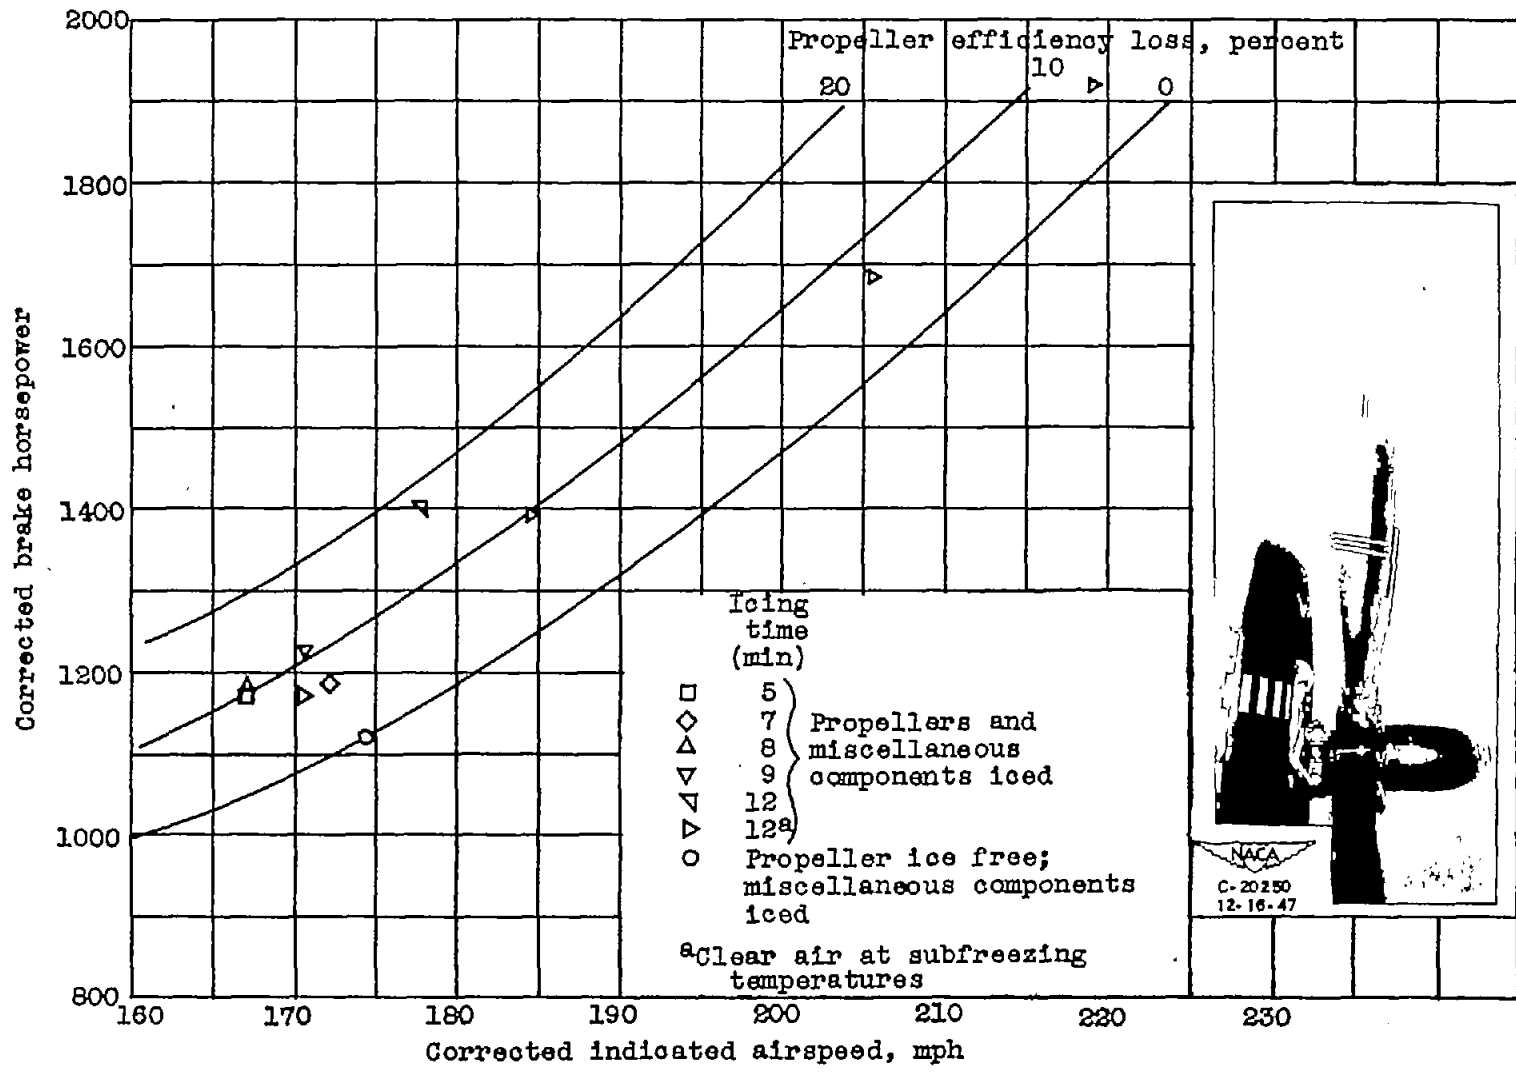
Figure 3. - Performance of airplane with ice-free propellers and with accumulations of glaze ice on propellers. Icing rate, 2.3 inches per hour.

The variation with indicated airspeed of the power required to maintain level flight for the twin-engine airplane used at the Cleveland laboratory with typical ice formations on the propellers is shown in figures 3 and 4. Calculated curves of power required with various losses in propeller efficiency are also included in order that the loss in propeller efficiency with ice accretion on the blades can be estimated. These data represent the maximum deleterious effects of glaze-ice and rime-ice formations on the propellers encountered during this investigation. With glaze-ice accretion, a heavy ice formation extended to approximately 30 percent of the blade radius and some deposits extended to 60 percent of the radius (fig. 3). The data for this condition indicate a loss in propeller efficiency of 7 percent, which is equivalent to a decrease in airspeed from 195 to 187 miles per hour at 1400 brake horsepower. During this icing encounter, another ice formation resulted in a propeller-efficiency loss of 17 percent. Such formations did not remain on the propellers for prolonged periods of time, however, because of natural shedding of ice from the blades.
