TECHNICAL NOTE 2709

FATIGUE AND STATIC TESTS OF FLUSH-RIVETED JOINTS

By Darnley M. Howard and Frank C. Smith

June 1952

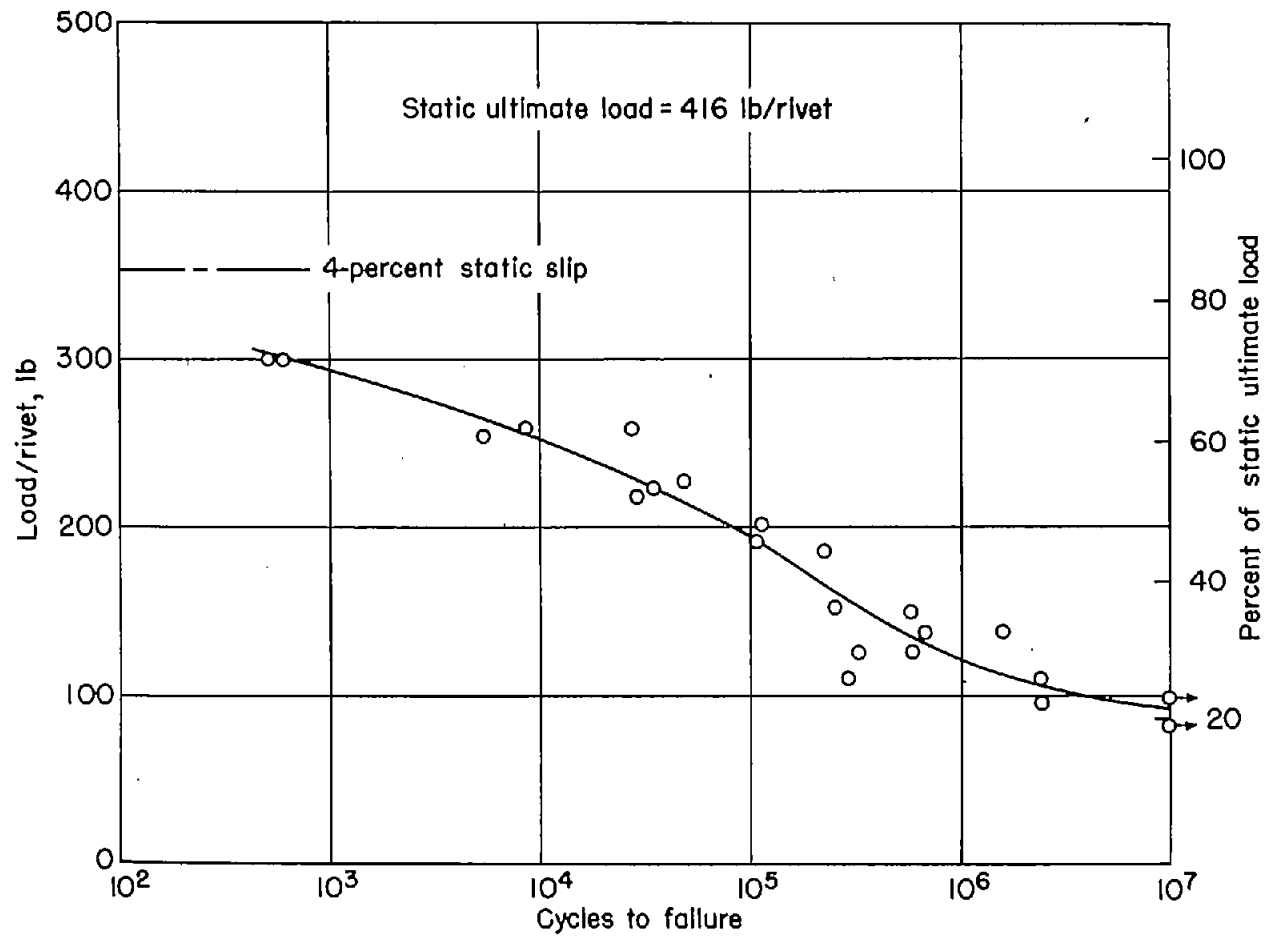
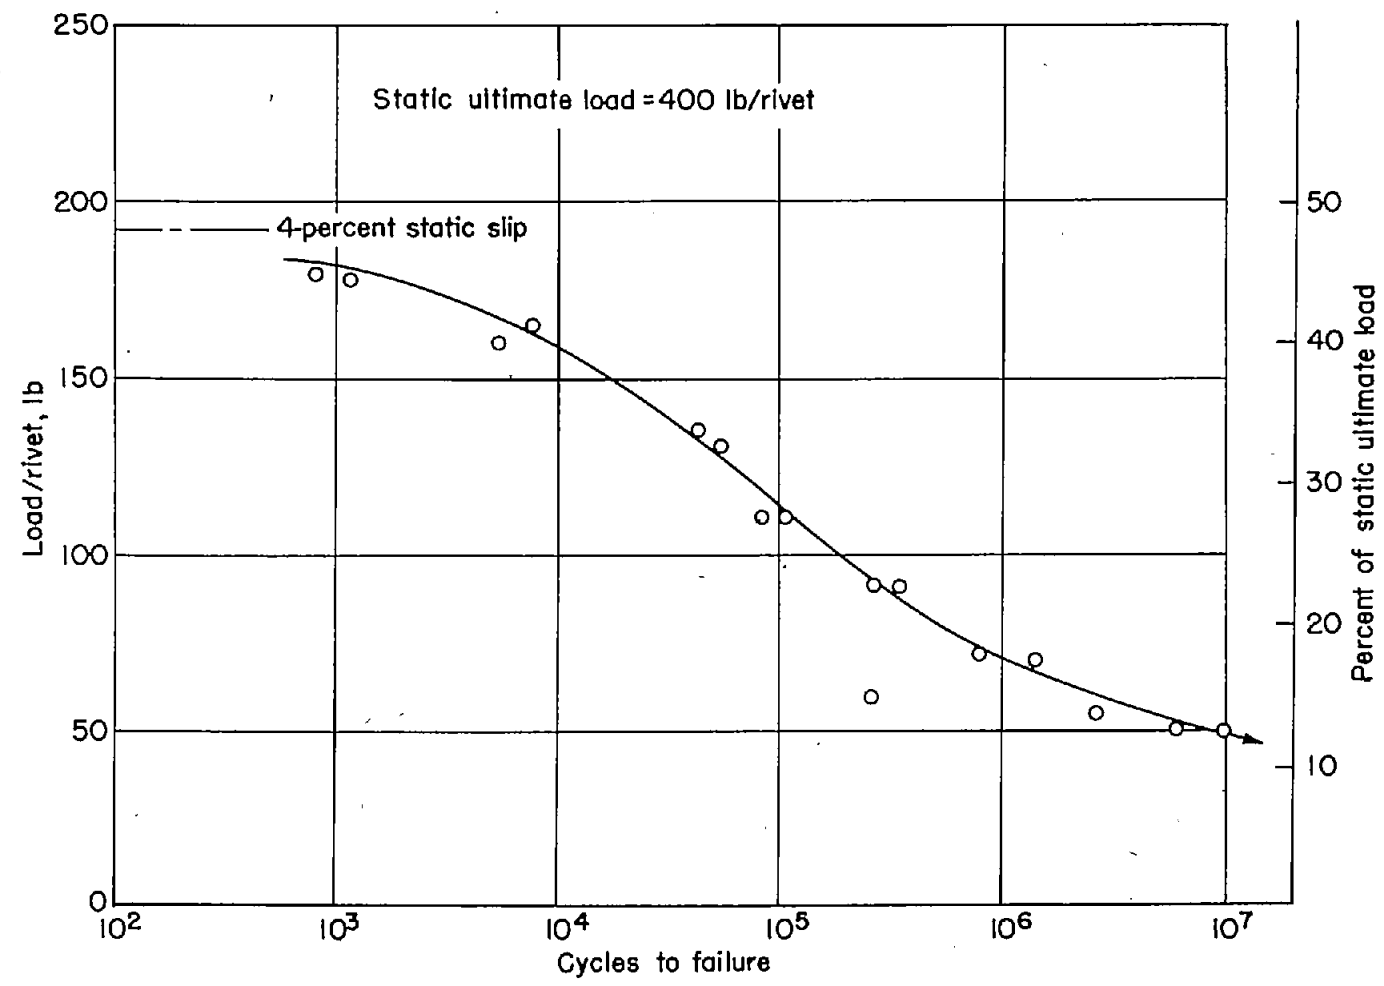
(e) 0.032-inch bare 24S-T3.

(d) 0.032-inch bare 75S-T6.

(c) 0.032-inch alclad 24S-T3.

(b) 0.064-inch alclad 75S-T6.

(a) 0.032-inch alclad 758-T6.

Figure 9.- Curves of load per rivet against cycles to failure for machine-countersunk lap joints.

Fatigue tests at zero mean load were made on 190 multiple-rivet joints. The types of joints for which the fatigue tests were made and the number of tests of each type are listed in table 3. The curves of load per rivet against cycles to failure are given in figures 8, 9, and 10. The average load for a slip of 4 percent of the rivet hole diameter and the maximum static load, as given in table 2, are shown in each figure. A scale obtained by dividing the fatigue load amplitude by the average maximum static load per rivet as given in table 2 is also shown on the right side of each figure. The results show that joints of alclad sheets using machine-countersunk holes had greater fatigue strength than similar joints of bare sheets. Also, comparison of the lap and butt joints using machine-countersunk holes shows that the lap joints were superior under fatigue loads.

The curves faired through the data of figures 9 and 10 (lap joints) are repeated in figure 11 for comparison with each other. It is evident

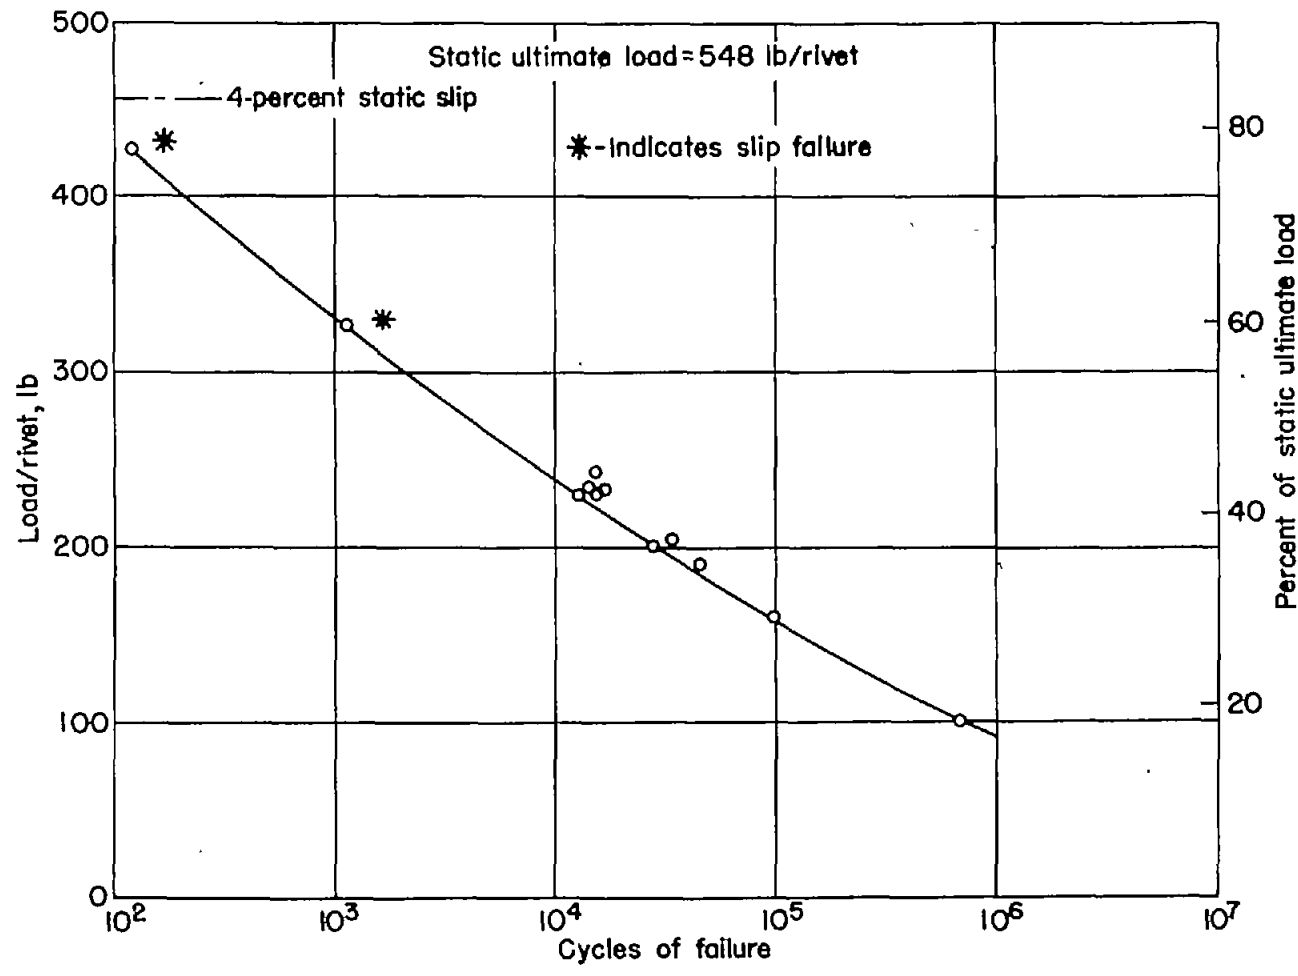
(d) 0.032-inch bare 248-T3.

(c) 0.032-inch bare 758-T6.

(b) 0.032-inch alclad 75S-T6.

(a) 0.032-inch alclad 24S-T3.

Figure 10.- Curves of load per rivet against cycles to failure for dimpled lap joints.

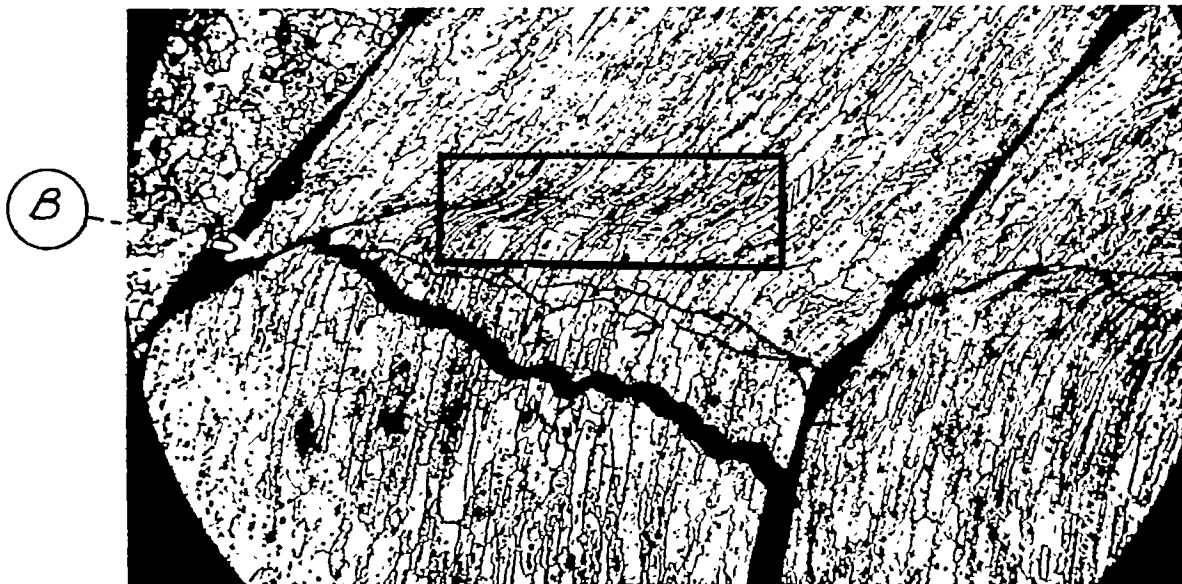
Figure 16.- Cracks at A in figure 15. Crack started at B, began to move through heavily cold-worked area (rectangular box), and changed direction probably because of higher stressing along line of eventual failure. X100.

completely in these joints. The damaged area at A (fig. 15) is shown much enlarged in figure 16. The crack began apparently at the point of highest cold-work B (fig. 16) and initially propagated in the direction of the slip lines. A secondary crack on the convex side of the sheet may have affected the direction of propagation as the failure progressed. A similar crack in another joint is shown in figure 17.
