TECHNICAL NOTE 2812

EFFECTS OF CYCLIC LOADING ON MECHANICAL BEHAVIOR
OF 24S-T4 AND 75S-T6 ALUMINUM ALLOYS
AND SAE 4130 STEEL

By C. W. MacGregor and N. Grossman
Massachusetts Institute of Technology

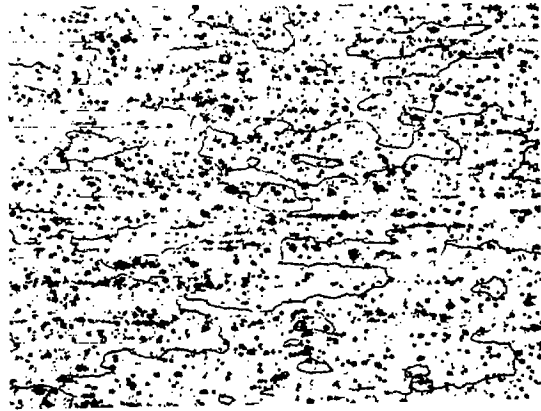
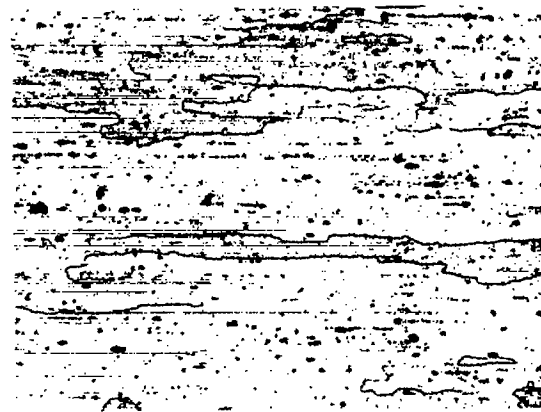
Figure 2.- Photomicrographs of aluminum alloys tested. X100.

Two commercial aluminum alloys (24S-T4 and 75S-T6) and an aircraft quality alloy steel (SAE 4130) were used in the present investigation. The rods were obtained in 1/2-inch-diameter stock from the Aluminum Company of America and the Carnegie-Illinois Steel Corp., respectively. Table I lists the chemical analyses and mechanical properties; figures 1 and 2 show the photomicrographs.

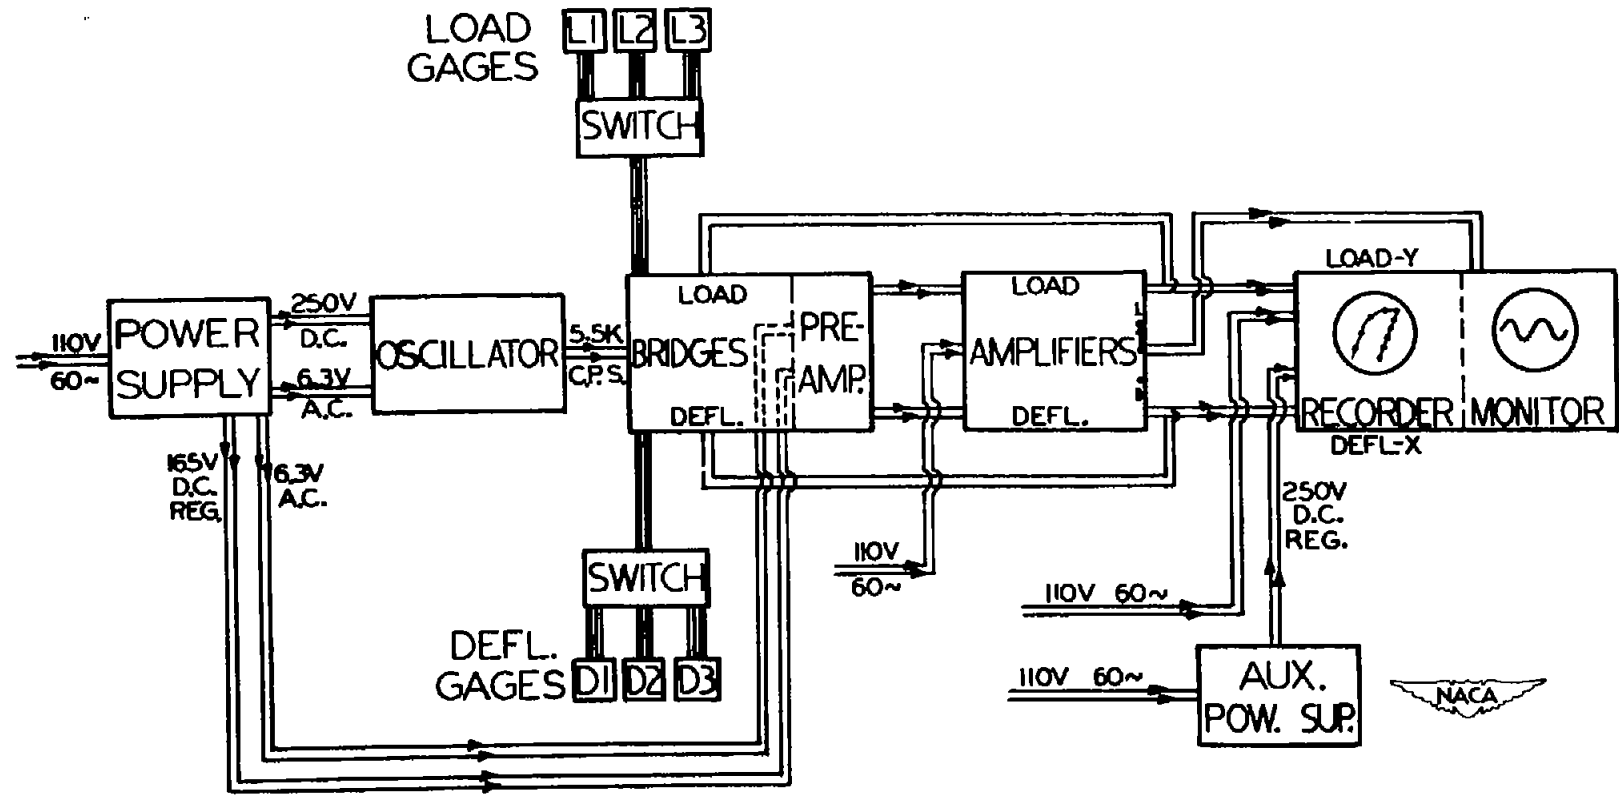
Figure 6.- Panel connections for electronic recorder with alternating-current bridge.

Slow-bend tests at constant deflection rates and temperatures were employed to determine the effects of the prior cycles of fatigue stressing on the mechanical properties. The testing equipment is designed to load a specimen in simple bending at a constant speed and temperature and to supply a load-deflection record of the test. Type AB 7 SR-4 electric strain gages connected in a bridge circuit are used to measure both the load and the deflection. The integral parts of the apparatus include the loading machine with strain gages, a thermocouple and millivoltmeter, a stop watch, electronic recorder, and still camera. The over-all picture of the test cabinet and electronic recorder is shown in figure 4. Figure 5 depicts the loading equipment and the electronic-recorder panel connections are illustrated in figure 6.

An alternating-current bridge system is employed whereby a 5500-cycle-per-second voltage is introduced into the load bridge and the deflection bridge with the resulting unbalance from loading or deflecting detected, amplified, and transmitted to a 5LPI tube. A record is made with a still camera. The load bridge and the deflection bridge contain a type AB 7 SR-4 strain gage in each of the four arms.

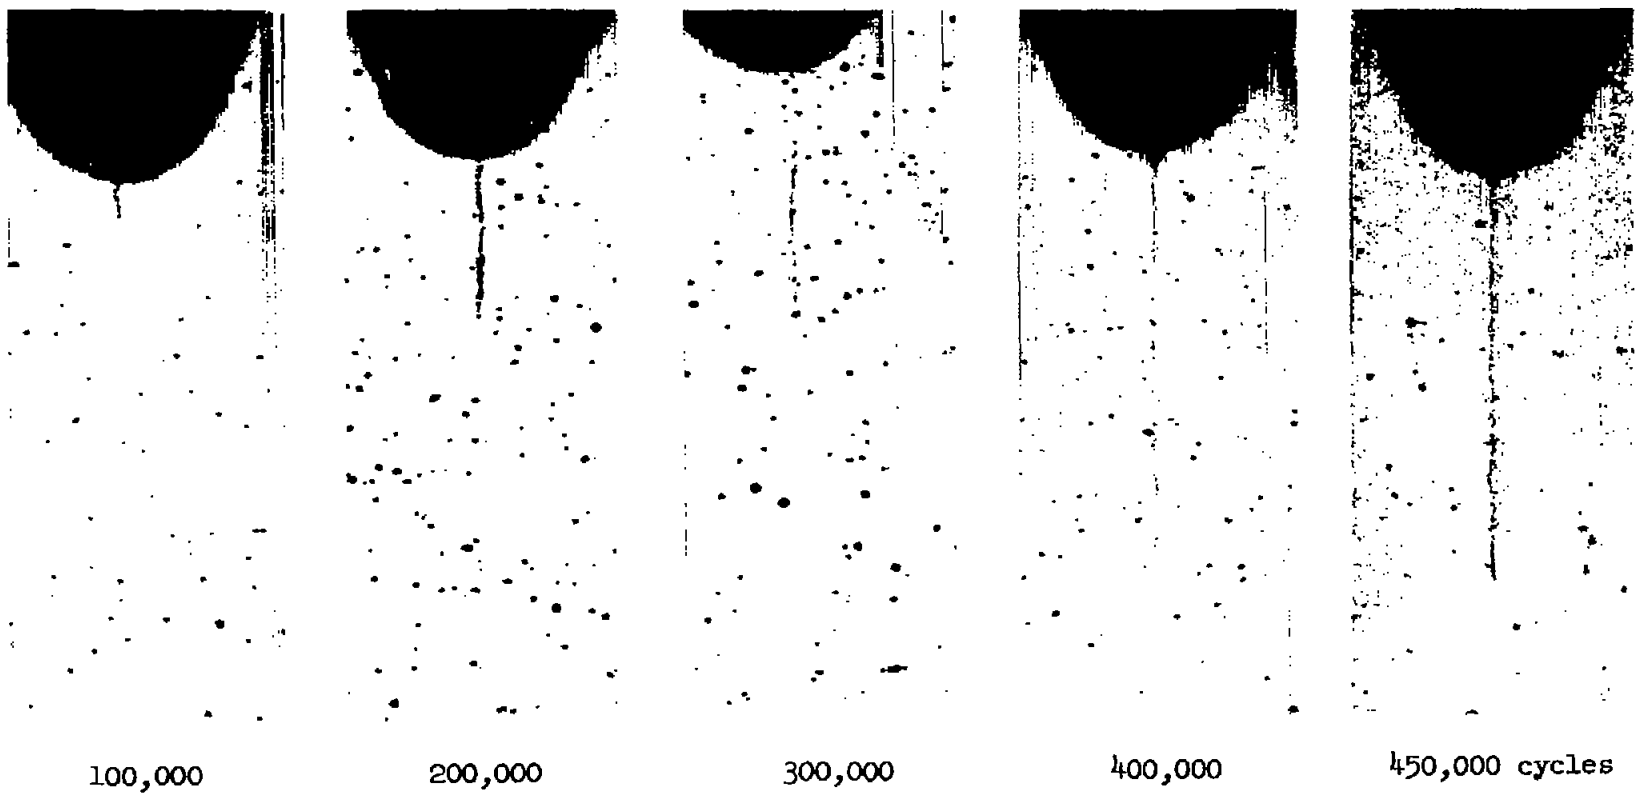
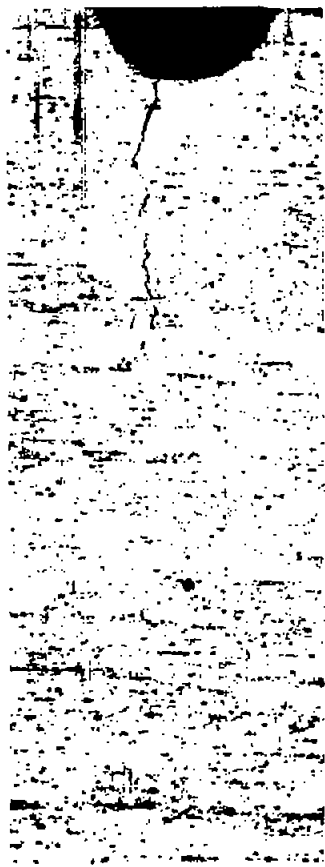
Figure 8.- Longitudinal sections of V-notched specimens showing cracks after various numbers of cycles of fatigue stressing. Notch, 1/16 inch deep with 0.01-inch radius.

It was deemed important, therefore, to determine whether this was a peculiarity of mild steel or whether this phenomenon occurred in other metals as well. Consequently, crack studies were made of specimens subjected to prior fatigue cycles for all three of the metals discussed here for stresses below and above the endurance limits. The technique used was described earlier under "Testing Procedure." Figures 8 to 10 show typical longitudinal sections revealing fatigue cracks for the three metals stressed above the notched endurance limit for different numbers of cycles. Figures 8(a) to 8(c) are for V-notched specimens; figures 9(a) and 9(b), for U-notched specimens; and figures 10(a) and 10(b), for unnotched bars. This method yielded erratic results because the circumferential cracks which originated at the root of the notch and penetrated radially inward were not necessarily symmetrical about the axis of rotation of the specimens. Thus, it was found satisfactory to photograph the stressed and subsequently fractured specimens which showed two clearly distinguishable areas, an outer ring due to the slowly penetrating cumulative "cracks" and the inner "core" which was suddenly fractured. Figures 11

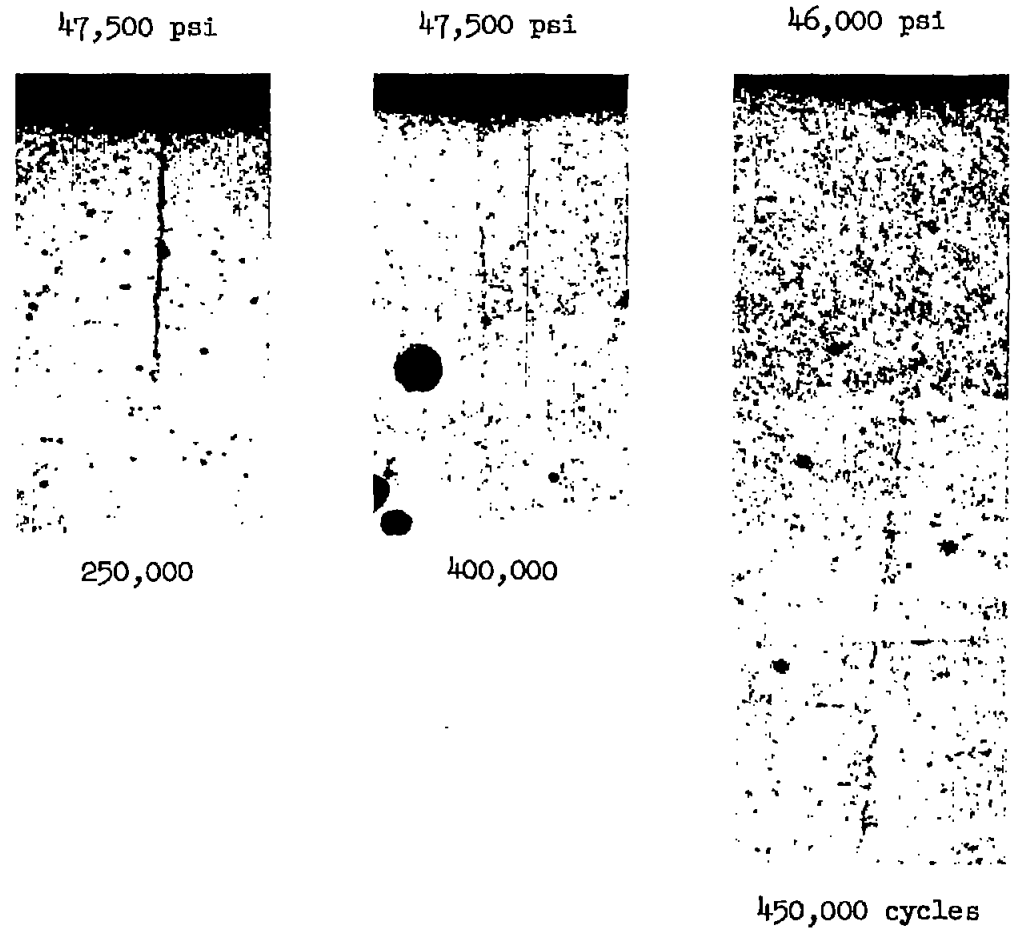
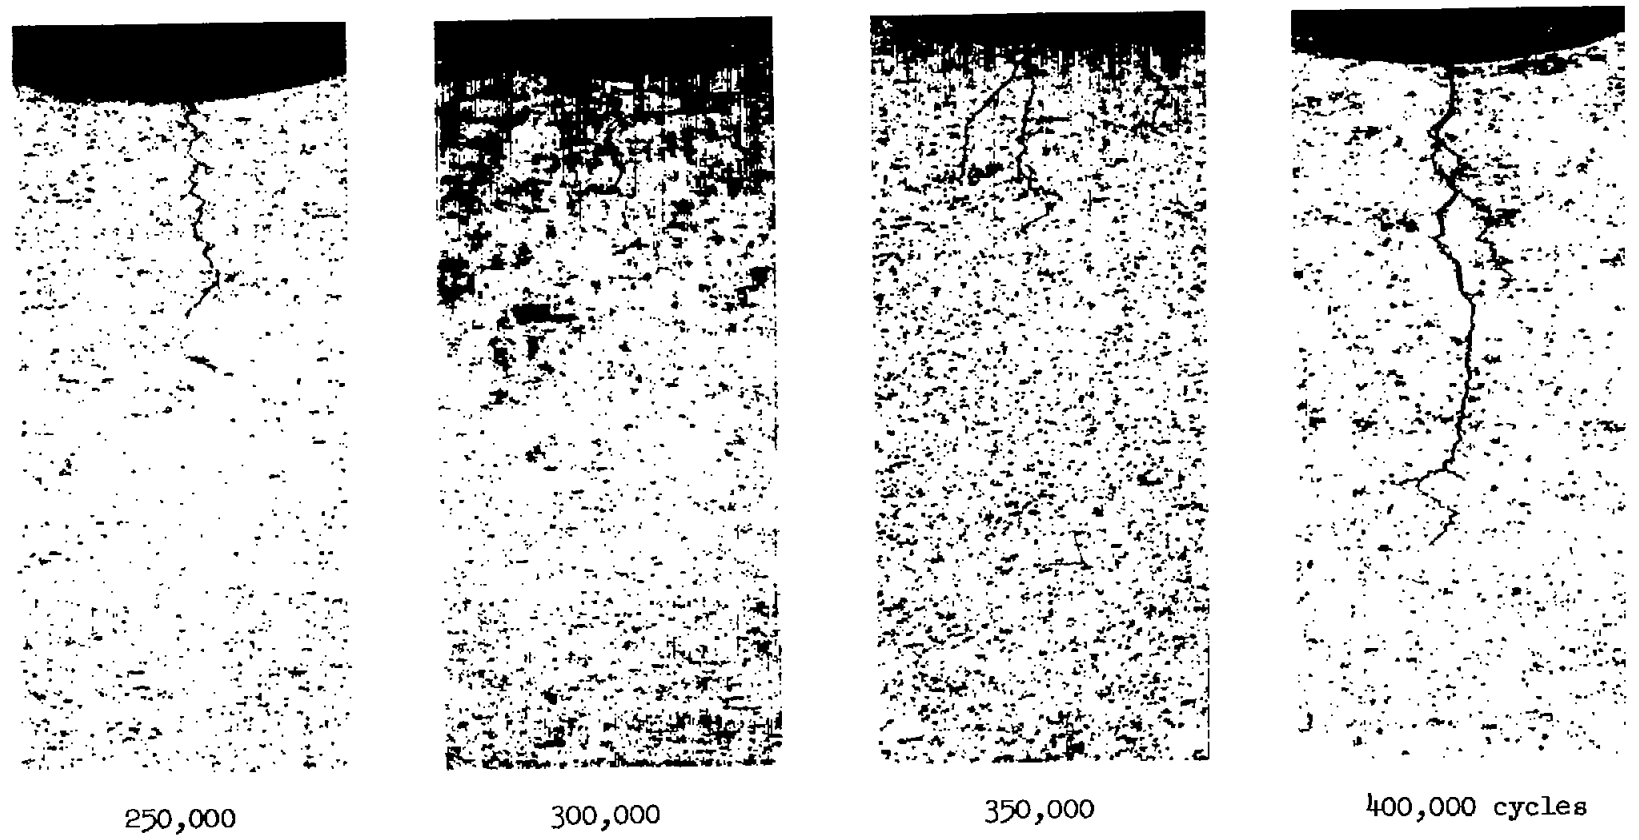
Figure 9.- Longitudinal sections of U-notched specimens showing cracks after various numbers of cycles of fatigue stressing. Notch, 1/16 inch deep with 1/16-inch radius.

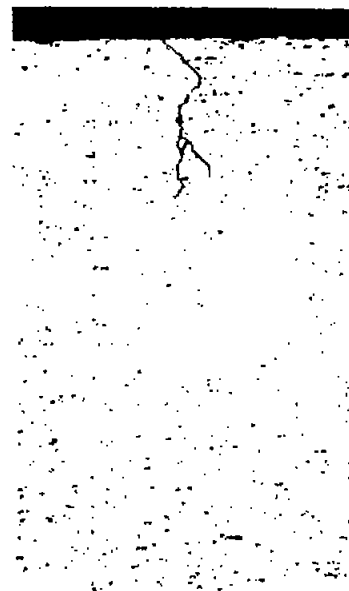
Figure 10.- Longitudinal sections of unnotched specimens showing cracks after various numbers of cycles of fatigue stressing.
