TECHNICAL NOTE 4100

VIBRATION SURVEY OF FOUR REPRESENTATIVE TYPES OF
AIR-COOLED TURBINE BLADES

By Howard F. Calvert and Gordon T. Smith

Lewis Flight Propulsion Laboratory
Cleveland, Ohio

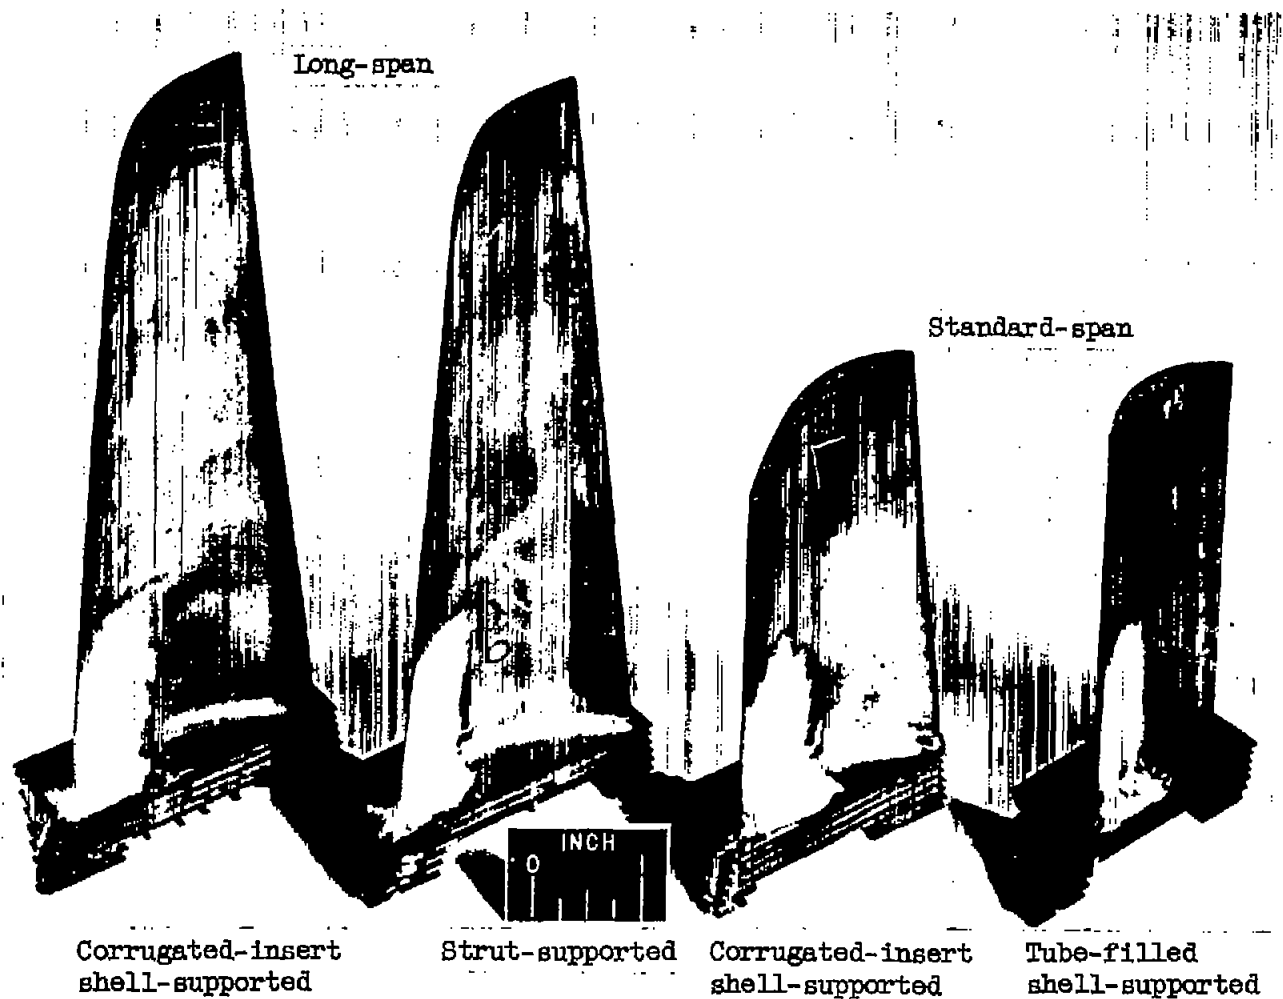
Figure 1. - Four blade types tested.

A blade of each of the four types of air-cooled turbine blades investigated is shown in figure 1. The reference name for each blade is indicated. Table I shows the sketches of the tip cross sections, and

gives the details of the materials used for the construction of blades reported herein. A shell-supported blade is one in which the outer shell is a main load-carrying member; a strut-supported blade is a blade in which an internal strut is the main member carrying the airfoil load. A corrugated-insert or tube-filled blade is a shell-supported blade in which corrugations or tubes have been inserted inside the shell to increase the heat-transfer area. The airfoil lengths of the short- or standard-span and the long-span blades were 4 and $6\frac{1}{4}$ inches, respectively. The chord length of the long-span blades was also greater than for the short-span blades. These blades were brazed structures utilizing cast bases and struts (if strut type), and sheet-metal shells and corrugations. All the blades in this investigation were new except the standard-span, tube-filled blades. These blades were used in a previous investigation and their prior running time was unknown.

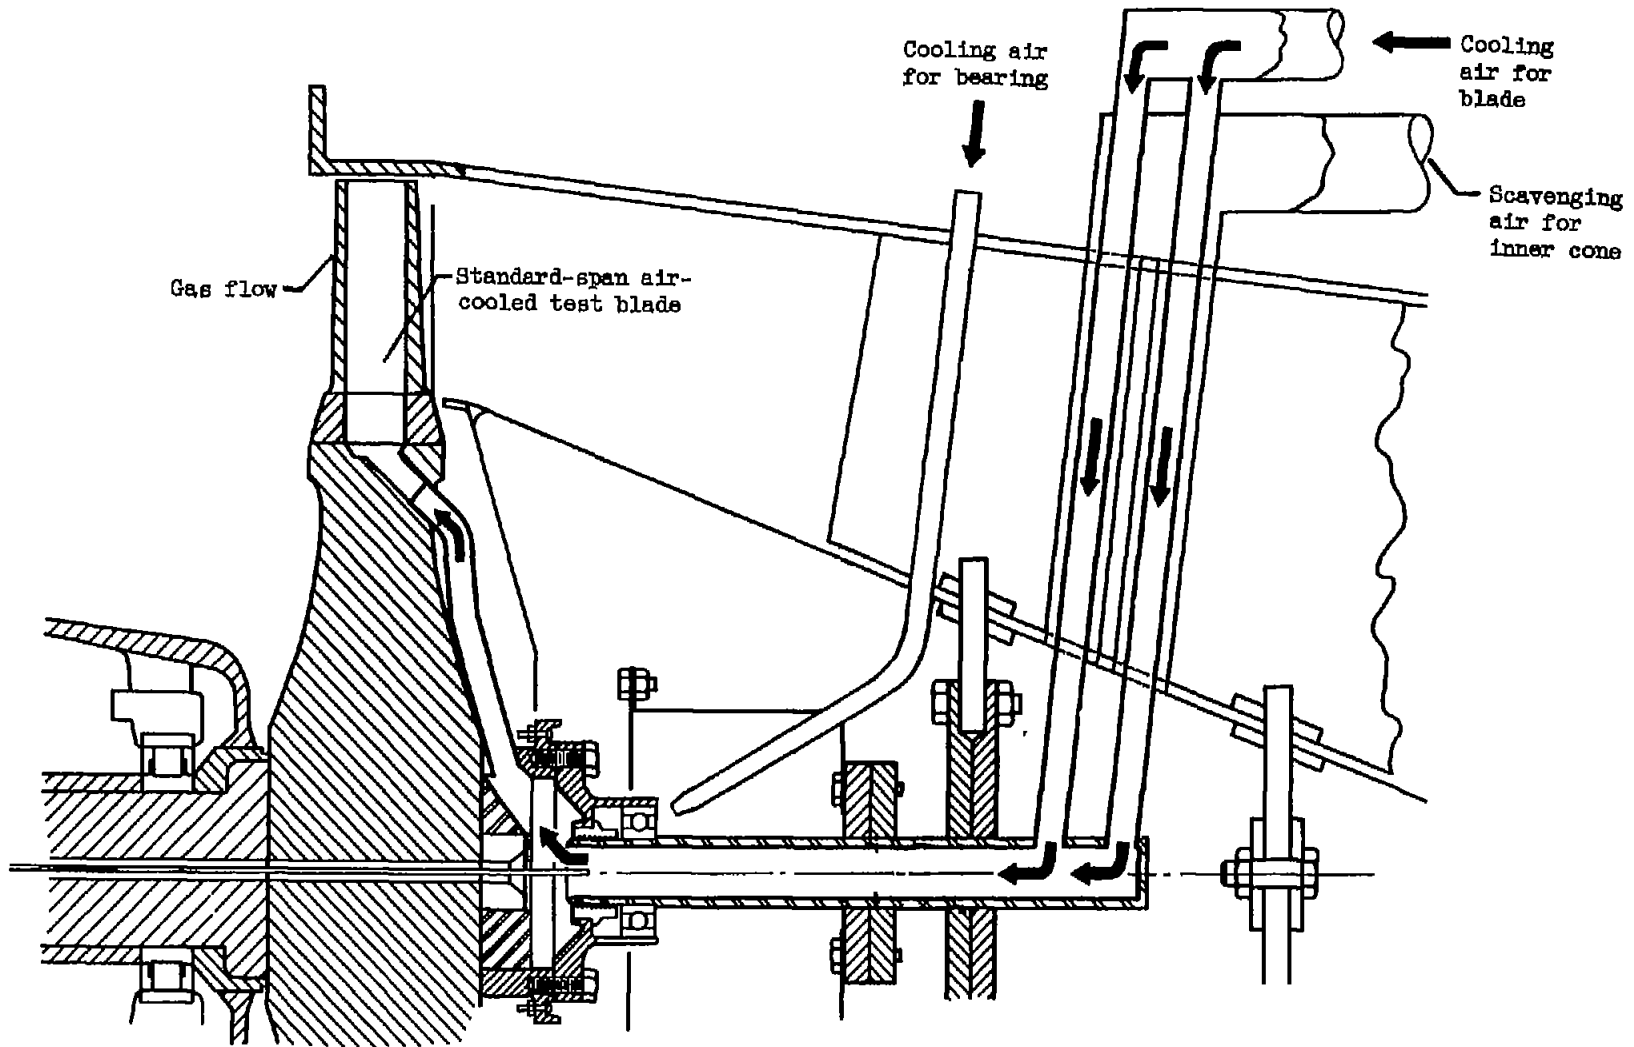
Figure 2. - Tailcone and air-supply system used for short-span blades.

The engine investigation was conducted with a turbojet engine operated in a sea-level static test stand. The test engine had a centrifugal compressor and a single-stage turbine modified to supply cooling air to two test blades located 180° apart. The cooling air was supplied to the two test blades from the rear face of the turbine wheel through a special tailcone assembly shown in figure 2. The details of the modification of the turbine rotor and tailcone are given in reference 5.

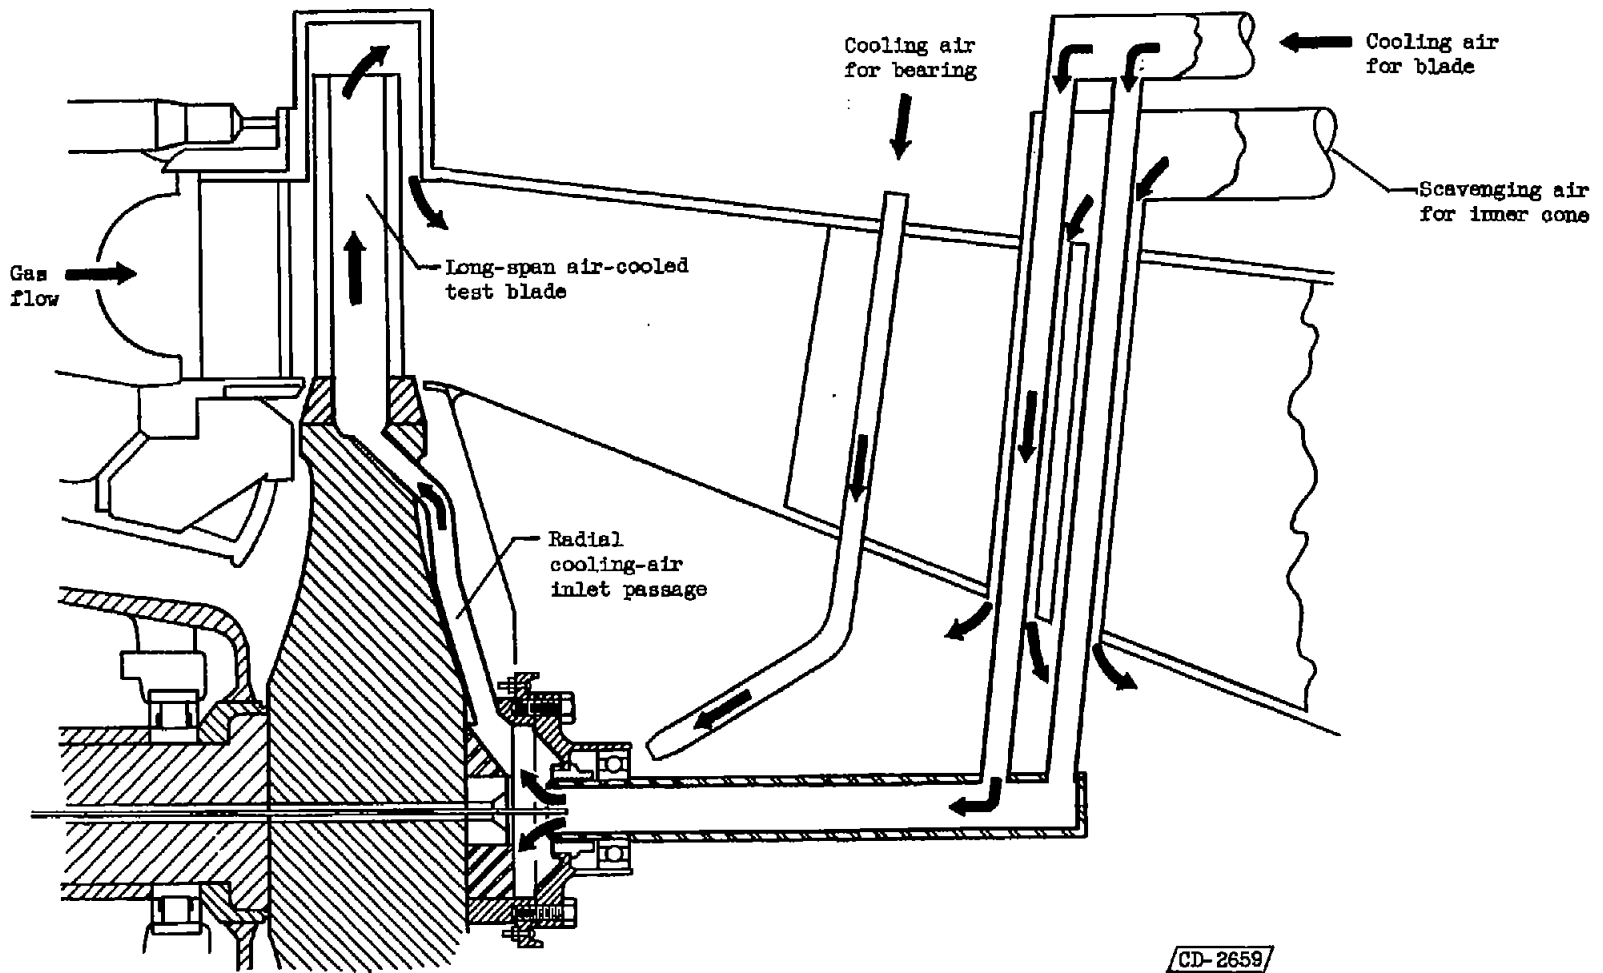
Figure 3. - Tailcone and air-supply system used for long-span blades.

The tailcone modifications reported in reference 5 were used only with the standard-span (4-in.) blades (standard production length for blades in the engine of this investigation). Additional modifications of the turbine shroud were made to accommodate the long-span ($6\frac{1}{4}$ in.) blades. Figure 3 schematically shows the special shroud that was used for this part of the investigation. The "nontest" blades were the same for the testing of all four types of blades. Therefore, the long-span blades extended radially approximately $2\frac{1}{4}$ inches beyond the tip of the other turbine blades. These portions of the test blades were partially shielded from the high-velocity working gas stream. The time and expense of providing a test facility in which a rotor, fully bladed with the long-span blades, could be tested was regarded as prohibitive. Therefore, the tailcone modifications described herein were utilized. The possible effect of this arrangement on the test results is discussed later.

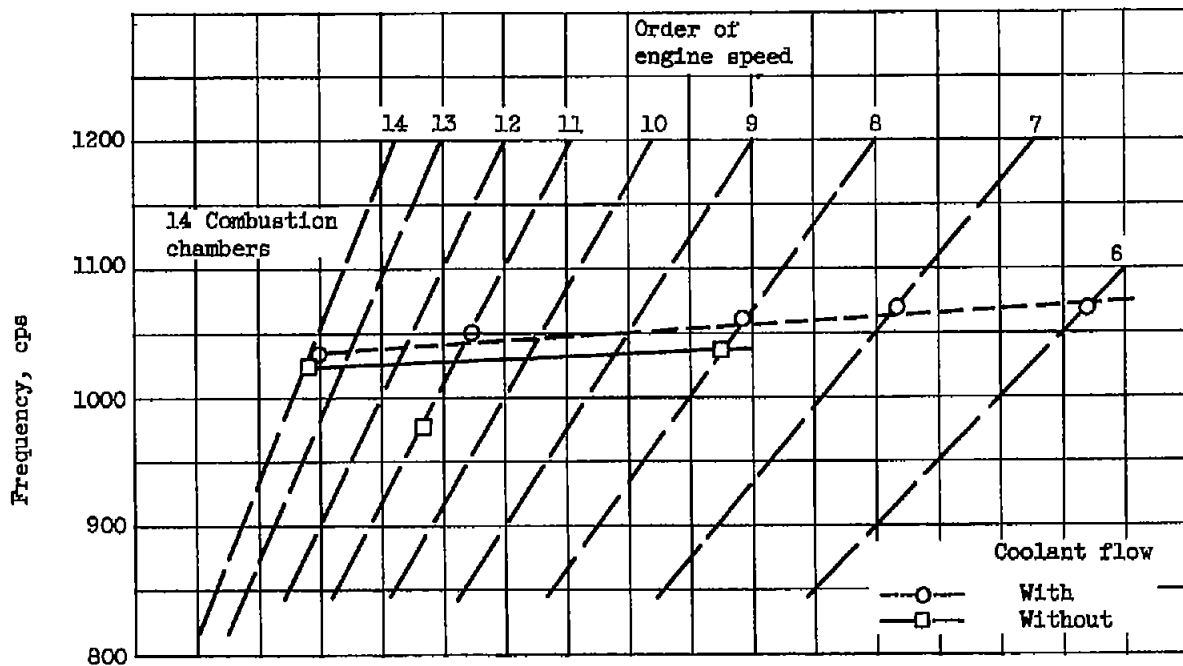
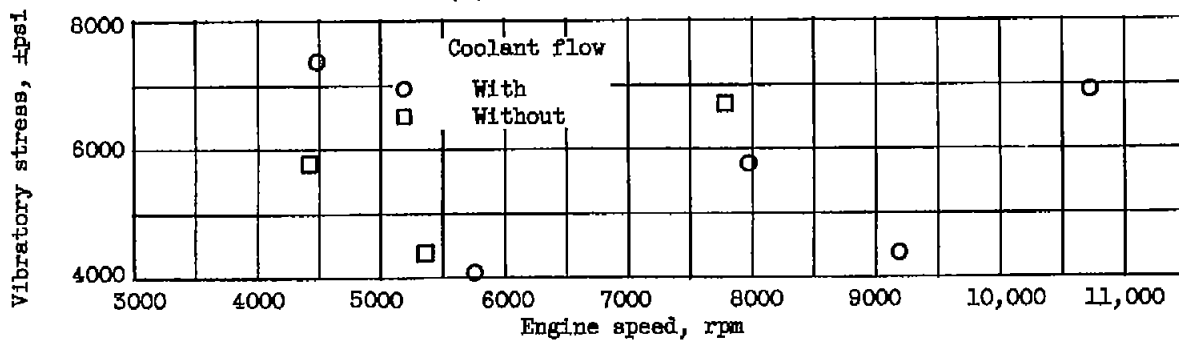
(a) Critical speed diagram.

(b) Measured vibratory stress.

Figure 4. - Measured blade frequencies and vibratory stress of standard-span tube-filled shell-supported blades.

Tube-filled shell-supported blade. - Figure 4 presents vibratory frequency and stress data. These data include the number of peaks or critical vibrations, the change in vibration frequency with coolant flow, and the vibratory stress at each critical speed. It can be noted in figure 4(a) that the sixth- and seventh-order vibrations were observed only with coolant flow. Hence, this blade type was more susceptible to vibration with coolant flow than without; that is, more vibrations were observed with coolant flow. Also, with a coolant flow rate of about 8 percent the vibrational frequency was increased approximately $2\frac{1}{2}$ percent. For example, with the eighth-order vibration the frequency was increased from approximately 1035 to 1060 cycles per second. Calculations based on temperature measurements from previous heat-transfer investigations indicated that the frequency increase was due to the increase in the blade-material modulus of elasticity with a decrease in blade-material temperature. The fourteenth-order vibration was probably excited by the presence of 14 combustor cans.

The peak vibratory stresses reported in figure 4(b) varied between ± 4000 to ± 7500 psi; however, the peak stress measured either with or without coolant flow was approximately the same, indicating that coolant flow had little effect on peak vibratory stress. These peak vibrations occurred over a narrow speed range and the resonant peaks were sharp and often difficult to obtain. Figure 5(a) presents a typical oscillogram showing the resonant-type vibration signal obtained with the tube-filled-type, air-cooled turbine blade.

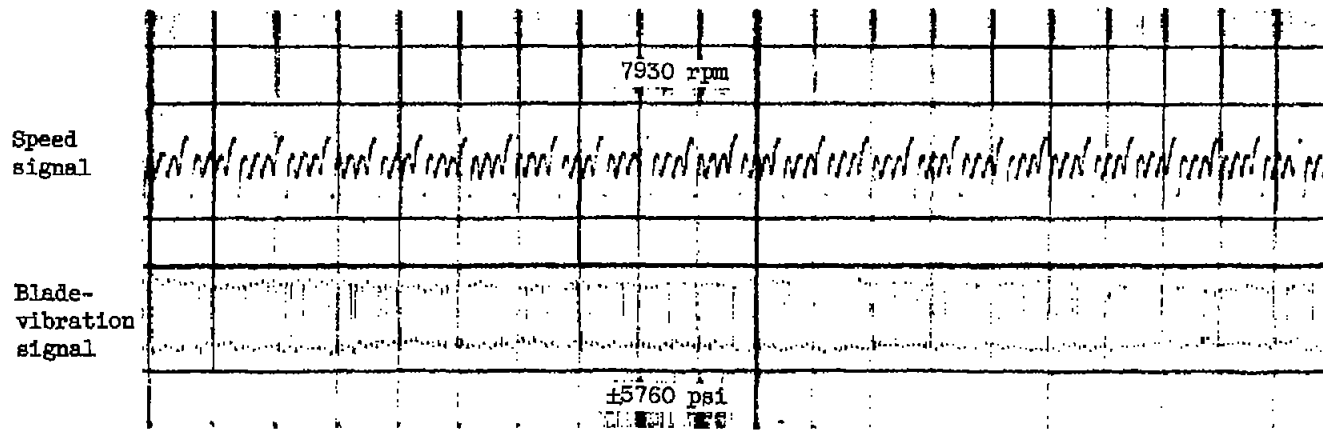
(a) Resonant-type vibration characteristic of standard-span tube-filled shell-supported blade.

signals for the corrugated-insert, shell-supported and solid blades were the same as for the tube-filled blade shown in figure 5.

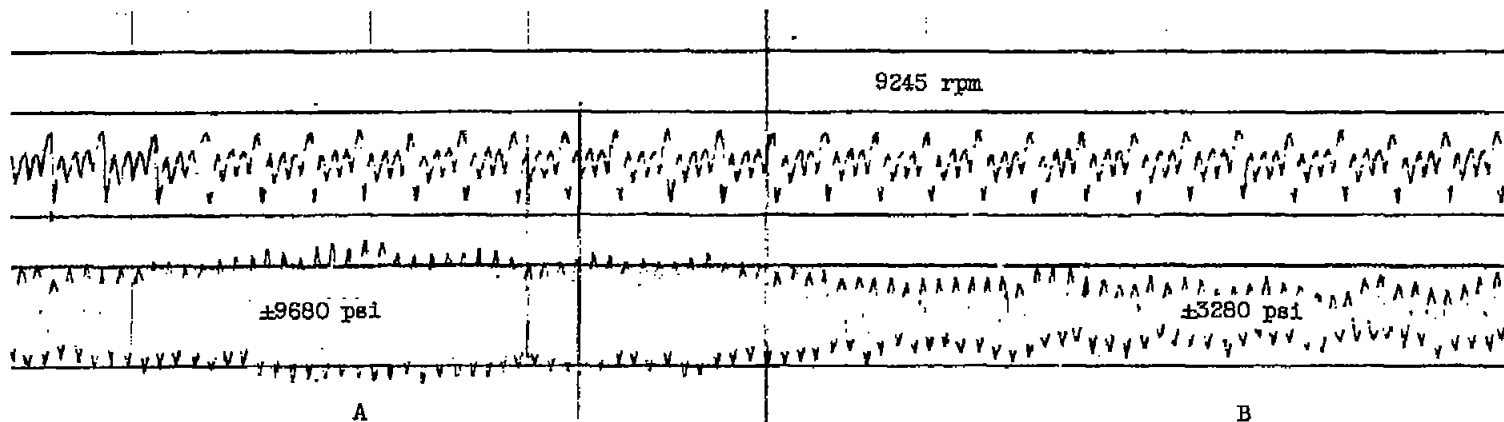
(b) Characteristic vibration signal for long-span, strut-supported blade.

In figure 7(b) the maximum vibratory stress was approximately ± 9680 psi at 9250 rpm without coolant flow. At speeds below 8700 rpm, the maximum stresses were measured with coolant flow. Figure 5(b) presents a typical oscillogram showing the characteristic vibration for a long-span strut-supported blade. Close examination of figure 5 shows that the amplitude of the long-span blade vibration is constantly changing. With the standard-span blade the amplitude was relatively constant. In figure 5(b) the stresses vary from approximately ± 3280 to ± 9680 psi, and the stresses varied in a like manner at all speeds. The excitation of these blades may have been associated with or influenced by the testing environment described in APPARATUS AND INSTRUMENTATION and shown in figure 3. The varying-amplitude-type vibration signal is considered to be associated with a stalling condition in axial-flow compressors. Since the tips of

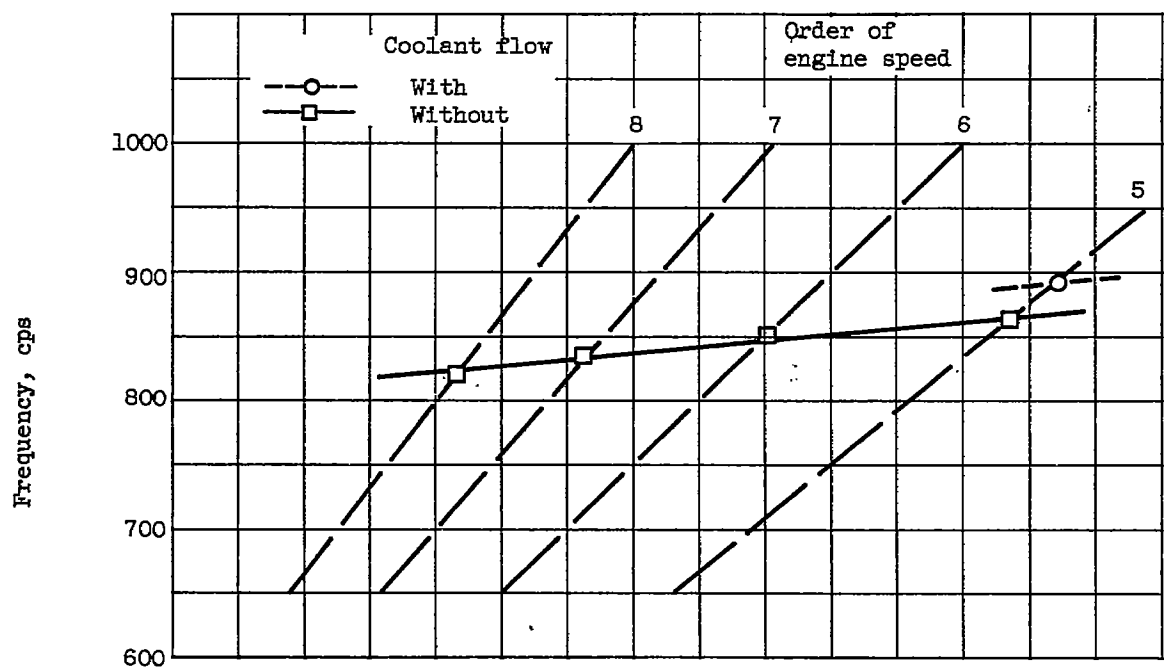
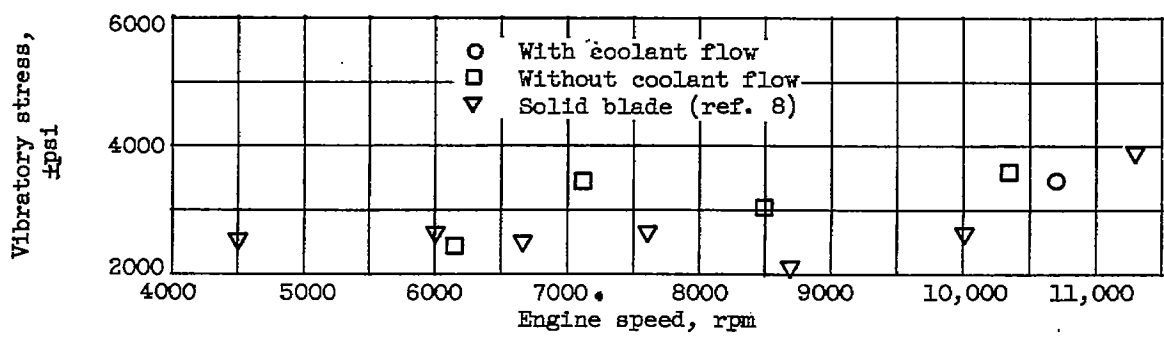
(a) Critical speed diagram.

(b) Measured vibratory stress.

Figure 6. - Measured blade frequencies and vibratory stresses in standard-span corrugated-insert shell-supported blade.

Corrugated-insert shell-supported blade. - The frequency and stress data are plotted in figure 6. The only vibration that was observed when the corrugated-insert shell-supported blade was operated with coolant flow was the fifth-order vibration. The fifth, sixth, seventh, and eighth orders of vibration were observed when the blade was operated without coolant flow. Therefore, this blade type was more susceptible to vibration when operated without coolant flow, or just the opposite result of that obtained with the tube-filled blade. The vibrational frequency was raised about 3 percent when the blade was operated with coolant flow.

The peak vibratory stresses measured were approximately ± 3500 psi (fig. 6(b)) or approximately one-half as high as for the tube-filled blades. These peak vibrations also occurred over a narrow speed range. Also plotted in figure 6(b) are the vibratory stresses measured in another investigation and reported in figure 4 of reference 8. These data were obtained with high-temperature strain gages mounted on solid blades used in the same type engine as this investigation. The vibratory stresses were of approximately the same magnitude as those reported herein for the corrugated-insert shell-supported blade. The characteristic vibration

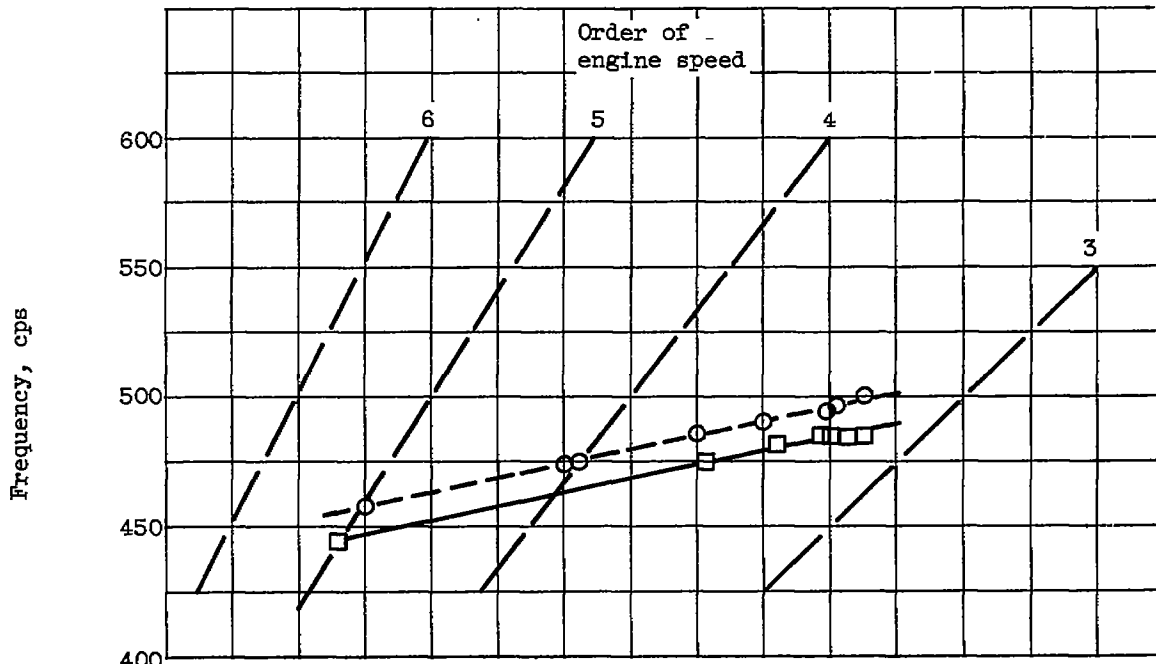
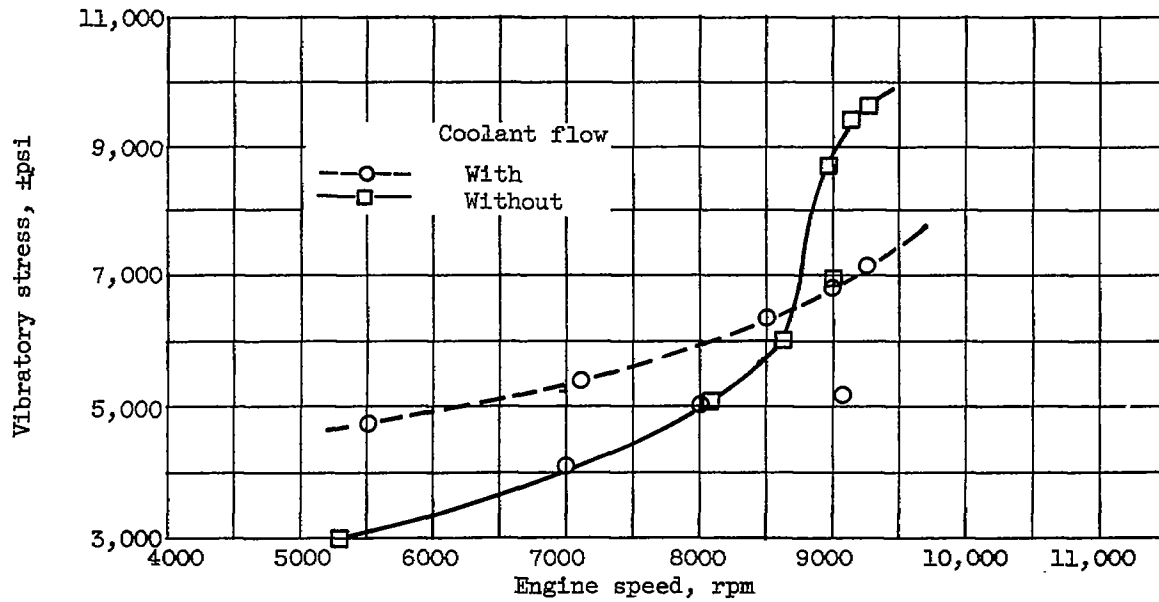
(a) Critical speed diagram.

(b) Measured vibratory stress.

Figure 7. - Measured blade frequencies and vibratory stresses in long-span strut-supported blades.

Strut-supported blade. - The vibration data are presented in figure 7. The blade vibration frequency data in the critical speed diagram (fig. 7(a)) do not all correlate with the order of engine speed lines as did the data for the standard-span blades (figs. 4 and 6). The long-span blades were different from the short-span blades in that they vibrated at all speeds investigated, and not just at critical speeds or the intersection of the measured blade frequency and engine speed order lines. In fact, data could have been obtained at any speed between idle and rated, and for this reason a continuous curve was drawn through the peak stress points. At speeds between the third and fourth engine speed orders, many data points were obtained in order to define the shape of the stress curve. Blade coolant flow increased the blade vibrational frequency approximately 3 percent.

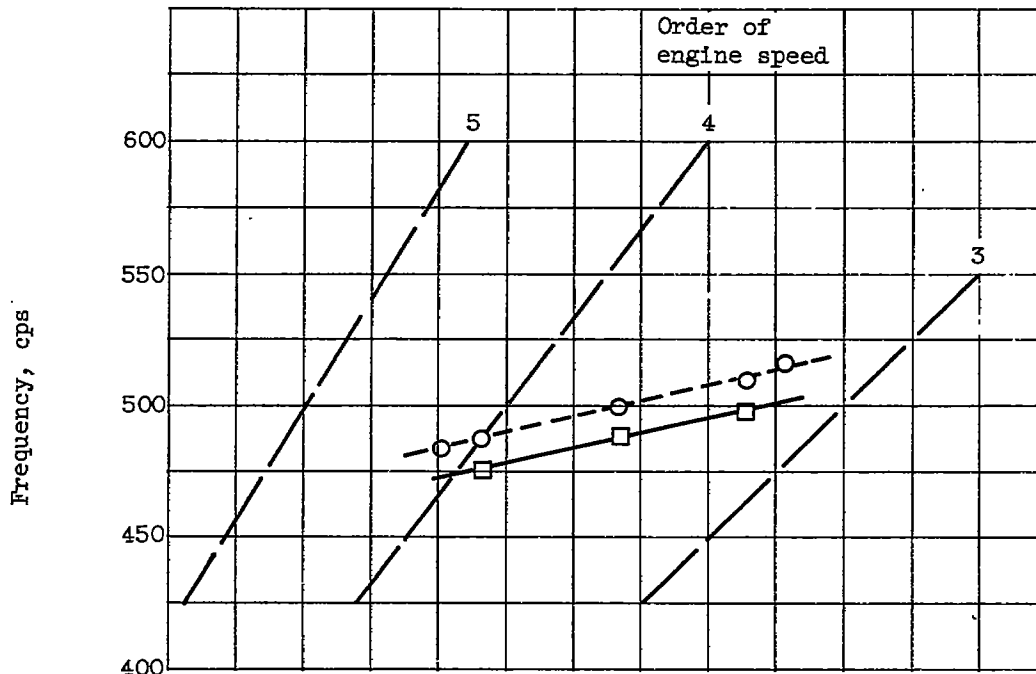
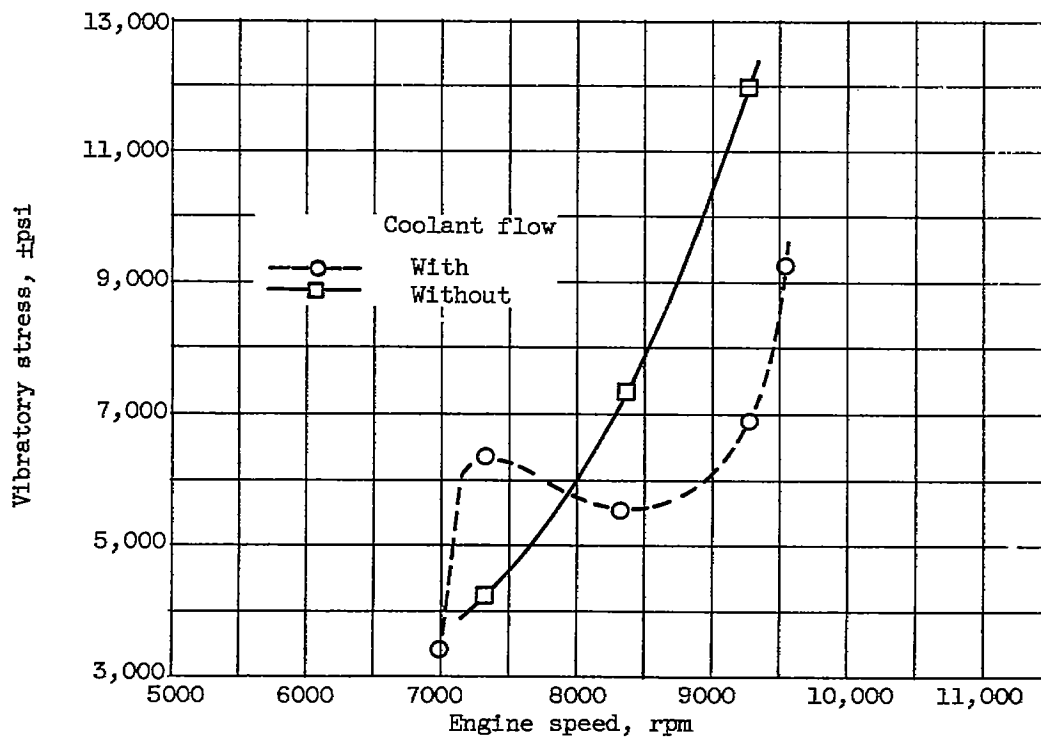
(a) Critical speed diagram.

(b) Measured vibratory stress.

Figure 8. - Measured blade frequencies and vibratory stresses in long-span corrugated-shell-supported blade.

Corrugated-insert shell-supported blades. The vibration data for the corrugated-insert shell-supported blades are reported in figure 8. The vibration frequency and character of the strain-gage signals were the same for both the strut-supported and corrugated-insert, shell-supported long-span blades. That is, the blades were vibrating at all speeds with an irregular amplitude. With the corrugated-insert, shell-supported blades, the vibration frequency was increased approximately 3 percent with coolant flow.

The maximum vibratory stress of $\pm 12,000$ psi (fig. 8(b)) was measured at 9250 rpm without coolant flow. Above 8000 rpm the stresses increased very rapidly with increased engine speed either with or without coolant flow.

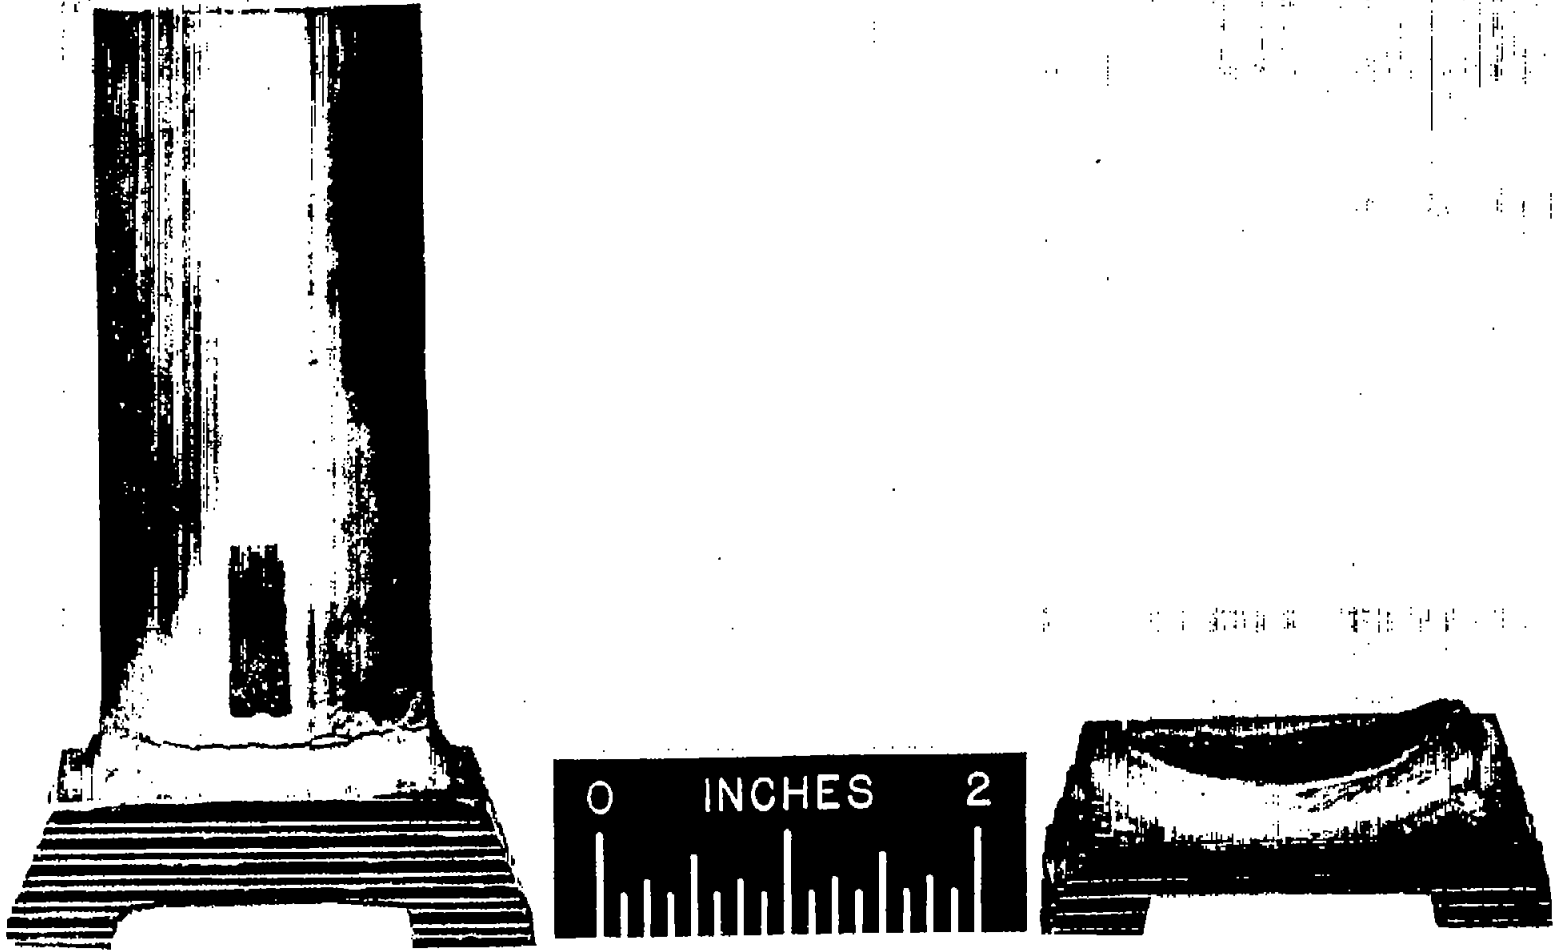
Figure 9. - Typical failures of short-span tube-filled shell-supported blades.

Tube-filled shell-supported blade. - Figure 9 shows a typical tube-blade failure obtained during engine operation and reported in reference 1. Blades 1 and 2 of static investigation reported herein (table II) also exhibited fatigue failures at the same location. With a vibratory stress of $\pm 10,000$ psi, blade 2 failed in only $7\frac{1}{2}$ hours. Figure 4 shows that vibratory stresses as high as approximately ± 7500 psi were measured during engine operation. A vibratory stress of ± 7500 psi may appear to be too low to cause blade failure; however, because of stress concentrations at the fillet, the stress at the point of failure would be many times higher or high enough to cause blade failure.
