No. 670

N.A.C.A. STALL-WARNING INDICATOR

By F. L. Thompson
Langley Memorial Aeronautical Laboratory

Washington
October 1938

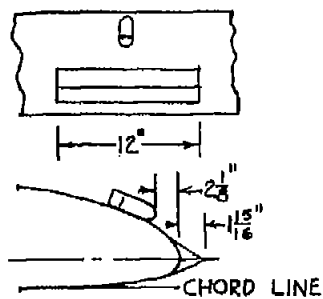
Table I

TABLE I.- TESTS OF STALL WARNING DEVICE - ARRANGEMENTS TESTED AND RESULTS.

It appears from a study of the results given in table I that the functioning of the stall-warning device is adjustable through a considerable range by means of alterations of the shape and size of the sharp edge and of the nose of the head. It appears to be very important that the dynamic opening of the head be close to the wing surface in order to avoid the necessity for a large, sharp edge. With the dynamic opening above the wing surface about one-half inch as it was with the original nose piece, satisfactory results were obtained only with the large, sharp edges of arrangements A and B. With the dynamic opening brought down close to the surface, satisfactory results were obtained with the sharp edge reduced to a length of 6 inches in a spanwise direction and an extension of $11/16$ inch in a chordwise direction (arrangements F and H). A further reduction in size might have been possible but appeared to be unnecessary in view of the apparent insignificance of the alteration of the wing contour.

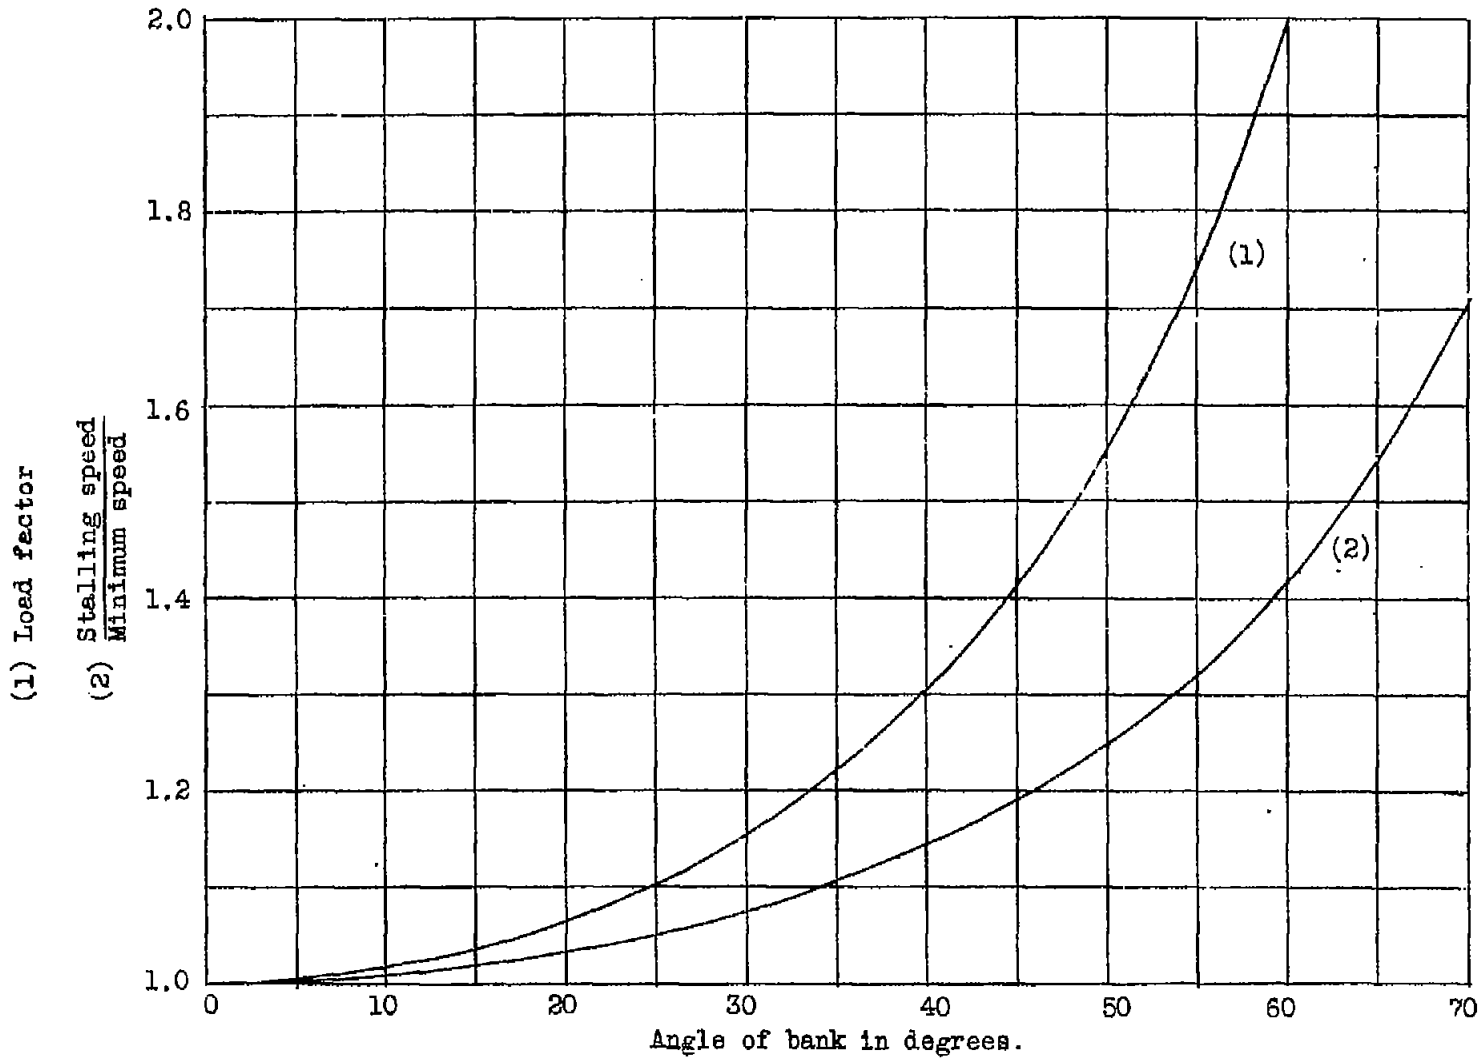
Figure 1.- Variation of load factor and ratio of stalling speed to minimum speed with angle of bank in horizontal turns.

The load factor and the ratio of V_{stall} to V_{min} in turns are plotted in figure 1 to show how these quantities vary with angle of bank. The curve of stalling speed is an ideal one that does not take into account the influence of errors in the air-speed meter reading. In general, such errors will further complicate the situation because calibrations made in steady flight will not apply in accelerated flight unless the correction for position error of the air-speed head is negligible. If an instrument is to be used to give a warning of the stall, therefore, it appears desirable that its functioning should be dependent on angle of attack rather than air speed. Furthermore, it seems desirable in order to avoid the necessity for watching the instrument continuously that it be arranged to give a warning signal when a safe limit has been reached.

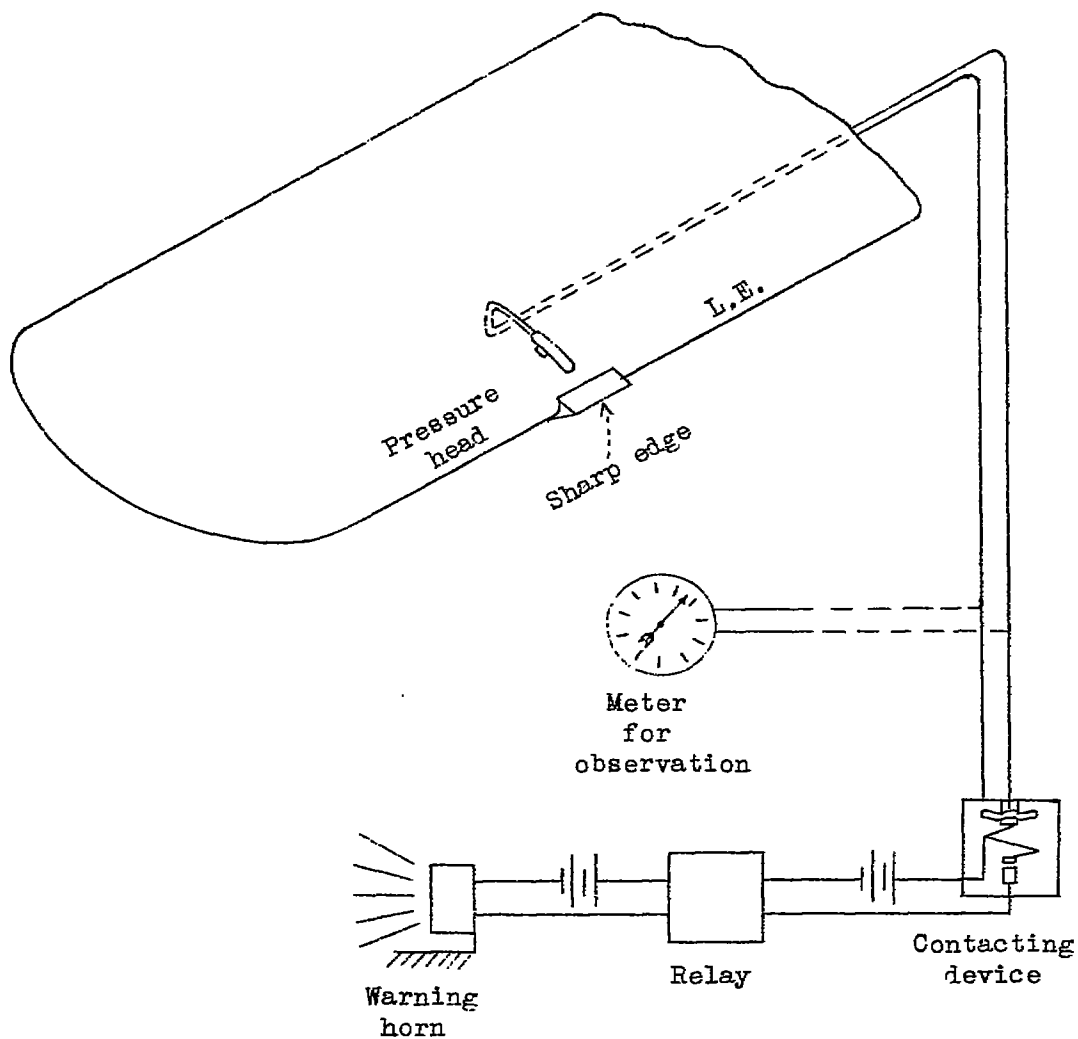
Figure 2.- Diagram of stall warning device.

A stall-warning device developed by the National Advisory Committee for Aeronautics is shown diagrammatically in figure 2. It makes use of a modified type of pitot-static head set close to the wing surface in a region wherein stalling occurs (or is made to occur) at an angle of attack considerably below that at which the main portion of the wing stalls. This head is connected to a pressure cell fitted with electrical contacts and for observations during tests it may also be connected to a conventional air-speed meter. When the air flow in the region in which the head is located breaks away from the wing surface, that is to say, when local stalling occurs, the pressure indicated by the head drops sharply to zero. When this occurs the electrical contacts close a circuit that operates a warning signal. The signal as used in flight tests of this device was a horn such as that used with retractable landing gears, but of course any suitable type of warning may be used.

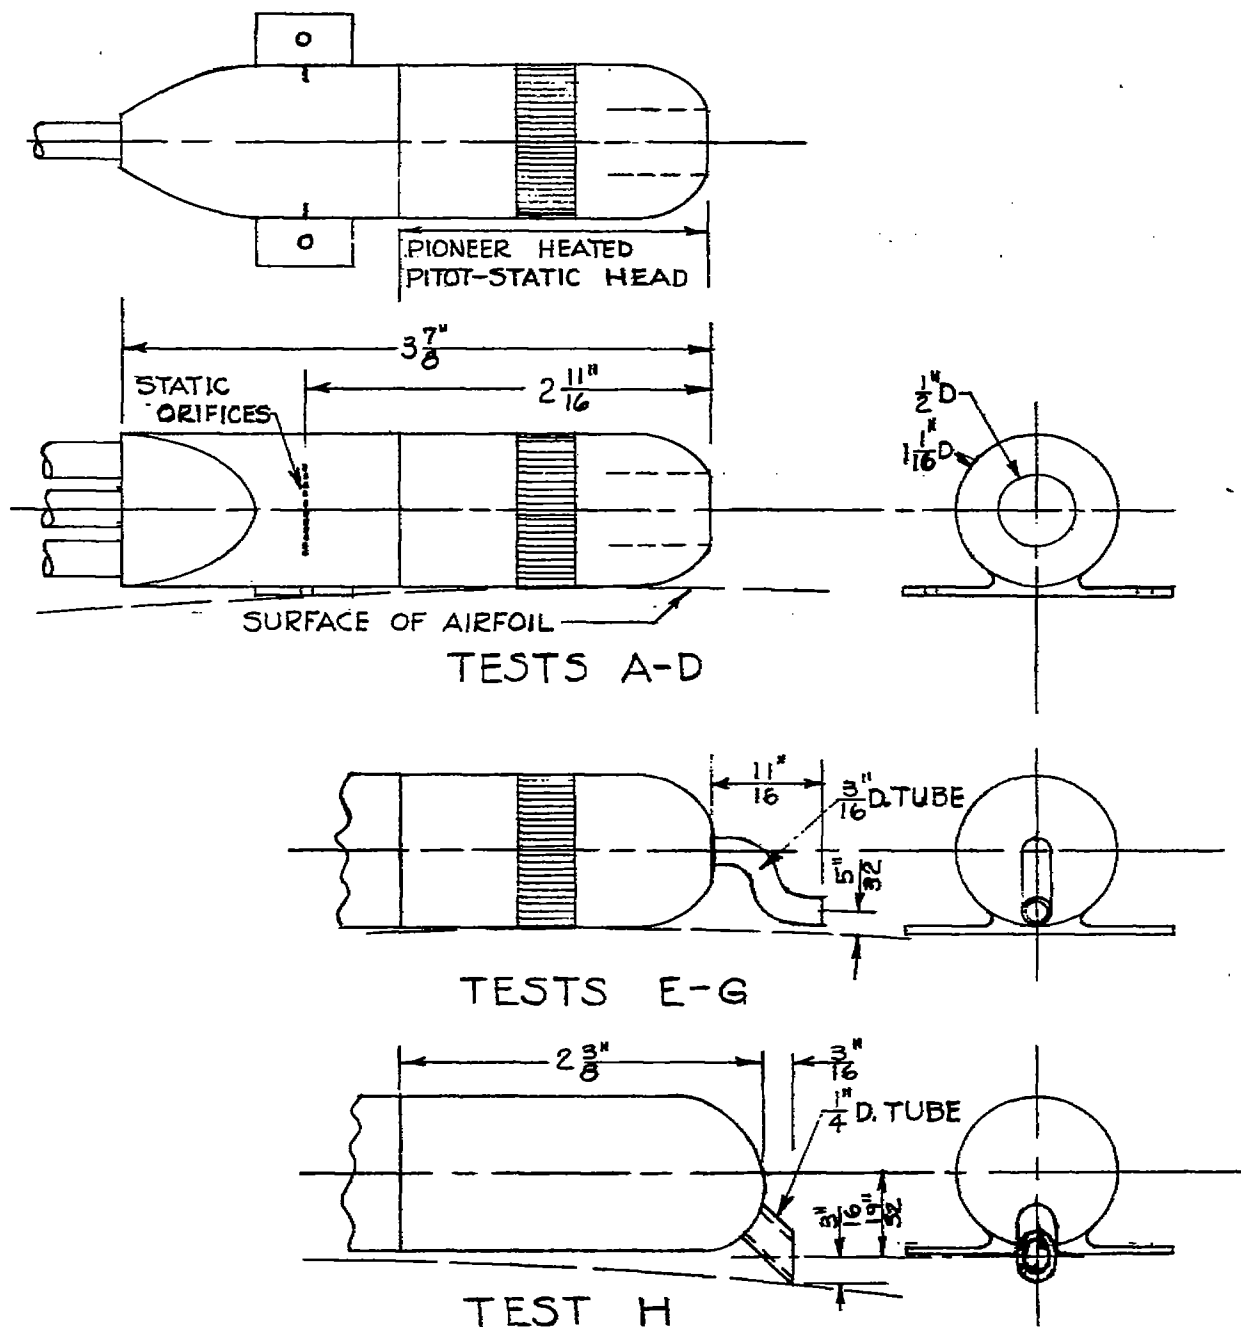
Fig. 3

FIGURE 3.- PRESSURE HEADS USED WITH STALL WARNING DEVICE.

The head used in the experiments with different nose pieces is shown in figure 3. Table I shows the various arrangements of sharp edge and head that were tested and figure 4 shows photographs of combination H. For the tests the contacting device was set to operate when the local air speed as indicated by the stall-warning device dropped below 70 miles per hour. As will be shown later, this setting was appreciably below what would normally be the local velocity over the curved portion of the leading edge of the wing at the minimum speed of the airplane on which the tests were made. A considerable variation of this setting, however, would not have altered the results appreciably.

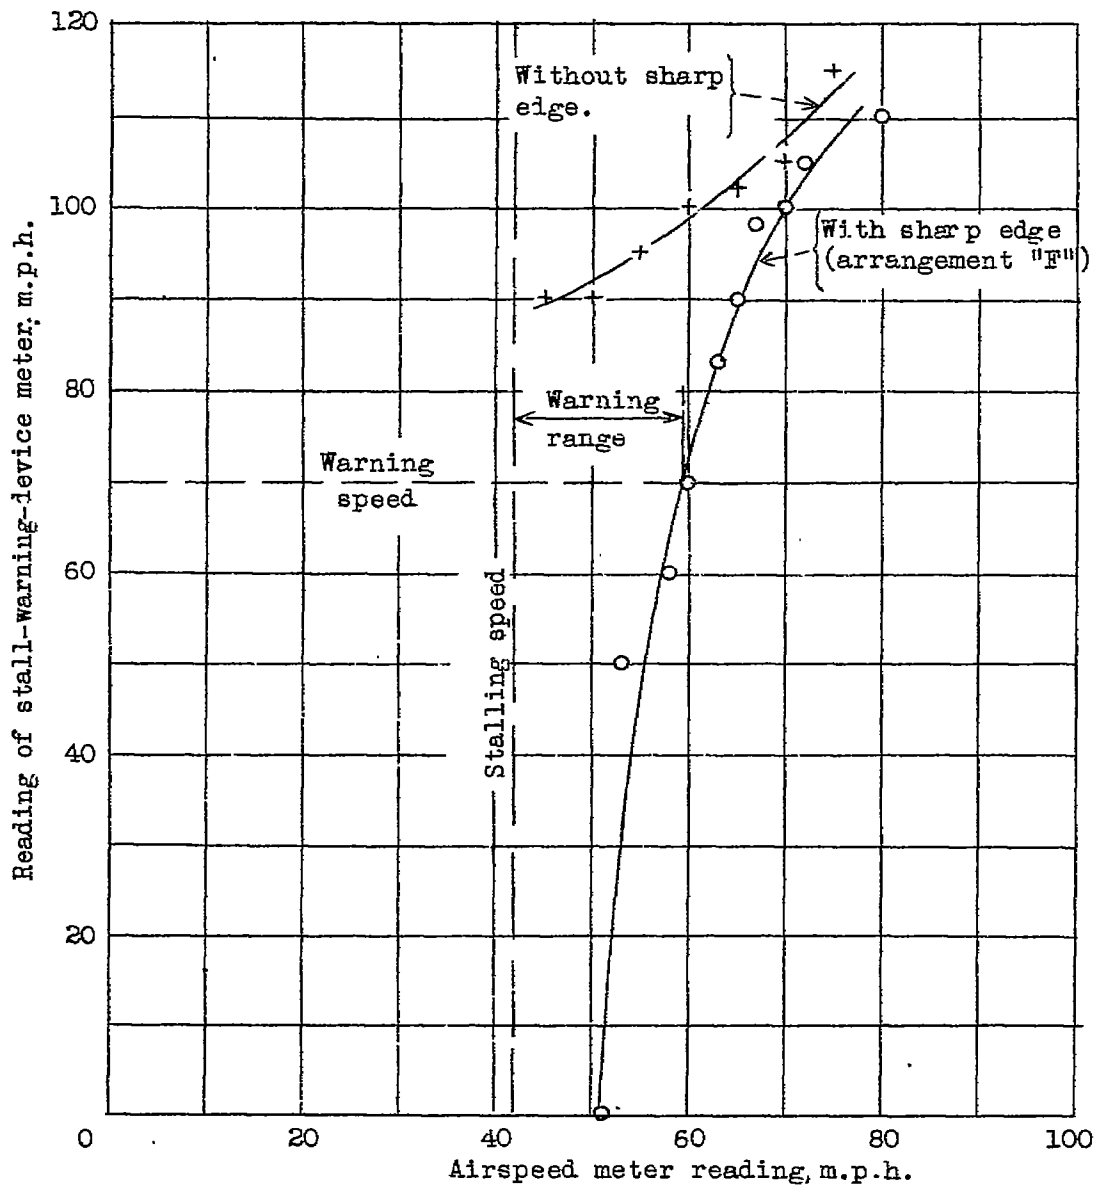
Figure 5.- Characteristics of stall-warning device for typical case.

Before a comparison is made of the results obtained with different arrangements, it seems advisable to describe the general characteristics of the behavior of the device by reference to figure 5. This figure shows the readings of the meter connected to the stall-warning head plotted against the readings of the air-speed meter of the airplane with arrangement F and also with the sharp edge removed. The results shown in this figure for arrangement F are typical of arrangements considered to be satisfactory. It will be noted that whereas the reading of the air-speed meter of the airplane at minimum speed is 42 miles per hour, the warning is obtained at about 59 miles per hour, the speed at which the local velocity falls below 70 miles per hour. Without the sharp edge the local velocity over the leading edge of the wing does not fall below 90 miles per hour. It may also be noted that, although the device was set to warn when the local velocity reached 70 miles per hour, a change of setting of several miles per hour in either direction would not have greatly altered the airplane speed at which the warning occurred. In other words, the adjustment of the contacting device was not critical. One other point of practical interest brought out by figure 5 is that in the normal flight range the local velocity is considerably greater than the air

speed of the airplane, so that the pressure unit used in the contacting device must be rugged enough to withstand pressures much larger than the dynamic pressure corresponding to the maximum speed of the airplane relative to undisturbed air.
