AGATE

FULL-SCALE TEST AND DEMONSTRATION

REPORT NO: C-GEN-3451 - 1 (REV N/C)

Work Package Title: Full-Scale Test & Demonstration - WBS 3.4.5.1

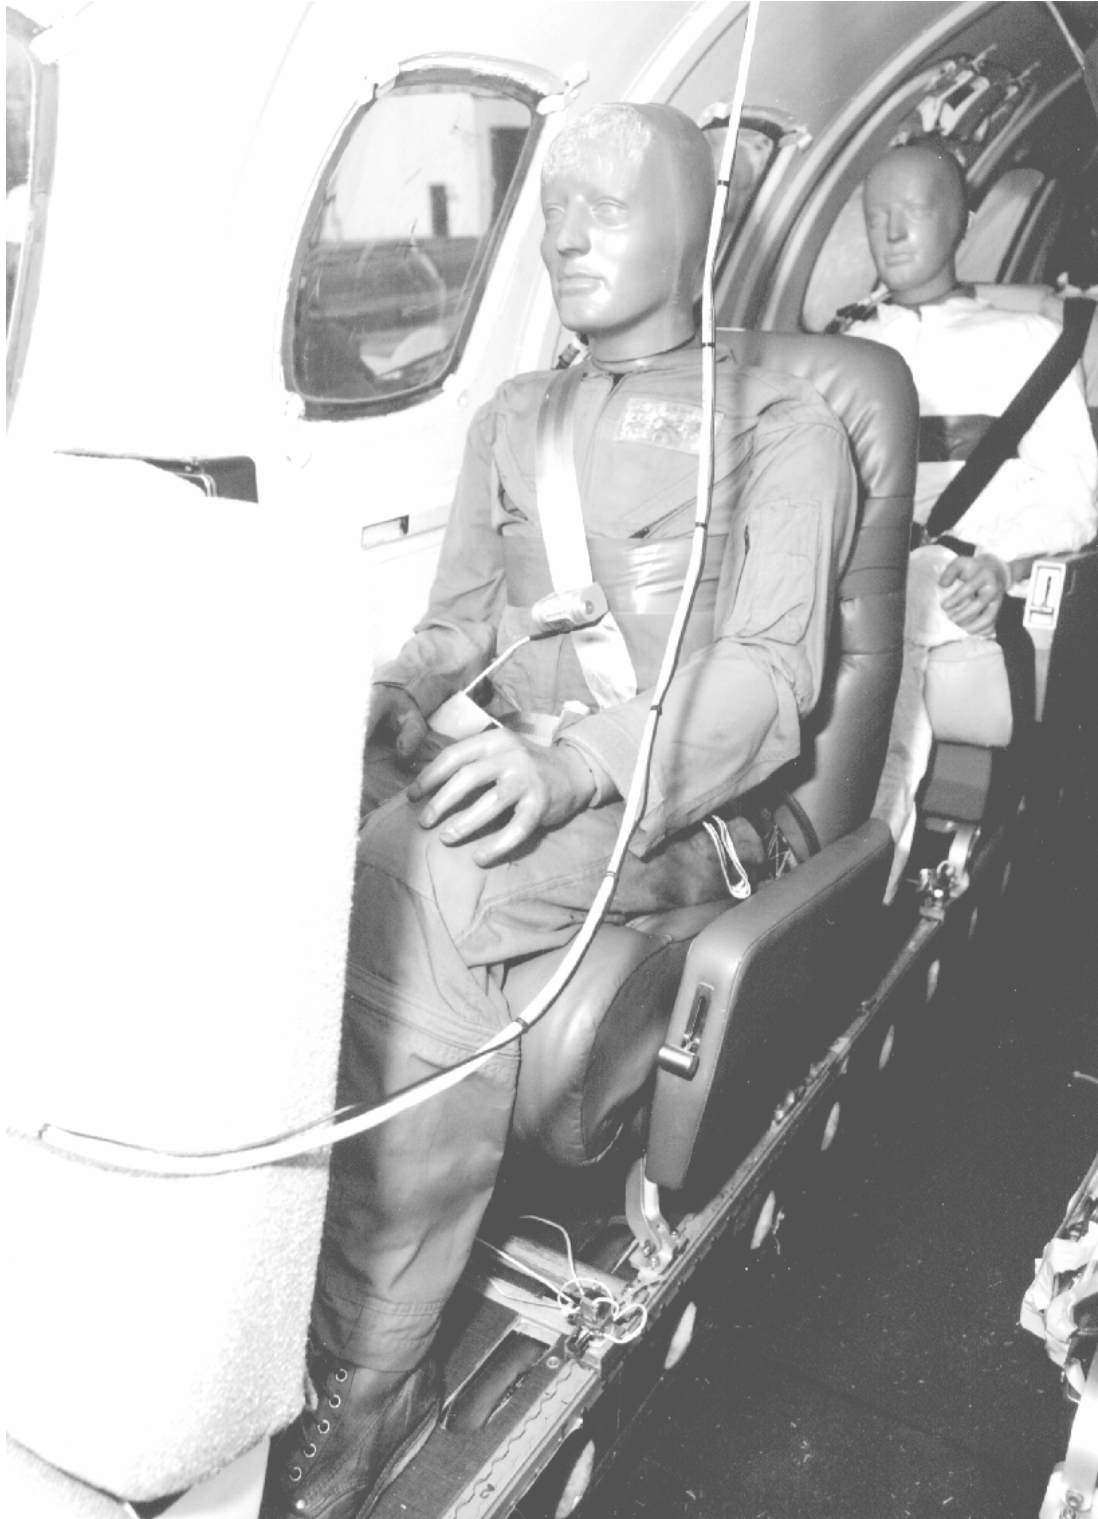
the overall dynamic response when it comes into contact with the airbag. The relative position of Seat No.5 with respect to Seat No.3 is shown in Figure 2.2. The inboard feet for both seats are attached to the seat tracks which are directly mounted to the floor beams. Due to the difference in spacing between the seat legs and floor beams, the outboard feet could not be installed directly to the outboard floor beams. Instead, a cross-beam was installed across the inboard and outboard floor beams, and the outboard seat legs were attached to the cross-beam. Figure 2.3 shows the installation and relative position of Seat No.3 and Seat No.5 in the fuselage.

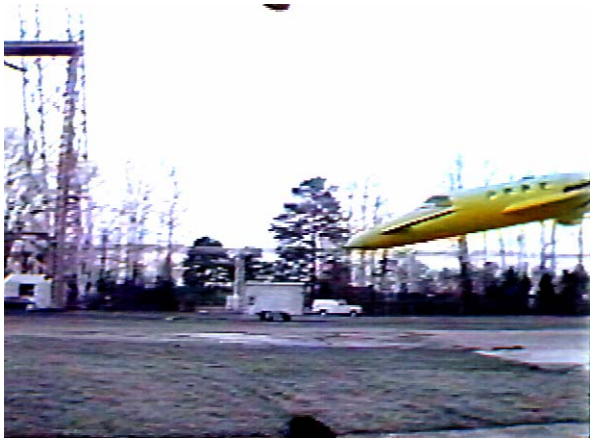
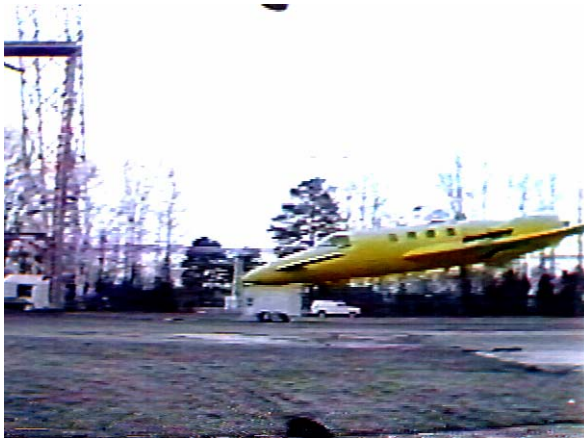
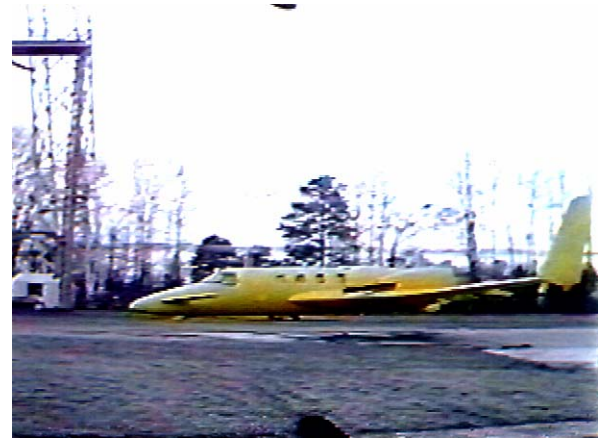
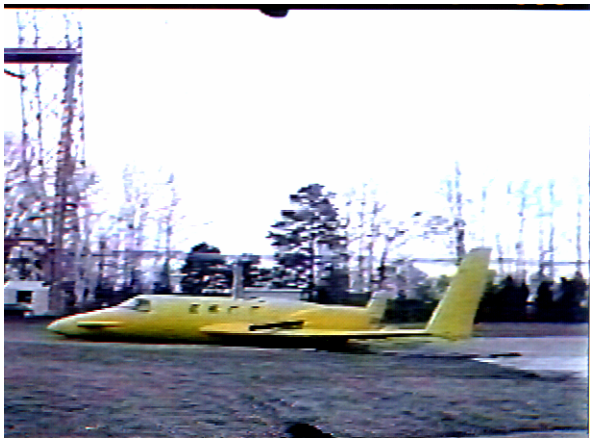
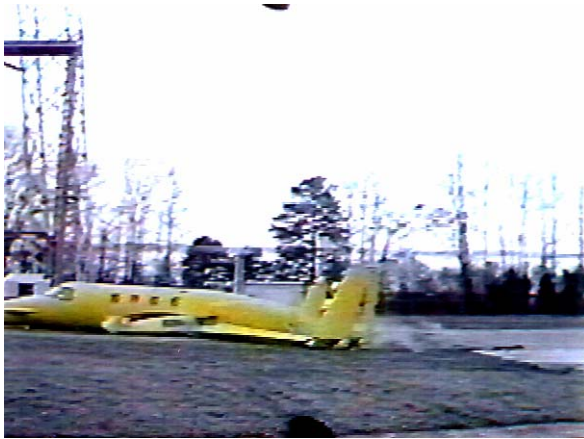
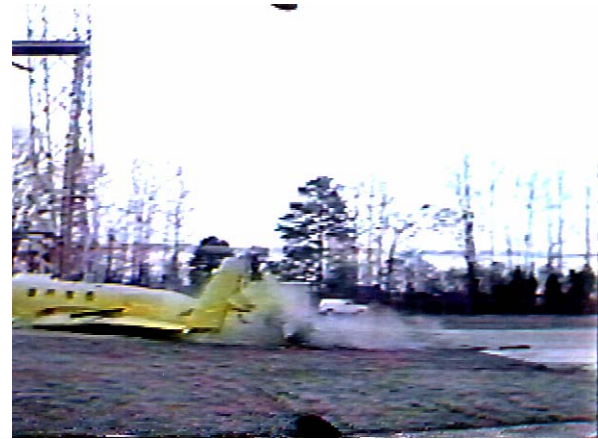
Figure 5.1 (a)-(f): Crash Sequence - Side View

The test article was dropped with the landing gear retracted onto concrete surface. During the drop, the aircraft followed a flight path of -18 degrees with a +18 pitch angle relative to the flight path. At impact, the flight attitude were 0 degrees of pitch, 0 degrees of yaw and 5 degrees of roll. After primary impact, the aircraft rebounded and rose approximately 2 feet off the surface, and traveled for another 55 feet before impacting the ground again and sliding towards the embankment. As the aircraft impacted the dirt embankment, its canard dug into the dirt causing the nose section to lift up. The aircraft began to climb up the embankment until it came to rest at a 30 degree pitch angle with the mid-fuselage section resting on the top side of the embankment. Photographic coverage of the crash sequence is shown in Figure 5.1(a)-(f) and Figure 5.2(a)-(i).
