R. & M. No. 2789  
(11,412)  
A.R.C. Technical Report

# Investigations on Stalling Behaviour, Rudder Oscillations, Take-off Swing and Flow Round Nacelles on the Tudor I Aircraft

D. J. LYONS, B.Sc. (ENG.)

*December, 1947*

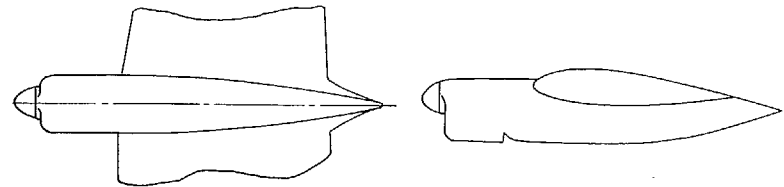
FIG. 8. Sketches of inner nacelle shapes.

5.3. *Flow Tests on Extended Type Inner Nacelle.*—A sketch of the extended inner nacelle is given in Fig. 8c. Deep-tufting tests showed no signs of any flow breakaway round the nacelle over the speed range from slow cruising to top speed; at low speeds the flow over the top of the nacelle rear fairing became confused with the wing root breakaway. The vibration level of the aircraft with the extended nacelles, flaps up, was lowered appreciably from either of the other two cases.

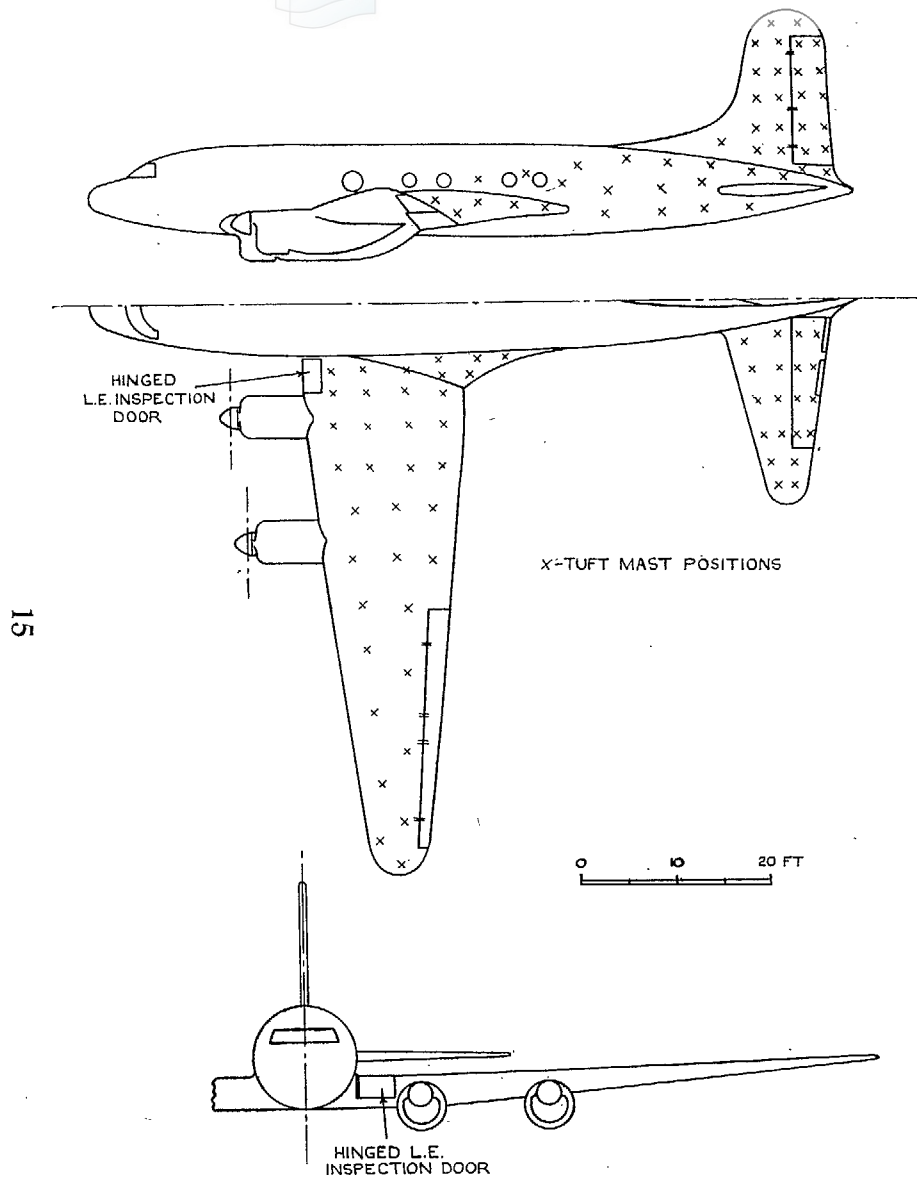
FIG. 1. Three-view general arrangement drawing of *Tudor I* with large fillets showing deep-tufting positions.

A map of the tuft mast positions indicating the density of tufting is given in Fig. 1. The behaviour of the tufts was observed visually mostly through the cabin windows, but a periscope was used for observation of the tailplane, fin and body tufting.
