ATSB TRANSPORT SAFETY BULLETIN
Aviation Level 5 Investigations
AB-2010-103
Final

Level 5 Factual Investigations: 1 October 2010 to 31 December 2010

**Level 5 factual investigations:
1 October 2010 to 31 December 2010**

Report No.	Publication date	ISBN	Reference Number
AB-2010-103	January 2011	978-1-74251-132-0	Jan11/ATSB05

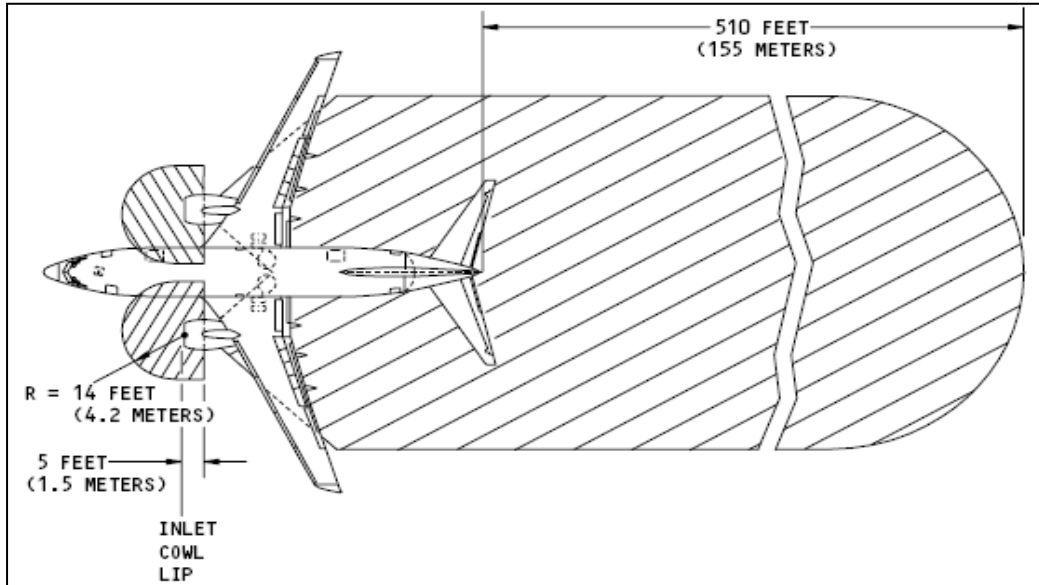
Figure 2: B737 inlet and exhaust hazard areas at breakaway power

When the engine is at ground idle, as may be experienced during the pushback operation, the low pressure hazard area extends to a distance of 3.1 m from the mouth of the inlet. When breakaway power is applied to move the aircraft, this hazard area increases to 4.2 m. A hazard area also exists when hot air exits the engine exhaust at a very high temperature and speed. When the engines are operating at forward breakaway power, the exhaust hazard area extends 155 m to the rear of the aircraft tail (Figure 2).

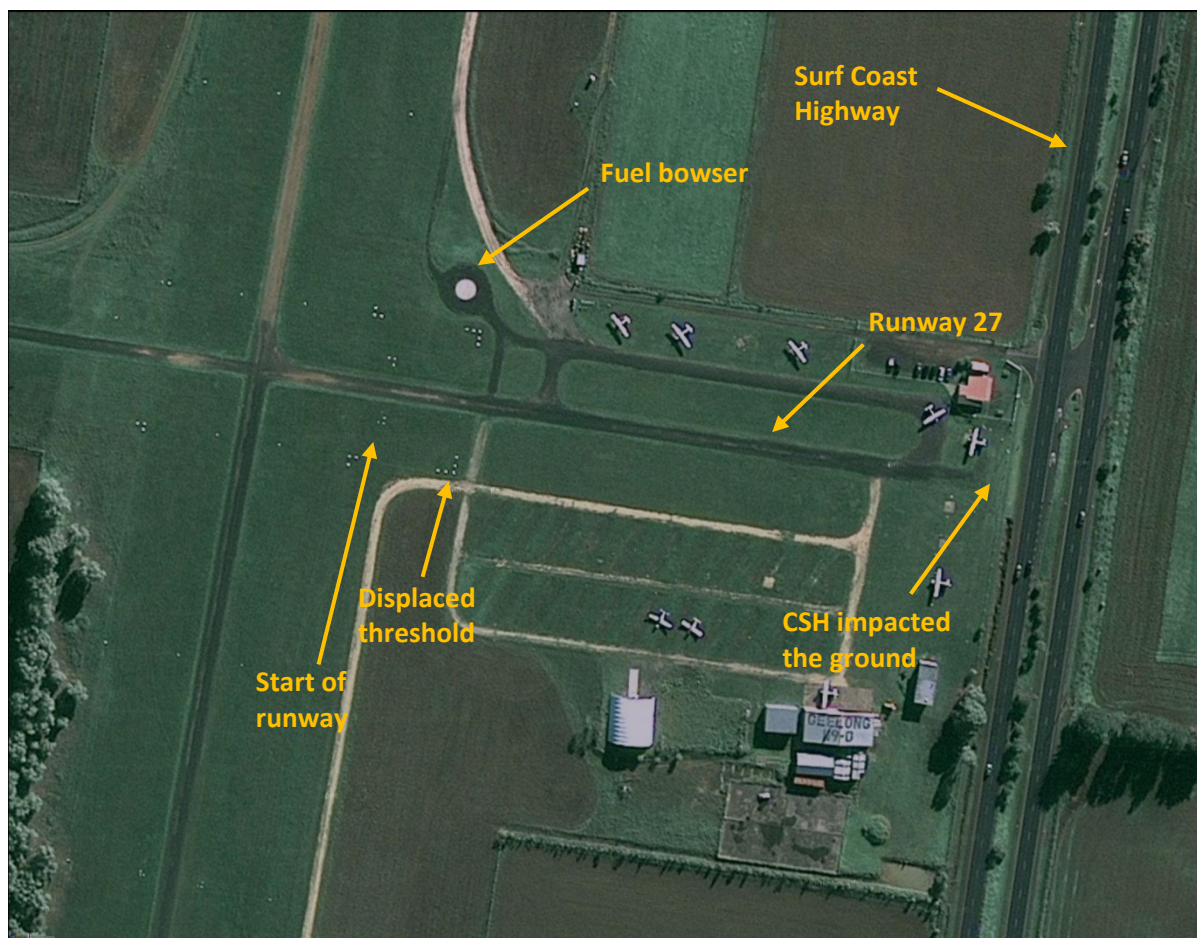
Figure 2: Geelong (ALA)

A witness, who was another pilot, located near the fuel bowser (Figure 2) noted that the aircraft appeared to be wide and low when it turned onto final. As the aircraft approached the runway, he believed it was a bit low and that the intended touchdown point was prior to the displaced threshold. He observed the aircraft ascend and descend, and then strike the powerlines. The witness had landed on runway 27 about 10 minutes prior to the accident and stated that the wind was from 290° at about 15 kts. He did not experience any mechanical turbulence or windshear during his approach.

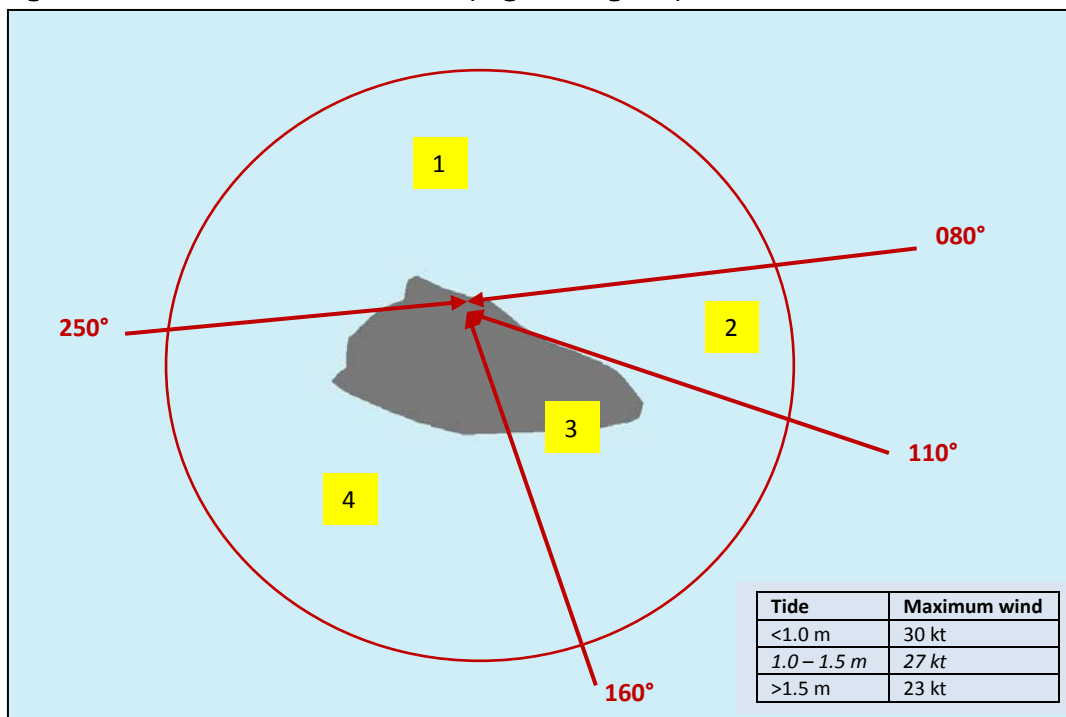
Figure 2: Tide and wind limitation chart (degrees magnetic)

The chart, designed by the operator, was divided into four sectors (Figure 2) based on wind direction. For each sector, the maximum allowable wind speed, based on the predicted tide height was provided.
