Aviation Short Investigation Bulletin

Issue 27

ATSB Transport Safety Report
Aviation Short Investigations
AB-2014-024
Final – 19 March 2014

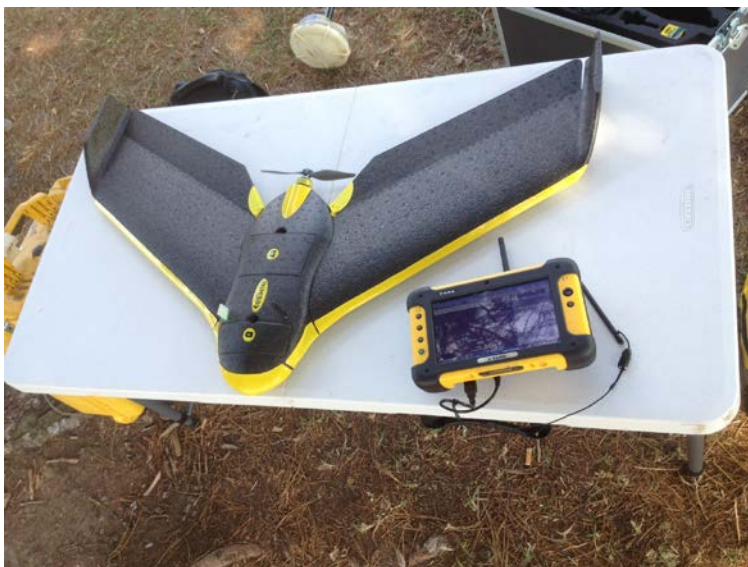
Figure 1: Sensefly eBee 178

At about the same time, the operator of an unmanned aerial vehicle (UAV), Sensefly eBee 178 (Figure 1), arrived at the 'Iluka Echo' (Echo) mine site to conduct an aerial photography survey of the site. After having completed his pre-flight preparations and a risk assessment of the operation, the operator heard an aircraft operating about 1-1.5 km away on a neighbouring property to the north-east of the UAV launch site (Figure 2).

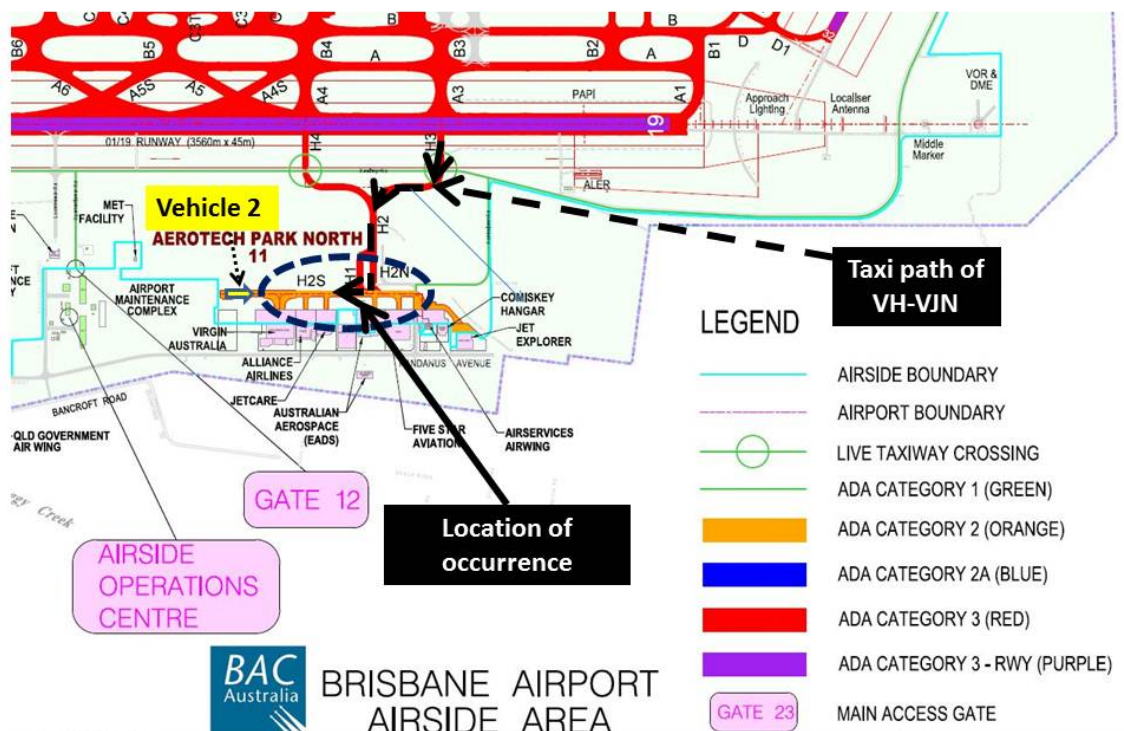
Figure 1: Brisbane Airport

The crew taxied VJN via taxiway 'Hotel 3' (H3), 'Hotel 2' (H2), and then via a right turn onto 'Hotel 2 South' (H2S) (Figure 1). As per company policy, the aircraft was taxied at a maximum speed of 9 kt during turns. During the 90° turn from H2 to H2S the pilot saw a vehicle approaching from the opposite direction along H2S. The vehicle had headlights on, but no flashing light. The captain reported he manoeuvred the aircraft to the right by 2-3 m and braked firmly. During this manoeuvre the captain observed the vehicle brake, and turn right onto the grass. The vehicle passed close to the aircraft's left wingtip.

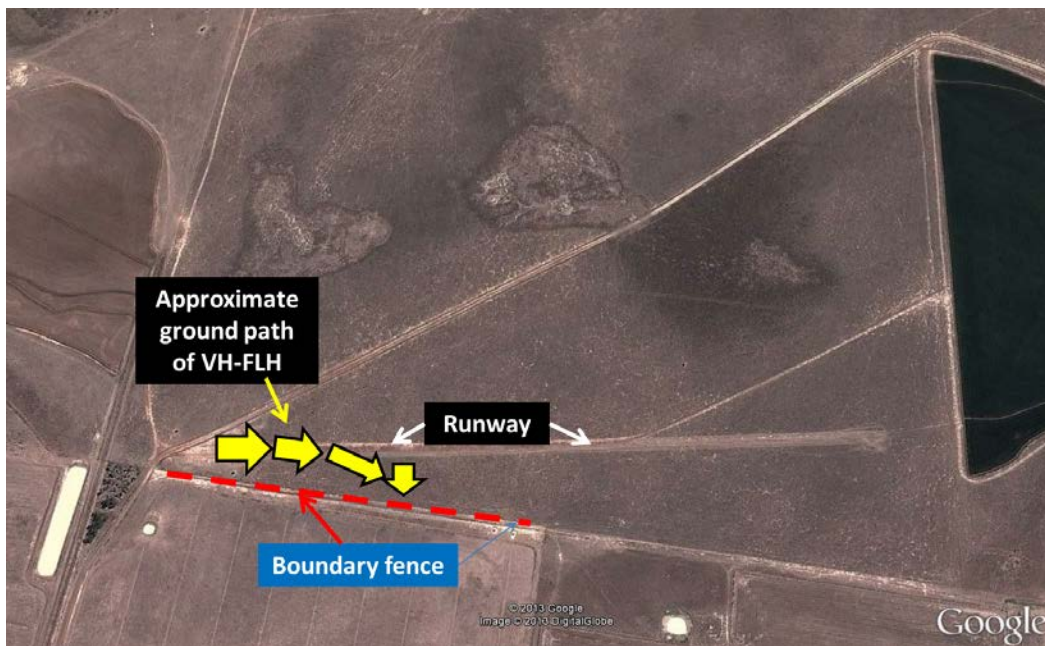
Figure 1: Accident site

During the landing, the main wheels touched down first, followed by the tail, which was locked into place. Shortly after, the aircraft suddenly veered right about 45°. The pilot considered a go-around, but was concerned that the aircraft would not clear the boundary fence (Figure 1). Consequently, he elected to continue the landing and selected reverse thrust, applied left brake, left rudder and left aileron in an attempt to re-align the aircraft with the runway. The aircraft did not slow down as the pilot expected. The wheels began to 'grab' and the left undercarriage leg became detached which caused the aircraft to rotate facing about 90° away from the runway. The left wingtip and propeller subsequently contacted the ground. The pilot shut down the aircraft and exited. The pilot was not injured, but the aircraft was substantially damaged (Figure 2).

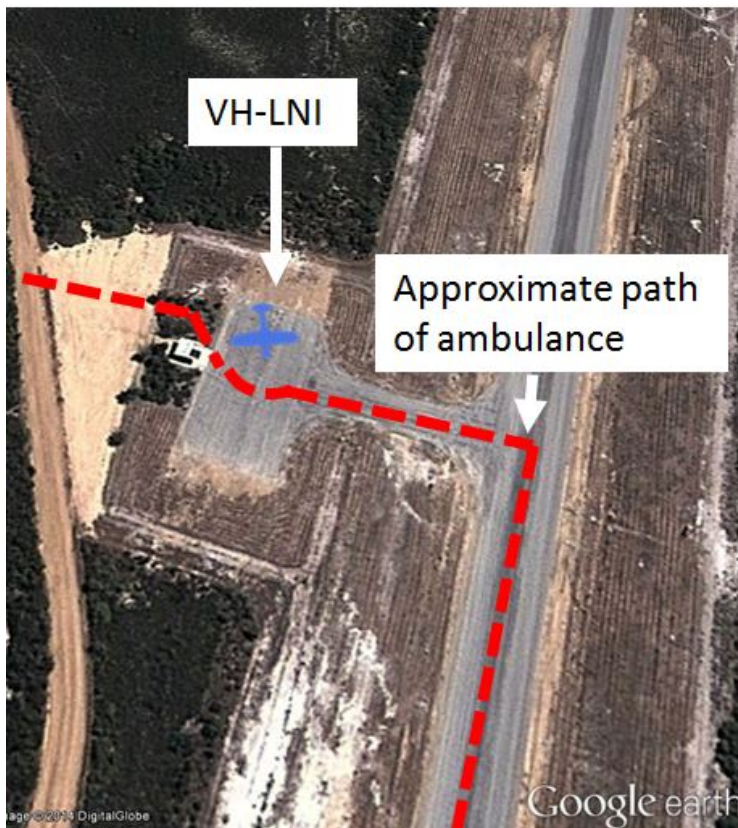
Figure 2: Jurien Bay (ALA)

The ambulance driver then proceeded to the runway and stopped prior to entering the runway. The driver reported that he and his ambulance partner conducted a thorough visual inspection for aircraft approaching and on the runway. The ambulance then entered the runway and drove towards the helipad, about 300 m south of the RFDS apron (Figure 2).

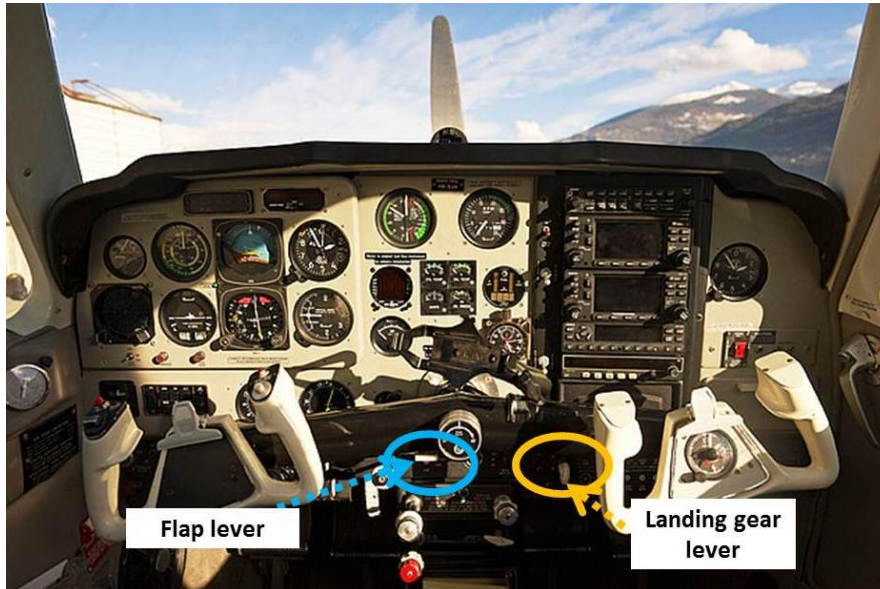
Figure 1: Cockpit of a Beech Bonanza similar to VH-YEN

The student had completed his recent training in a Cessna 182 aircraft, which had the flap lever located in a position similar to that of the landing gear lever in the Bonanza (Figure 1 and Figure 2).

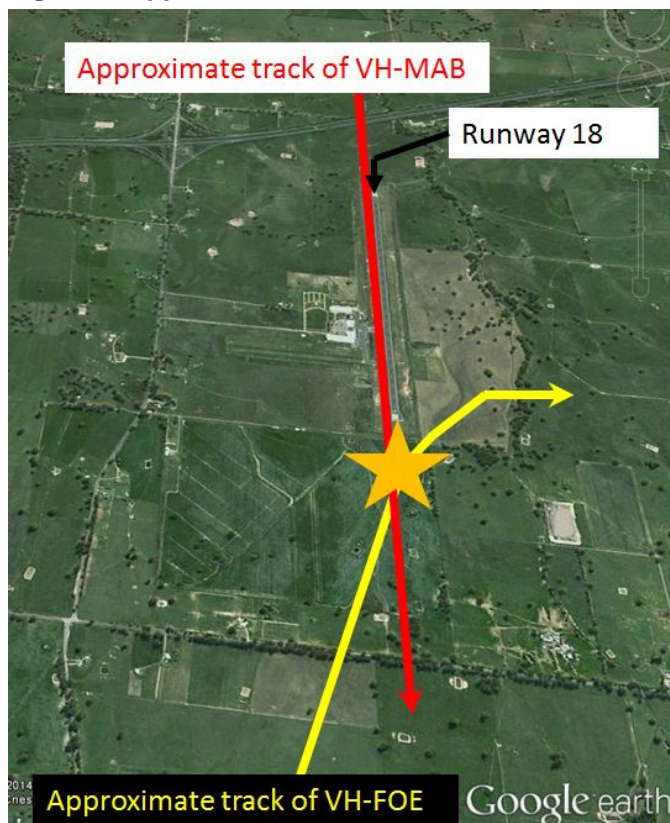
Figure 1: Approximate aircraft tracks

The pilot of FOE broadcast on the CTAF joining downwind, which was heard by the instructor of MAB. As MAB departed the area, the instructor also heard the pilot of FOE broadcast a base call on the CTAF and cancel SARTIME⁶ with Melbourne Centre.
