Australian Government
Australian Transport Safety Bureau

Aviation Short Investigations Bulletin

Issue 30

ATSB Transport Safety Report
Aviation Short Investigations
AB-2014-064
Final – 26 May 2014

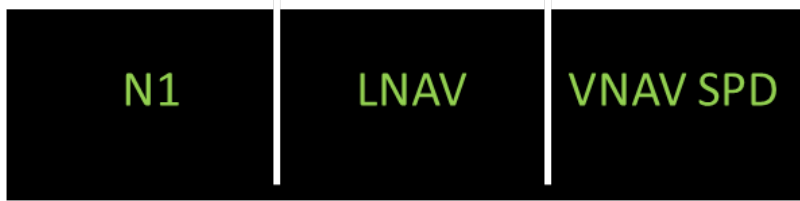
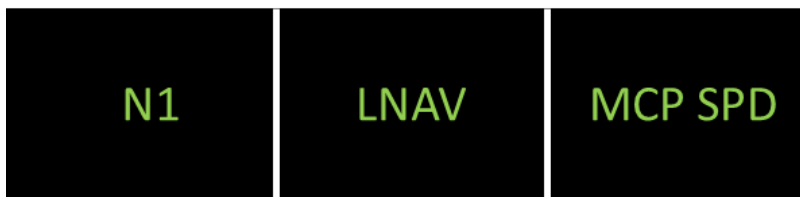
Figure 2: Representation of the FMA during climb in VNAV and LVL CHG modes

Example of FMA annunciations during a climb in VNAV mode. In this case, VNAV SPD indicates that the auto-flight system is following the FMC-computed speed profile. N1 indicates that the auto-throttle system is commanding a set engine speed limit and LNAV (lateral navigation) indicates that the auto-flight system is following a programmed lateral track.

Example of FMA annunciations during a climb in LVL CHG mode. In this case, MCP SPD indicates that the auto-flight system is in LVL CHG mode maintaining the speed set on the MCP. As above, N1 indicates that the auto-throttle system is commanding a set engine speed limit and LNAV indicates that the auto-flight system is following a programmed lateral track .

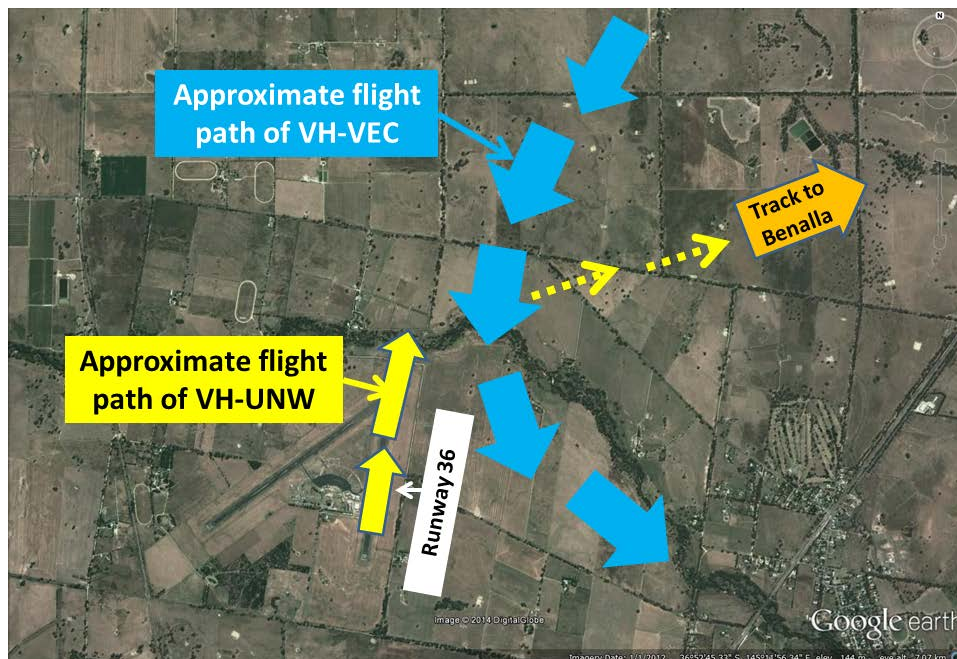
Figure 3: Approximate flight path of VH-VEC and VH-UNW

The second aircraft to depart was VH-UNW (UNW). As UNW was taxiing, the solo student pilot heard an 'ALL TRAFFIC' broadcast from VEC placing the aircraft 10 NM to the north-east at 2,000 ft AMSL and returning to the field. From the broadcast, the student pilot misunderstood the intentions of VEC, thinking he was inbound to land at Mangalore. He thus did not expect any conflict between the two aircraft. Also, as the broadcast had been to all aircraft, and not specifically UNW, he did not respond.

As UNW commenced the take-off, the student made an advisory broadcast that his aircraft was rolling on runway 36. He then, as per his training, focussed on flying the aircraft during the take-off and initial climb phases until the aircraft reached about 1,200 ft AMSL, where he lowered the aircraft's nose to check the airspace for any traffic

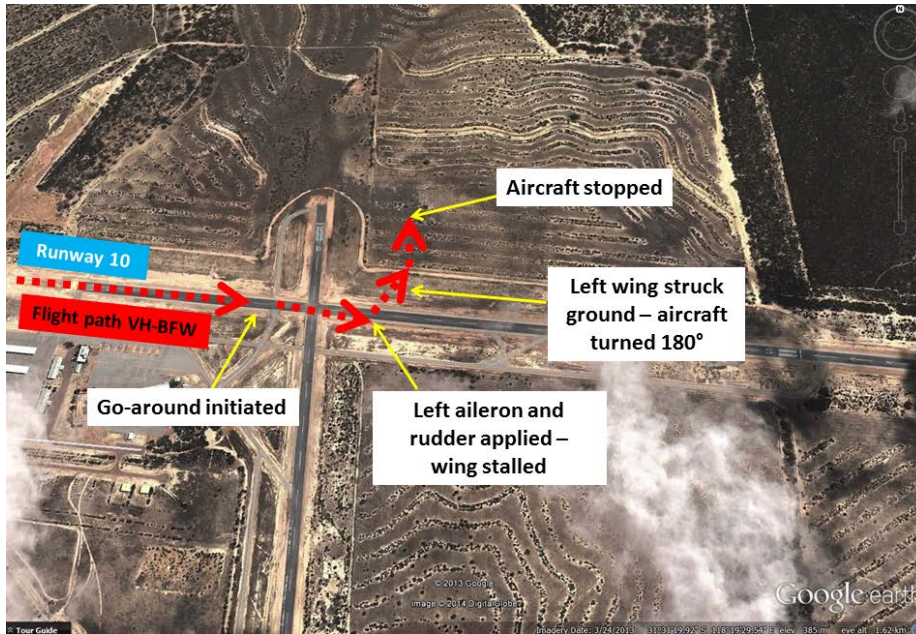
Figure 1: Approximate flight path of VH-BFW

After about an hour and a quarter he returned to the aerodrome using the correct inbound procedure of overflying the field at 3500 ft above mean sea level, prior to joining the circuit. Due to the density of traffic in the circuit, he conducted about three orbits at this level prior to descending and joining crosswind for runway 10. He noted the windssock now indicated a left crosswind, but as there was already an aircraft landing on runway 10, he elected to continue and join for this runway. The student reported the crosswind, downwind and base legs of the circuit all went according to plan and he was anticipating a good landing.

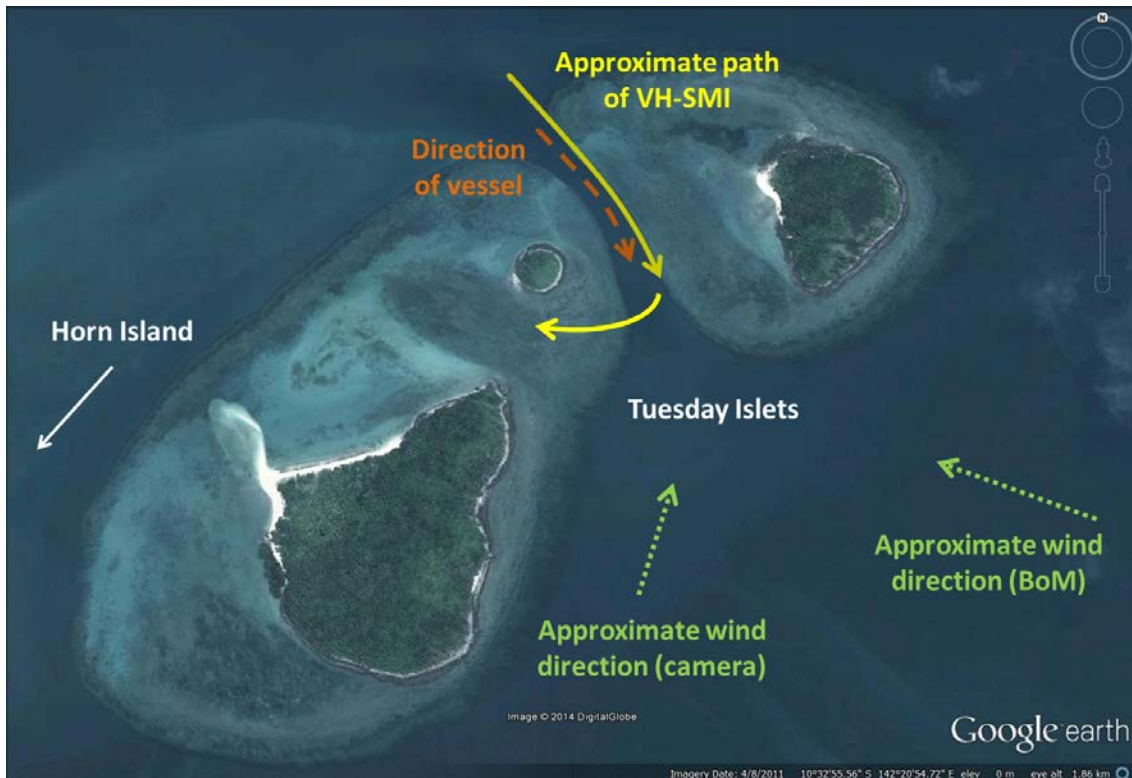
Figure 1: Approximate path of vessel and VH-SMI

The purpose of the flight was to film a 20 metre vessel travelling back and forth along a channel in between the Islets. A digital camera system was mounted under the nose of the helicopter and controlled remotely by the camera operator from within the cabin. The pilot also had a view finder positioned in the cockpit so that he could monitor the camera view.

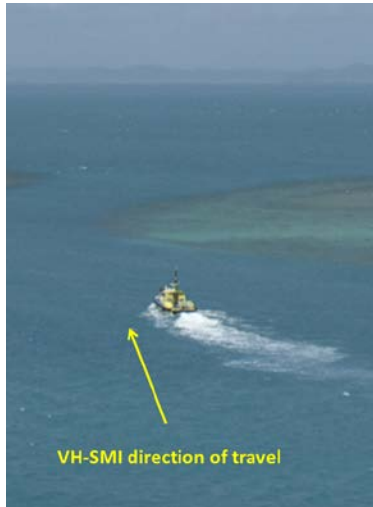
Figure 2: Approaching

After having completed four passes over the vessel, above 500 ft above sea level, the pilot positioned the helicopter for the next pass. Maintaining 200 ft, and with an airspeed of about 55 kt, the helicopter approached the vessel from behind and to the left (Figure 2). The vessel was travelling into wind.

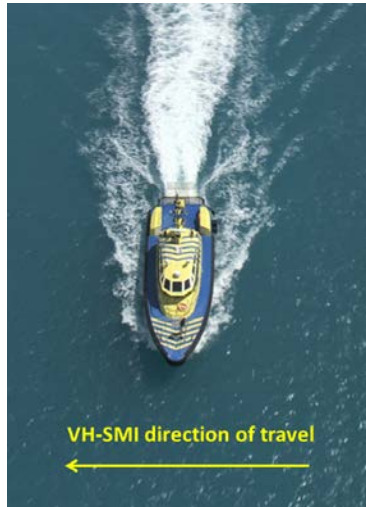
Figure 3: Passing in front

As the helicopter flew abeam the vessel, the pilot initiated a climb and selected about 95% engine torque and then commenced a right turn, to pass in front (Figure 3). The helicopter passed in front of the vessel at about 300-400 ft. At that time, the pilot was monitoring the view finder to ensure that the helicopter's skids did not impede the film shot. The pilot reported that the wind direction was then 280° relative to the helicopter.

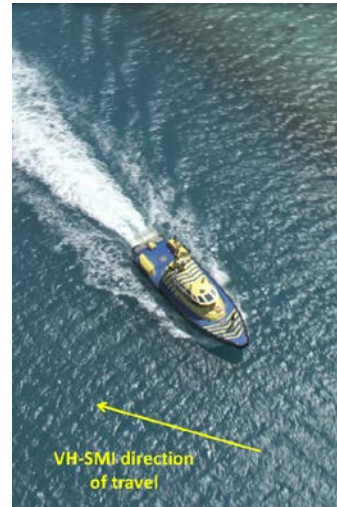
Figure 4: Prior to LTE

After having completed the film shot (Figure 4), when at about 450 ft, the helicopter entered an uncommanded yaw right by about 25-30° and started to experience a loss of tail rotor effectiveness (LTE). In response, the pilot attempted to manoeuvre the helicopter into wind by applying forward and left cyclic.¹ The pilot reported that the helicopter rotation stopped, but shortly after, it began to yaw right again. The pilot believed that he was not going to be able to recover from the situation.

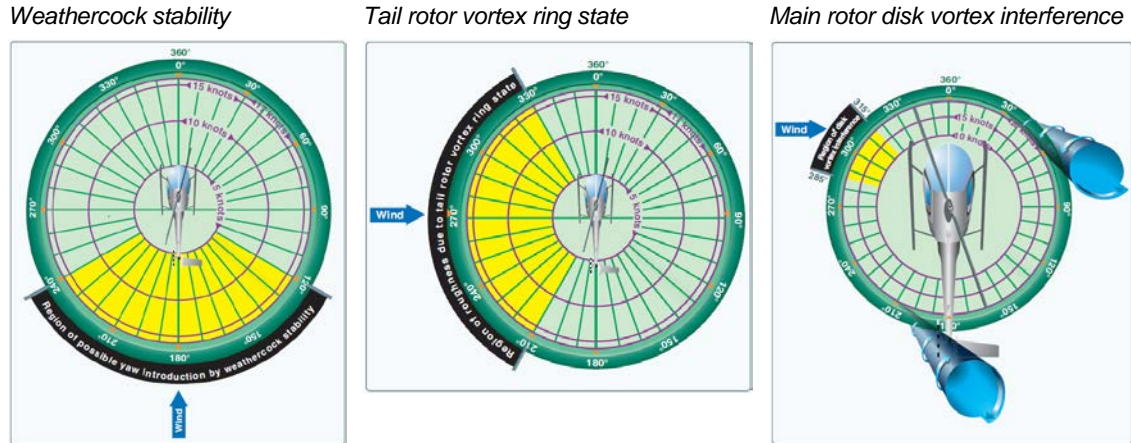
Figure 6: Relative wind azimuth regions

Any manoeuvre that required the pilot to operate in a high-power, low-air-speed situation with a left crosswind or tailwind, created an environment conducive to LTE. The susceptibility for LTE was also greater in right turns for US designed helicopters such as the Bell 206B, particularly during low airspeed flight where the pilot may not be able to stop the yaw. Flight and wind tunnel tests had identified four relative wind azimuth regions and aircraft characteristics that could, singularly or in combination, result in LTE (Bell Helicopter Information Letter 206-84-41) (Figure 6).

- *Main rotor disc vortex interference (285° to 315°)*: main rotor vortex passes the tail rotor, reducing the tail rotor angle of attack. This causes a reduction in thrust and a right yaw acceleration will commence.
- *Loss of translational lift (all azimuths)*: results in increased power demand and additional anti-torque requirements. If this occurs during a right turn, the turn will be accelerated as power is increased unless corrective action is taken.

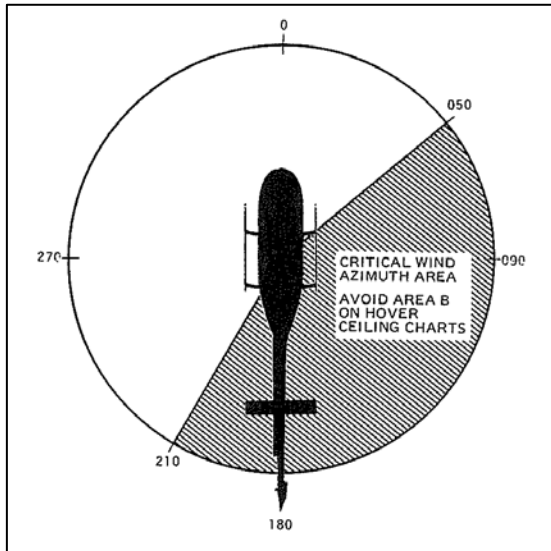
Figure 7: Critical relative wind azimuth area

The Bell Information Letter also emphasised that the helicopter could be operated in all of the above conditions if suitable attention was given to controlling the helicopter. However, if the pilot's attention was diverted and a right yaw rate commenced, the rate may increase unless appropriate corrective action was taken. It further noted that the above did not replace the critical relative wind azimuth chart located in the helicopter's flight manual (Figure 7).
