Wirestrike involving a Robinson R44, VH-LOL

142 km WSW of Adelaide, South Australia, 10 April 2015

ATSB Transport Safety Report
Aviation Occurrence Investigation
AO-2015-037
Final – 27 August 2015

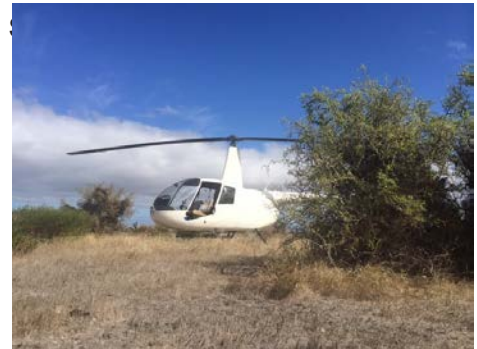
Also on board were client representatives who were directing the noxious weed management operation and manually dispensing the chemical into each bush. In the course of traversing the field at low level in search of the weed, the helicopter struck a previously unidentified power line. The helicopter's main rotor blade made initial contact with the power line and during the avoidance manoeuvre, the tail rotor blades also made contact, severing the blade tips (Figure 1). The pilot landed the helicopter safely. The helicopter was substantially damaged but the occupants were uninjured.

Figure 1: Tail rotor blade damage to VH-LOL
