## TECHNICAL ANALYSIS REPORT

Report No. 05/04

# **Examination of failed Integrated Nozzle Assembly and Thrust Reverser components from a RB211-524 Turbofan Engine**

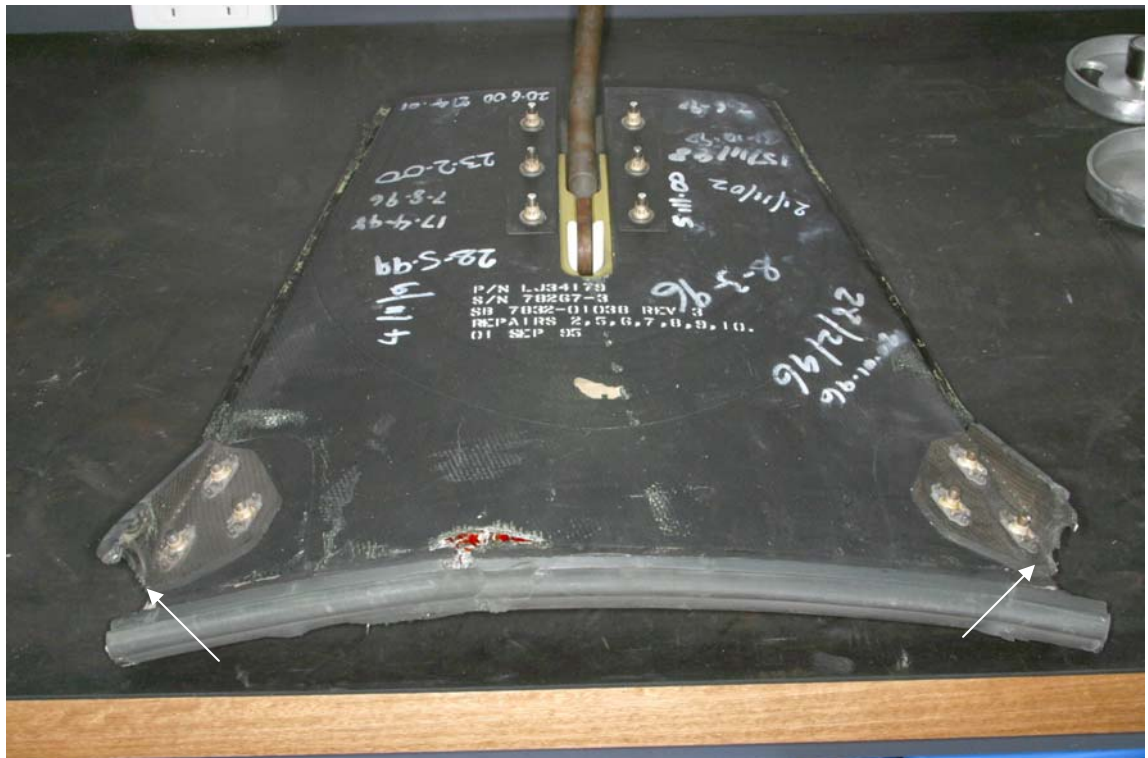
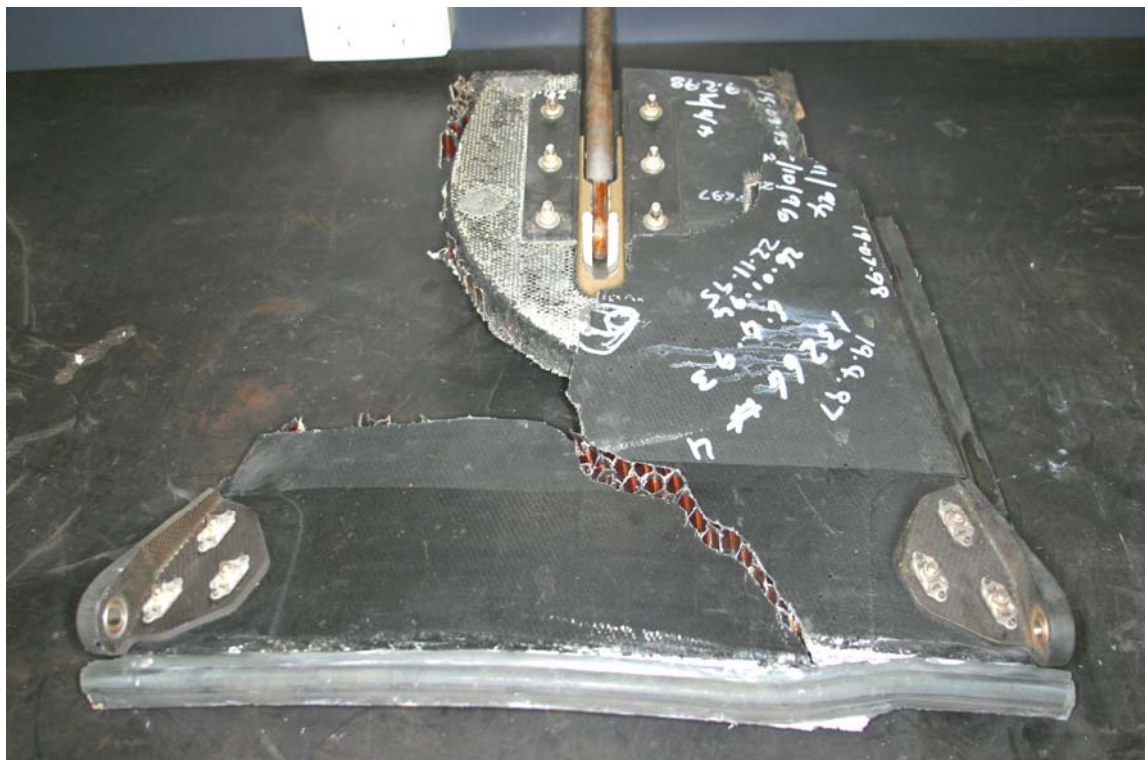
All of the fractures and disruptions presented by the blocker door sections were consistent with physical overload failures. There was no evidence of progressive cracking, disbonding or other degenerative type failure modes.
