AVSCOM Report No. 76-22

EVALUATION OF SCRATCH- AND SPALL-RESISTANT WINDSHIELDS

AMMRC TR 76-39

December 1976

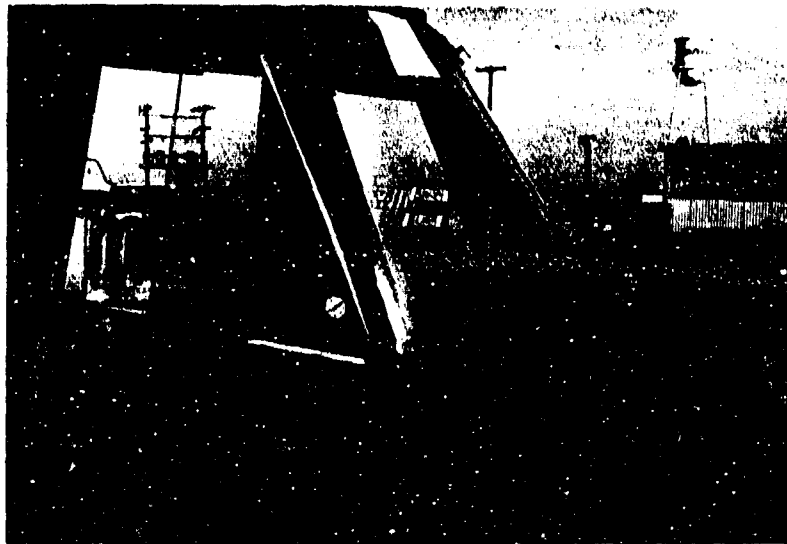
Figure 7. UH-1 windshield ballistic test structure with pressure box.

Each windshield tested was mounted in the UH-1 structure in a manner approximating a normal installation for this article. A transparent plastic box was mounted directly behind the windshield. This box was utilized to apply a vacuum to the aft side of the windshield during test to simulate aerodynamic loading imposed at the aircraft redline speed of 120 knots (see Figure 7). The calculated loading for the windshield at 120 knots was 0.328 psi.

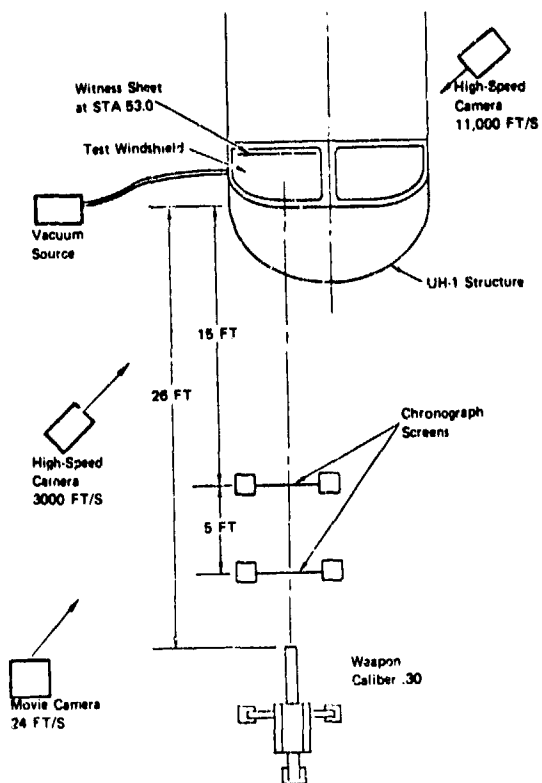
Figure 8. Ballistic test setup.

One high-speed camera operating at 3,000 frames per second was used to view the front side of the windshield. The back side of the windshield was monitored with an 11,000-frame-per-second camera during each test firing. One additional camera operating at a standard framing rate was used to document the test setup and individual firing sequences. A schematic of the ballistic test setup used in this evaluation is shown in Figure 8a and the actual test setup in Figure 8b.

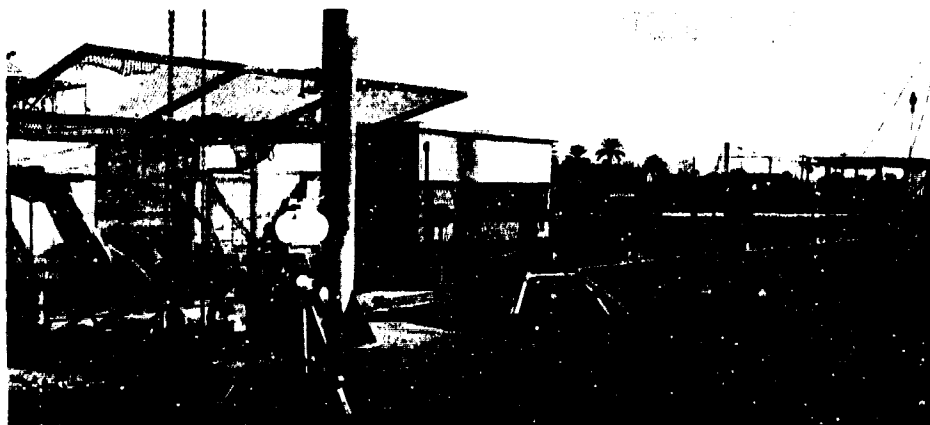
Figure 13. Bird-impact test facility.

The velocity of the bird was measured by using counters to measure the time interval between breaking of "start" and "stop" wires. The stop wire is approximately six feet in front of the target window. A UH-1B fuselage was cut in two behind the front door bulkhead so as to maintain the same structural integrity as an unaltered aircraft. This fuselage section was then positioned and anchored in front of the gun where all tests were conducted (see Figure 13).
