REPORT 1363

ORIGIN AND PREVENTION OF CRASH FIRES IN TURBOJET AIRCRAFT ¹

By I. IRVING PINKEL, SOLOMON WEISS, G. MERRITT PRESTON, and GERARD J. PESMAN

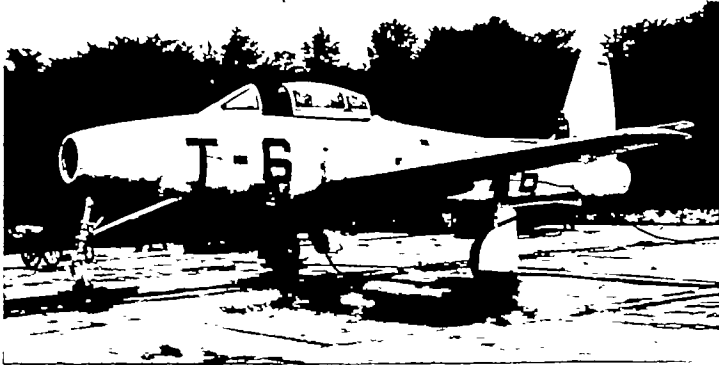
FIGURE 3.—F-84 Fighter airplane used in crash-fire investigation.

The F-84 fighter (fig. 3), carrying its turbojet submerged in the fuselage structure, caught fire in a similar crash. In this crash the fuel that entered the engine inlet was spilled from a fuselage fuel tank adjacent to the engine-inlet duct. Arrangements for ensuring the failure of this tank in the crash are shown in figure 4. A driving strut was attached at one end to the nose wheel strut. The free end of the driving strut carried a spear-like tank cutter aimed at the fuselage fuel tank, whose wall is adjacent to that of the air duct. When the nose wheel strut failed rearward in crash, the driving strut cut the duct and tank walls. Fuel in liquid form poured into the air duct and was drawn into the engine.

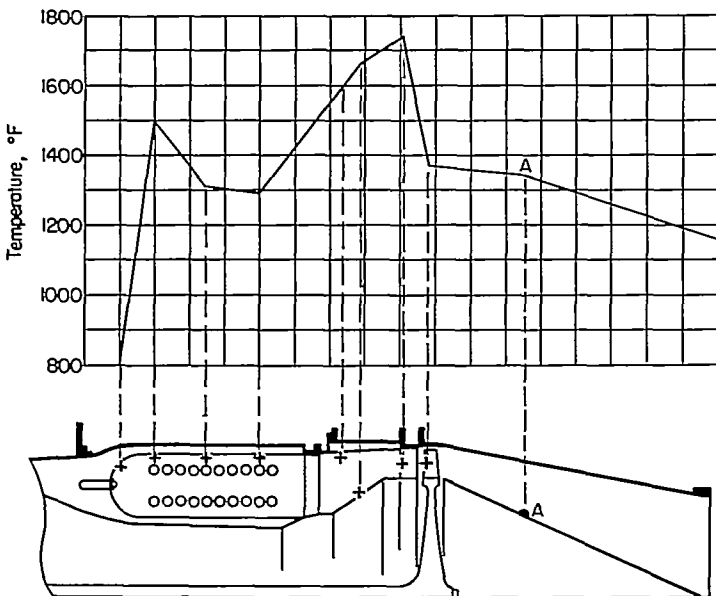
FIGURE 7.—Maximum temperatures of metal components in main gas stream of J47 and J35 engines.

Maximum temperatures obtained with the J47 and J35 engines running on the test stand were comparable (fig. 7). Temperatures of similar locations in the J30 engine, which are not given here, were also comparable to those recorded on the J47 and J35 engines.

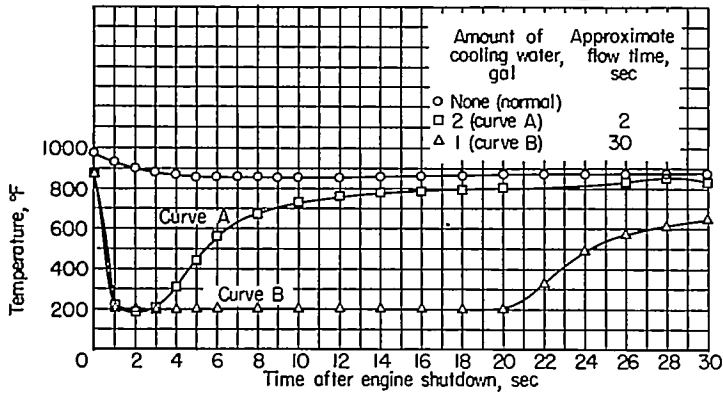
FIGURE 18.—Comparison of turbine-wheel cooling with short- and long-duration water sprays.

Because the turbine wheel had large mass and thickness, reheating of the wheel surface to unsafe temperatures occurred after the applied cooling water was expended. An example of the reheating of the hottest part of the wheel is shown in figure 18. In early experiments, when 2 gallons of water were sprayed over a 2-second period onto the aft

face of the turbine at the hub, the surface temperature dropped rapidly to the boiling temperature of water (curve A, fig. 18). Shortly after the water was expended, the surface of the wheel reheated by conduction from the hot interior. Unsafe temperatures above 600° F were established in less than 7 seconds. In order to avoid reheating to unsafe temperatures, the water discharge period was extended to 30 seconds. Experiments indicated that the quantity of water necessary could be reduced from 2 to 1 gallon for each face of the turbine disk. The wheel temperatures obtained are shown by curve B in figure 18. The time interval before reheating began was increased from 3 to 20 seconds. Reheating to temperatures above 600° F occurred after 27 seconds, at which time, however, the chance for fuel ingestion was remote.

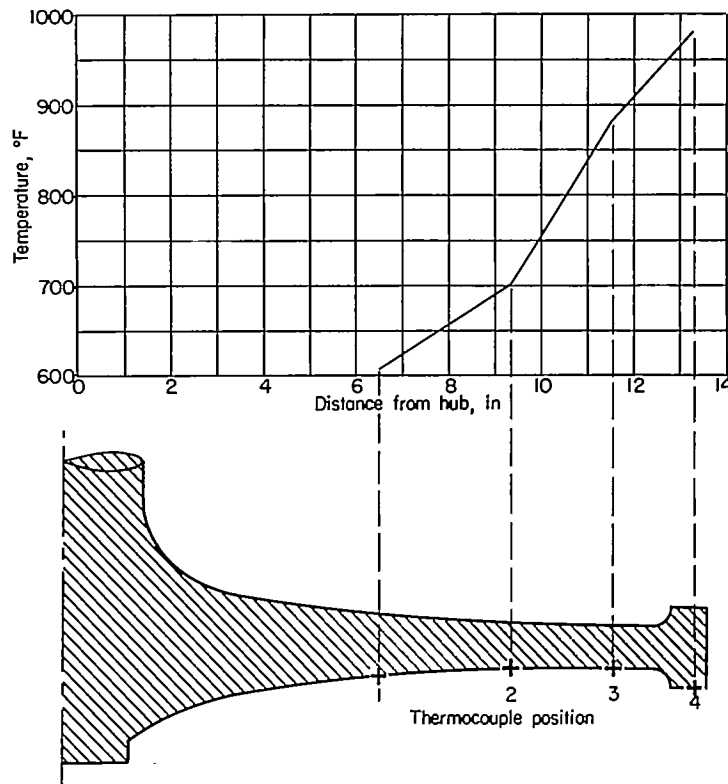
FIGURE 28.—Maximum temperatures recorded on J47-engine turbine wheel.

Engine parts not in the main gas stream were heated mostly by conduction. The turbine wheel was the most massive engine part heated this way. The radial variation in temperature on the surface of the turbine wheel, shown in figure 28, resulted from the fact that the heat conduction was from the wheel rim to the relatively cool hub. The data shown were obtained with the engine operating at rated sea-level conditions. The turbine-wheel surface temperature varied from approximately 980° F at the rim to about 605° F at a point midway between the rim and hub. Cooling air from the compressor applied to the hub to protect the engine bearings maintained this temperature pattern.

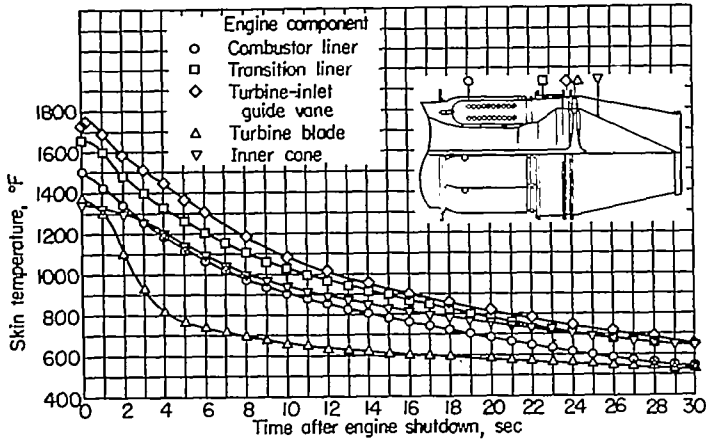
FIGURE 29.—History of maximum skin temperatures on engine components in main gas streams.

A history of the temperature of engine parts lying in the main gas stream is shown in figure 29. Fuel shutoff occurred at zero second, and the temperatures indicated were the maximum recorded anywhere on the component at the time noted. The hottest section of the combustion-chamber liner cooled from 1500° to 600° F in 24¼ seconds. It took over 30 seconds for the transition-liner temperature to decline from 1660° to 600° F. In 30 seconds the turbine-inlet guide vane temperature dropped from a maximum temperature of 1750° to 645° F. The rotating turbine blade temperature fell from 1370° to 600° F in 16 seconds. Inner-cone skin temperatures declined from 1350° to 640° F in 30 seconds.

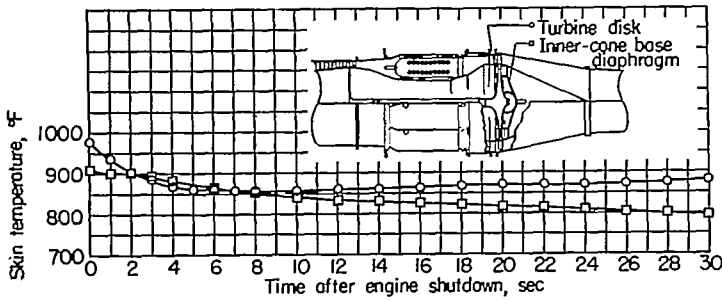
FIGURE 30.—History of maximum skin temperatures on turbine disk and inner-cone base diaphragm.

Engine parts not located in the main gas stream declined in temperature at much slower rates (fig. 30). The hottest part of the turbine wheel was initially at 980° F and dropped only 100° F in 30 seconds after fuel flow to the engine had stopped. The turbine wheel remained above the ignition

temperature of JP-4 fuel for 30 minutes after the engine was shut down. The large mass of the turbine disk contributed to its slow cooling rate. The inner-cone base diaphragm exhibited the same slow rate of cooling. Its maximum temperature was 910° F and cooled only approximately 115° F in 30 seconds.

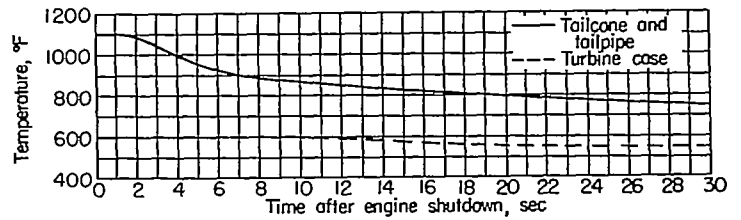
FIGURE 31.—History of maximum external skin temperatures on J47 turbine case and tailcone and tailpipe.

Temperature measurements made on the external skin of the J47 engine (fig. 31) indicated that the tailcone and tailpipe temperatures remained above 600° F for more than 30 seconds after the fuel to the combustor was shut off. Temperatures of the engine case upstream of the tailcone and tailpipe were usually below 600° F (fig. 32). Although the turbine case reached a maximum temperature of 600° F and remained so for 10 seconds after the fuel was shut off (fig. 31), no ignitions were experienced here.

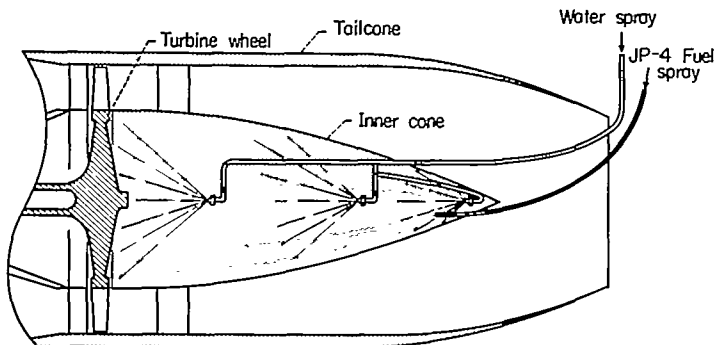
The engine cavity farthest downstream, the inner cone, was studied first. The arrangements used for the J30 tailcone are shown schematically in figure 34. A fuel system,

In this study of internal ignition zones the engine was run at rated conditions until temperature equilibrium was established. The fuel flow to the combustor was stopped, and 0.2 second later the fuel spray in the inner-cone cavity was turned on. Ignition of this fuel occurred. The process was repeated with increasing intervals between engine combustor fuel shutoff and the beginning of fuel spray into the inner-cone cavity. Ignitions were obtained up to 20 seconds after the combustor fuel was shut off.

Following this evaluation of the inner-cone interior as an ignition hazard the runs were repeated, but this time the water sprays were also turned on with the fuel spray in the inner cone. Initially, sufficient water was used to ensure absence of ignition. By progressively reducing the water quantity in repeated runs a minimum water requirement was established below which ignition would sometimes occur.

FIGURE 34.—Typical equipment used to study ignition hazard (J30 inner tailcone).

consisting of a single tube and nozzle, was arranged to spray fuel in measured quantities into the cavity of the inner cone to produce a combustible atmosphere. In addition, three water spray nozzles were installed facing the upstream direction. Since the J30 engine has no base diaphragm, the downstream face of the turbine wheel must be taken as a bounding surface of this cavity. The upstream water nozzle
