NACA TN 3190

TECHNICAL NOTE 3190

FATIGUE INVESTIGATION OF FULL-SCALE  
TRANSPORT-AIRPLANE WINGS

SUMMARY OF CONSTANT-AMPLITUDE TESTS THROUGH 1953

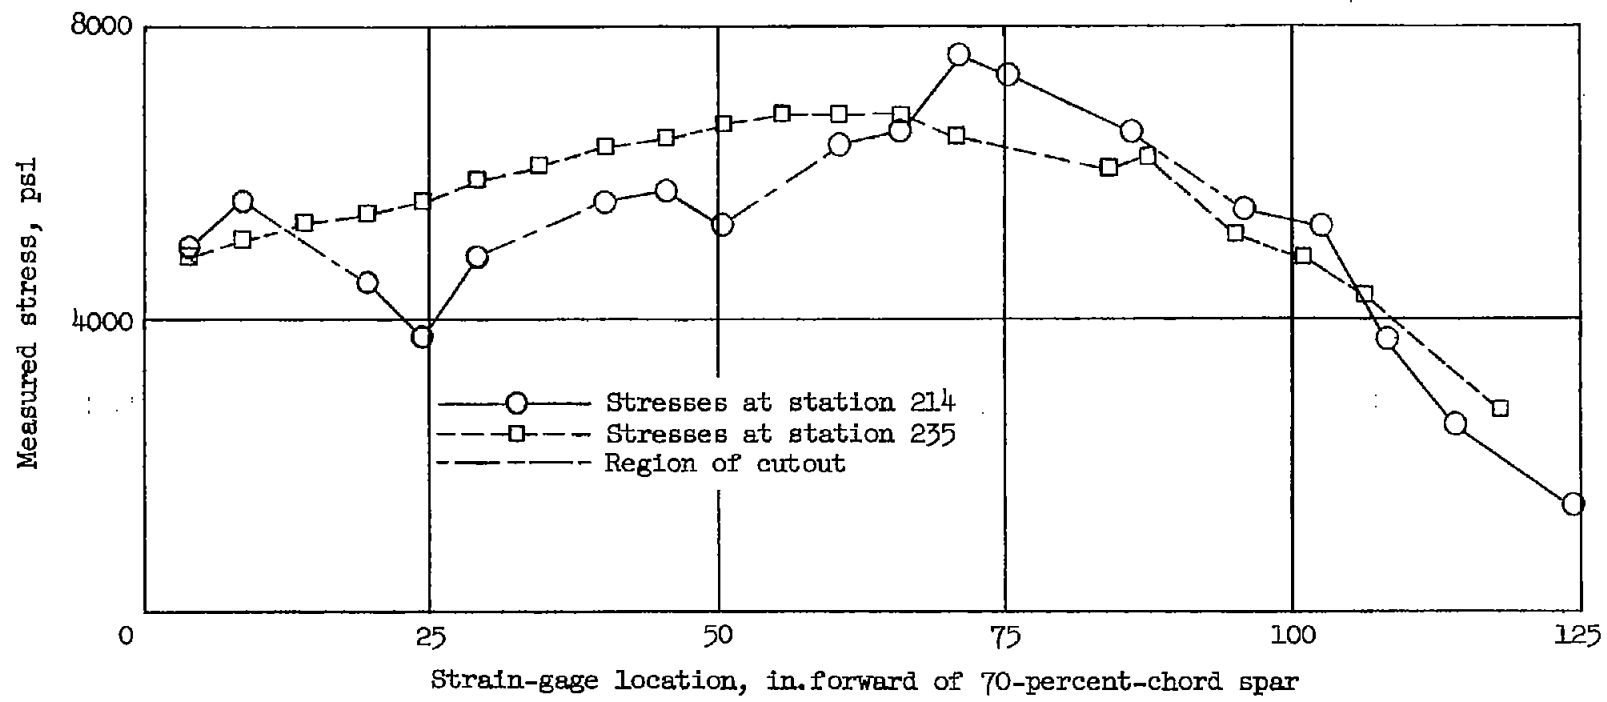
Figure 8.- Chordwise distribution of measured spanwise 1 g stresses.

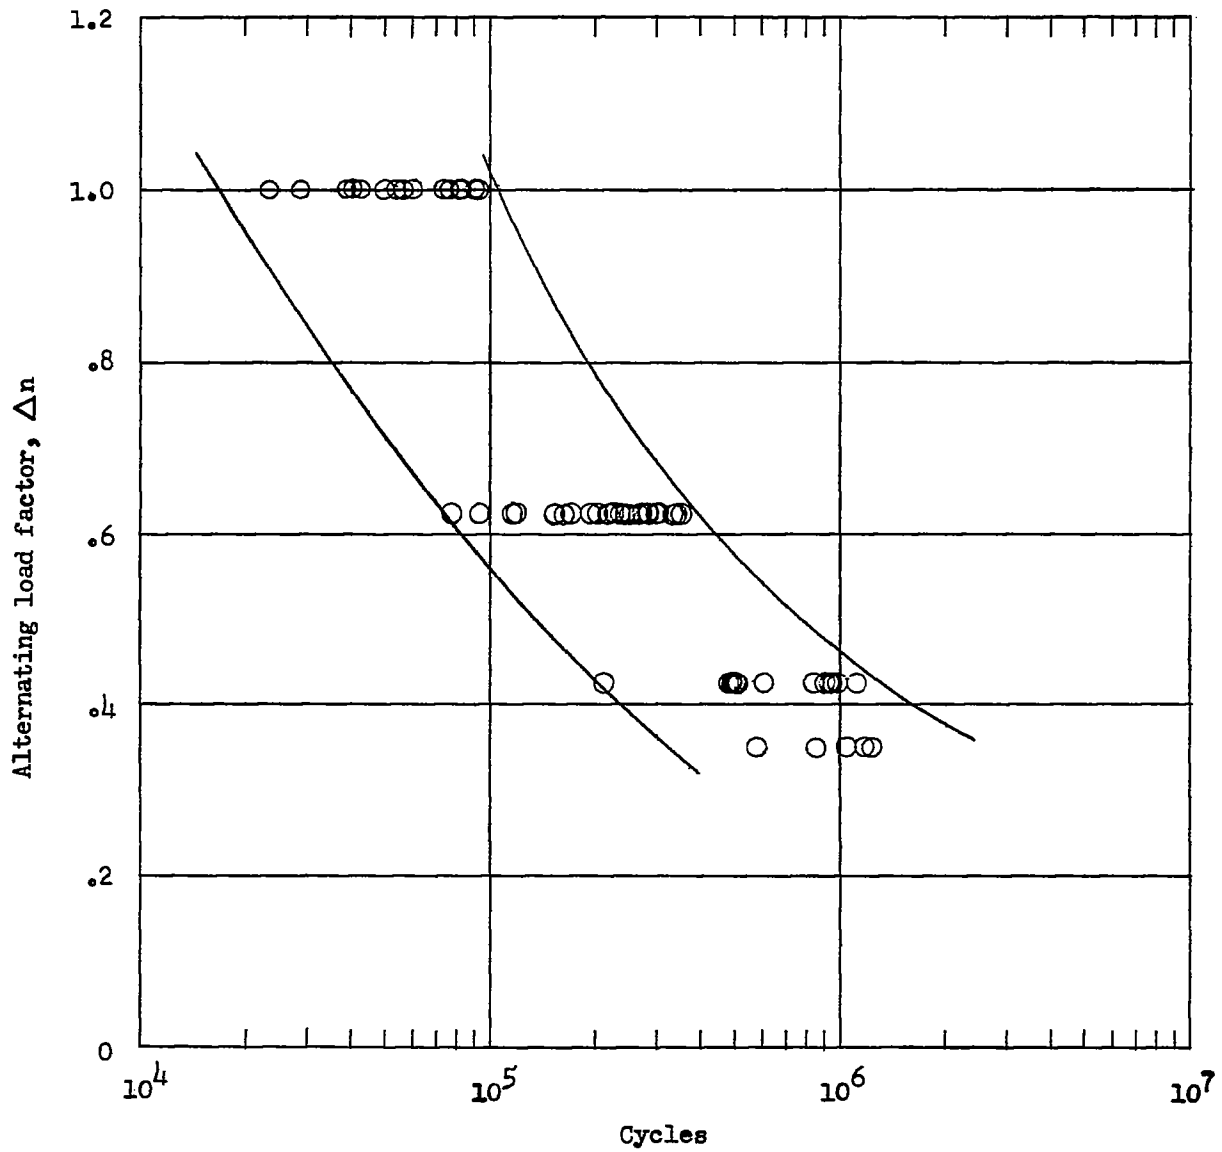
The number of cycles to initial failure is included in table 1. The fatigue life for this structure at the various test levels appeared in figure 9 in the form of a load-lifetime diagram. This figure showed the load-lifetime diagram for initial failure, as previously defined, for all failures that occurred during the tests. For no apparent reason some of these failures never grew to more than an inch in length, while others grew to a considerable size. In figure 12 is shown the load-lifetime diagram of initial and final failure for those failures that grew until their respective crack-propagation curves indicated that the critical percentage of tension material had failed. The number of cycles to final failure, estimated from the individual crack-propagation curves for each of the failures, is listed in table 1. It is evident from the rate of crack growth indicated by the curves of figure 11 that this estimate would not be much in error.

Figure 9.- Load-lifetime diagram for initial failure showing scatter band for 95-percent probability.

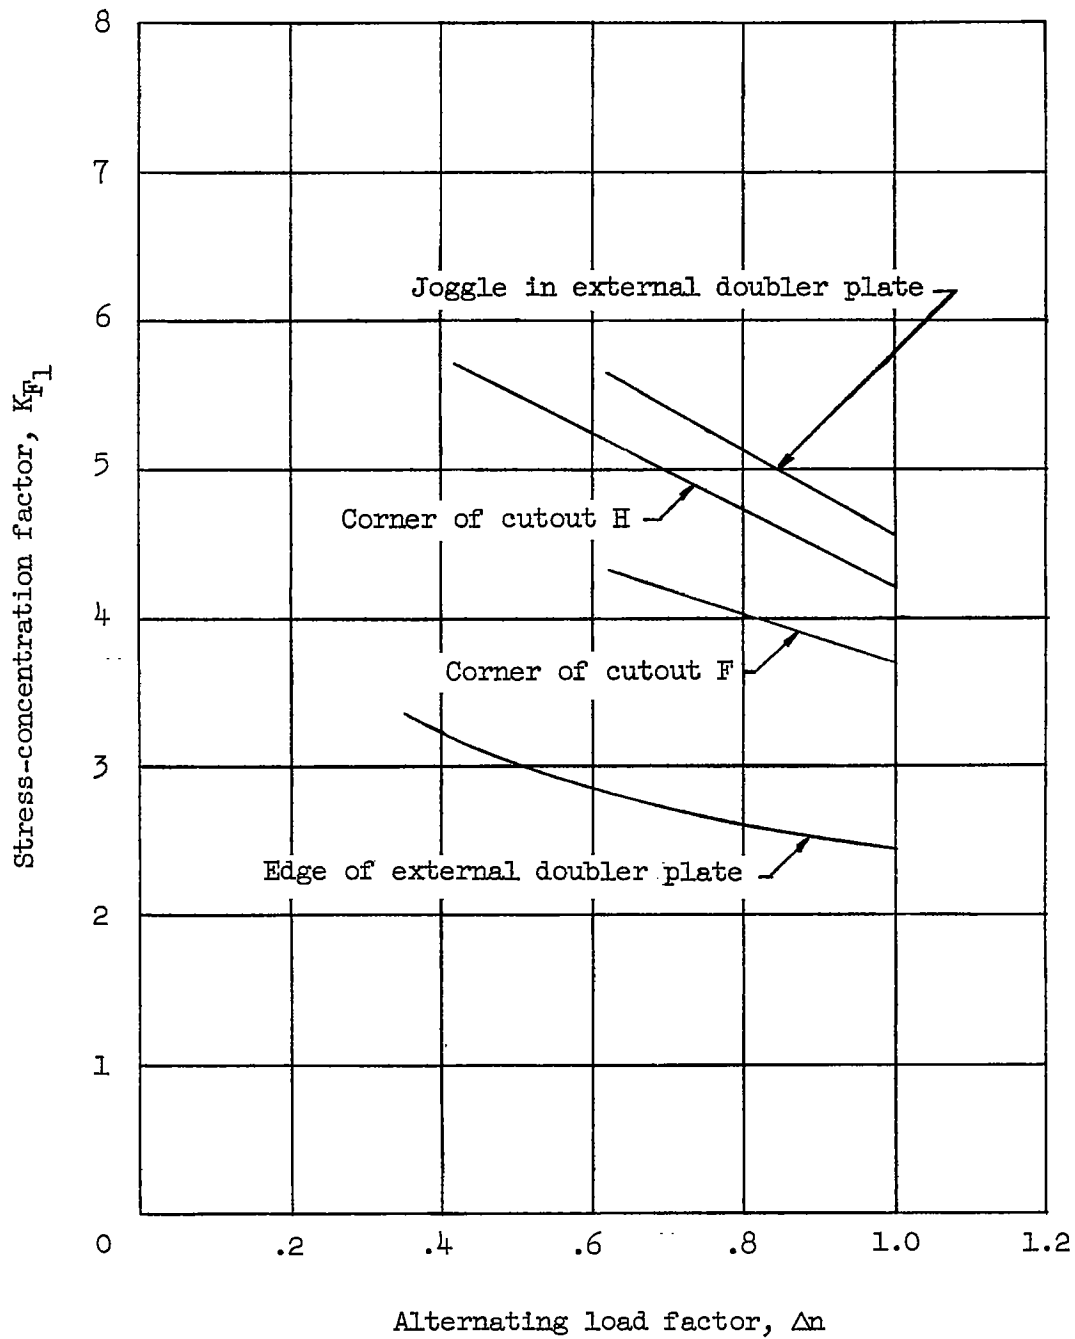
The range of concentration factor  $K_{F1}$  occurring at each load level for the five types of failures is shown in table 2. It can be noted from this table that the concentration factor tends to decrease with increasing load level. This trend is shown graphically in figure 10 for several locations where failures occurred at more than one load level. The trend is assumed to be caused by the increasing effects of plasticity associated with higher stresses as the load level is increased. Both  $K_{F2}$  and  $K_{F3}$  show the same decreasing trend with increasing load level that  $K_{F1}$  does, but in the case of  $K_{F3}$  the trend is not very apparent because of the lower magnitudes involved.

Figure 10.- Effect of load level on the stress-concentration factor.

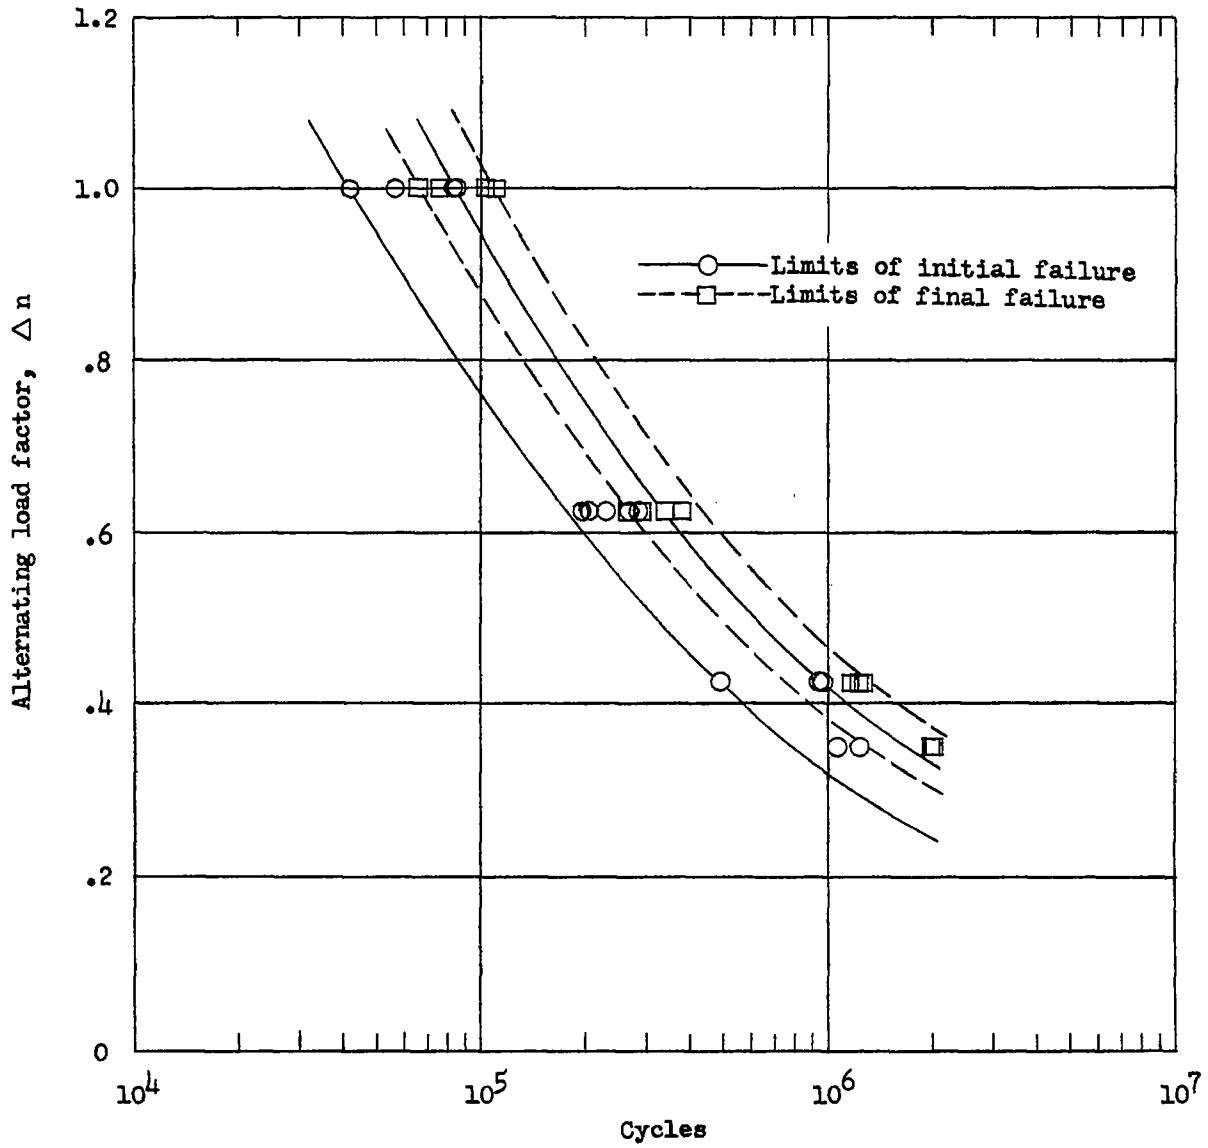
Figure 12.- Load-lifetime diagram for failures that grew past the critical point.

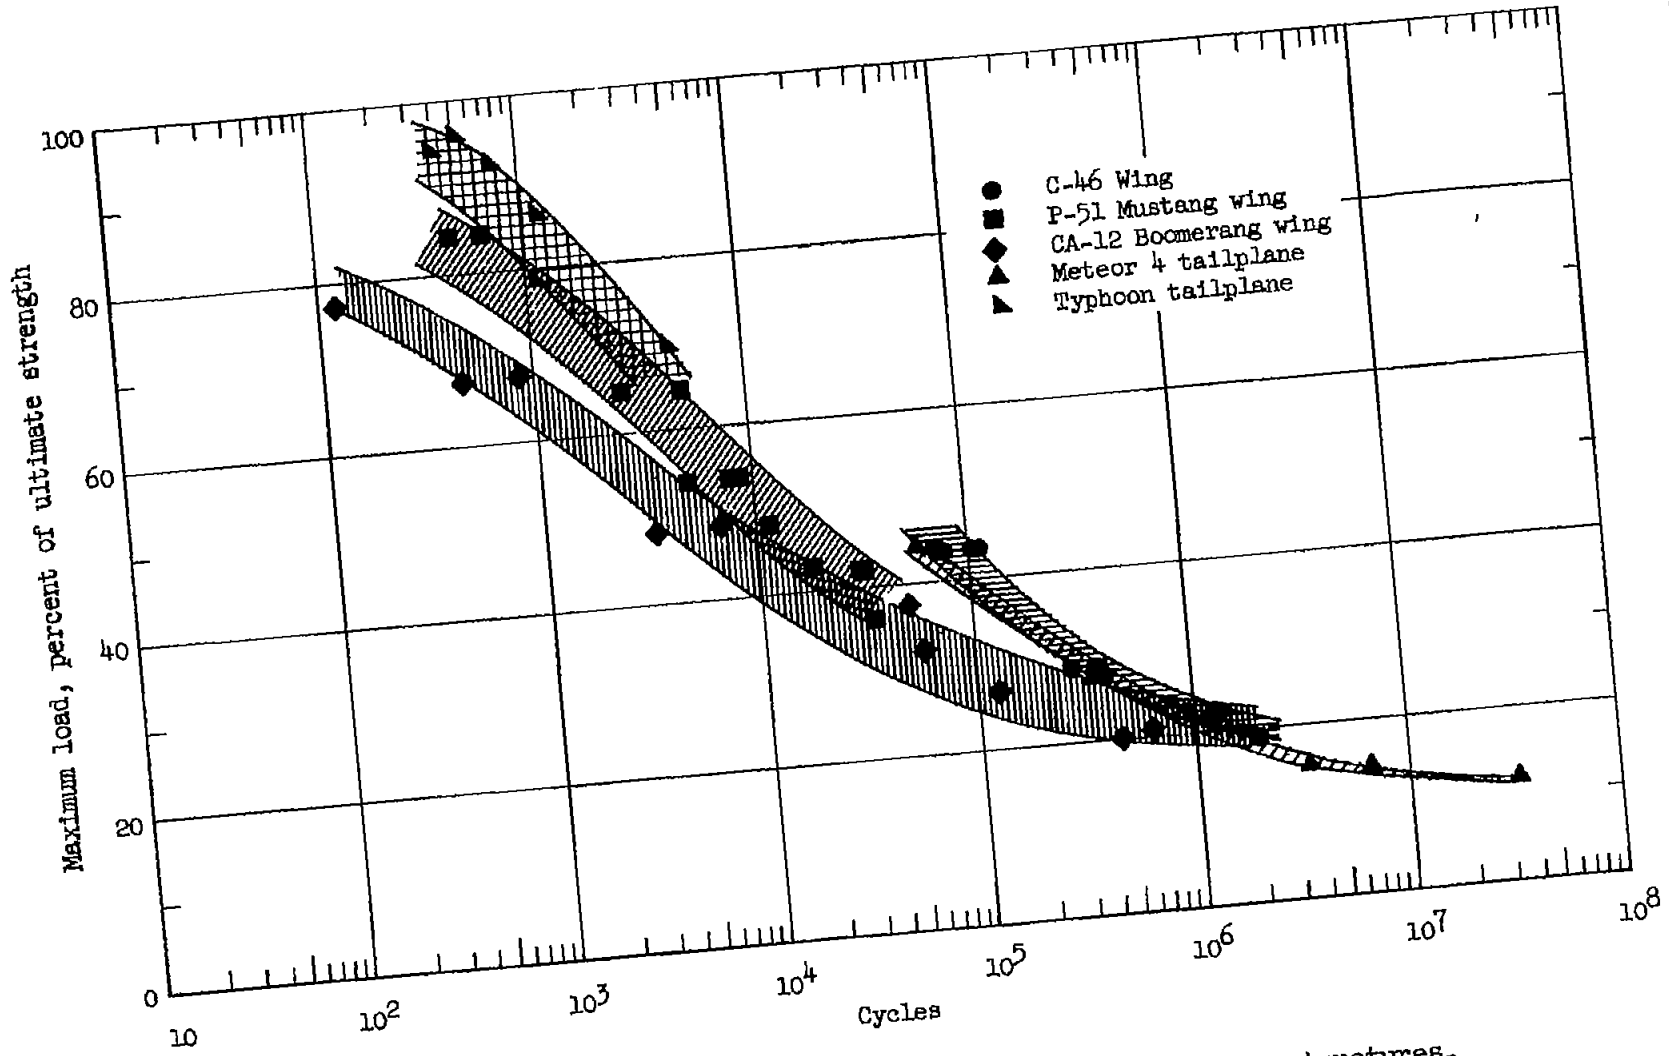
The load-lifetime diagram for final failure is presented in figure 13, along with results of fatigue tests on a number of other airplane structures taken from references 7 to 10. The load is given in percent of the ultimate static strength of the structure. It can be seen from this figure that all of the full-scale data presented lie within a comparatively narrow scatter band, considering the fact that the data include different types of airplanes and components with many types of stress raisers. Full-scale fatigue data from other airplanes have been found to fall within the scatter of the data that are presented.

Since the ordinate of figure 13 is based on the ultimate strength of the structures and since fatigue failures occurred principally on the tension surface, the load-lifetime comparison could best be made on the basis of the ultimate strength of that surface. In the static tests to determine the ultimate strength of the structures in references 7 to 10, the P-51 wing and Meteor 4 tailplane failed in compression while the remaining structures failed in tension. The C-46 curve in this figure is based on the design ultimate strength of the wing, because the actual ultimate strength is unknown. In static tests performed by the U. S. Air Force the wing failed in compression at 95 percent of the design ultimate load, and was subsequently reinforced but not retested.

If, in the case of those structures which failed in compression, the strength of the tension surface is assumed to be greater than the strength used in the comparison of figure 13, the load-lifetime curves would be shifted downward. This downward shift would very likely result in even less scatter in the data of this figure than is now present.

Figure 13.- Load-lifetime diagrams for several aircraft structures.
