TECHNICAL NOTE 3973

ORIGIN AND PREVENTION OF CRASH FIRES IN TURBOJET AIRCRAFT

By I. Irving Pinkel, Solomon Weiss, G. Merritt Preston,  
and Gerard J. Pesman

Lewis Flight Propulsion Laboratory  
Cleveland, Ohio

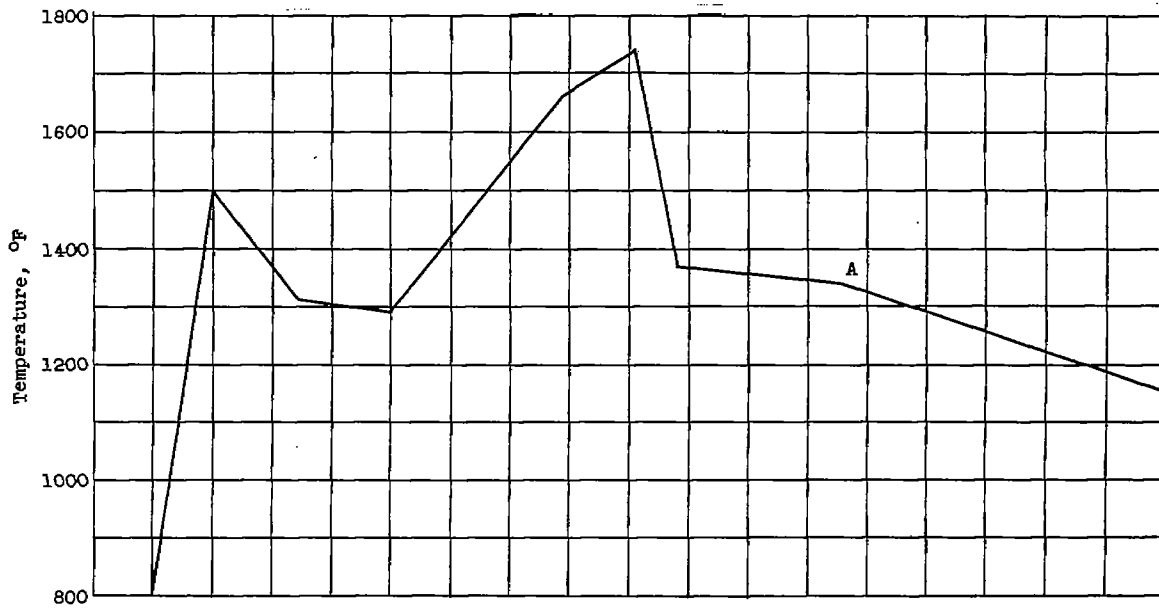
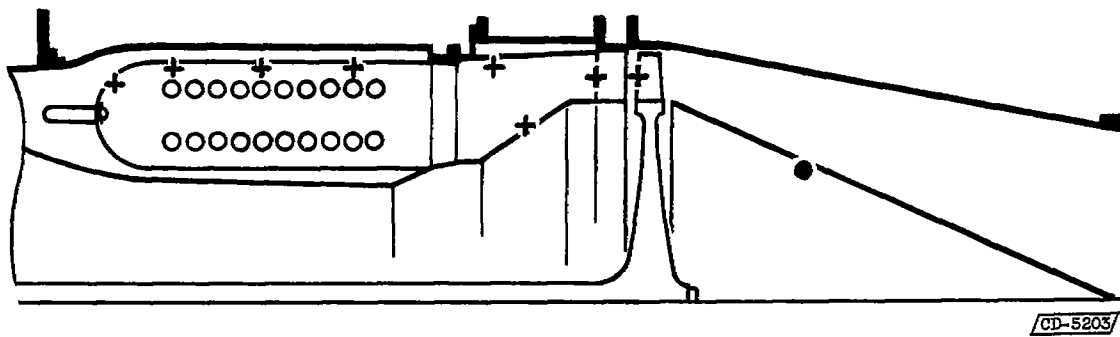
The hottest parts of the engine, when operated at rated conditions, were those which lay in the main gas stream downstream of the compressor. The highest temperatures (fig. 7) were measured on the primary zone of the combustion liner, on the bend in the transition liner where the hot gases leaving the combustor impinge, and on the turbine nozzle vanes. Temperatures as high as 1660° and 1740° F were found on the transition liner and the adjacent turbine nozzle vanes, respectively. The stagnation gas temperature at the moving turbine blades was less than the stagnation temperature at stationary engine members in the same gas stream. The temperature of the blades was correspondingly lower, being about 1370° F for the hottest parts of the blade. The gases leaving the turbine were reduced in temperature because of the turbine work that had been done. Therefore, the temperature of the inner tailcone at location A on figure 7 was about 400° cooler than the turbine nozzle vanes. The temperature was about 1350° F at the hottest point of the inner cone and about 1150° F at its coolest point.

The largest temperature gradients occurred within the combustor (fig. 7) where some metal was in contact with the relatively cool combustor-inlet air and other metal was heated by the combustor flame. The maximum temperatures recorded were about 800° F on the dome, about 1500° F on the primary section of the combustor liner, and about 1300° F at the outlet. The lower temperatures at the combustor liner outlet were produced by the cooler secondary combustor air.

Figure 7. - Maximum temperatures of metal components in main gas streams of J47 and J35 engines.

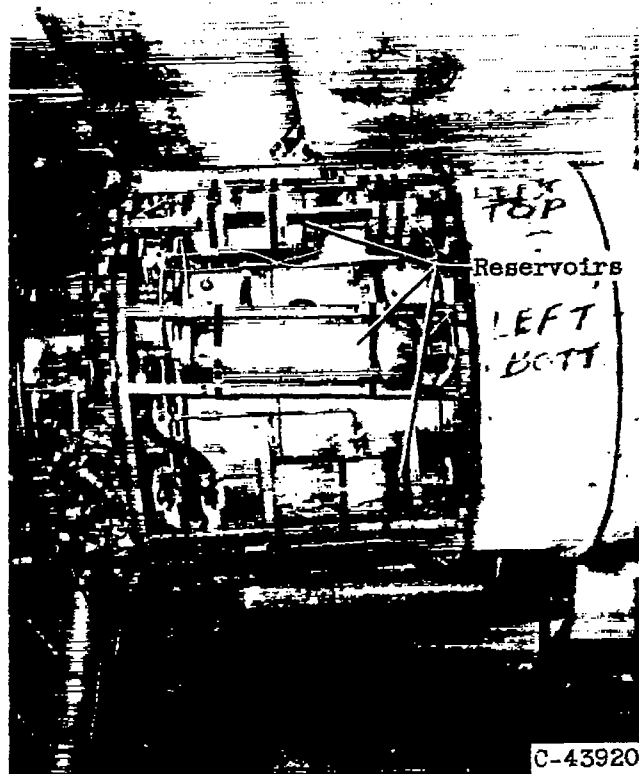
(b) Secured to J47 engine.

Figure 21. - Water reservoirs.

For this crash special water reservoirs were made that would fit in the spaces between the combustors on the J47 engine. Some of the water reservoirs held to the combustors by metal bands are shown in figure 21(b). To ensure complete expulsion of the water regardless of the nacelle orientation, reservoirs of the type shown in figure 23 were employed. Each consisted of a steel cylinder with a neoprene-fabric bladder insert. Water was retained in the steel cylinder while the volume of the bladder was filled with nitrogen gas at a pressure necessary to give the desired water discharge rate. When the outlet valve was opened, the bladder expanded, forcing the water to flow.

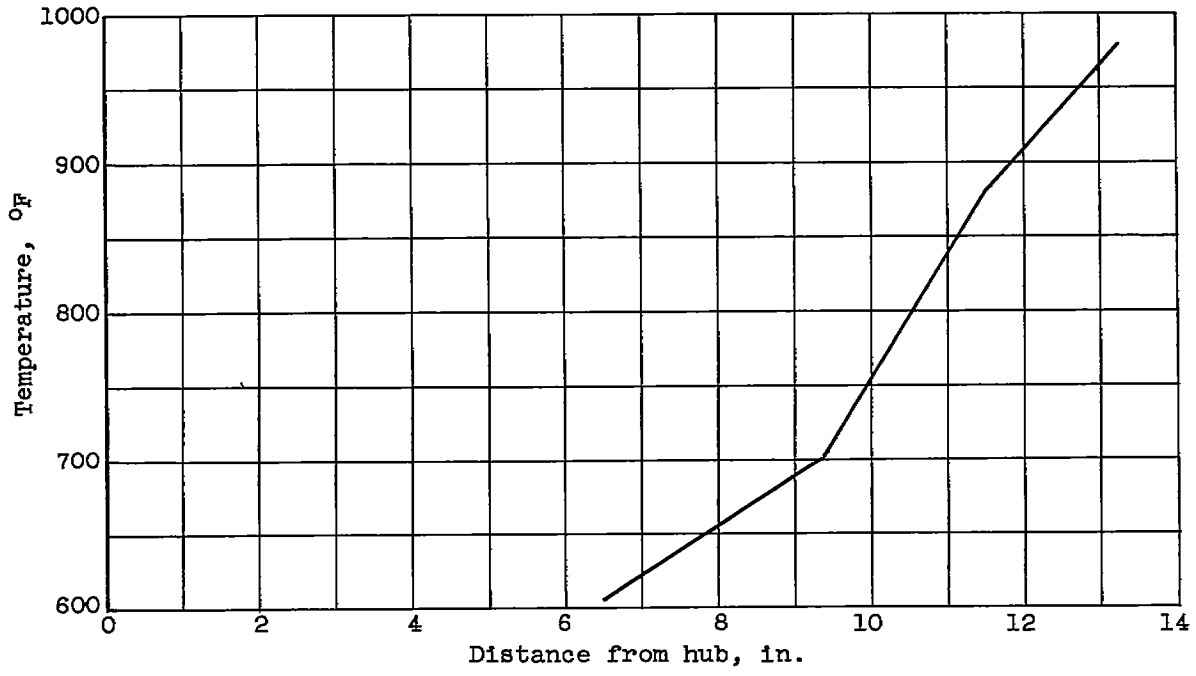
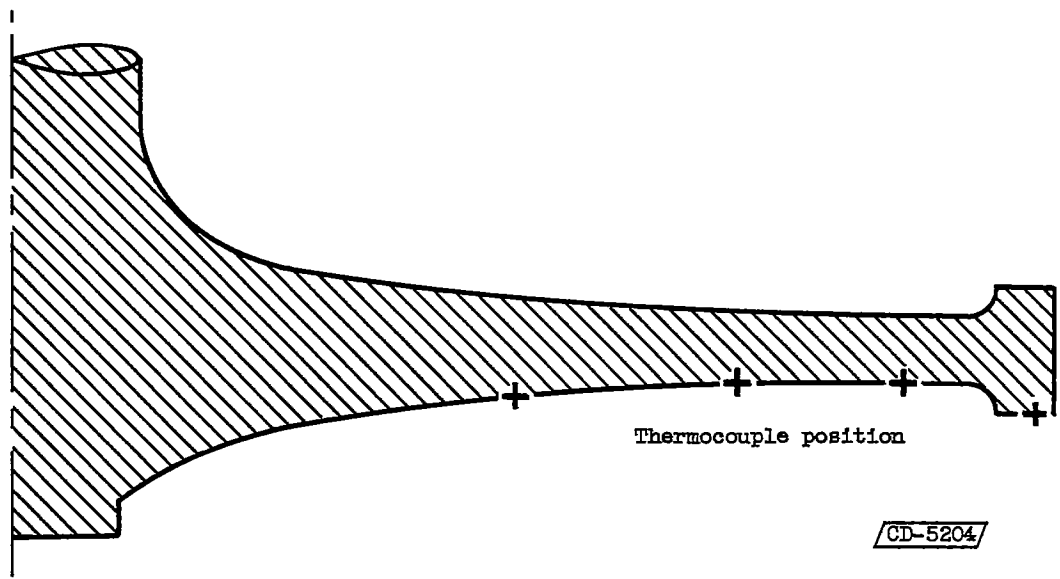
Engine parts not in the main gas stream were heated mostly by conduction. The turbine wheel was the most massive engine part heated this way. The radial variation in temperature on the surface of the turbine wheel, shown in figure 28, resulted from the fact that the heat conduction was from the wheel rim to the relatively cool hub. The data shown were obtained with the engine operating at rated sea-level conditions. The turbine-wheel surface temperature varied from approximately 980° F at the rim to about 605° F at a point midway between the rim and hub. Cooling air from the compressor applied to the hub to protect the engine bearings maintained this temperature pattern.

Figure 28. - Maximum temperatures recorded on J47-engine turbine wheel.

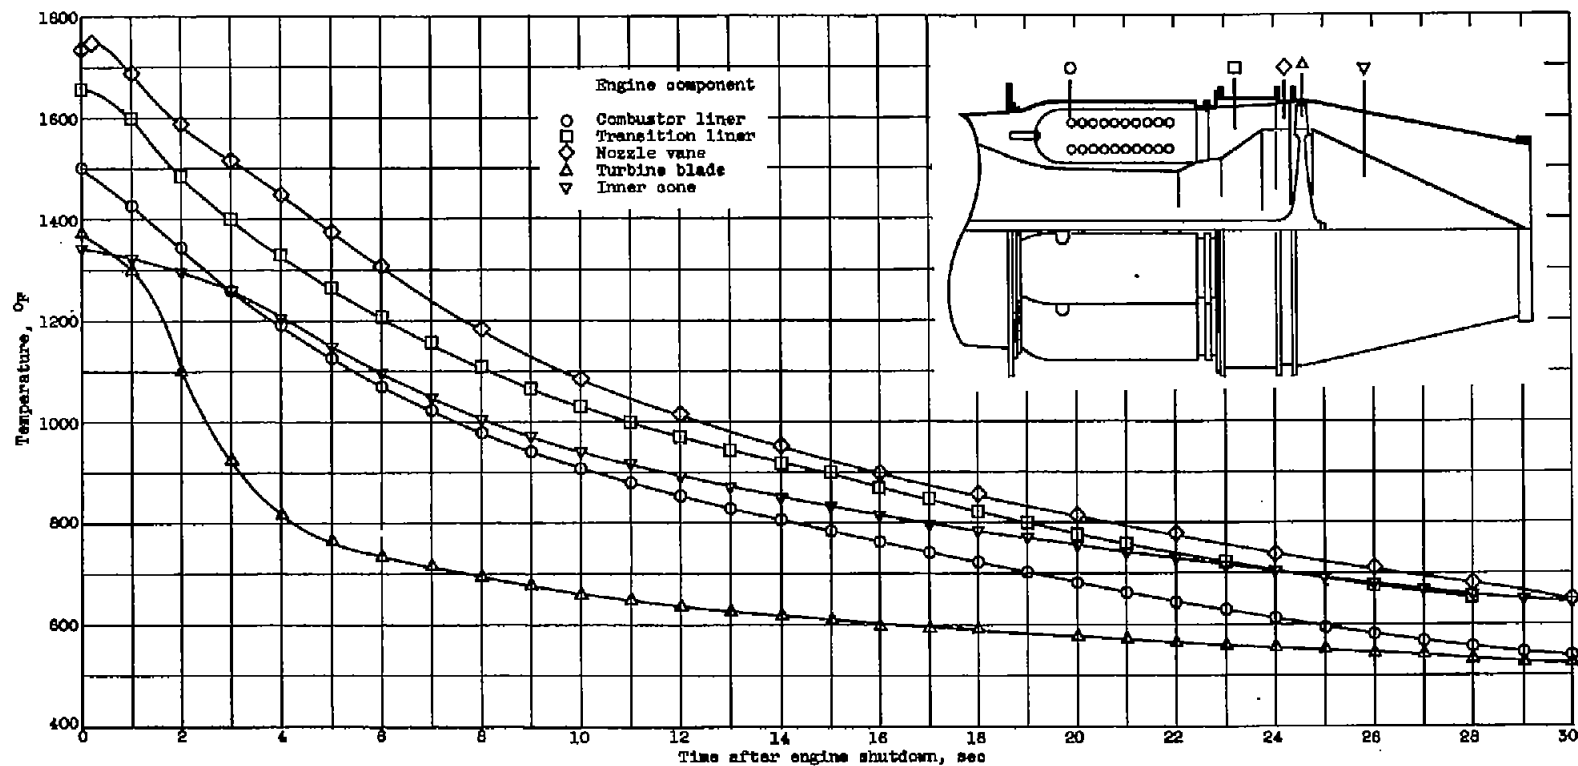
A history of the temperature of engine parts lying in the main gas stream is shown in figure 29. Fuel shutoff occurred at zero second, and the temperatures indicated were the maximum recorded anywhere on the component at the time noted. The hottest section of the combustion-chamber liner cooled from  $1500^{\circ}$  to  $600^{\circ}$  F in  $24\frac{1}{2}$  seconds. It took over 30 seconds for the transition-liner temperature to decline from  $1660^{\circ}$  to  $600^{\circ}$  F. In 30 seconds the turbine nozzle-vane temperature dropped from a maximum temperature of  $1750^{\circ}$  to  $645^{\circ}$  F. The rotating turbine blade temperature fell from  $1370^{\circ}$  to  $600^{\circ}$  F in 16 seconds. Inner-cone skin temperatures declined from  $1340^{\circ}$  to  $640^{\circ}$  F in 30 seconds.

Figure 29. - History of maximum temperatures on engine components in main gas stream.

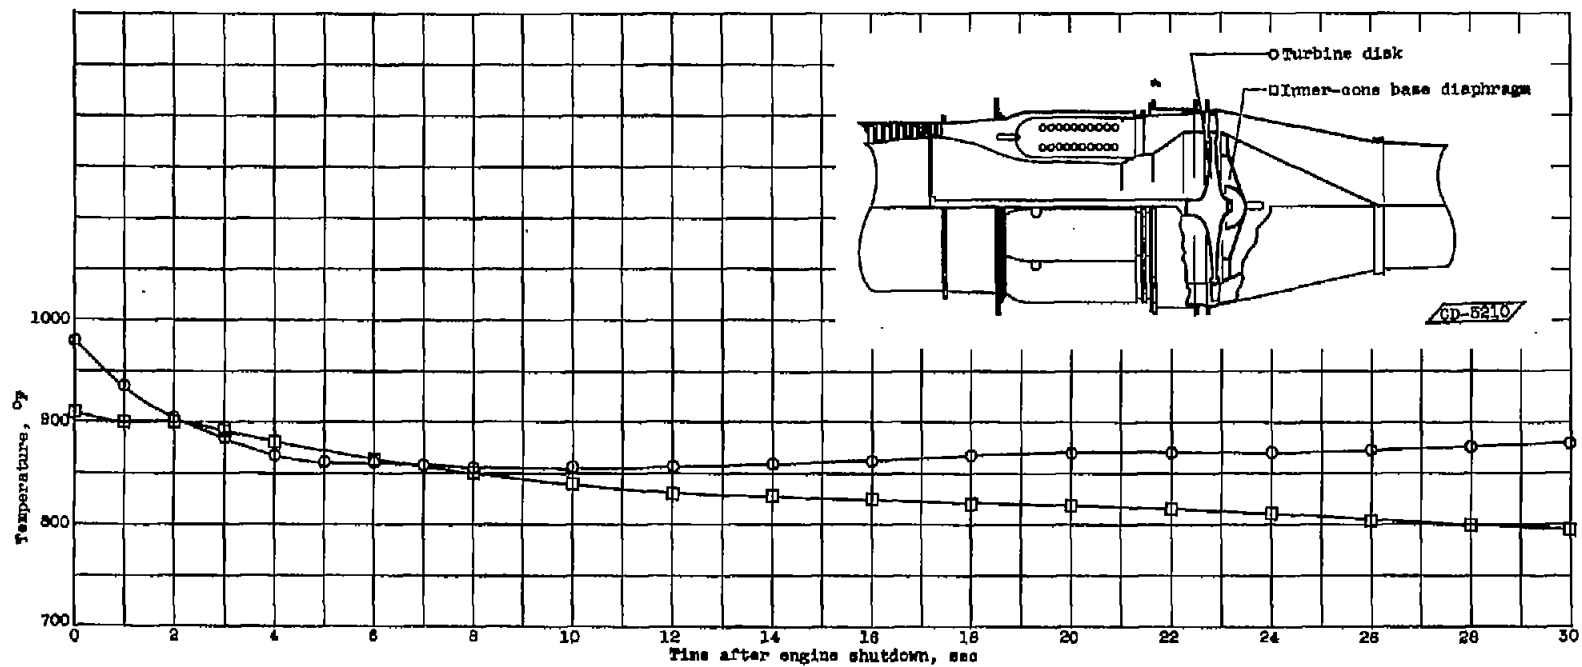
Engine parts not located in the main gas stream declined in temperature at much slower rates (fig. 30). The hottest part of the turbine wheel was initially at  $980^{\circ}$  F and dropped only  $100^{\circ}$  F in 30 seconds after fuel flow to the engine had stopped. The turbine wheel remained above the ignition temperature of JP-4 fuel for 30 minutes after the engine was shut down. The large mass of the turbine disk contributed to its slow cooling rate. The inner-cone base diaphragm exhibited the same slow rate of cooling. Its maximum temperature was  $910^{\circ}$  F and cooled only approximately  $115^{\circ}$  F in 30 seconds.

Figure 30. - History of maximum temperatures on turbine disk and inner-cone base diaphragm.

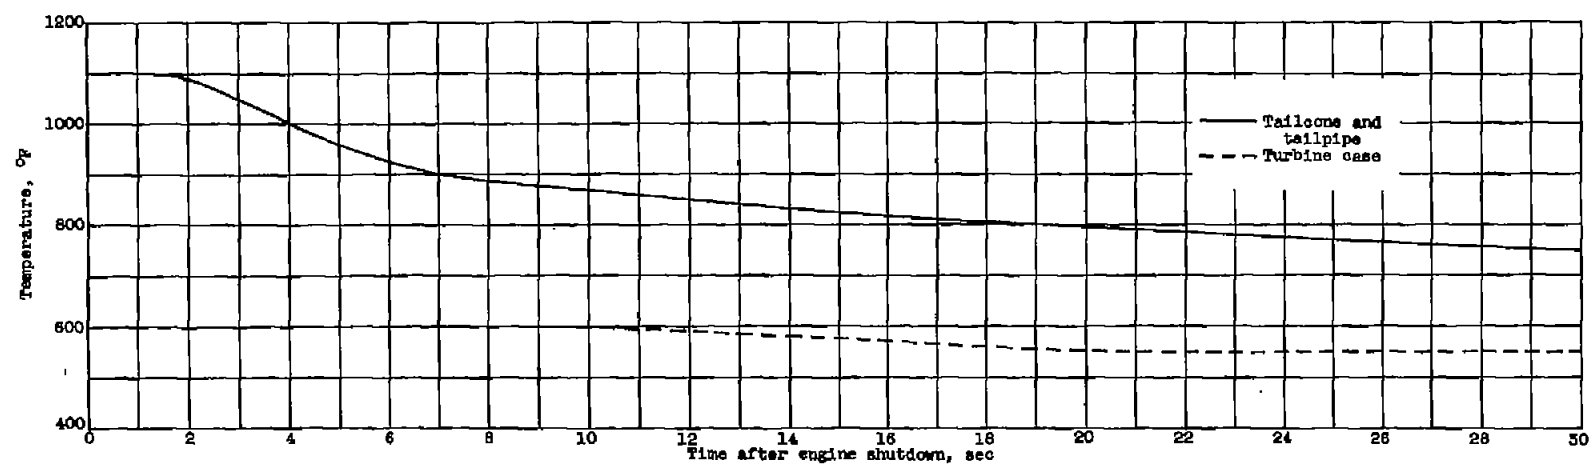
Temperature measurements made on the external skin of the J47 engine (fig. 31) indicated that the tailcone and tailpipe temperatures remained above  $600^{\circ}$  F for more than 30 seconds after the fuel to the combustor was shut off. Temperatures of the engine case upstream of the tailcone and tailpipe were usually below  $600^{\circ}$  F (fig. 32). Although the turbine case reached a maximum temperature of  $600^{\circ}$  F and remained so for 10 seconds after the fuel was shut off (fig. 31), no ignitions were experienced here.

Figure 31. - History of maximum external skin temperatures on J47 turbine case and tailcone and tailpipe.

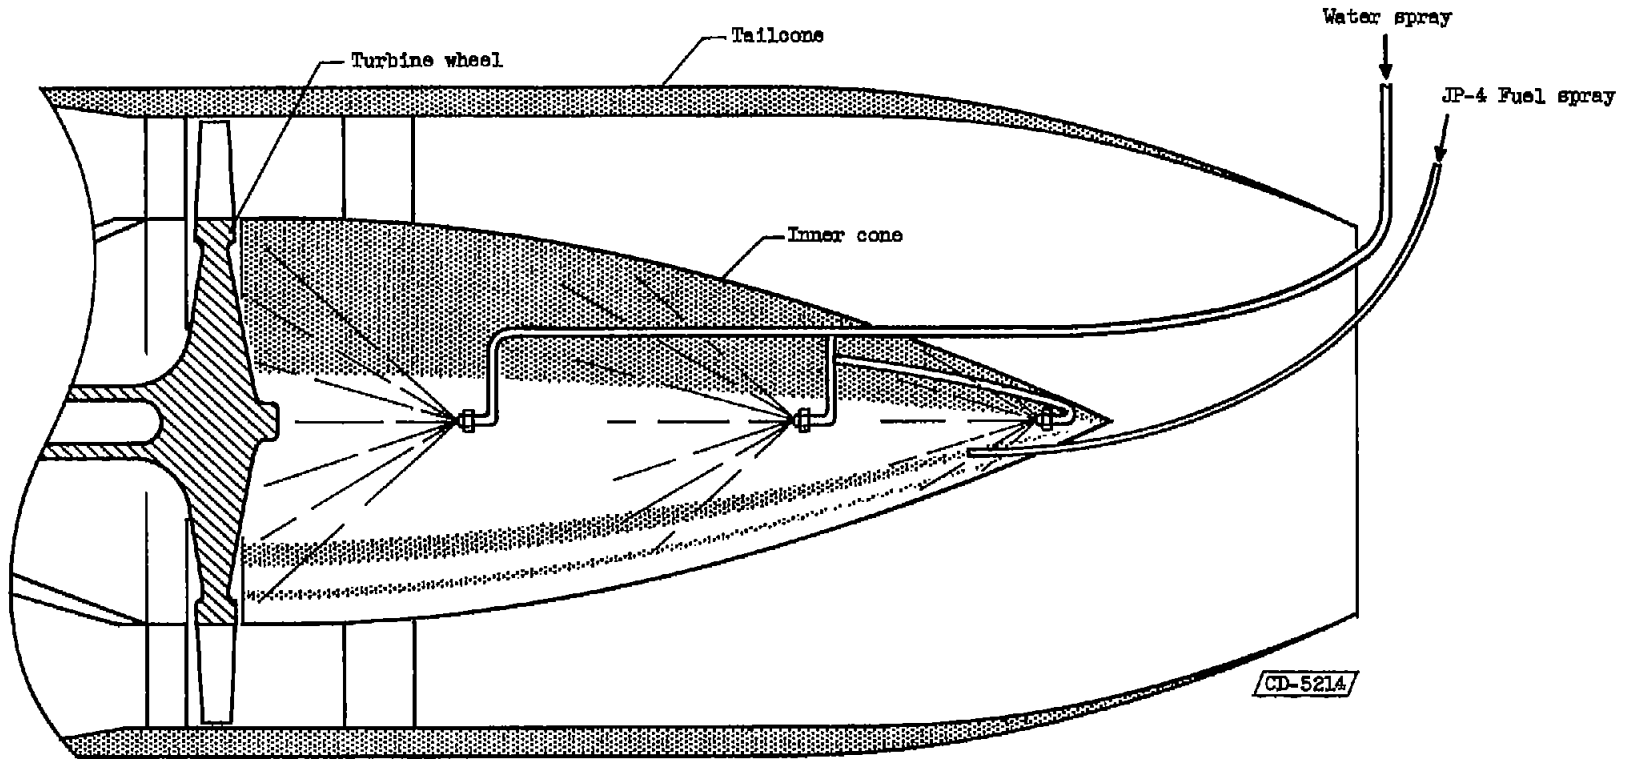
The engine cavity farthest downstream, the inner tailcone, was studied first. The arrangements used for the J30 tailcone are shown schematically in figure 34. A fuel system, consisting of a single tube and nozzle, was arranged to spray fuel in measured quantities into the cavity of the tailcone to produce a combustible atmosphere. In addition, three water spray nozzles were installed facing the upstream direction. Since the J30 engine has no base diaphragm, the downstream face of the turbine wheel must be taken as a bounding surface of this cavity. The upstream water nozzle was arranged to spray water on the turbine wheel to avoid ignition from this source.

Figure 34. - Sketch of typical equipment used to study ignition hazard (J30 inner tailcone).
