NASA TECHNICAL NOTE

NASA TN D-7775

LIGHTNING DAMAGE TO A GENERAL AVIATION AIRCRAFT - DESCRIPTION AND ANALYSIS

by Paul T. Hacker
Lewis Research Center
Cleveland, Ohio 44135

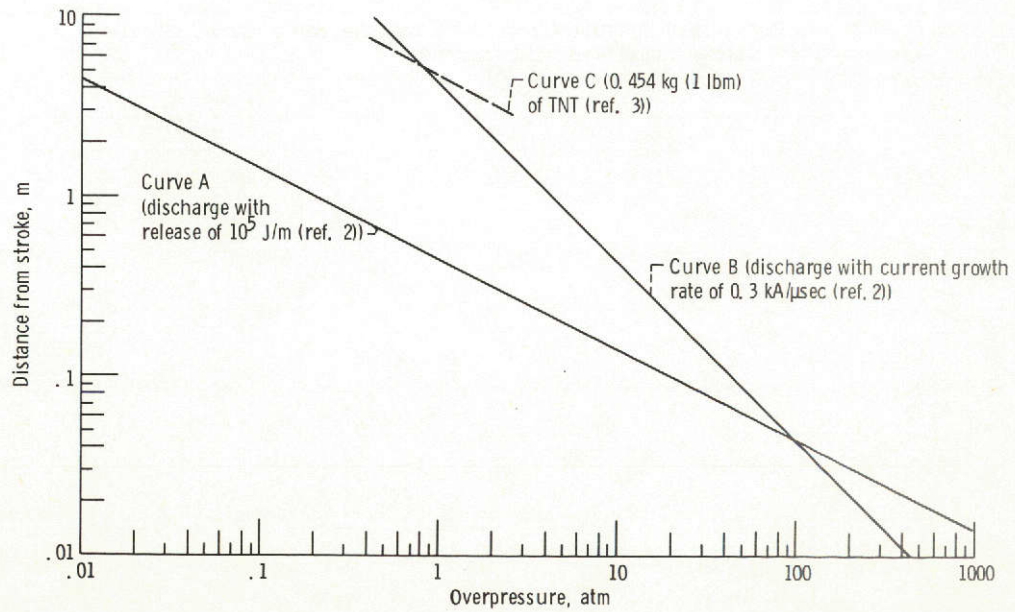
discharges are shown in figure 25 as curves A and B. The calculations for the two curves are based upon different assumptions, as indicated in the figure and give widely different results at large distances. Curve B at distances of about 5 meters (16.4 ft) gives overpressures equivalent to 0.454 kilogram (1 lbm) of TNT, curve C (ref. 3). When a traveling shock wave is intercepted by a solid surface, the load imposed on the surface is greater than that due to the overpressure in the incident shock wave itself. The kinetic energy of motion of the incident shock wave is transformed into a pressure rise, which increases the overpressure in the reflected shock wave. For shock waves traveling in a direction normal to a surface that does not absorb any energy from the wave, the ratio of the overpressures, reflected to incident, varies from 2 for very low overpressures in the incident shock wave to many times for incident shock waves with large overpressures. When the direction of travel of the shock wave is not normal to the surface, the imposed load is less.

The predicted overpressures given in figure 25 would be sufficient to have caused the observed damage if the lightning discharge path was close enough. Therefore, it may be of interest to theorize on the probable lightning discharge path and lightning characteristics.

Figure 25. - Predicted shock wave overpressure generated by typical lightning discharge.

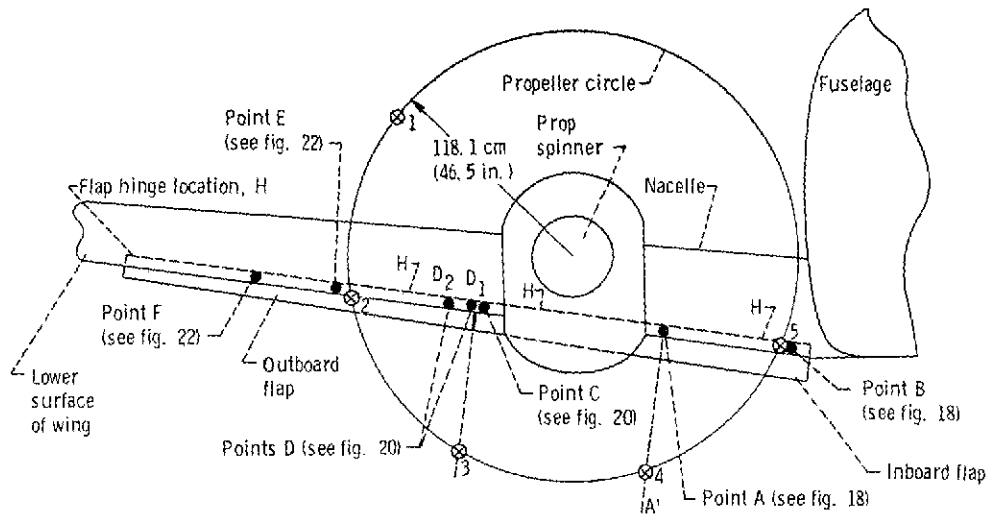
Some damage sustained on the lower right surfaces of the aircraft cannot be easily associated with the shock waves created by only two strokes. These damages are the localized indentations sustained by the lower surfaces of the wing flaps near their leading edges as indicated in figures 18 to 20 and 22. The locations of these indentations on the flaps with respect to the wing, nacelle, and propeller tip circle are shown in figure 26. The most severe damage was at point A. The damage at points B, C, and D is moderate. Damage at point E was slight and at point F very light. It is proposed that these localized indentations were caused by five different strokes while the lightning was attached to the propeller tip. They resulted from the orientation of the stroke with respect to the aircraft, the cylindrical nature of the lightning-generated shock wave, and the wing-flap geometry. At the time of the lightning strike, the flaps were extended and lowered, creating a corner along the junction of the flap leading edge and the wing. The localized indentations were all in the flap and located along this corner line.

Figure 26. - Locations of sharp indentations (points A to F) on leading edge of flaps and estimated positions (1 to 5) of propeller tip at times strokes occurred.

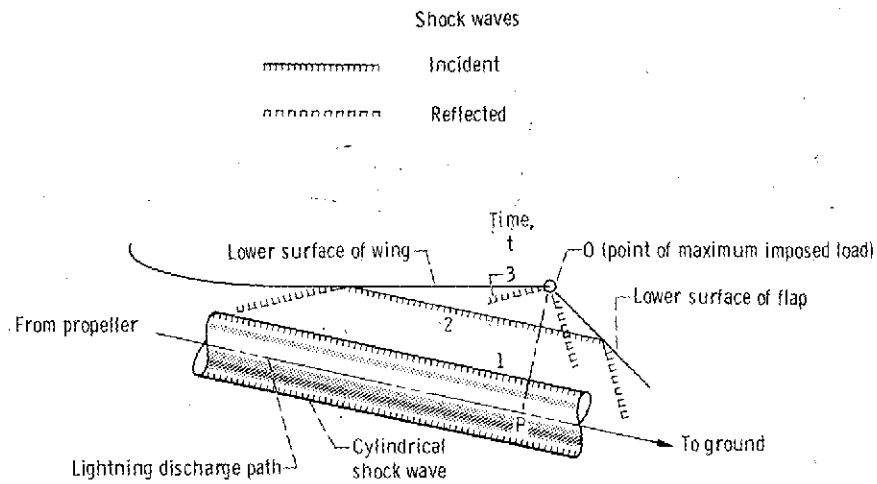
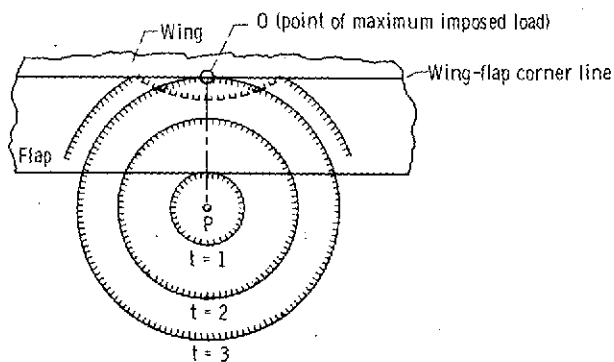
In order to explain the occurrence of these localized indentations, we assumed that the portion of the lightning discharge path from the propeller tip to the ground was oriented in a general longitudinal or chordwise direction under the wing, as illustrated in figure 27(a). There is a high probability that the lightning discharge path was parallel neither to the underneath surfaces of the flap or wing, except maybe at a point on the forward portion of the wing where the surface is highly curved, nor to the wing-flap

Figure 27. - Orientation of lightning path and shock wave with respect to lower side of aircraft wing-flap combination.

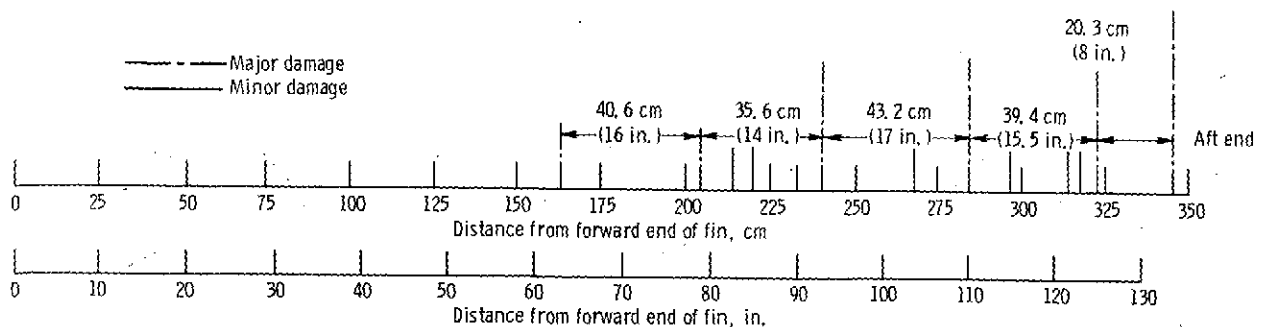
Figure 28. - Location of damage points along ventral fin due to swept stroke. (Length of line marking damage points indicates magnitude of damage.)

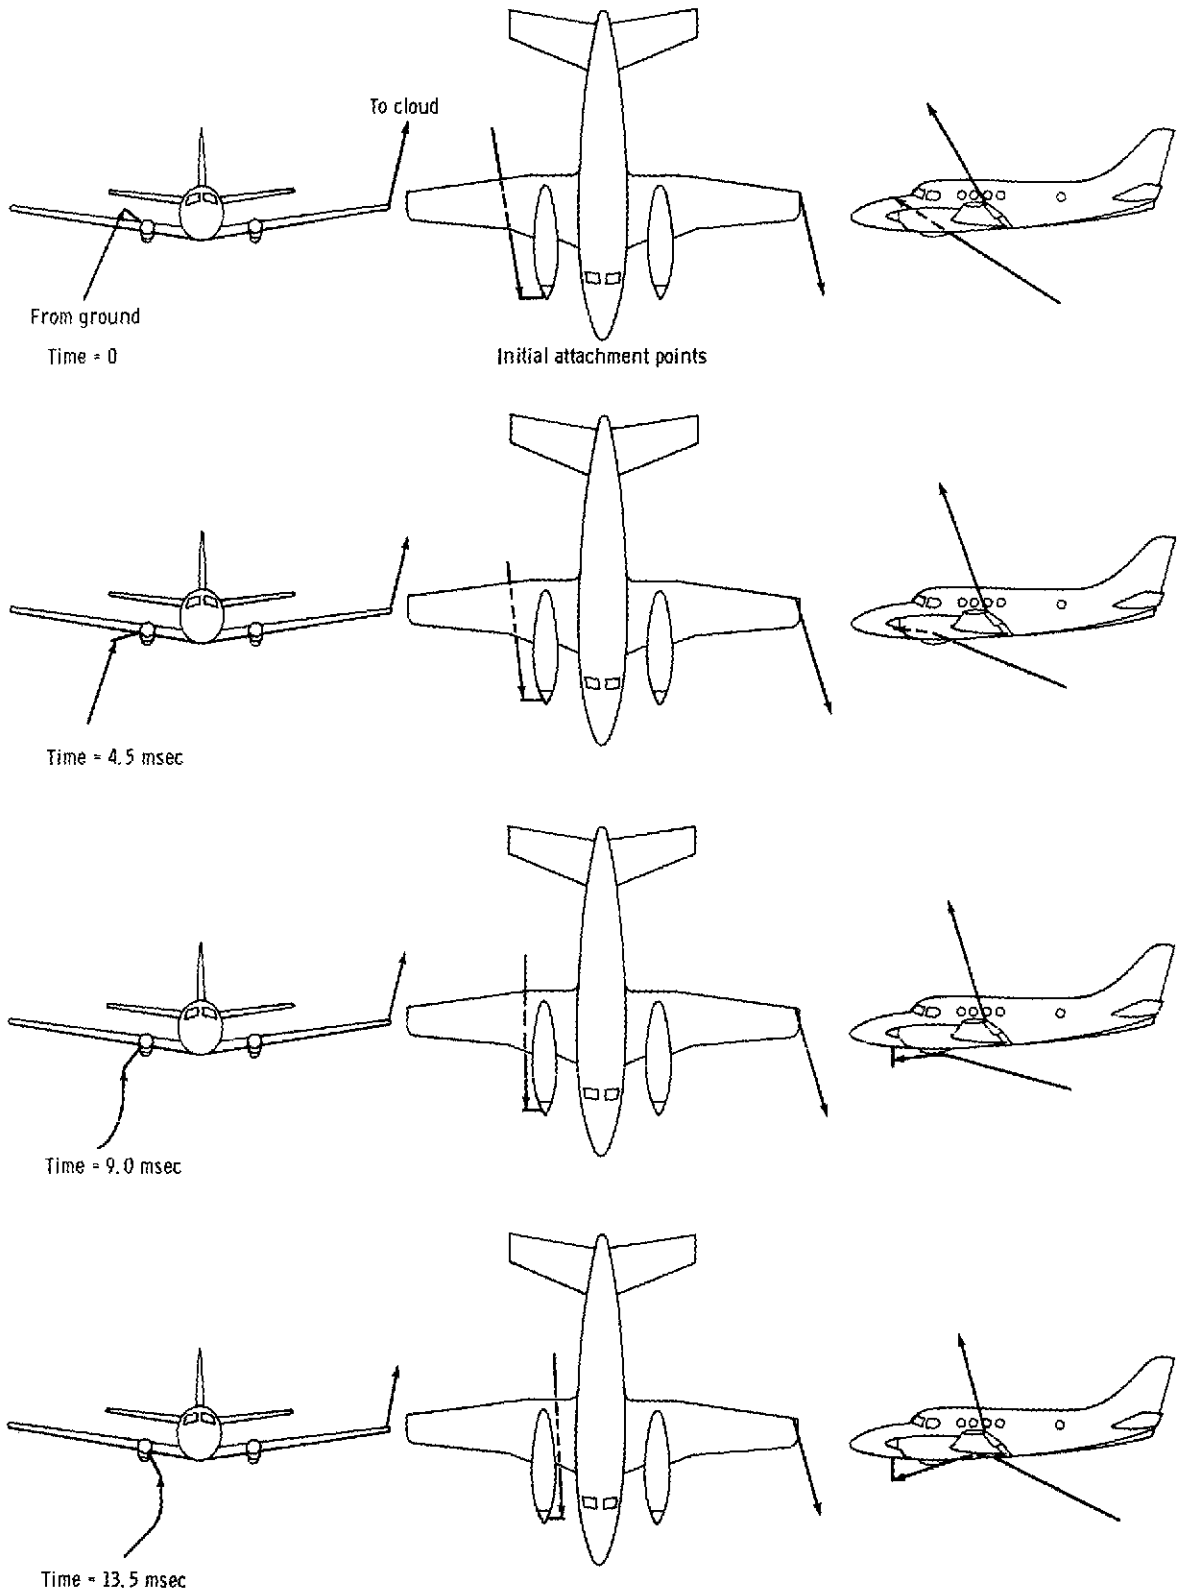
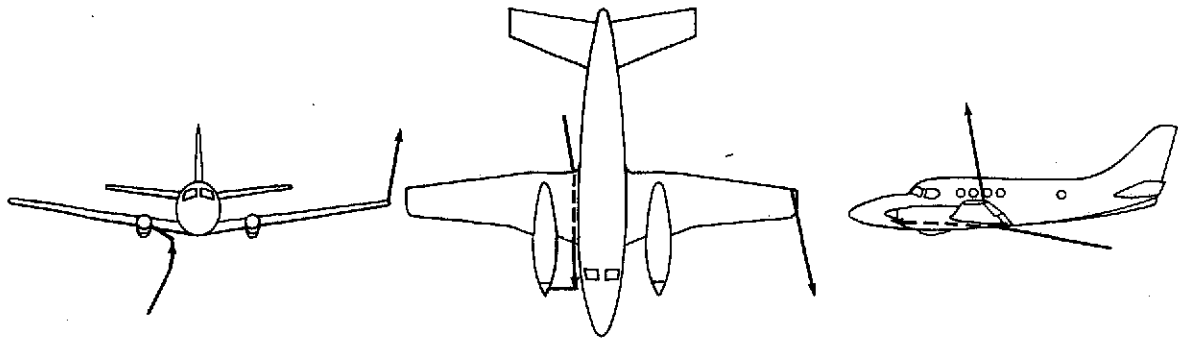
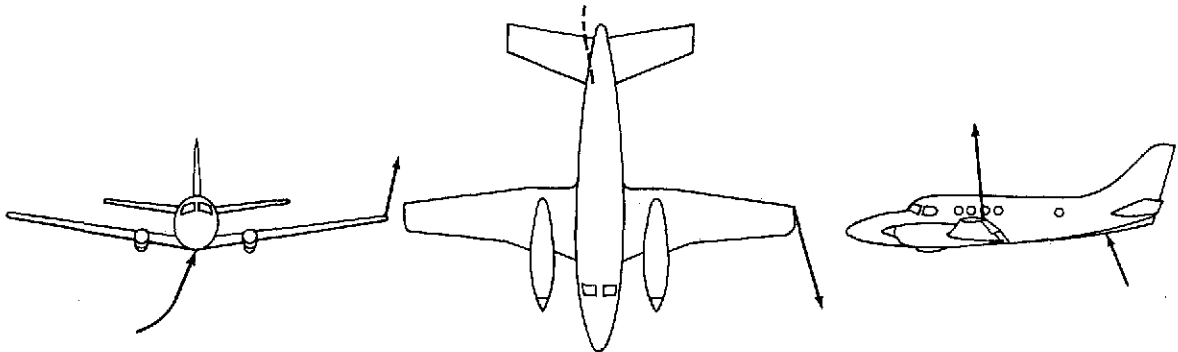
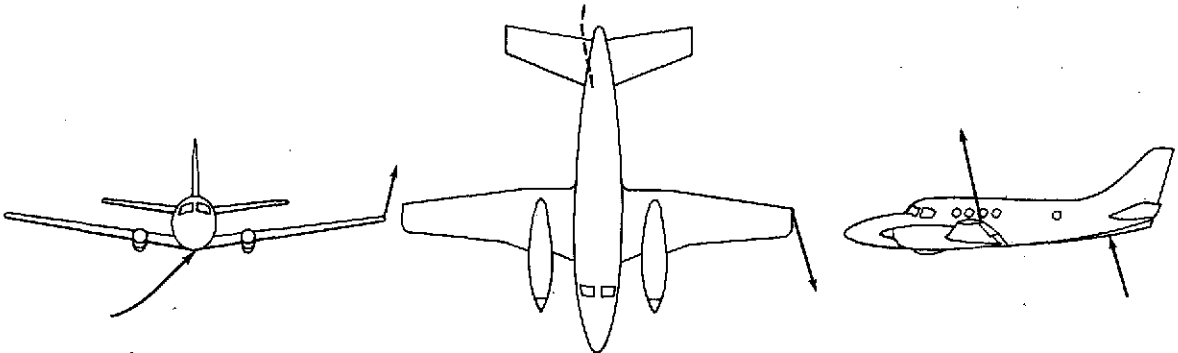
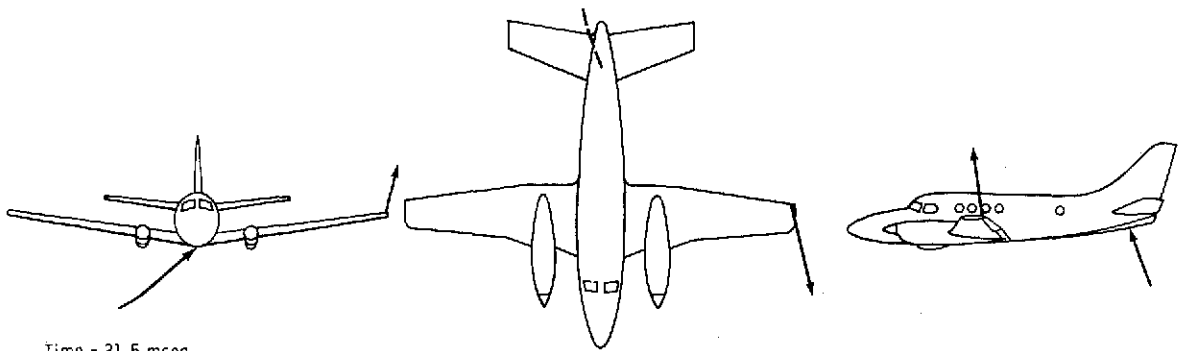
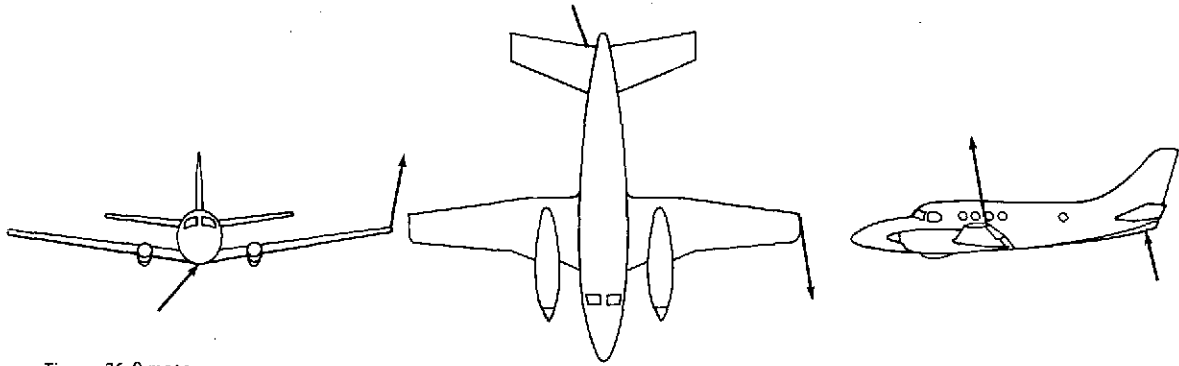
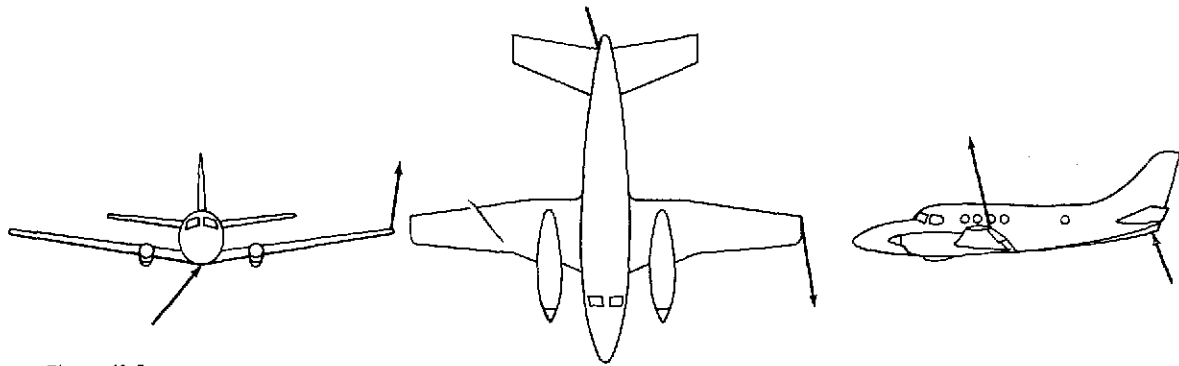
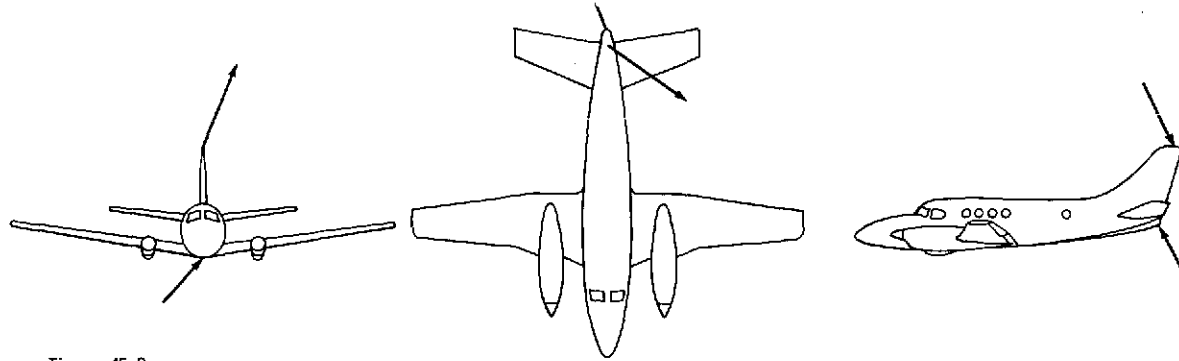
Figure 29. - Probable lightning path with respect to aircraft. (Indicated times are for high-current-stroke portions of discharge.)

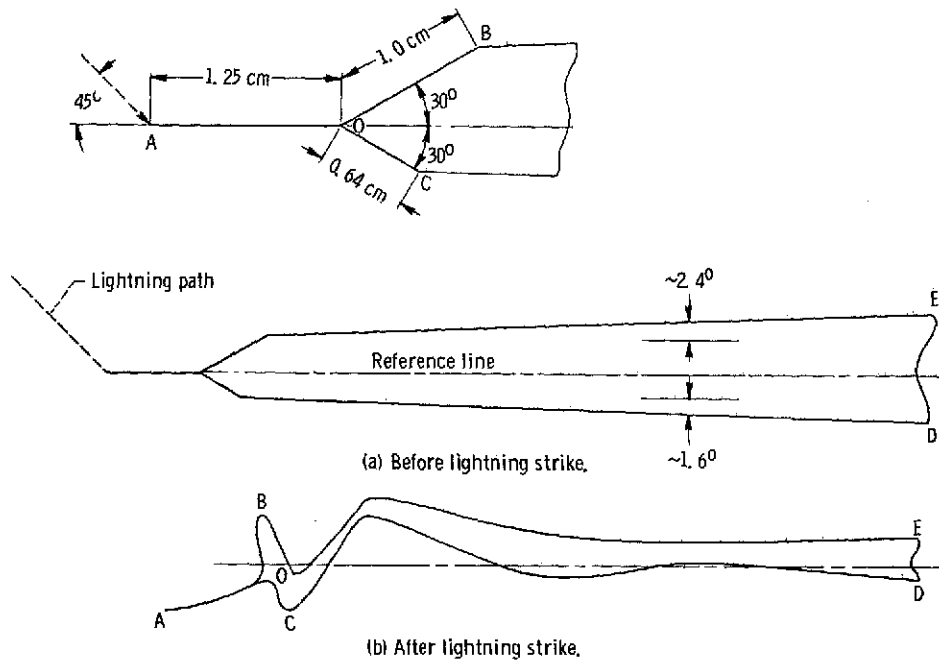
Figure 30. - Approximate geometry of chordwise cross section of wingtip trailing edge.

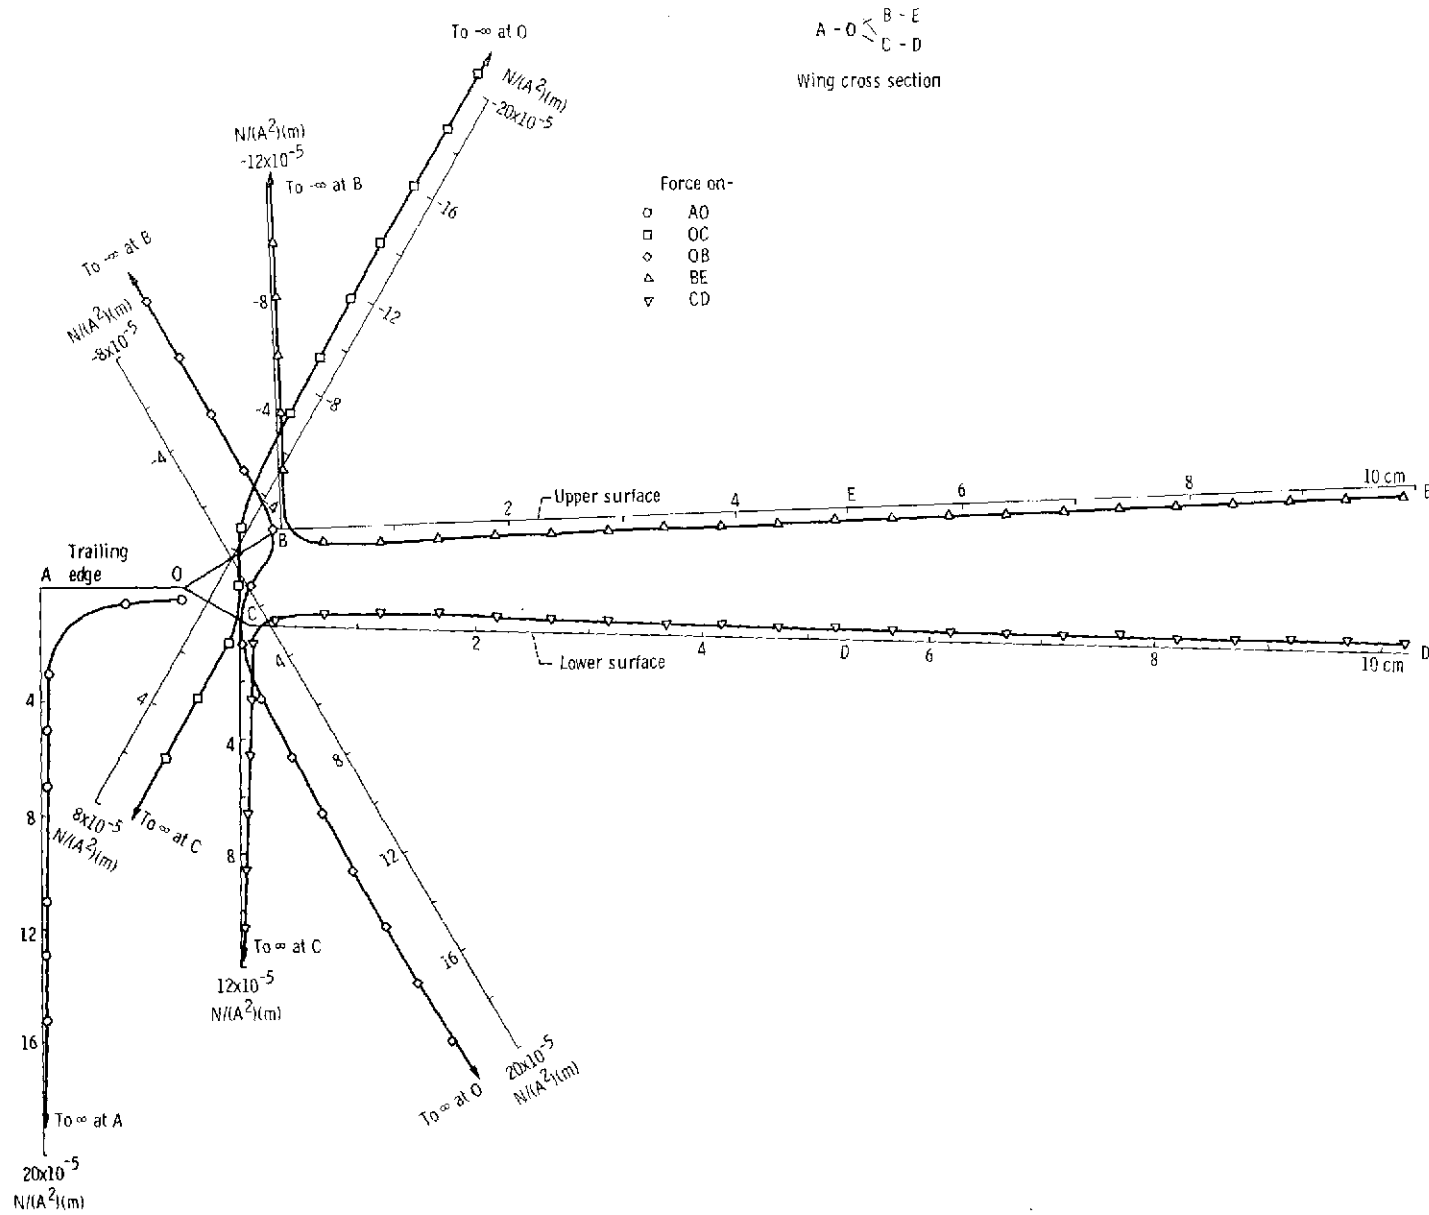
Figure 31. - Direction and magnitude of forces on trailing-edge surfaces of aircraft wing due to interaction of magnetic fields and electrical currents. (Force is in newtons per ampere squared of lightning current per meter of surface length of circuit.)

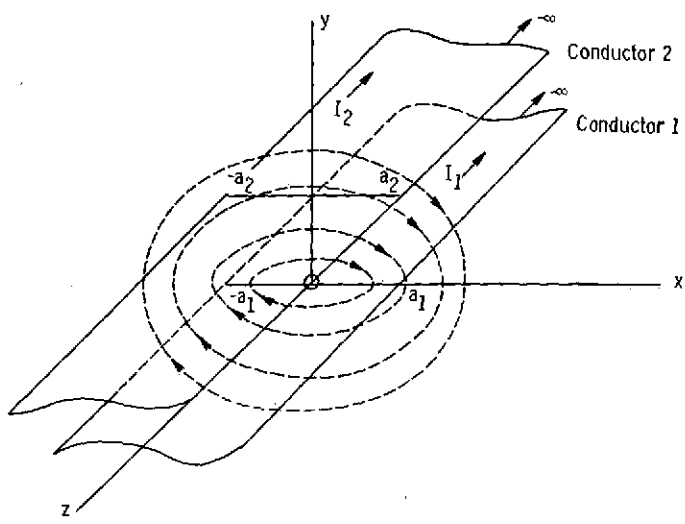
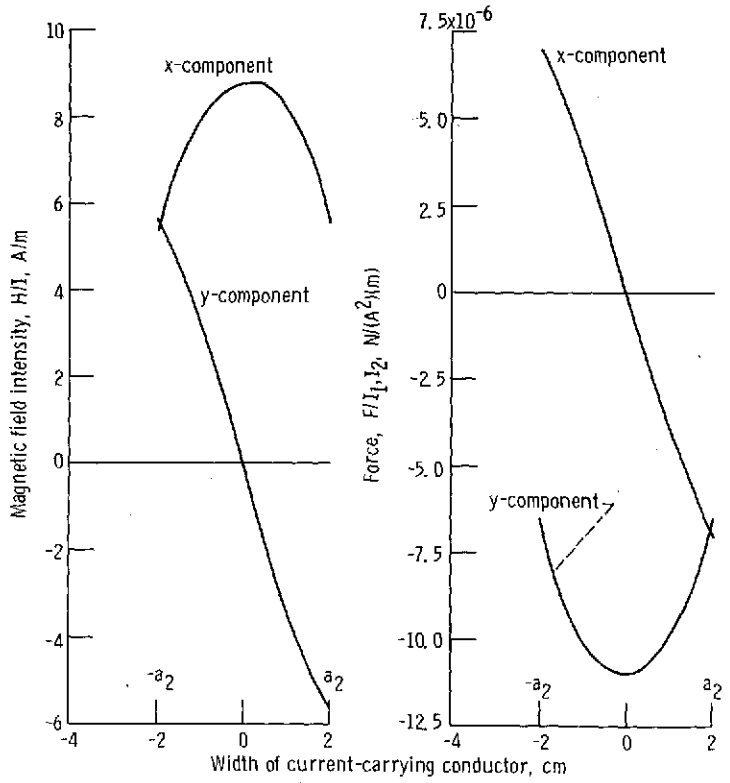
The x- and y-components of the magnetic field intensity on conductor 2 due to current flow in conductor 1 are presented in figure 32(b). The x- and y-components of the force per meter per ampere squared along conductor 2 due to the magnetic field of conductor 1 are presented in figure 32(c). The forces were derived from the magnetic field intensities of figure 32(b) by

Figure 32. - Magnetic fields and forces created by two infinitely long, 4-centimeter-wide, current-carrying conductors separated by 1 centimeter (assuming uniform current density in each conductor).

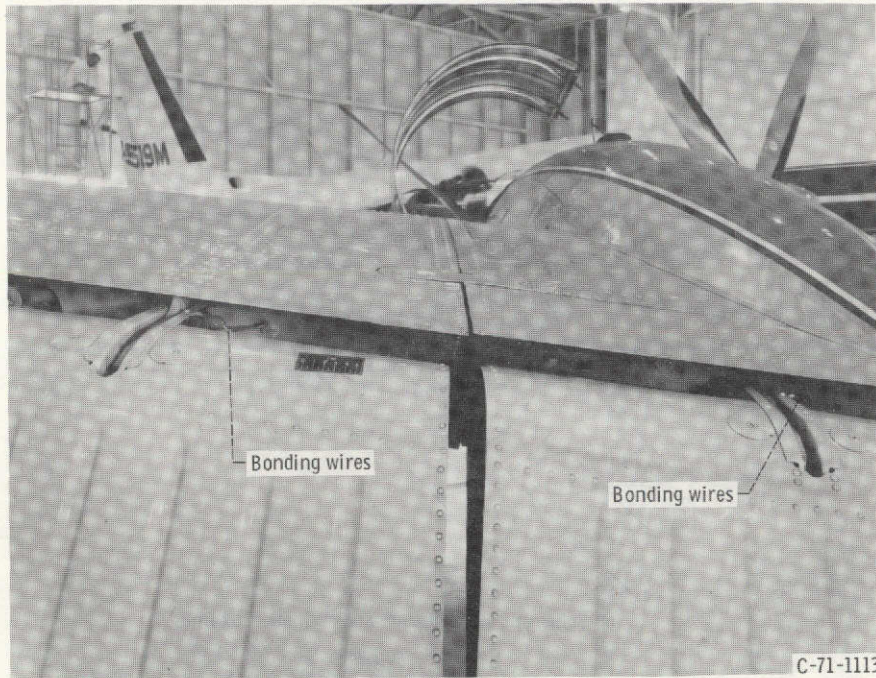
The pitting of the left wing-flap bearings (figs. 23 and 24) by electrical arcing is typical of damage that can occur on mating surfaces which are not adequately electrically bonded. Bonding in this case is difficult because the flaps have to be free to move with respect to the wing. The bonding provided on the aircraft consisted of flexible cables, one for each of the four flap support and attachment points (two per flap). These cables were about 0.5 centimeter (3/16 in.) in diameter and 25 centimeters (10 in.) long and were connected to the main wing structure near the flap support structure and to the sheet metal structure to which the flap bearings were attached, as shown in figures 33 and 20. The flap actuators (fig. 19) also provided, through the bearing surfaces, a connection between the flaps and the main wing structure.

Figure 33. - Electrical bonding wires on left wing flaps.

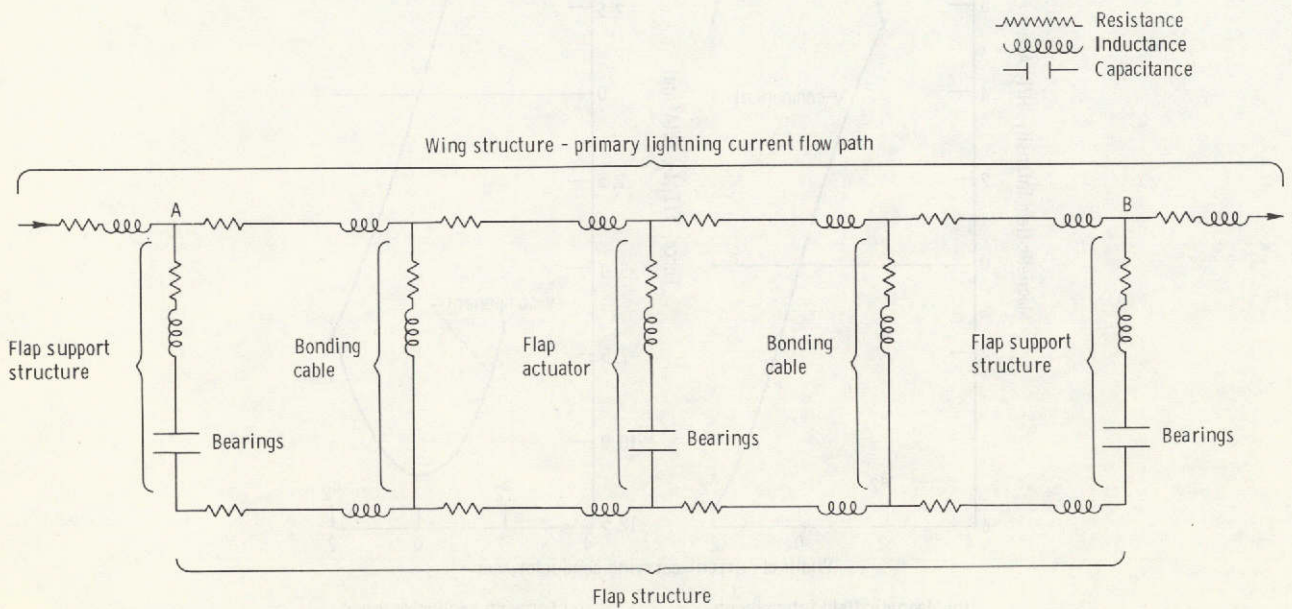
Figure 34. - Electrical circuit representation of wing-flap structure and interface attachments.
