Lessons Learned from
Accidents Involving
Remotely Piloted and
Autonomous Aircraft

Crash Course

Peter W. Merlin

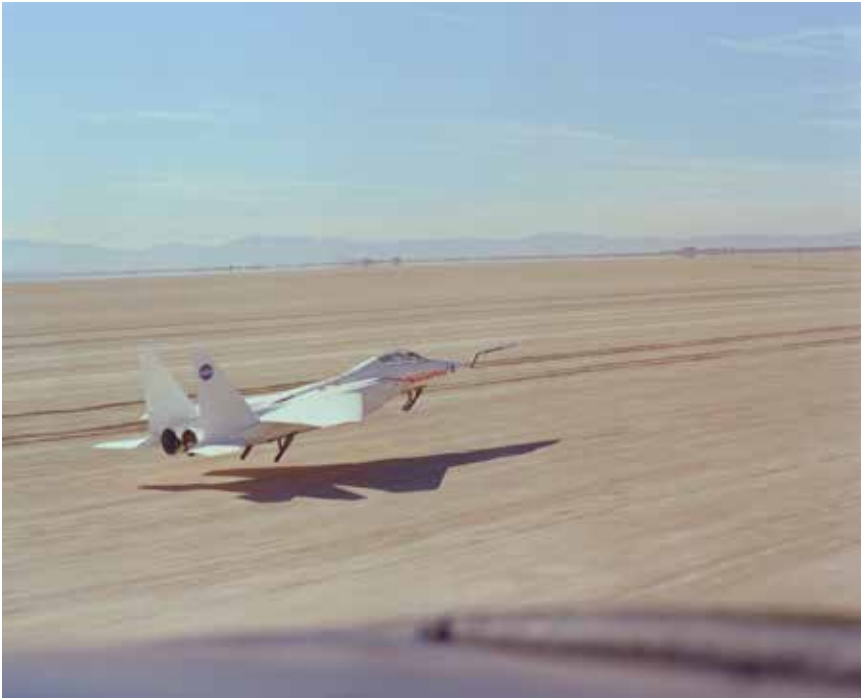
The F-15 RPRV was eventually modified with skids for landings on the dry lakebed at Edwards. NASA

As a result of this successful remotely piloted landing, and considering previous parachute recovery difficulties, further use of MARS was discontinued. The RPRV was modified with landing skids, and all flights thereafter ended with horizontal touchdowns on the lakebed.²⁴

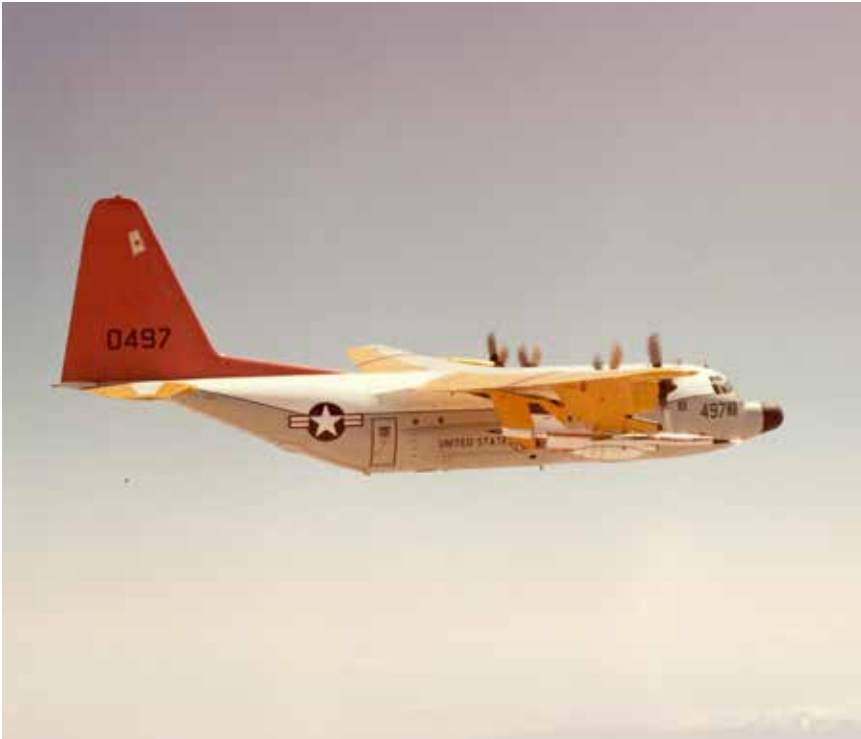
In 1983, a DC-130A was used as a mother ship for the DAST-2. Following two captive flights, the first launch attempt ended in failure. NASA

The next three flight attempts were also aborted, the first due to a drone engine temperature warning, the second because of the loss of telemetry, and a third for unspecified reasons prior to taxi.²⁸

The board recommended that all future DAST launches be conducted from the NASA B-52. This would insure adherence to NASA maintenance practices and policies.³⁸

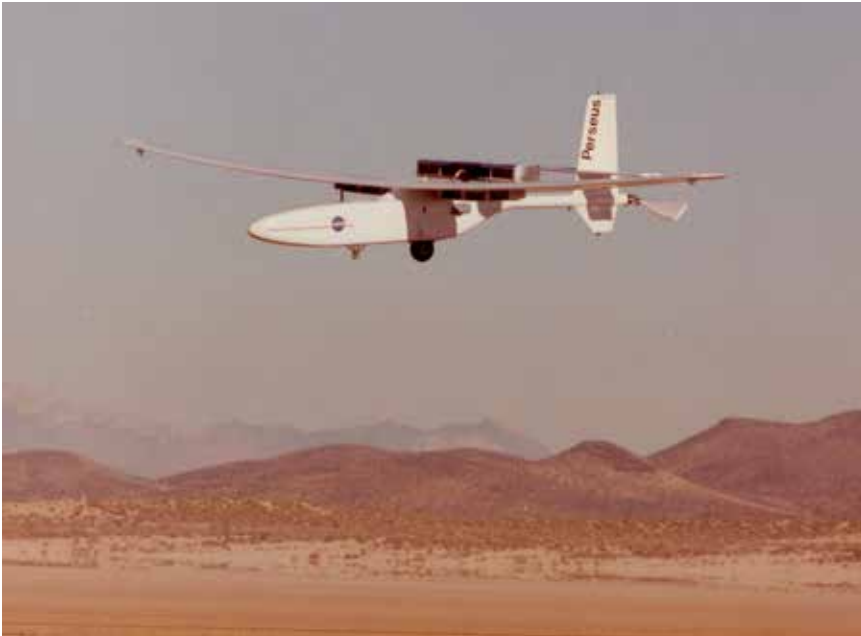
The Perseus-A had a maneuver speed limit of 61 knots indicated airspeed (KIAS) and a never-to-exceed speed limit of 71 KIAS. NASA

The pilot reduced the throttle setting and began descent procedures that included a normal engine shutdown. As the Perseus-A descended through 34,000 feet, the aircraft experienced slight vertical oscillations that went unnoticed in the control room because personnel were focused on flying the aircraft through a band of high winds and establishing a positive ground speed. Indicated airspeed was increased from 52.5 to 62.4 knots. The Perseus-A had a maneuver speed limit of 61 knots indicated airspeed (KIAS) and a never-to-exceed speed limit of 71 KIAS.⁷

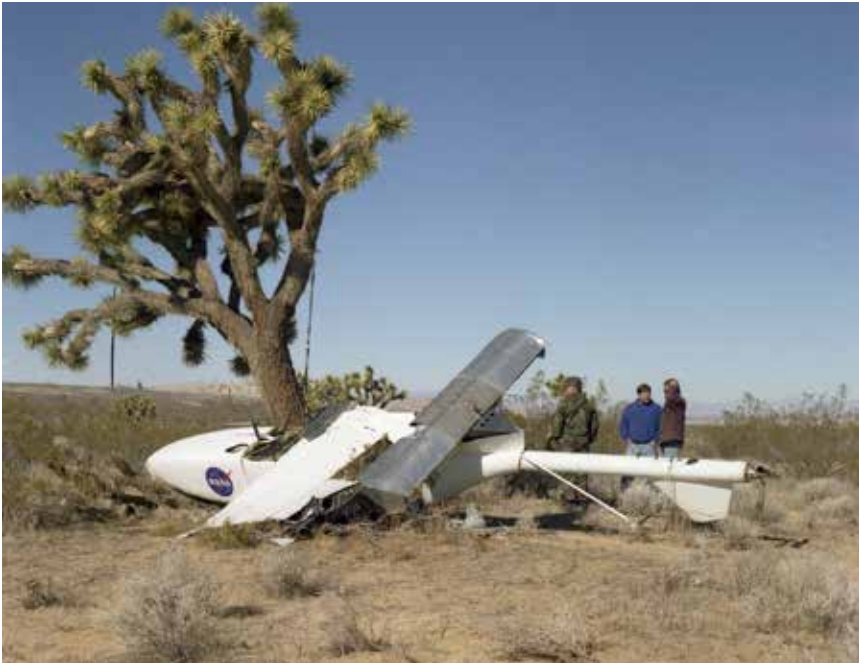
Members of the recovery crew examine the Perseus-A on the Edwards PIRA. NASA

As the aircraft's oscillations grew in amplitude, everyone in the GCS became aware of the anomalous motions. The pilot reduced airspeed, and the flight director commanded both autopilots be turned off. The flight engineer asked whether he should zero vertical gyro inputs to the autopilots, but the flight director said no. The backup pilot, then acting as pilot-in-command, asked the primary pilot for assistance in turning autopilot switches off.

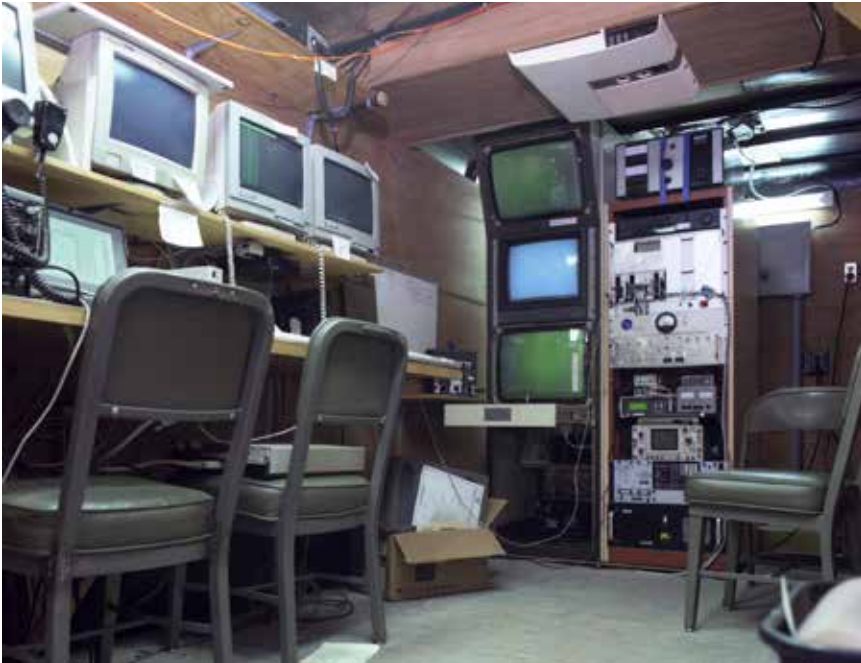
The Perseus GCS included positions for a pilot and several systems monitors. NASA

Several human factors contributed to the mishap. These were related to deficiencies in the design of the GCS as well as GCS team training.

First, displays in the GCS provided poor situational awareness. This precluded adequate mission monitoring and led to the test team's inability to detect the gyro failure. The control panel featured a very limited set of caution and warning annunciators and no autopilot-mode annunciation. Caution and warning indicators were primarily focused on catastrophic engine failures. None were used to indicate sensor failures. Although telemetry data were available to both the test director and flight-test engineer, the data were presented in a tabular format only, on one of 10 selectable pages. System limits were not indicated by these displays. Operating autopilot modes had to be determined by examination of the autopilot switches. At the time of the mishap, the test director was unable to see these switches due to the GCS layout and was unaware that the airspeed-hold autopilot had been switched back on.¹¹

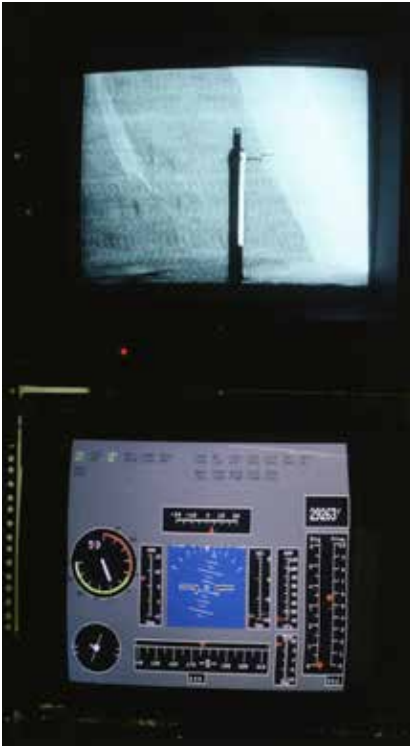
Two screens provided the Perseus pilot with outside visual reference (top) and virtual-cockpit instruments. NASA

screens caused pilots to focus on the head-up display on the center screen, precluding the ability to easily correlate and analyze aircraft flight information. Postflight analysis revealed that a vertical gyro failure could have been diagnosed from the information available on the three CRT displays.

Failure to correlate the displayed information also resulted from the pilot's lack of confidence in the fidelity of the attitude instrument display, which had a relatively slow update rate. During the flight, the instrument-panel display indicated the effects of erratic attitude information from the vertical gyro. That this display did not correlate with the head-up display on the center screen was a clear indication of a failing gyro. The aircraft appeared to stabilize at a nominal wings-level attitude just prior to loss of control, contributing to the pilot's belief that the pitch axis was healthy and leading to his reengagement of the failing pitch (airspeed-hold) autopilot.¹²

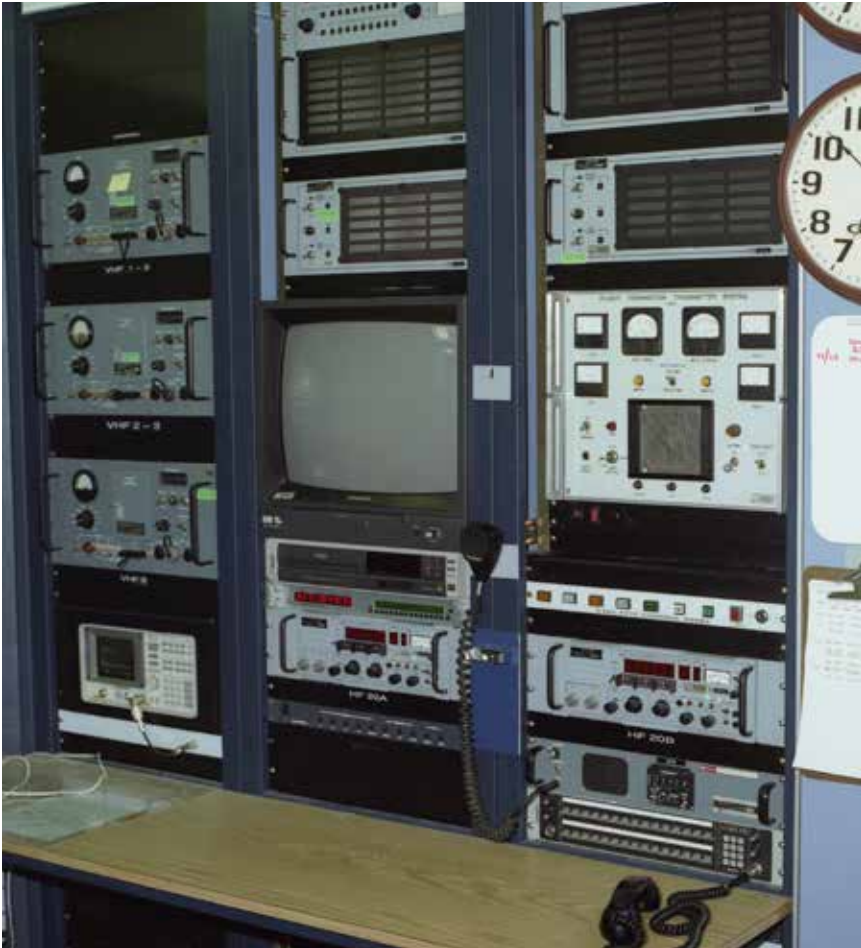
The Theseus FTS panel was designed to allow the RSO to shut down the airplane's engines and fire two rocket-deployed parachutes in the event of an emergency. NASA

command had no effect. Investigators concluded that operator error was the single factor leading to the FTS failure.¹³

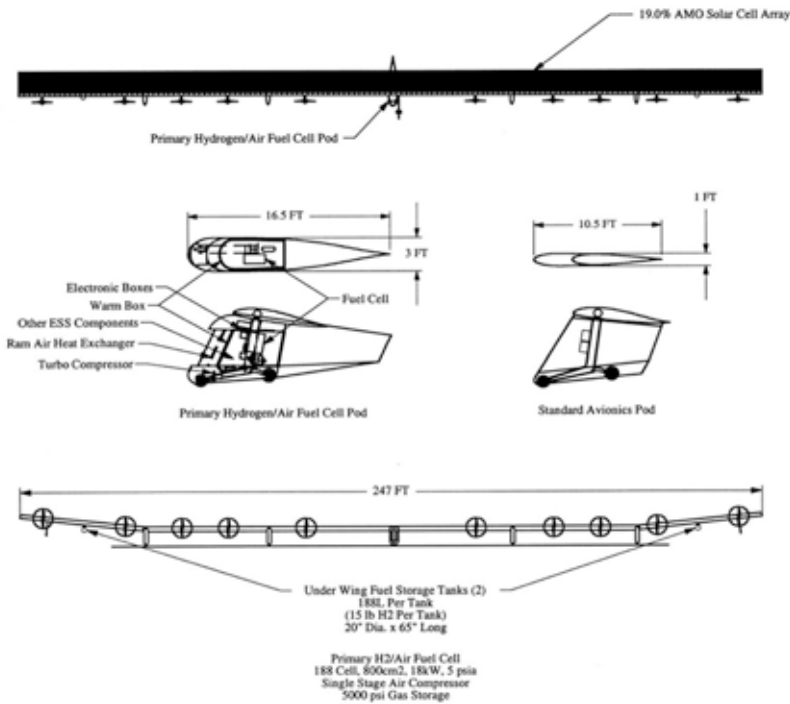
Addition of a center-mounted 520-pound fuel cell and two 165-pound fuel tanks beneath the outer wing panels changed the Helios Prototype from a span-loader to a point-loaded configuration. NASA

would have required only two regenerative fuel cell pods located about one-third the distance from aircraft centerline to the wingtips. Installation of three pods for the PFCS configuration resulted in increased point loading.

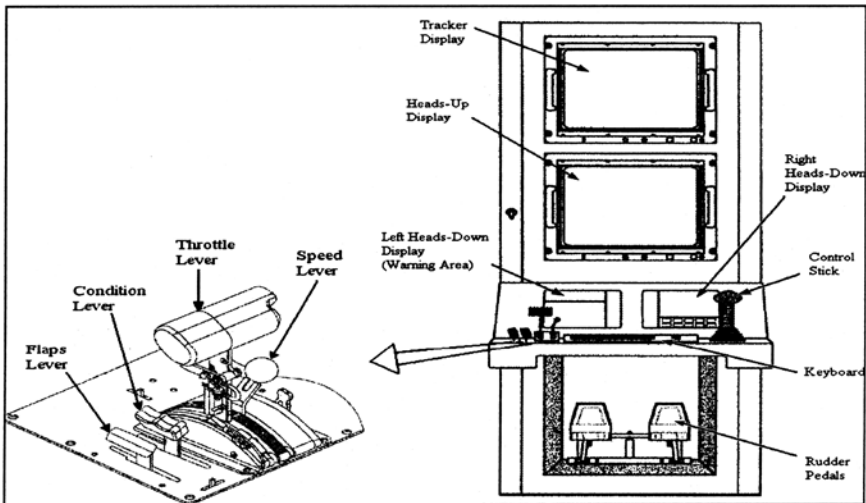
When PPO-1 is used as the primary aircraft control interface, movement of the “condition lever” to the forward position opens and closes the fuel valve. Moving the lever full aft closes the fuel valve and feathers the propeller. NTSB
