Report SAM-TR-77-19

OPTICAL EVALUATION OF F/FB-111
FIELD-SERVICE-TEST WINDSHIELDS

September 1977

Progress Report for Period 17 April 1975-16 November 1976

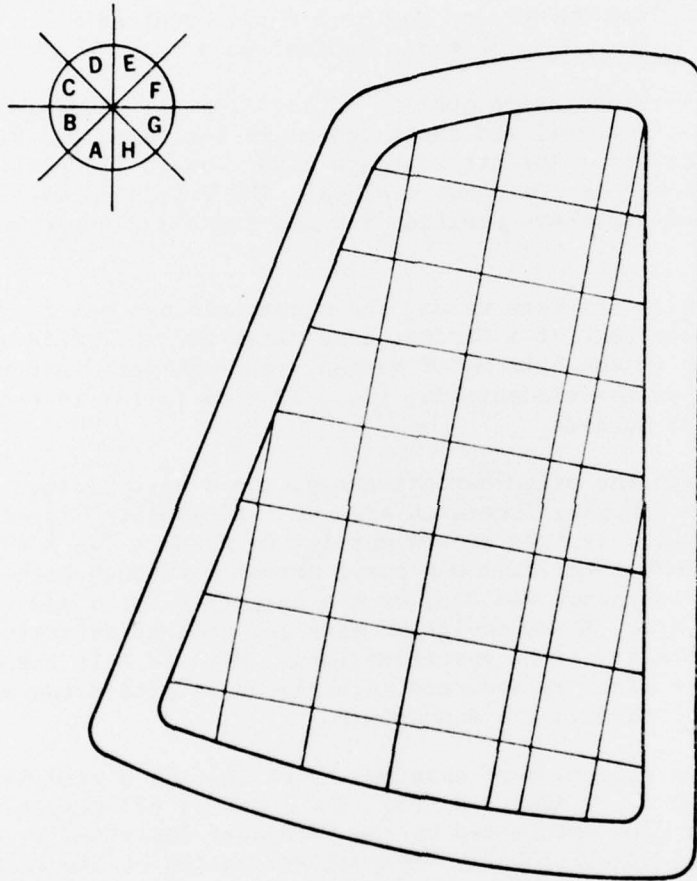
Figure 2. Prism-deviation overlay pattern.

To generate the prism-deviation map, the windshield was vertically suspended from a hoist, fore-arch area up. A template placed over the windshield divided it into approximately 10- X 10-cm (4- X 4-in) squares (Fig. 2). A HeNe laser beam was posed normally through each square, and the beam divergence was read from a target vectored and calibrated in minutes of arc. These deviation maps are used to determine if the windshield meets boresight specifications. With technic refinement, these data have afforded accurate information in predicting multiple-image locations through the windshield.
