Stall warnings in high capacity aircraft: The Australian context

2008 to 2012

ATSB Transport Safety Report

AR-2012-172

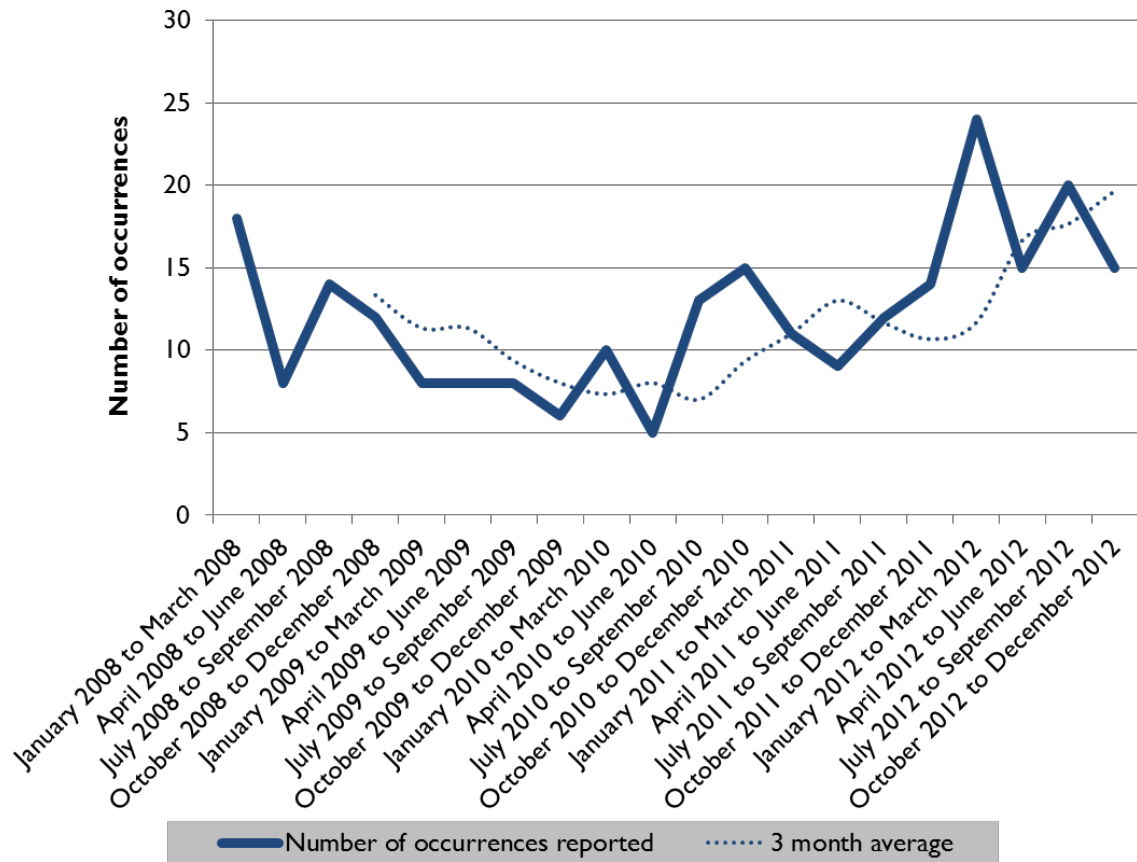
Figure 2 shows changes in the number of stall warnings reported to the ATSB in the 5 years since 2008. The growth observed since 2009 is reflective of increased reporting levels by operators, and improved capture by the ATSB of all stall warnings and stall warning system issues, not just those that resulted in activation of a stick shaker.

Figure 2: Stall warnings reported to the ATSB involving high capacity aircraft, 2008 to 2012

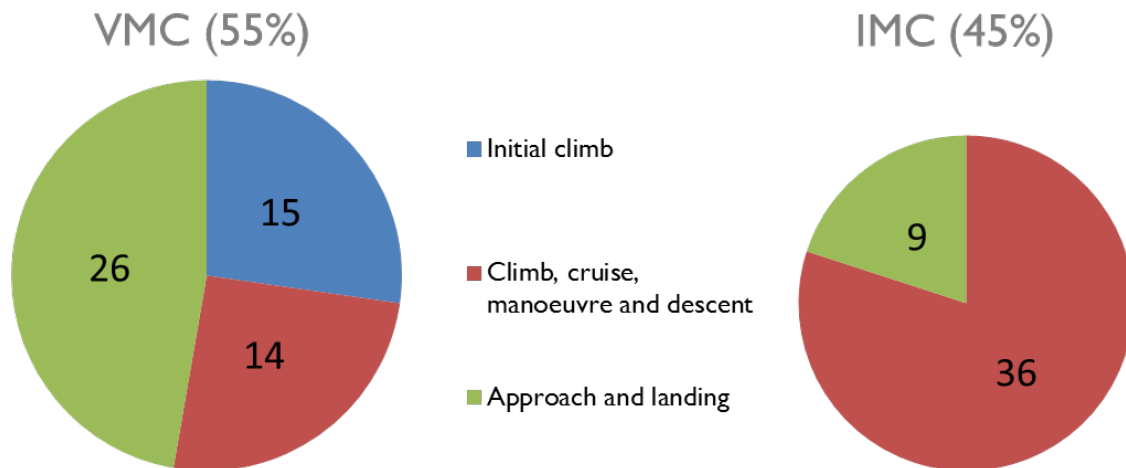
Stall warnings are not necessarily only associated with operations in poor weather (IMC). Flight conditions at the time of a stall warning were reported in 100 of the 169 genuine stall warnings that were reported to the ATSB between 2008 and 2012, and more than half of these (55 per cent) occurred in VMC. The graph below shows that there was a stark difference in the phase of flight a stall warning was most likely to occur in VMC versus IMC.

Figure 4: When genuine stall warnings occur, by flight conditions

Genuine stall warnings reported during initial climb all involved VMC flight. About 40 per cent of those stall warnings occurred when the flight crew was retracting high-lift devices. Most other occurrences involved activation due to momentary loss of airspeed in wake turbulence or due to a wind change when aircraft were at pitch angles of about 10°. There were only two occurrences reported where an aircraft was banking on initial climb and was affected by turbulence, leading to a wing loading (g) increase. Three occurrences were stick shaker activations, and coincided with a checklist item to retract the flaps. The effects of increased stall speed (and stall warning activation speed) when the wing load factor increases is discussed later in this report.

In climb and descent, stall warnings that occurred in VMC were normally due to a wind gust or turbulent conditions causing an airspeed fluctuation while the aircraft was in a high angle of attack condition, or was slowing down to approach a hold point. In most of these cases, the stall warning was as a result of a sudden change in wing loading (g), as the aircraft were operating at an airspeed (generally $V_{Ref} + 80$ kts) which was well above the stall warning speed, V_{SW} (V_{Ref} is about 8 to 10 per cent higher than V_{SW}). In IMC conditions, stall warnings in cruise were very common. All were associated with turbulence during the cruise, causing either airspeed or altitude fluctuations. In 9 of 21 stall warnings where the aircraft was in cruise in IMC, the aircraft was in a turn while deviating around weather when the fluctuations occurred, increasing wing (g) loading. Of those stall warnings that occurred on climb or descent in IMC, many involved autopilot (autothrottle) disengagement due to unsatisfactory speed control in turbulence, or due to a change in wind direction.

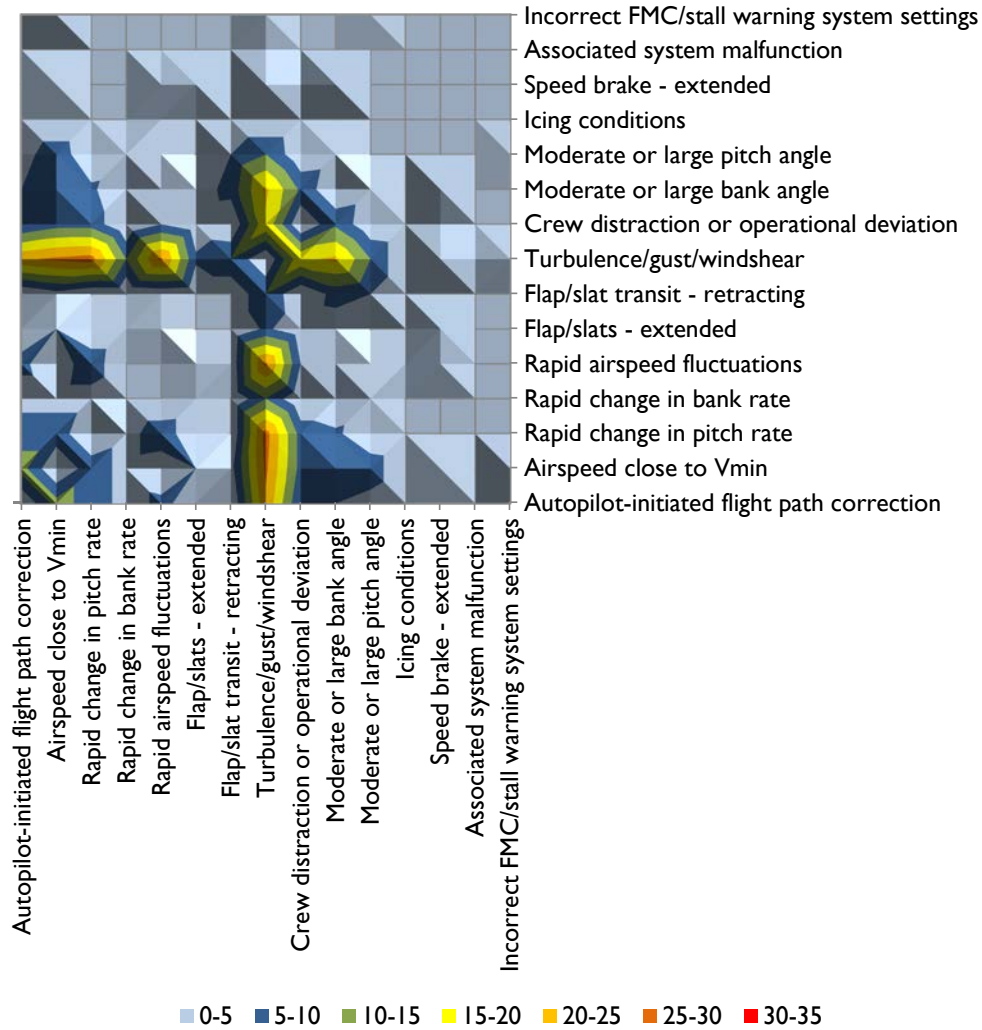
Figure 6 below shows relationships between different types of precursor conditions, that is, how often were certain combinations likely to exist in the lead up to a stall warning system activation. It shows that in the majority of occurrences, a stall warning occurred when turbulence existed with another precursor factor. The most common combinations were turbulence/gusts/windshear occurring in association with a rapid pitch angle rate of change (18 per cent) or airspeed change (17 per cent). Many of these disturbances occurred when the aircraft was under autopilot control, and an autopilot-initiated flight path correction triggered the stall warning (16 per cent).

Figure 6: Associations between precursors to stick shaker activations reported to the ATSB, 2008 to 2012

- Turbulence/gusts/windshear AND
 - operation at low airspeeds (26 occurrences)
 - bank angle greater than 20° (21 occurrences)
 - an operational deviation, such as a weather diversion (19 occurrences)
