CAP 762

CAA Research Project

The Effectiveness of Image Recorder
Systems in Accident Investigations

Safety Regulation Group

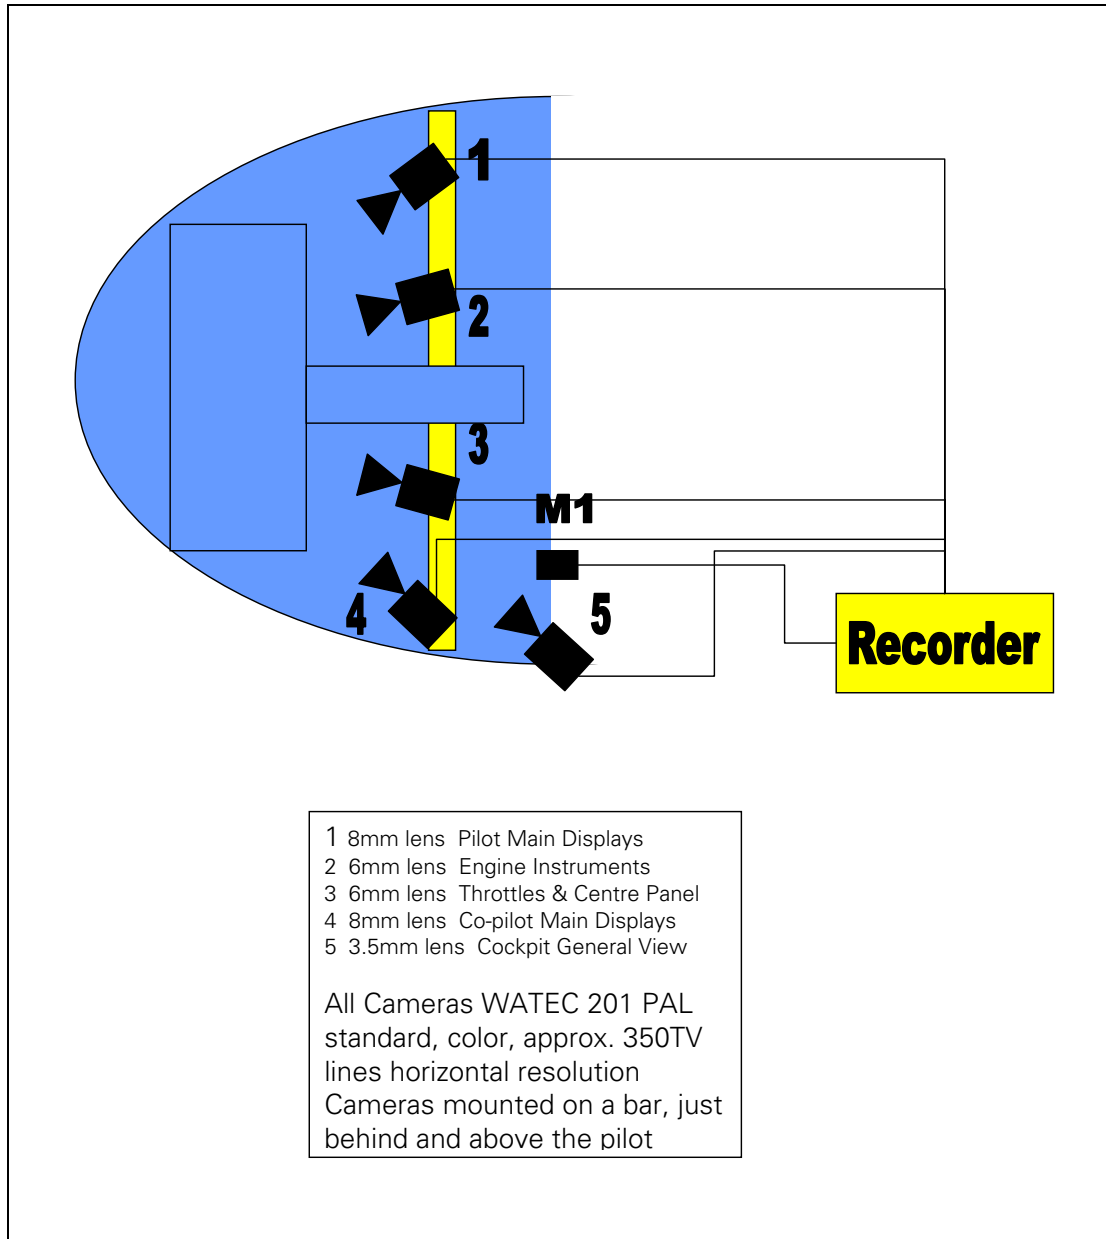
Figure 1 Flight Deck Camera Layout.

The cameras were located as shown in figure 1.

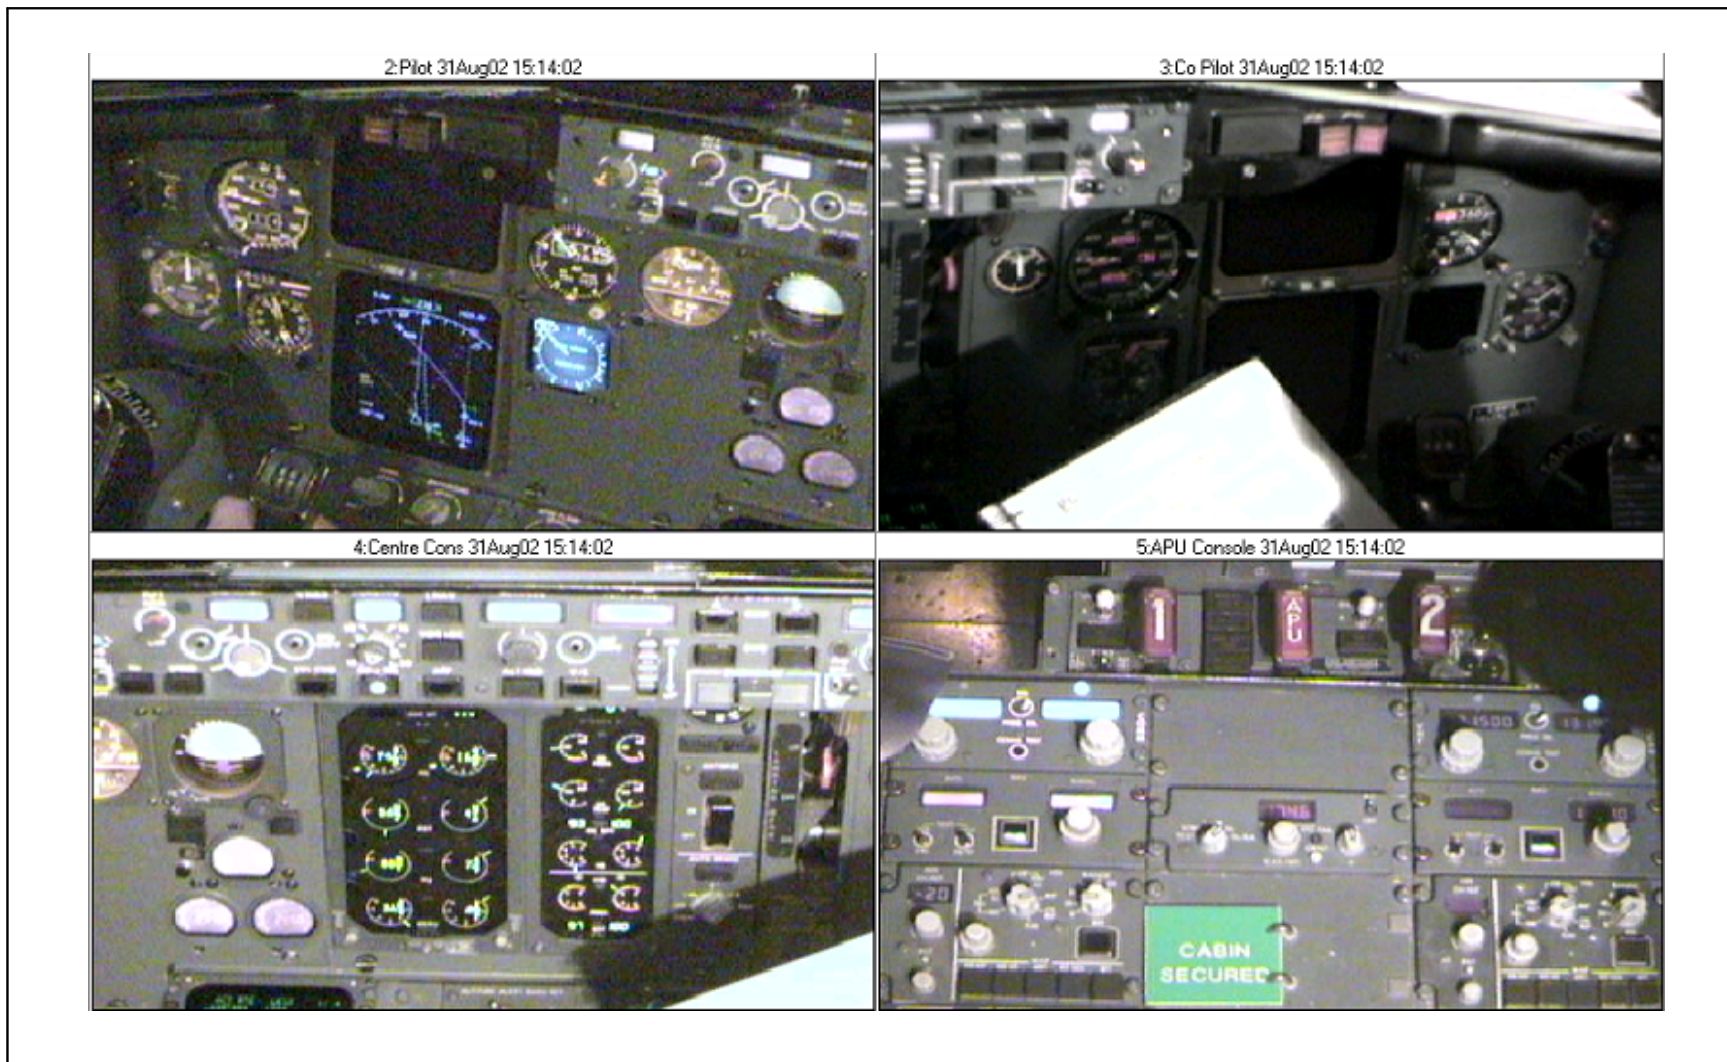
Figure 2 Images Supplied by Camera Views

The selected camera angles/locations resulted in the following types of image:

After reviewing the images presented it was agreed that they provided sufficient coverage of the flight deck instruments to allow the investigators to attempt an analysis of the accident scenarios. As previously stated, the camera installation did include one "typical" general area view which the investigators were instructed to use **only if they could not gain the information in any other way** as this camera did allow flight crew to be identified.

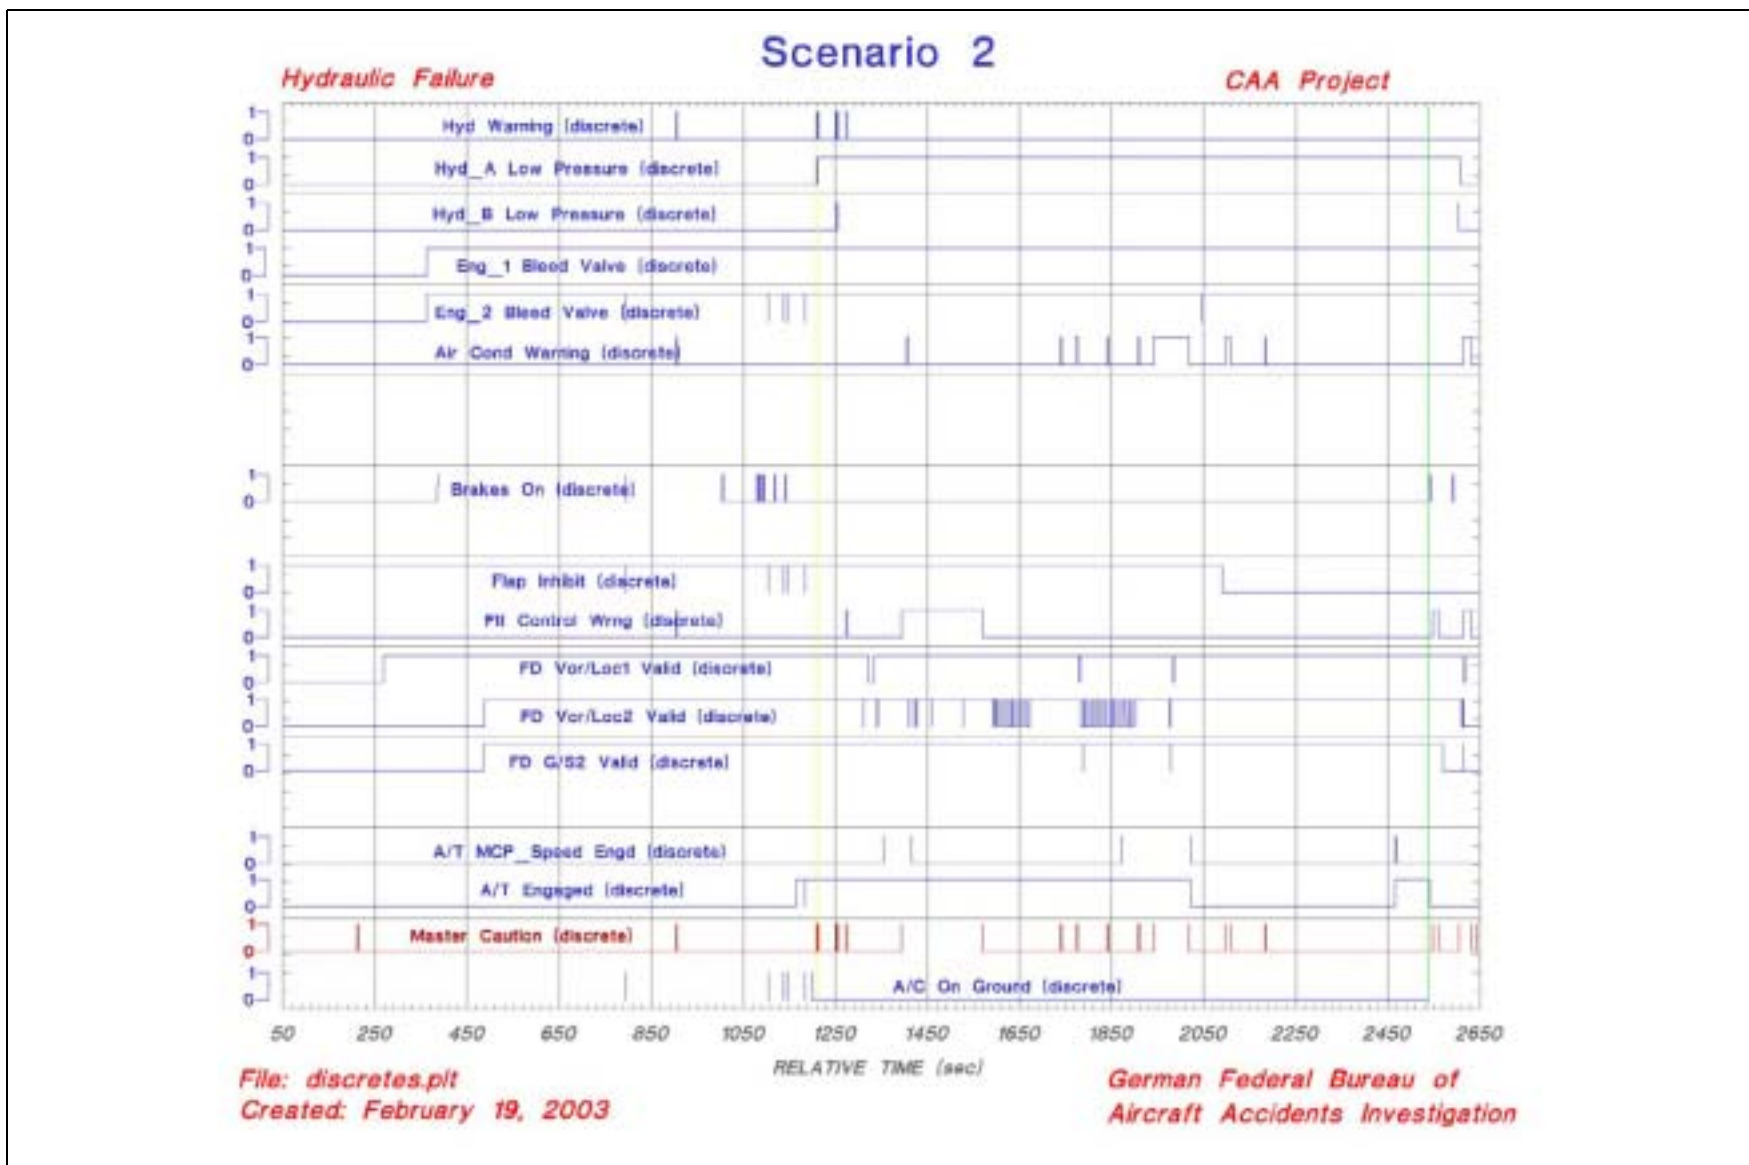
Figure 12

3.6 **BFU FDR Traces**

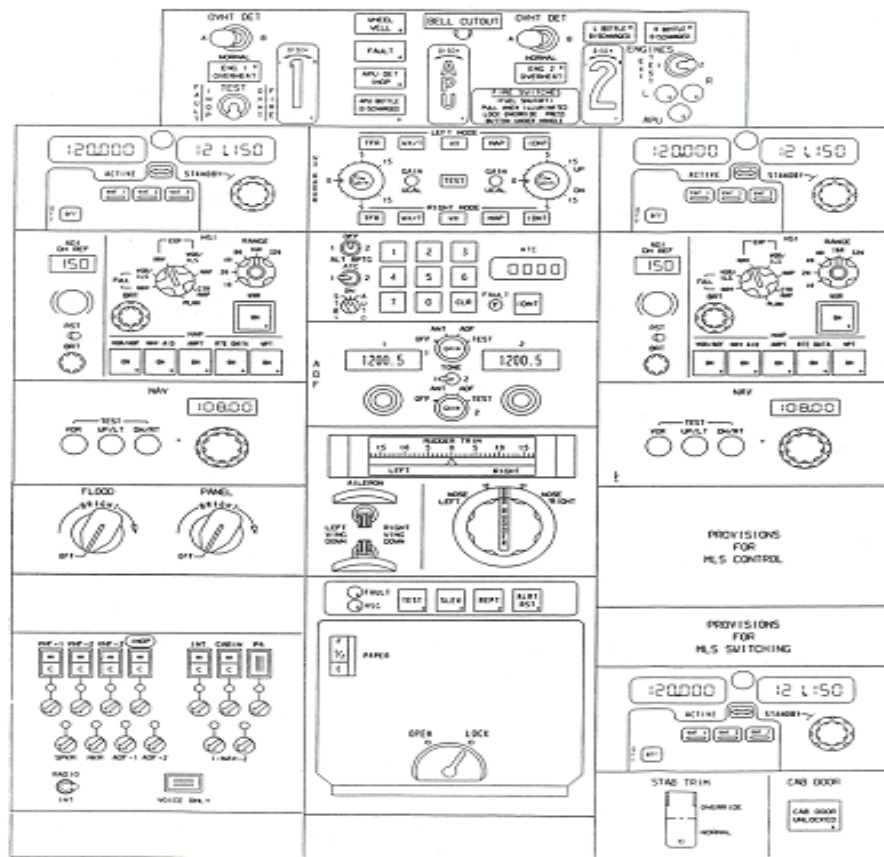
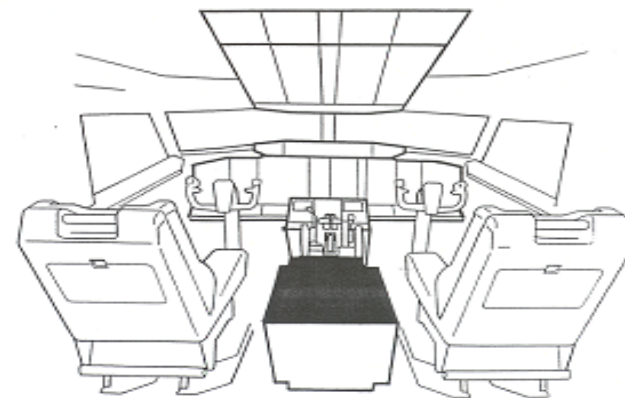
Aft electronics panel
P8

The Boeing 737 flight deck layout is shown in Appendix 7.

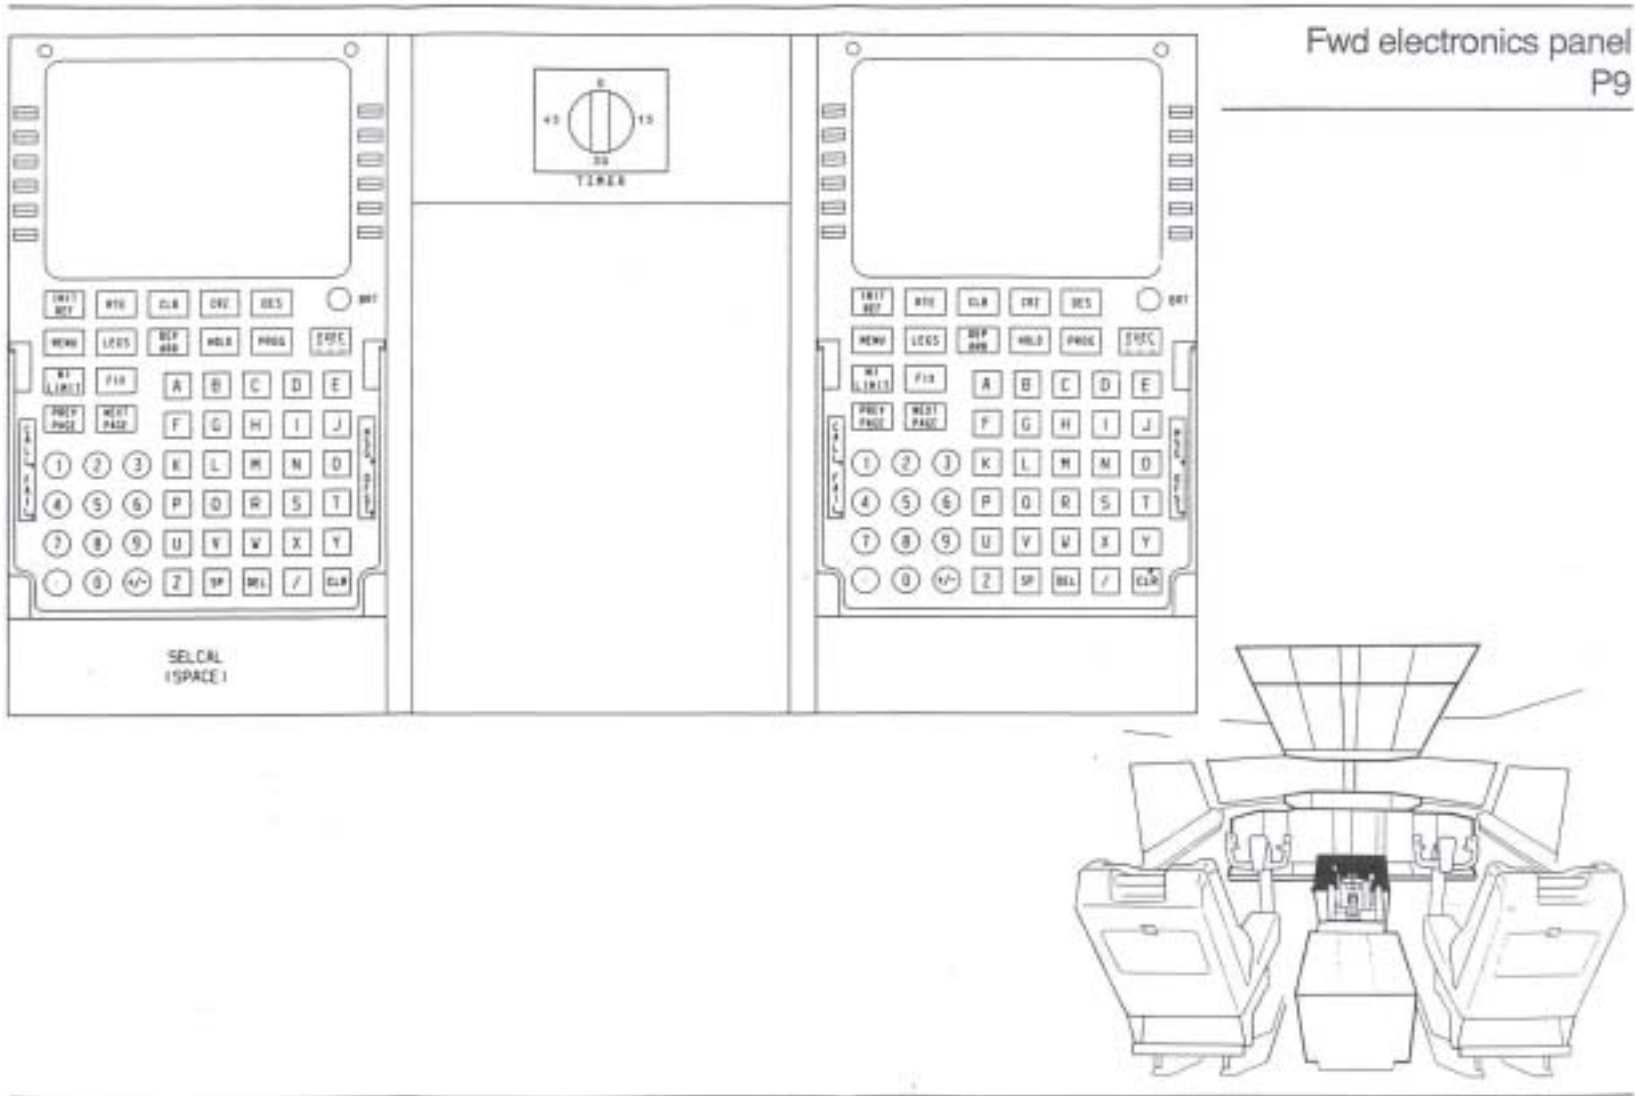
Fwd electronics panel
Pg

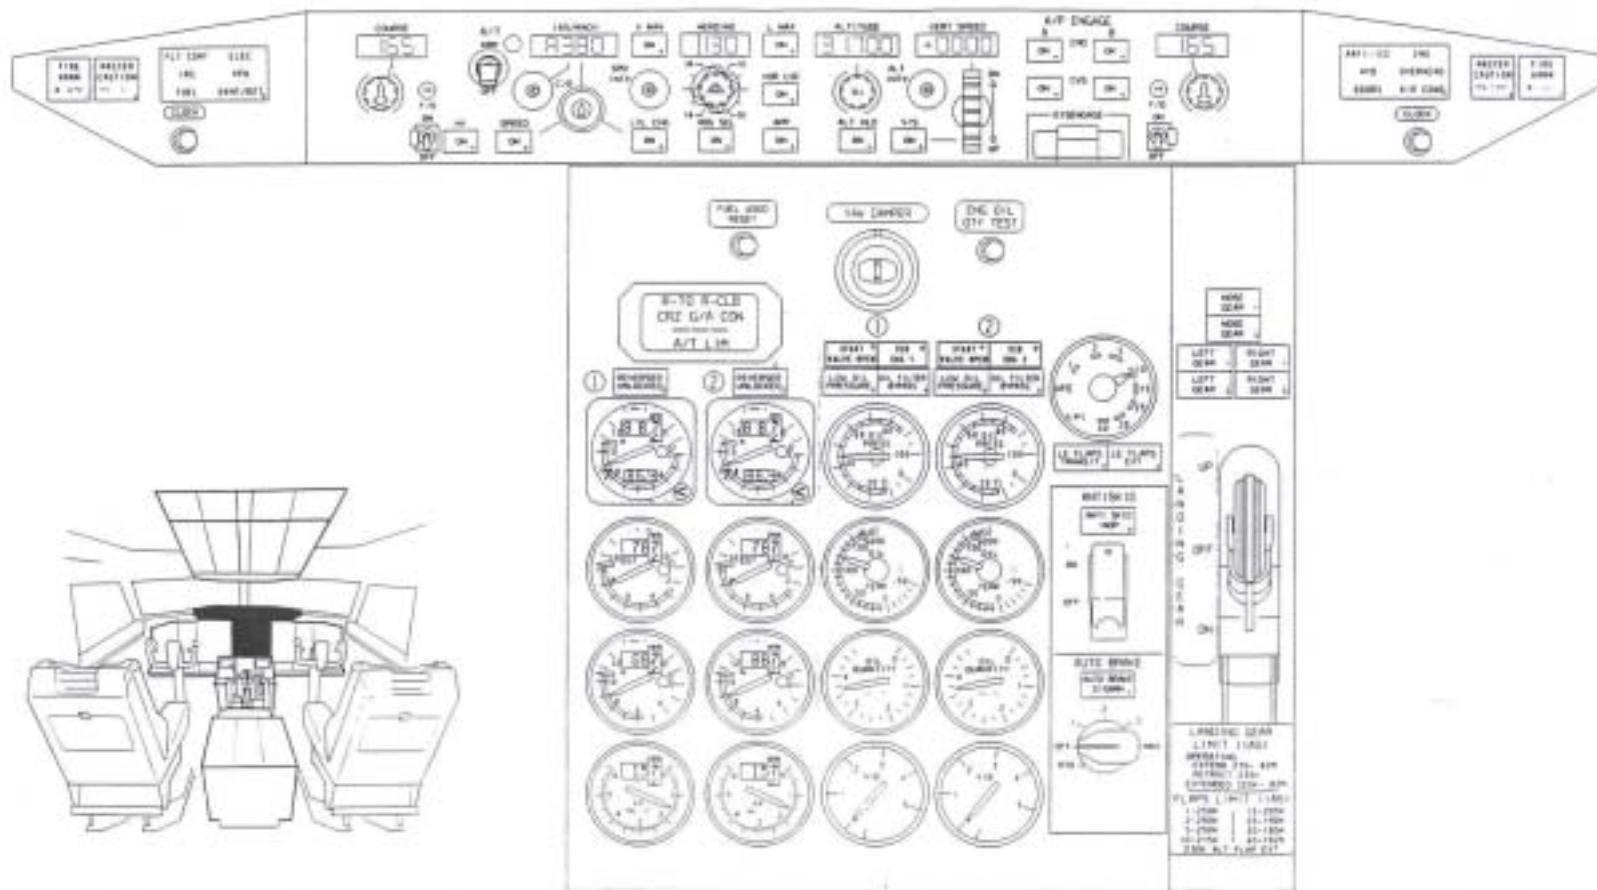
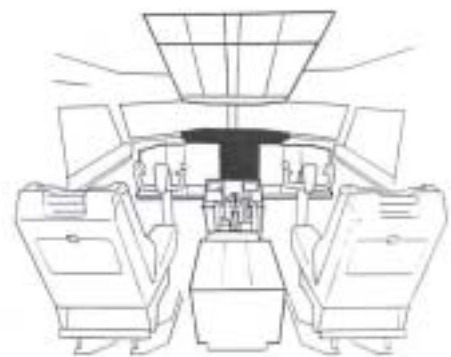
Centre instrument panel P2 Glareshield P7
